Re: Summary of Weston & Sampson Brazil Street Incident Review

SUBJECT: Melrose, MA – Brazil Street Sewer Review and Evaluation

At the request of the City of Melrose, MA (the City), Weston & Sampson Engineers, Inc. has prepared this memorandum after review of the sewer issue that occurred on Brazil Street on Thursday, June 20th, 2019. The purpose of the memorandum is to present an evaluation of the existing conditions of the sewer and sewer service connections, provide an opinion as to the cause of the issue, and present recommendations for improvements to the sewer.

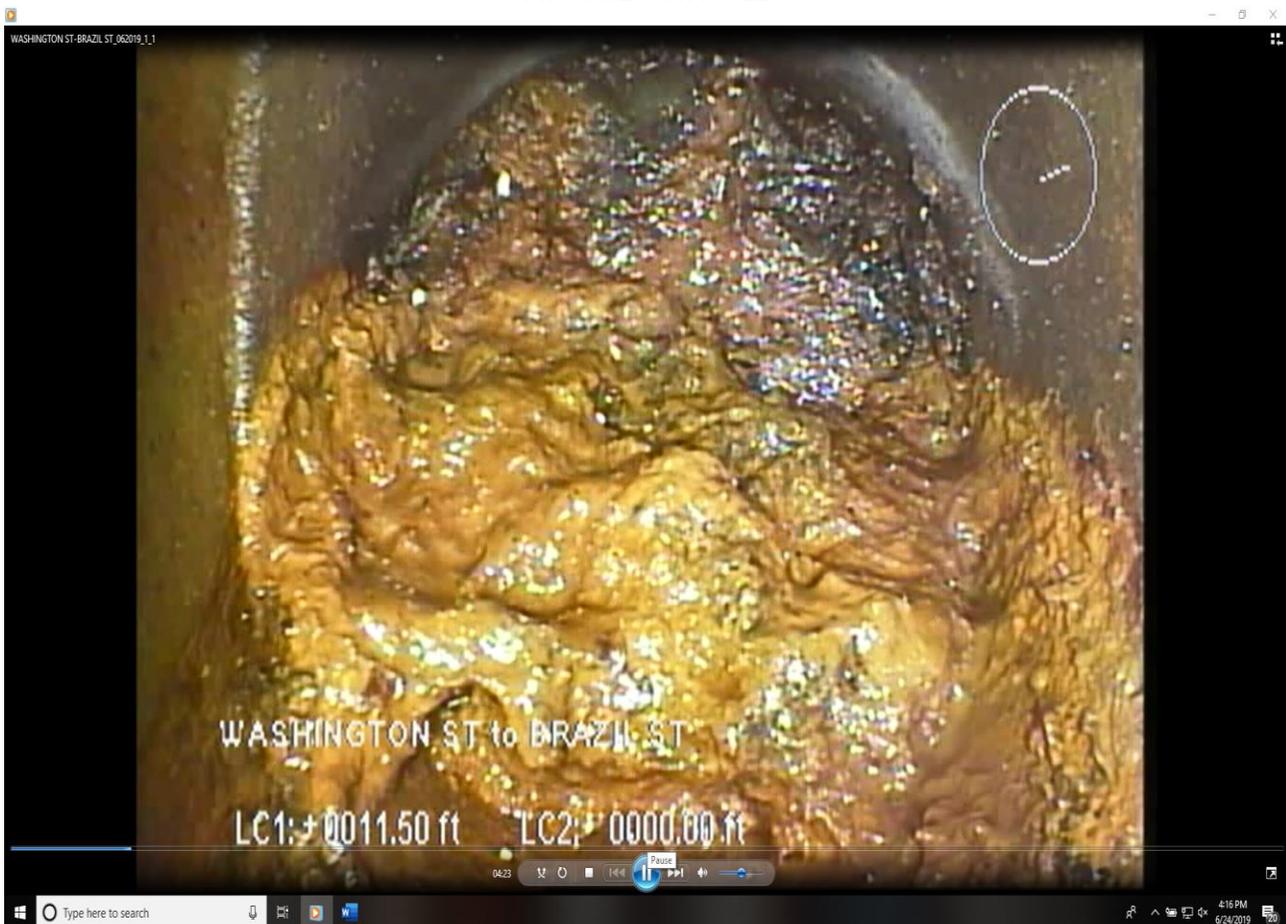
Photo #1 – STA 0+11

At STA 0+11, there appears to be a "capped" (or sealed off) service connection stub with large amounts of grease (see Photo #1).

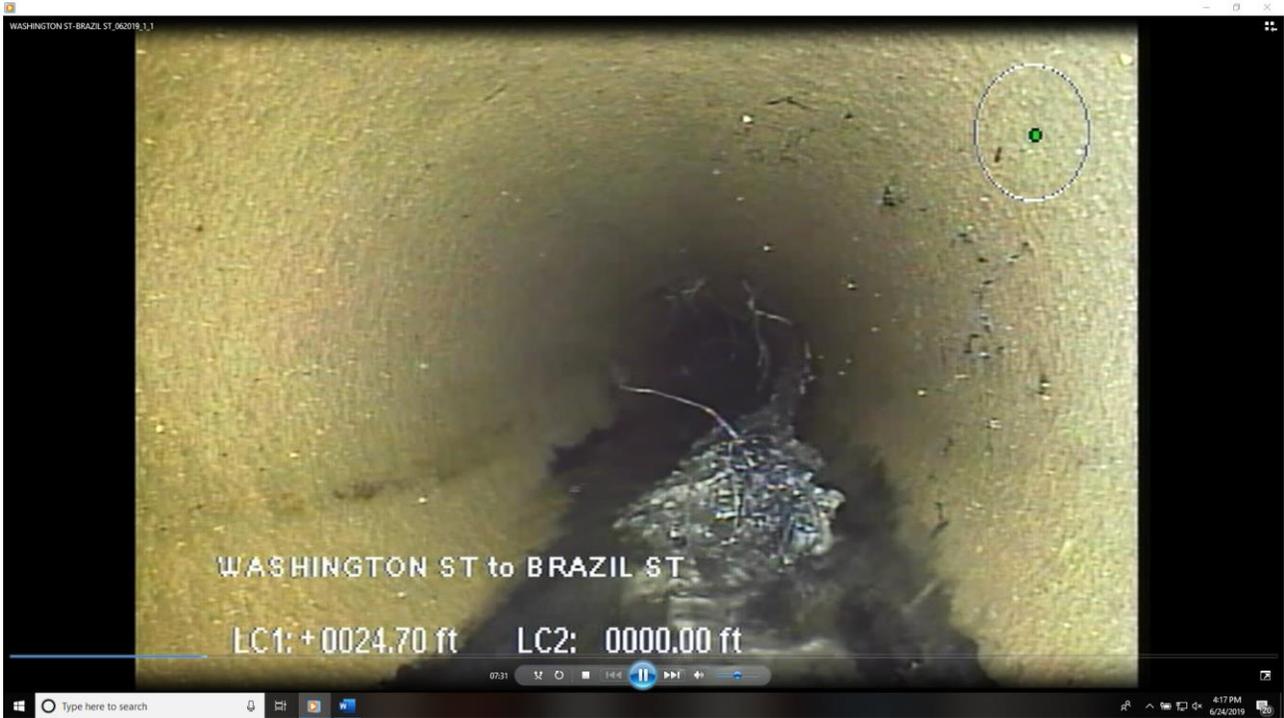
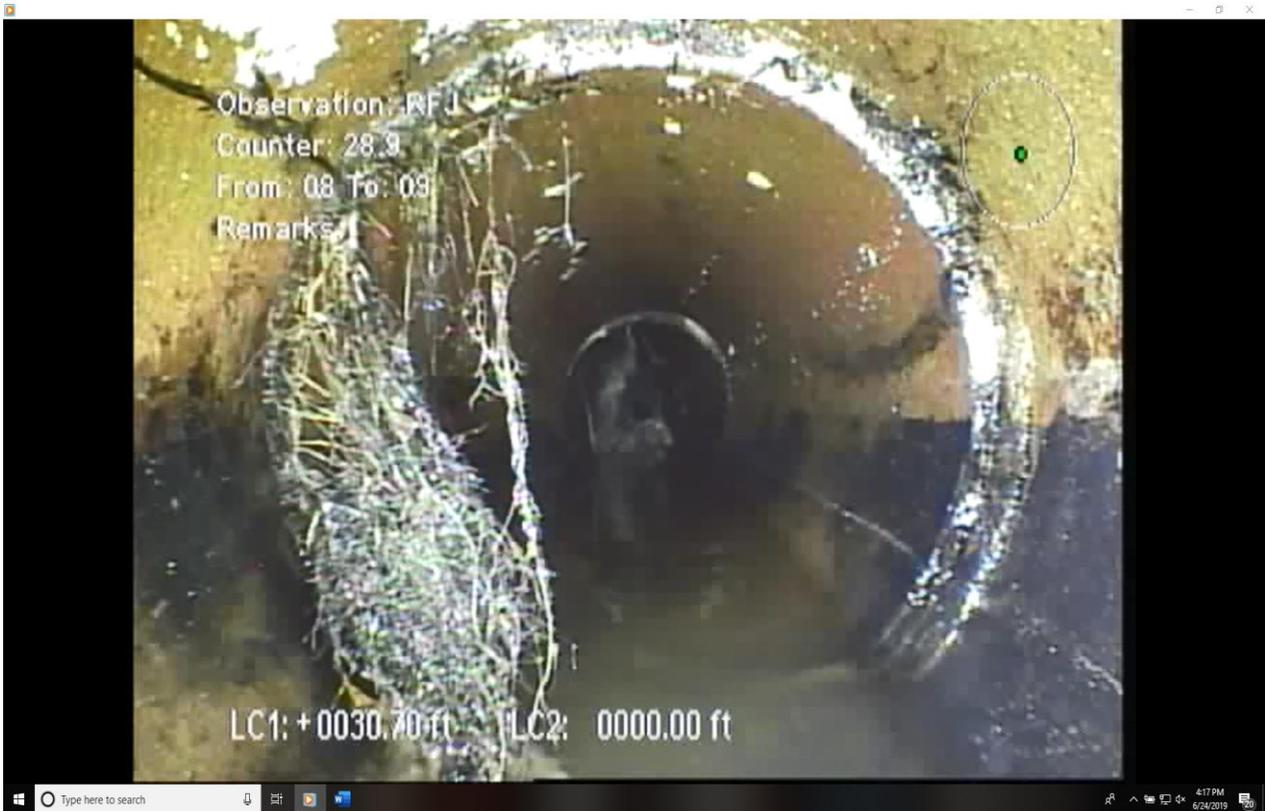
At STA 0+25 and STA 0+30, root intrusion was present at the sewer pipe joints (see Photos #2 and #3)

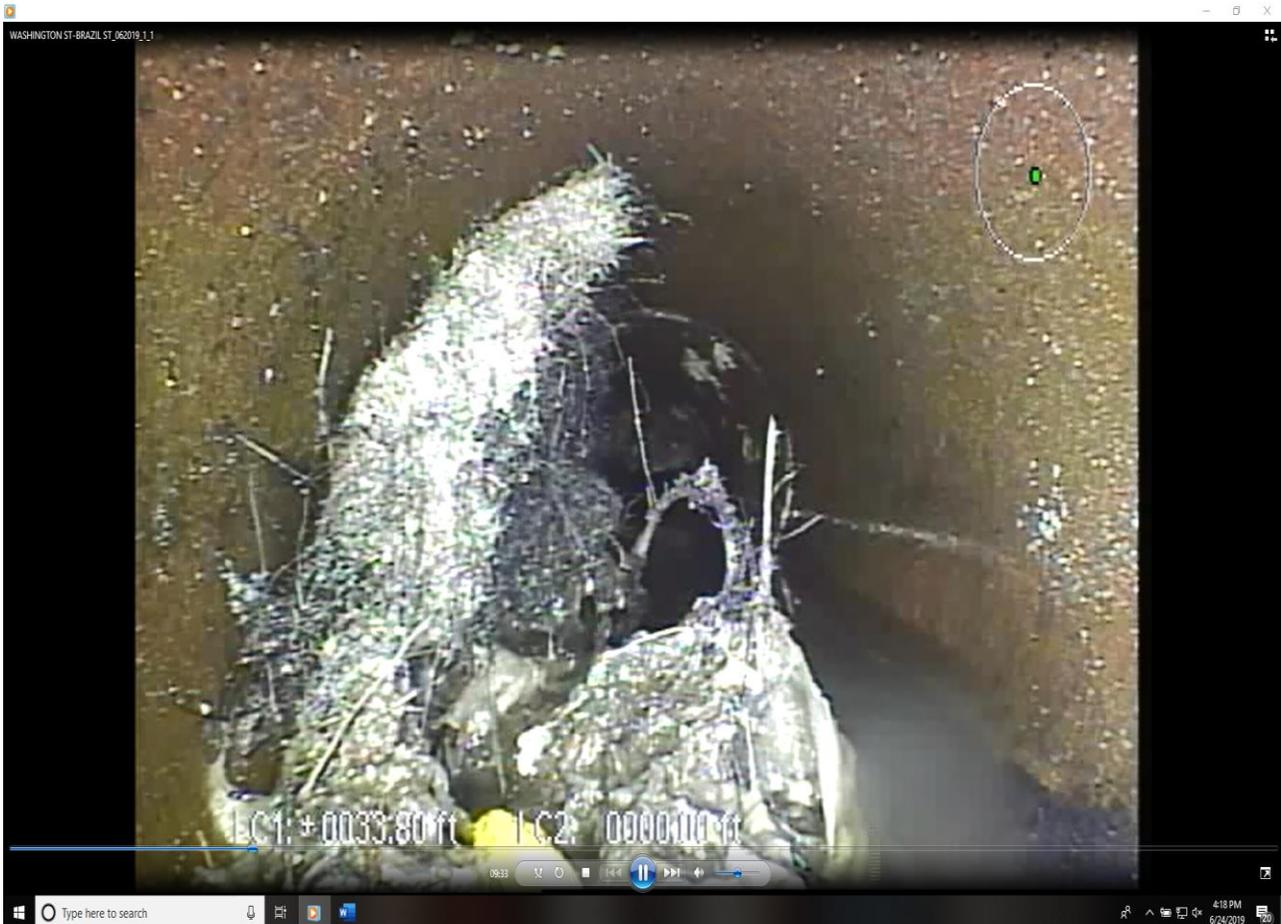
Photo #4 – STA 0+34

As previously stated, the City encountered an obstruction at approximate STA 0+34 during their jetting operations on June 20th. As shown below in Photo #4, large amounts of roots and debris were still present at STA 0+34 following the jetting operation.

There was also another “capped” service connection behind the roots shown in Photo #4 at STA 0+35 which was also completely filled with roots. As shown in Photo #4, a small amount of wastewater is flowing past the cluster of roots as indicated by the discolored water at the right side of the photograph. These roots were the obstruction encountered by the City personnel during their jetting operations on June 20th. In order to clear the obstruction, the flow and pressure from the jet hose were increased which allowed the jetting procedure to continue and to allow wastewater to flow better downstream toward SMH 0+00.

Based on our review of the CCTV inspection video, it appears that the existing 6-inch VC sewer pipe was completely filled (or surcharged) with wastewater behind the roots that were encountered at STA 0+34 as shown in Photo #4. Large amounts of grease and debris were seen in the video at the top of the pipe and along the sides of the pipe which are indicative of the pipe being full. The amount of grease and debris also indicate that this pipe was likely surcharged for enough time to allow for collection and deposition of grease and debris. Grease and debris appear to have collected in the roots as well, which further solidified the obstruction, surcharged the sewer behind it, and limited the normal flow of wastewater from Brazil Street.

- The City's procedure of increasing the flow and pressure of the jet hose when the obstruction was encountered at STA 0+34 is typical protocol when cleaning sewers. Had the City been aware of the roots and grease, different equipment may have been used, such as a nozzle with a cutting instrument, to clear the obstruction.

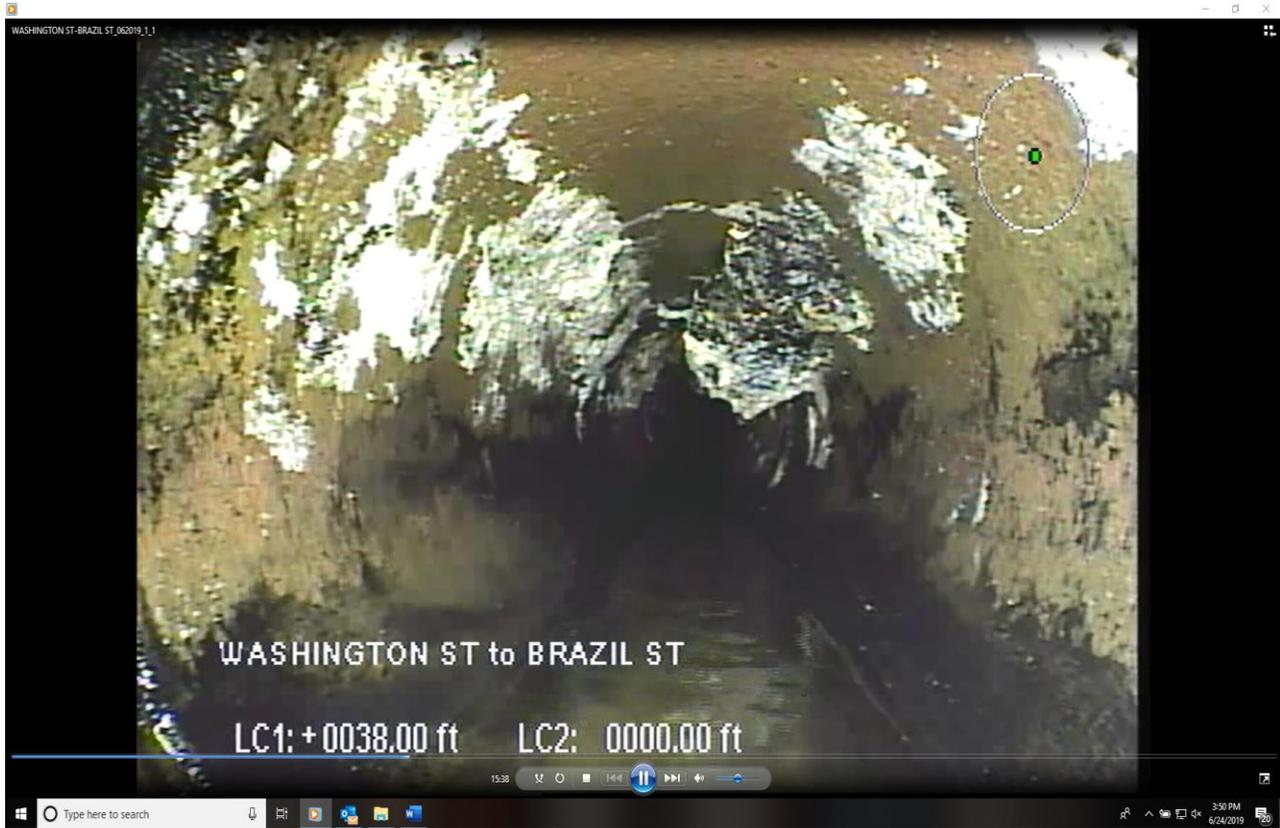
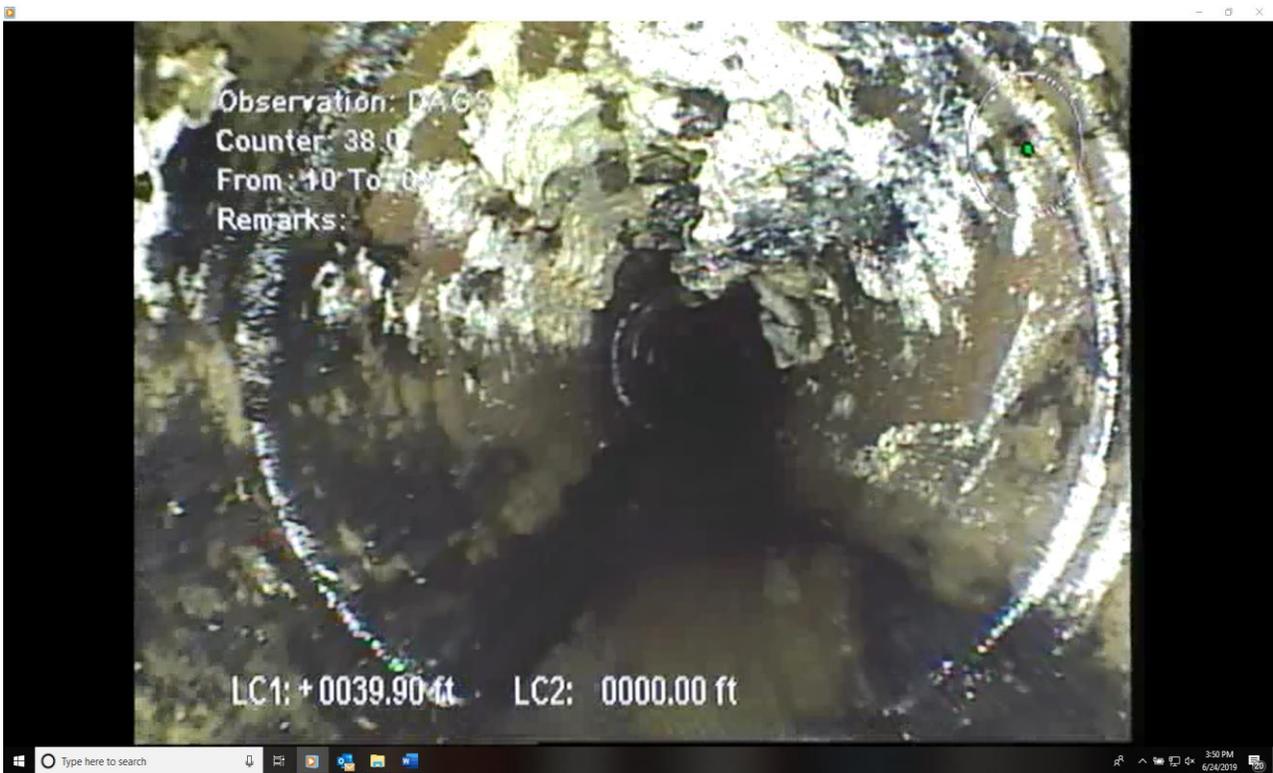
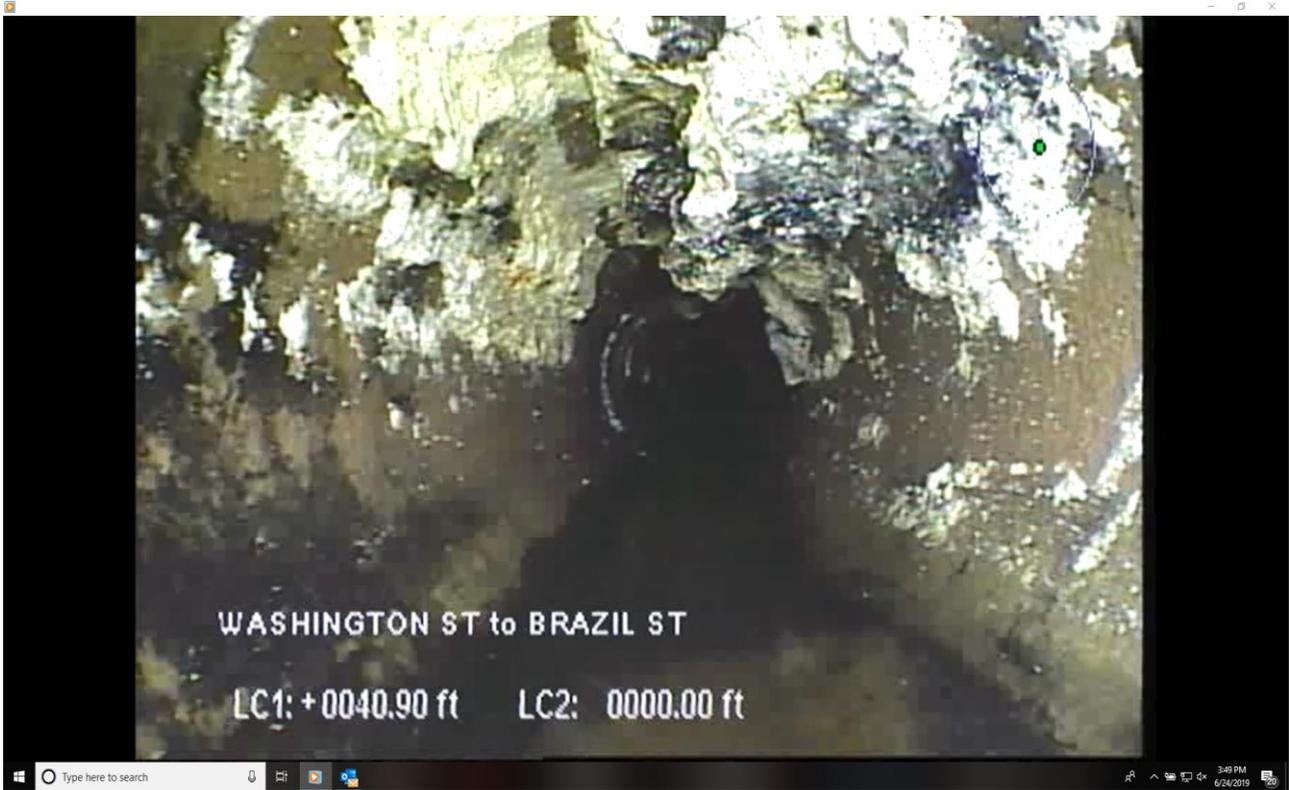
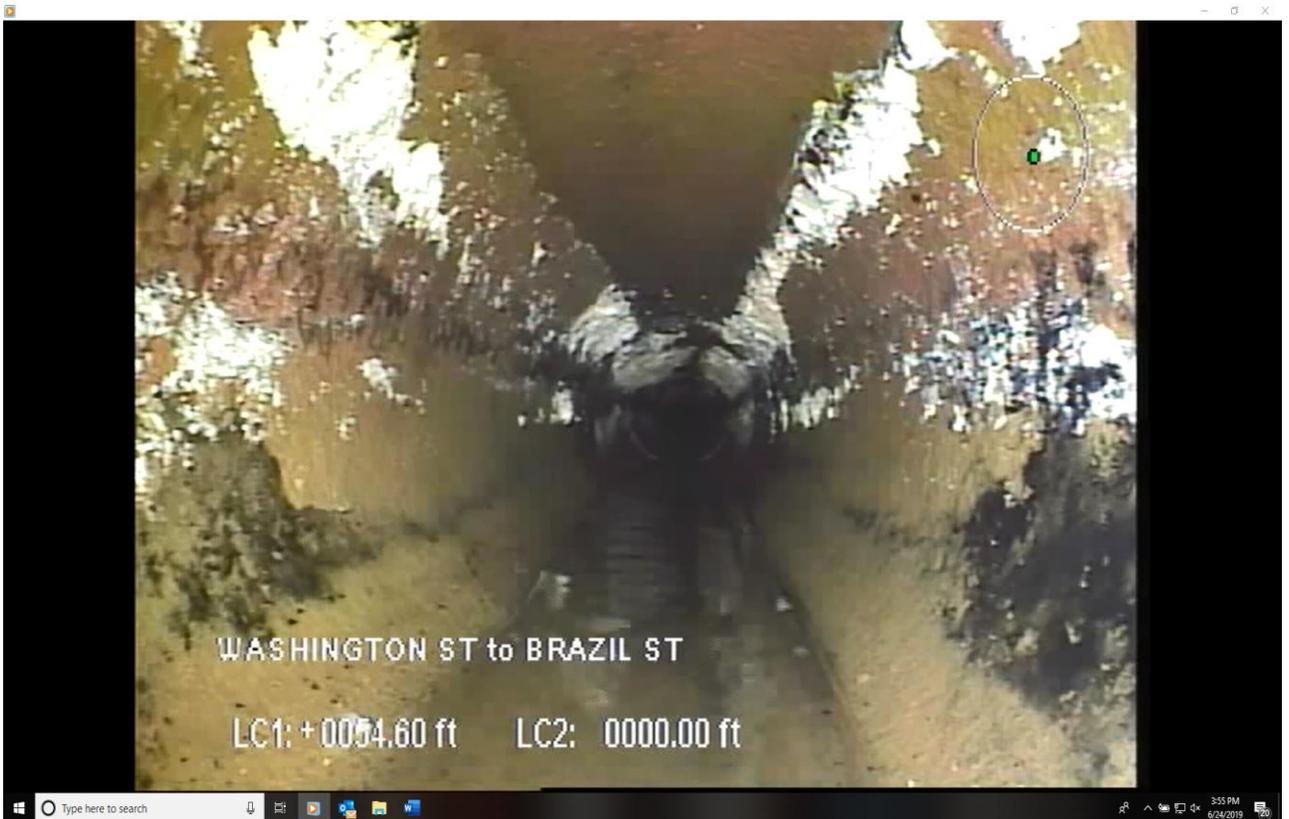
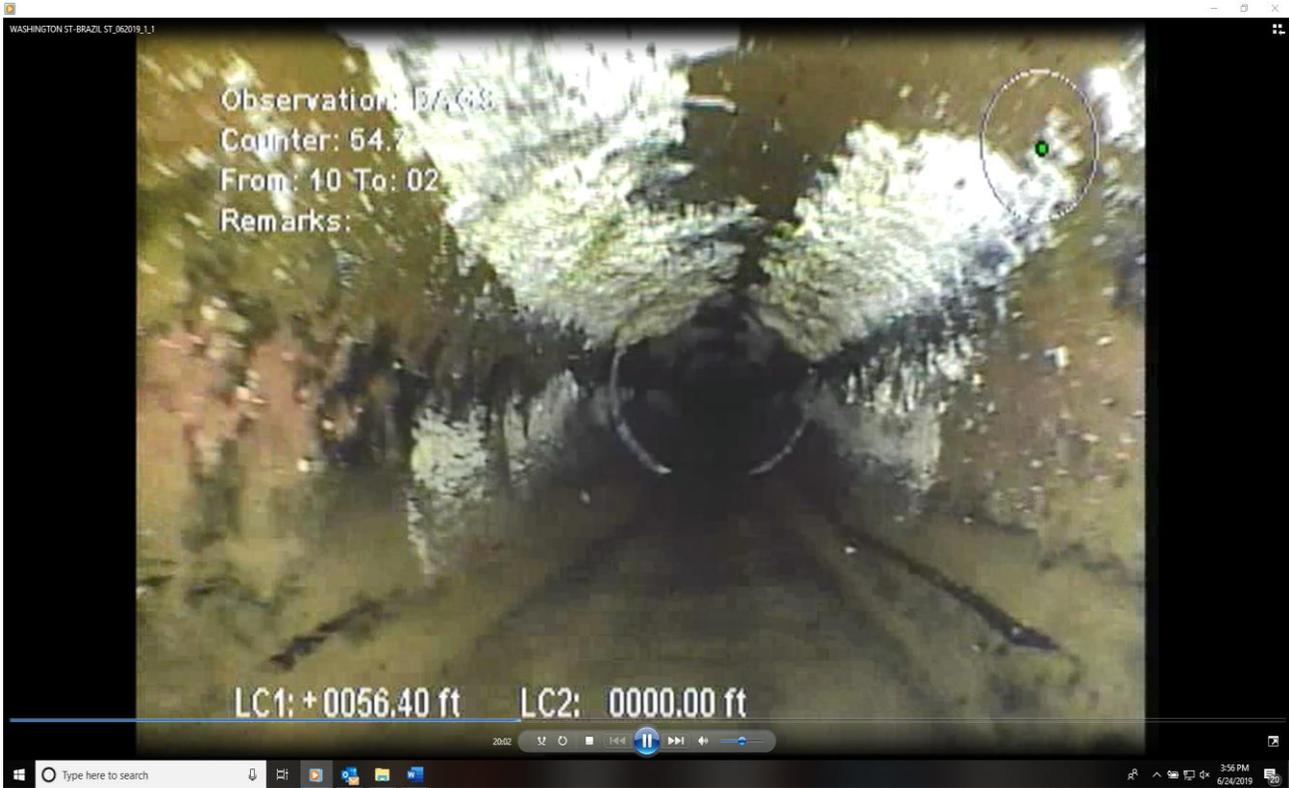
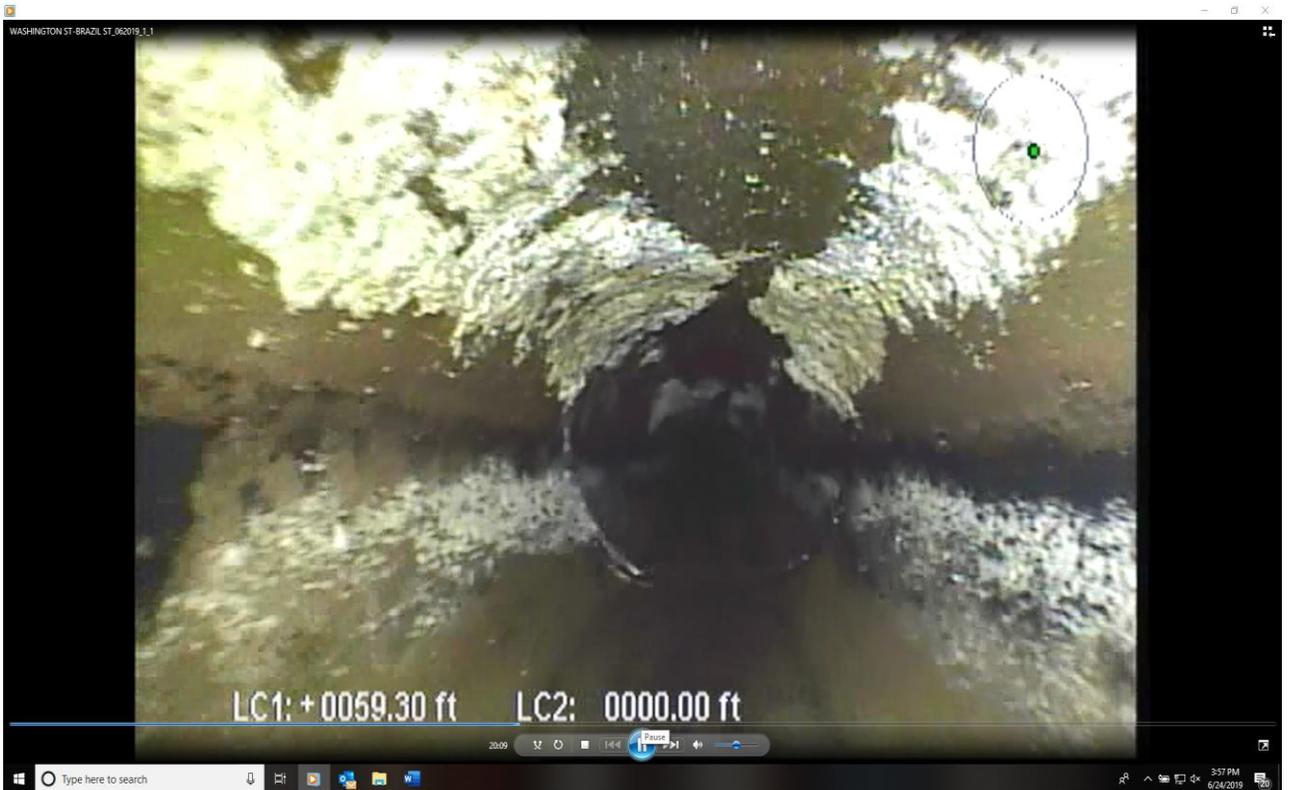
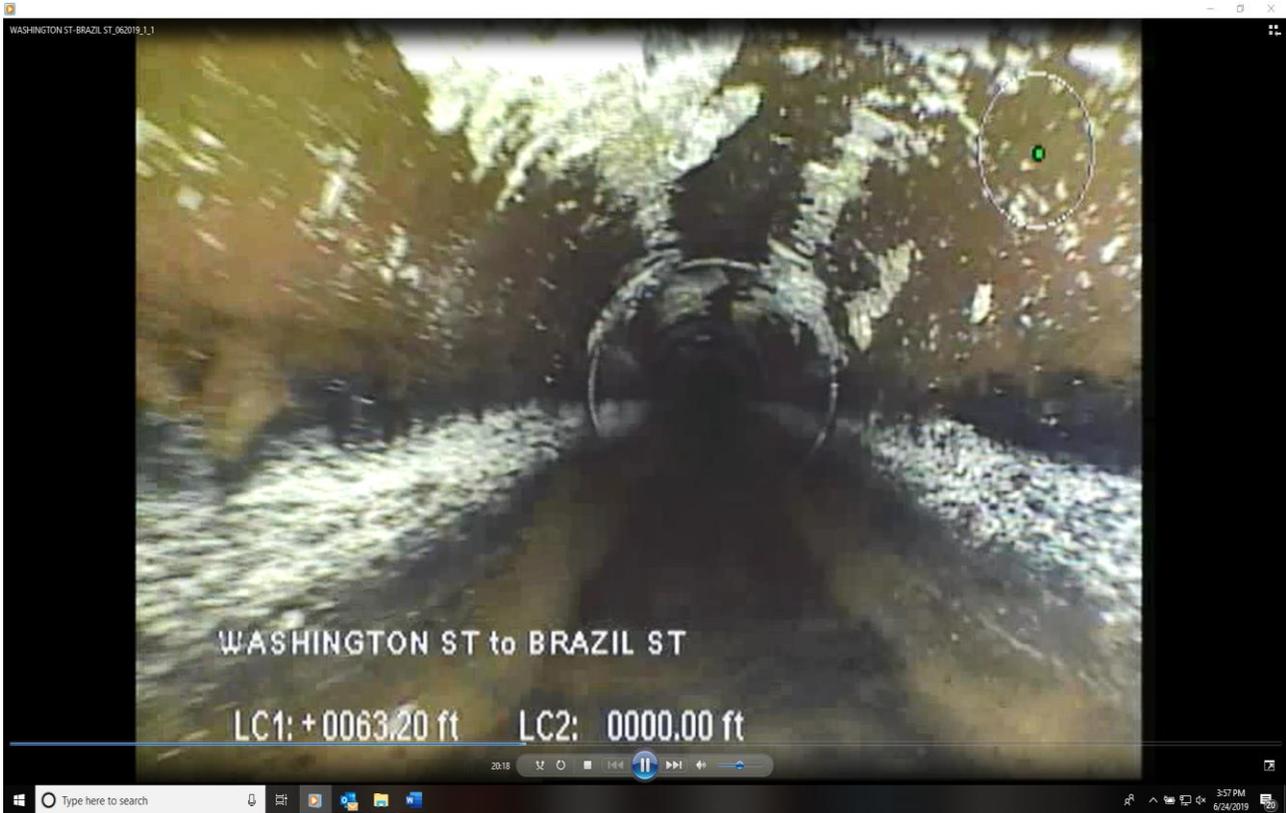
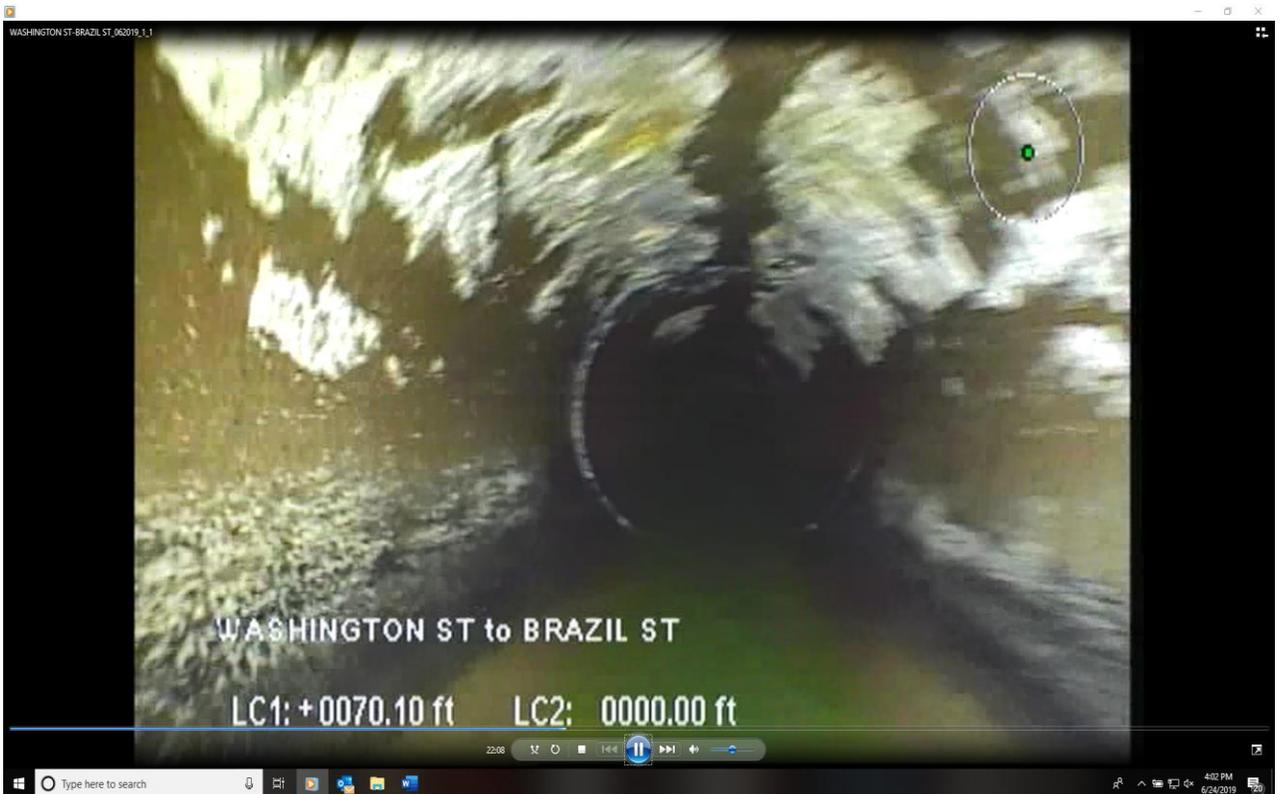
The following photos show the condition of the sewer behind the root obstruction found at STA 0+34.

In addition to the grease and debris present in the previous photos, “black staining” can be seen along the sides and near the top of the pipe. Such staining is indicative of wastewater flows being at this level for long periods of time. It appears to be a systemic problem in the existing Brazil Street sewer and not one that recently developed.

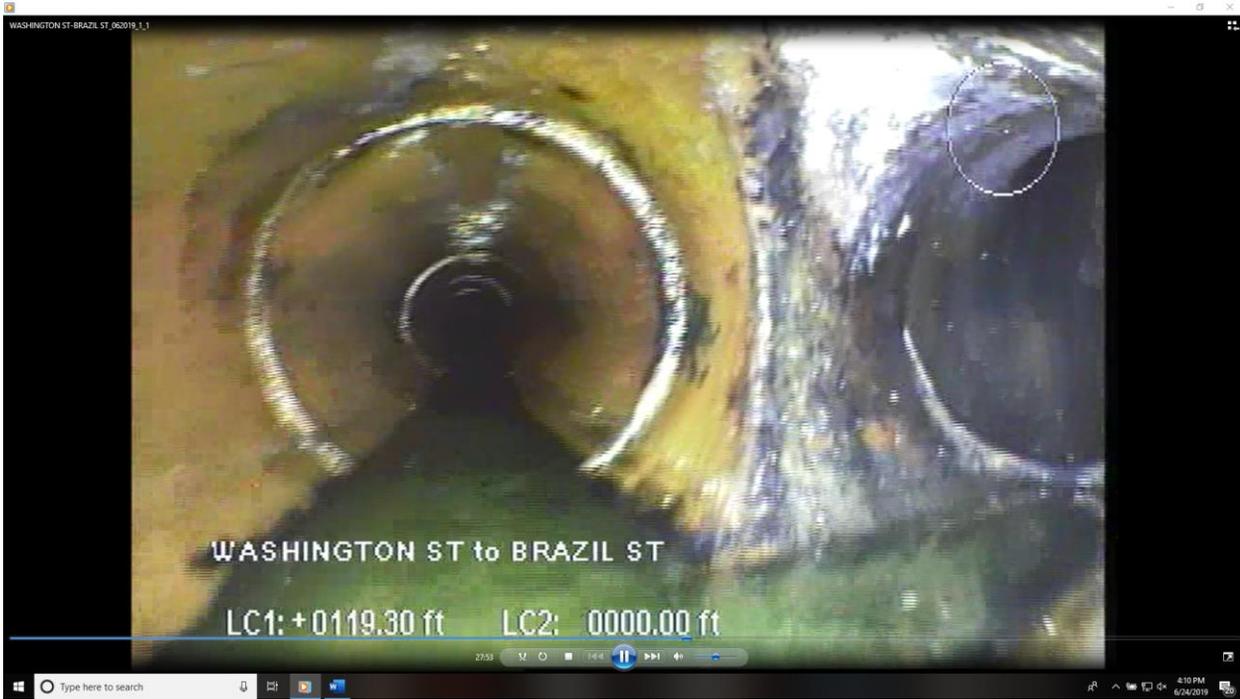
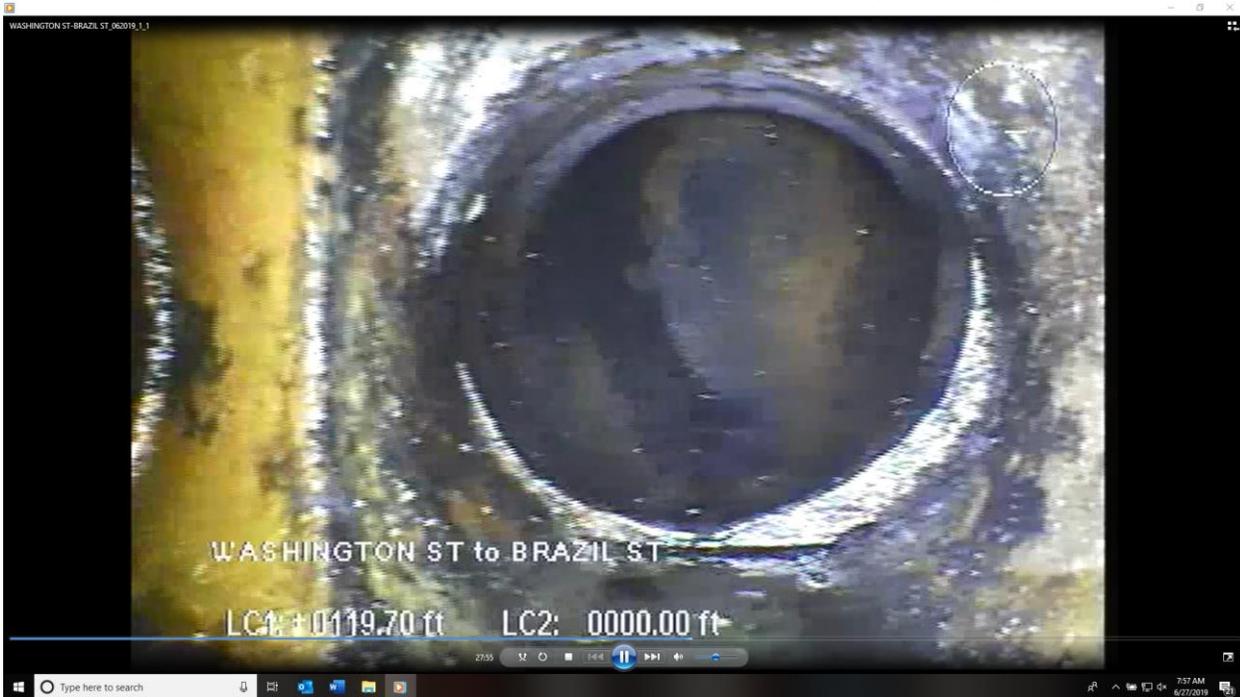
The following photos show the service connection to the #9 Brazil Street as observed from the 6-inch main.

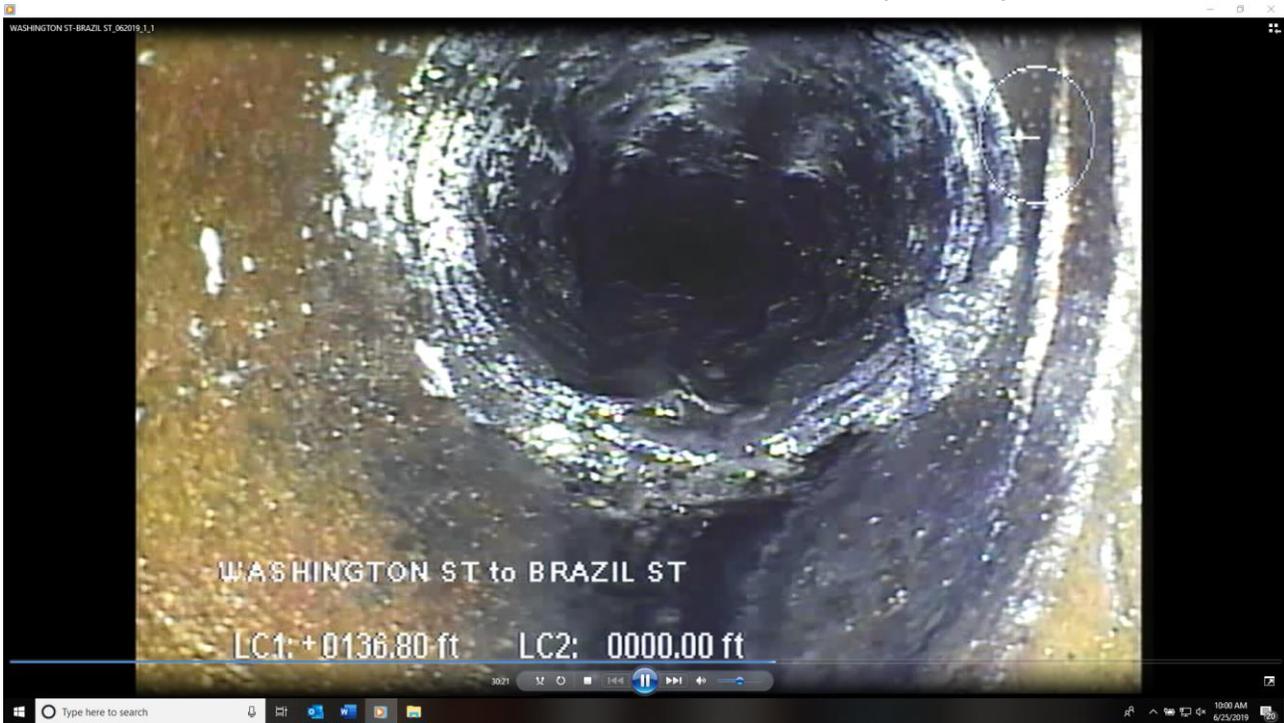
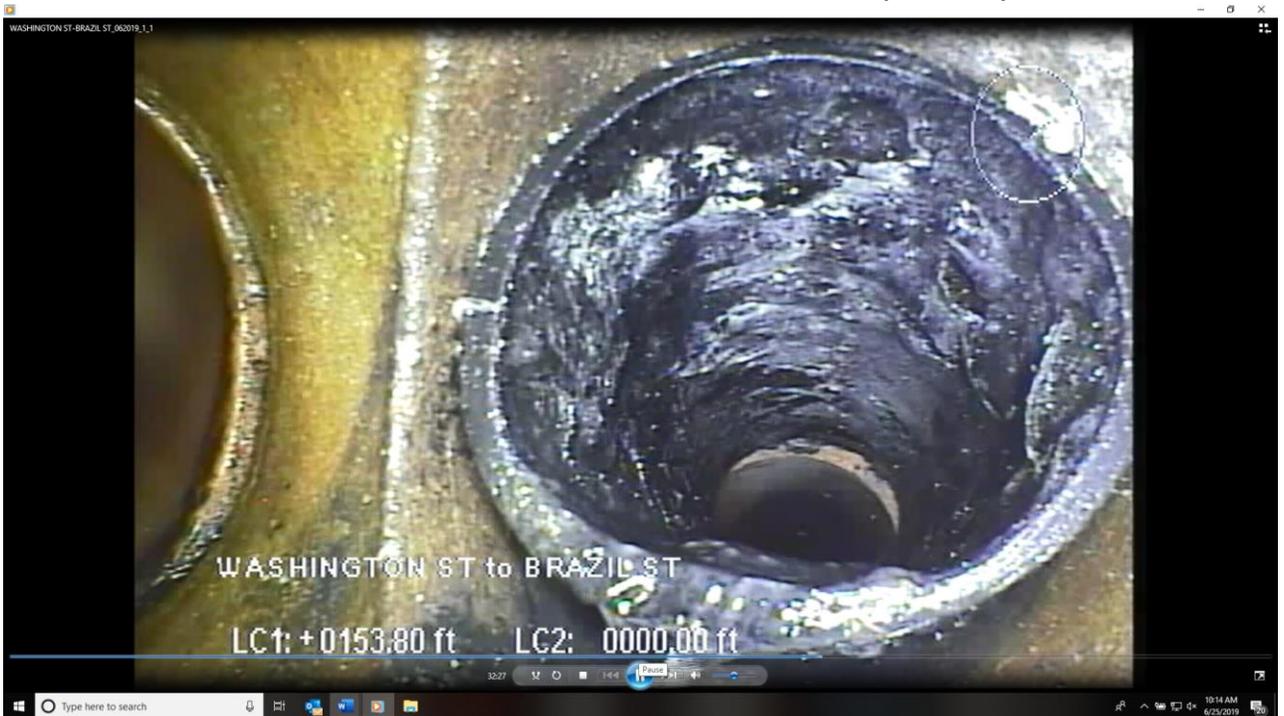
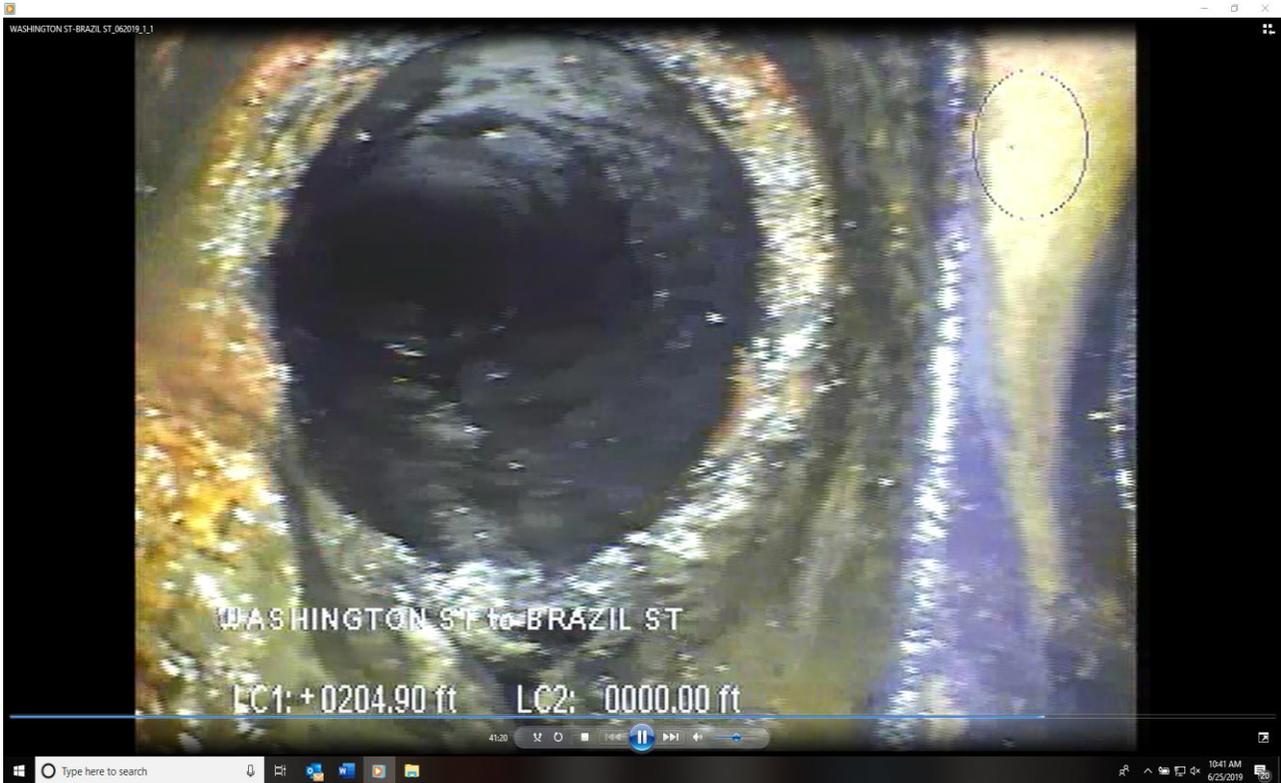
Grease or Indications of grease and surcharging (black staining) were also present in the service connections from #12, #13, and #18 as shown in the following photographs as observed from the 6-inch sewer main.

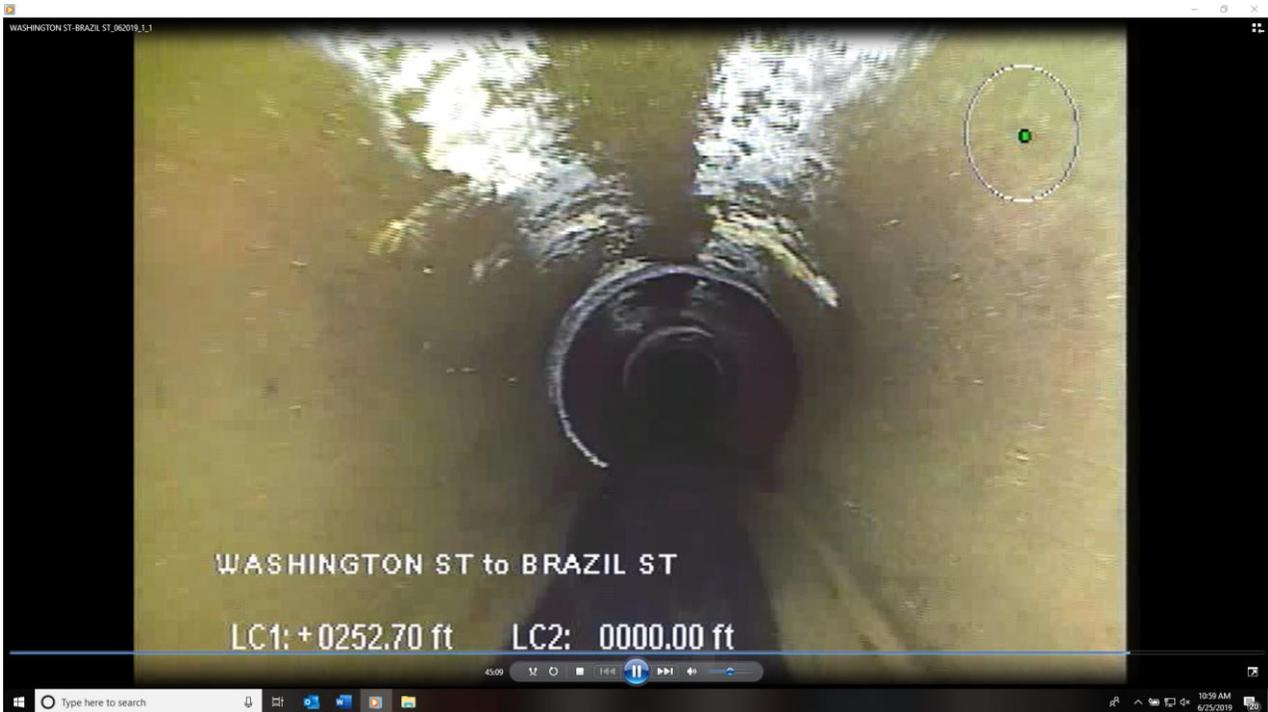
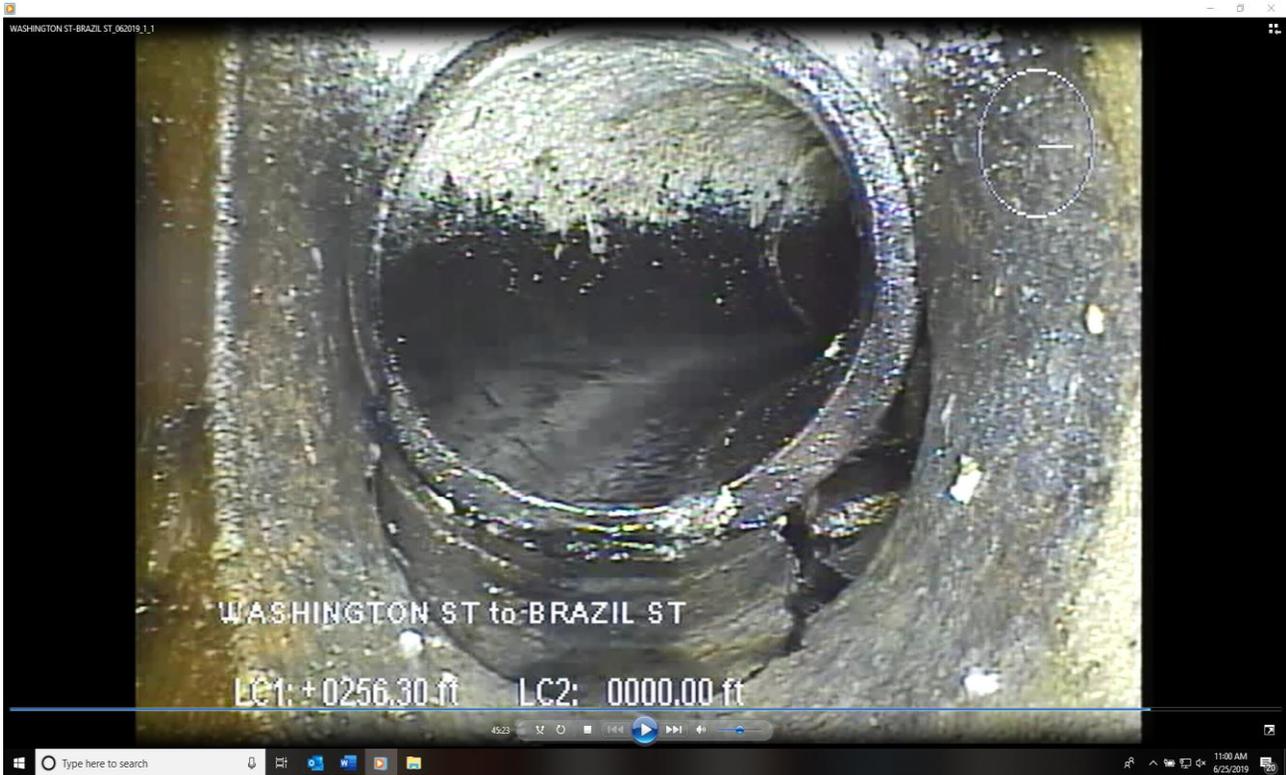
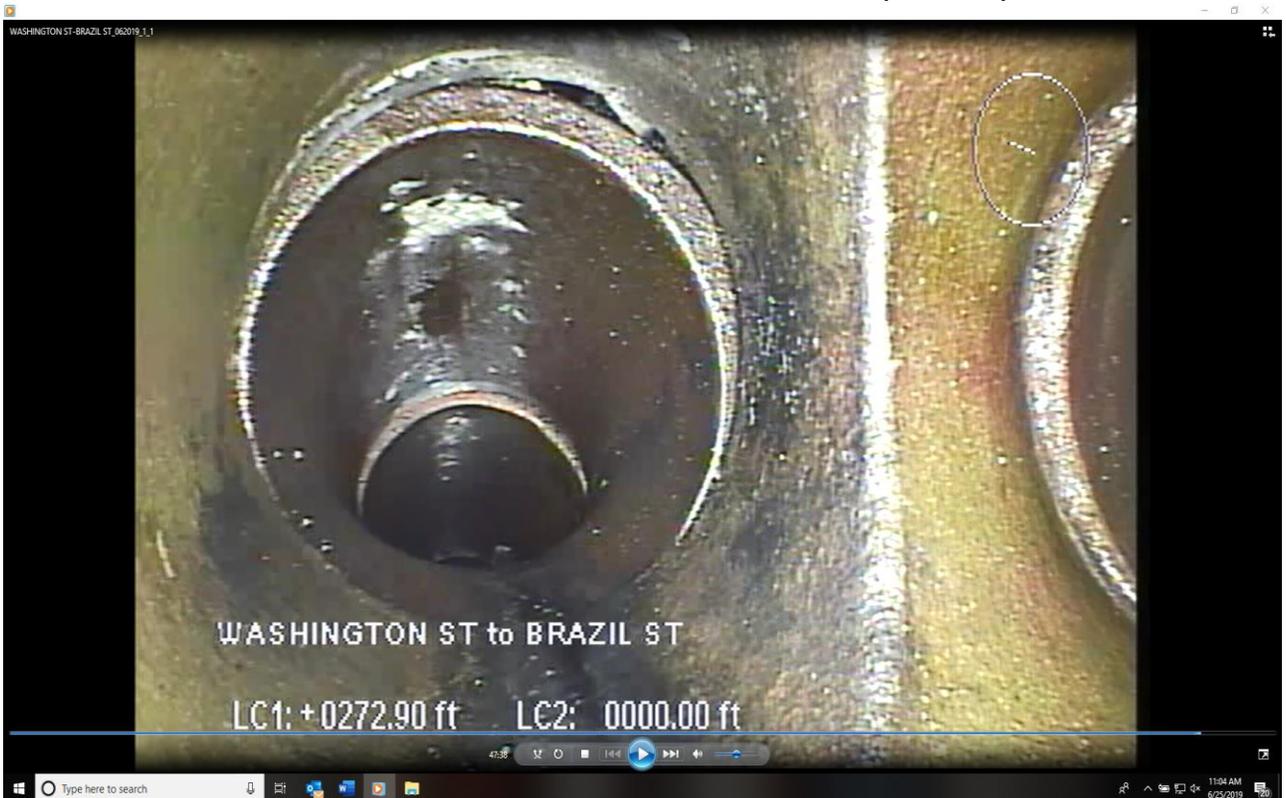
Evidence of pipe surcharging as far upstream as SMH 2+80 in Brazil Street can also be seen in the following photographs. Debris was observed at the top of the pipe and within the existing services.

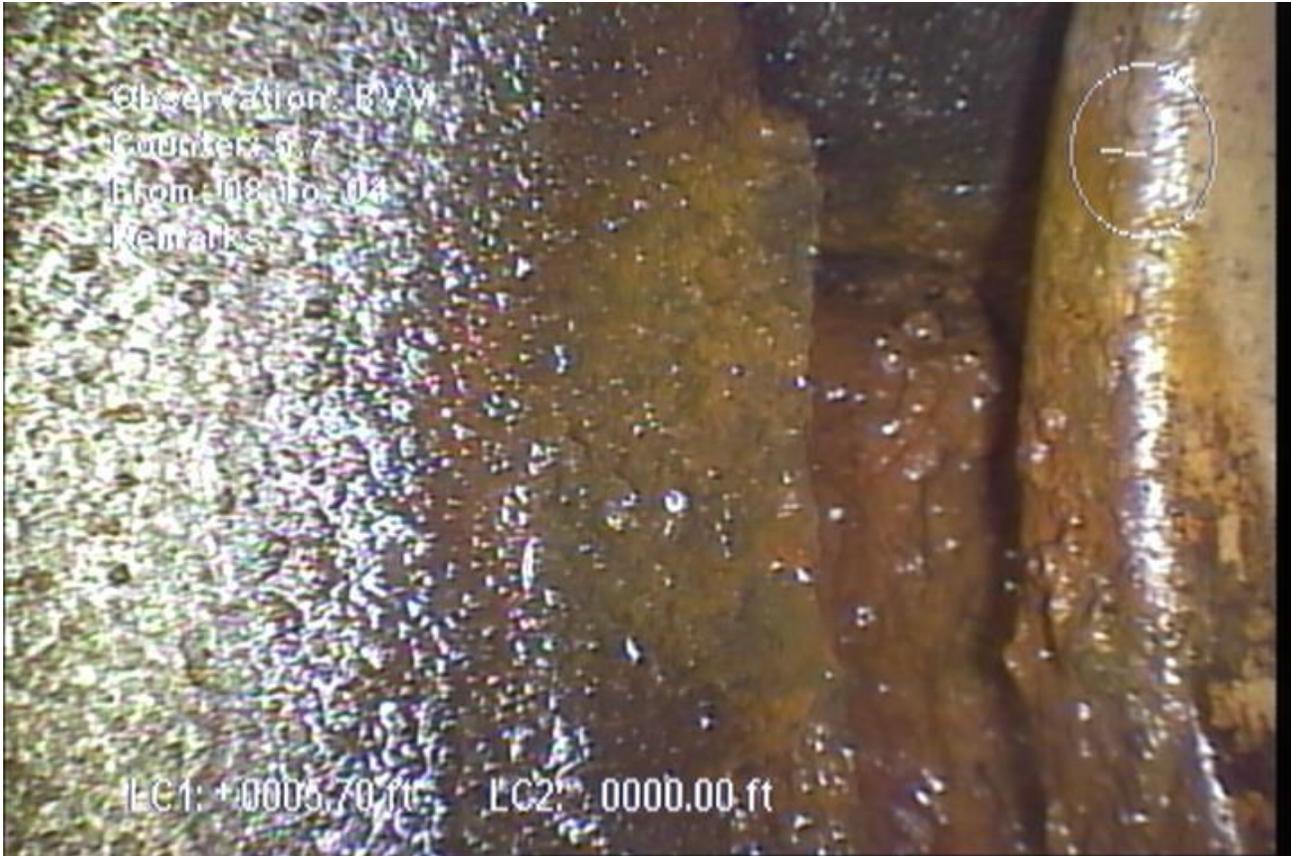
Photo #22 – Broken pipe at STA 0+06

In addition to the roots, grease and pipe surcharging, numerous structural issues were found during the CCTV inspection of the existing Brazil Street sewer. A total of 19 locations were identified with one or more of the following structural issues:

- Broken sections of pipe with large voids (see Photo #22 for an example)
- Spiral cracks and fractures (see Photo #23 for an example)
- Longitudinal cracks and fractures (see Photo #24 for an example)

- The remaining 6-inch VC sewer in Brazil Street upstream of SMH 2+80 should be CCTV inspected.
- At a minimum, the existing 6-inch VC sewer pipe should be removed and replaced with 8-inch polyvinyl chloride (PVC) sewer pipe in Brazil Street between SMH 0+00 and SMH 2+80. Unified Contracting, Inc. is currently under contract with the City to perform open-cut sewer repairs. If Unified Contracting, Inc. was willing to perform this 280-foot sewer replacement work, the total cost including trench paving and a 15% construction contingency would be approximately \$150,000, based on their current unit prices.
- Depending on the results of the additional recommended CCTV inspection and due to the current size of the existing sewer in Brazil Street, removal and replacement of the existing sewer beyond SMH 2+80 should also be considered.
