Re: Summary of Weston & Sampson Brazil Street Incident Review

SUBJECT: Melrose, MA – Brazil Street Sewer Review and Evaluation

At the request of the City of Melrose, MA (the City), Weston & Sampson Engineers, Inc. has prepared this memorandum after review of the sewer issue that occurred on Brazil Street on Thursday, June 20th, 2019. The purpose of the memorandum is to present an evaluation of the existing conditions of the sewer and sewer service connections, provide an opinion as to the cause of the issue, and present recommendations for improvements to the sewer.

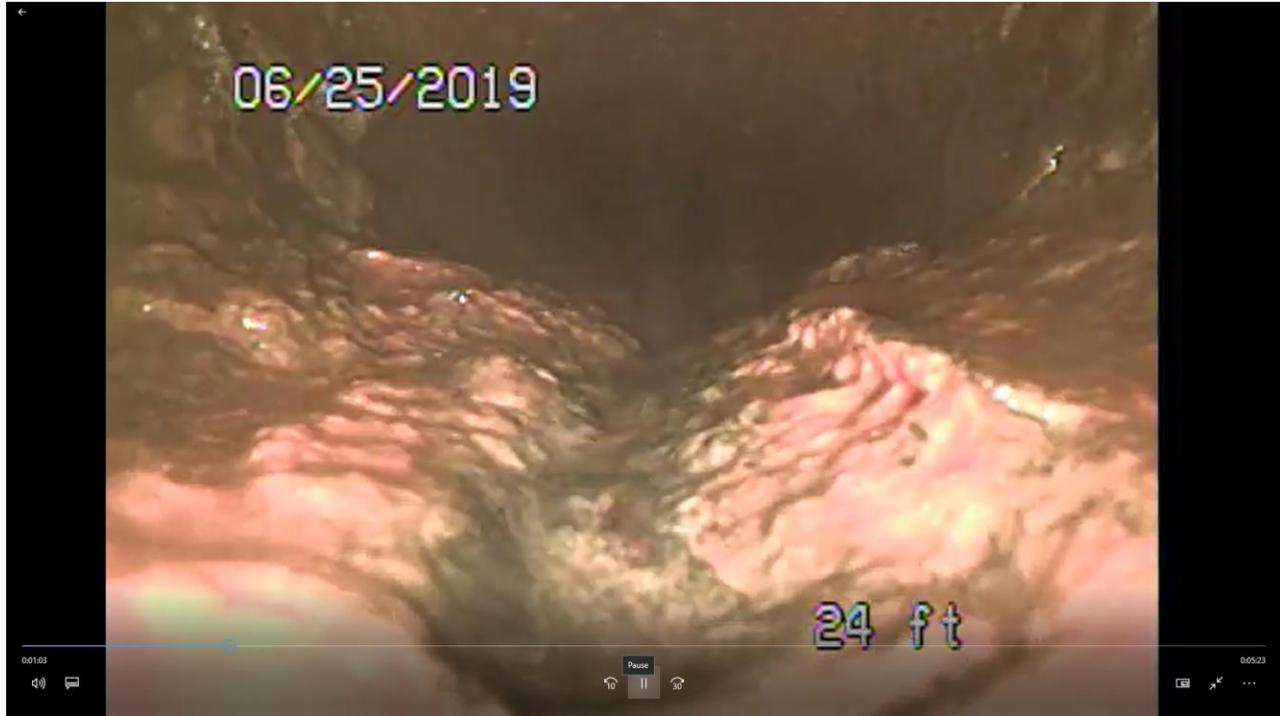
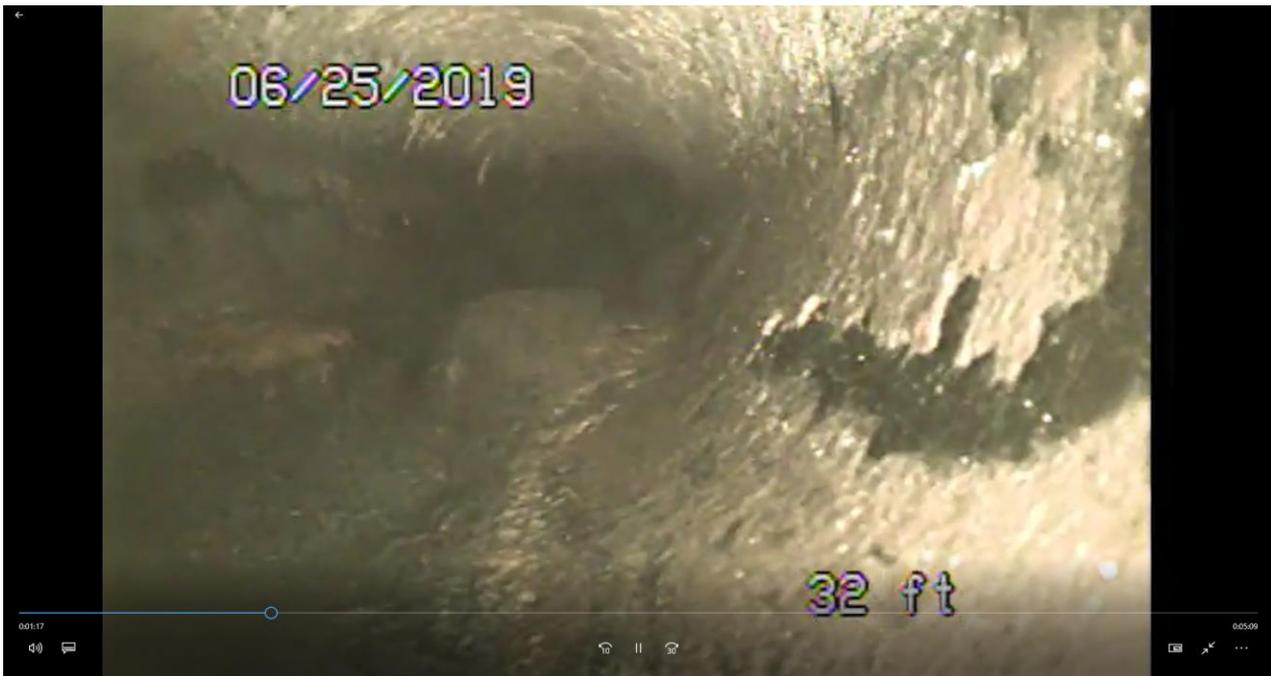
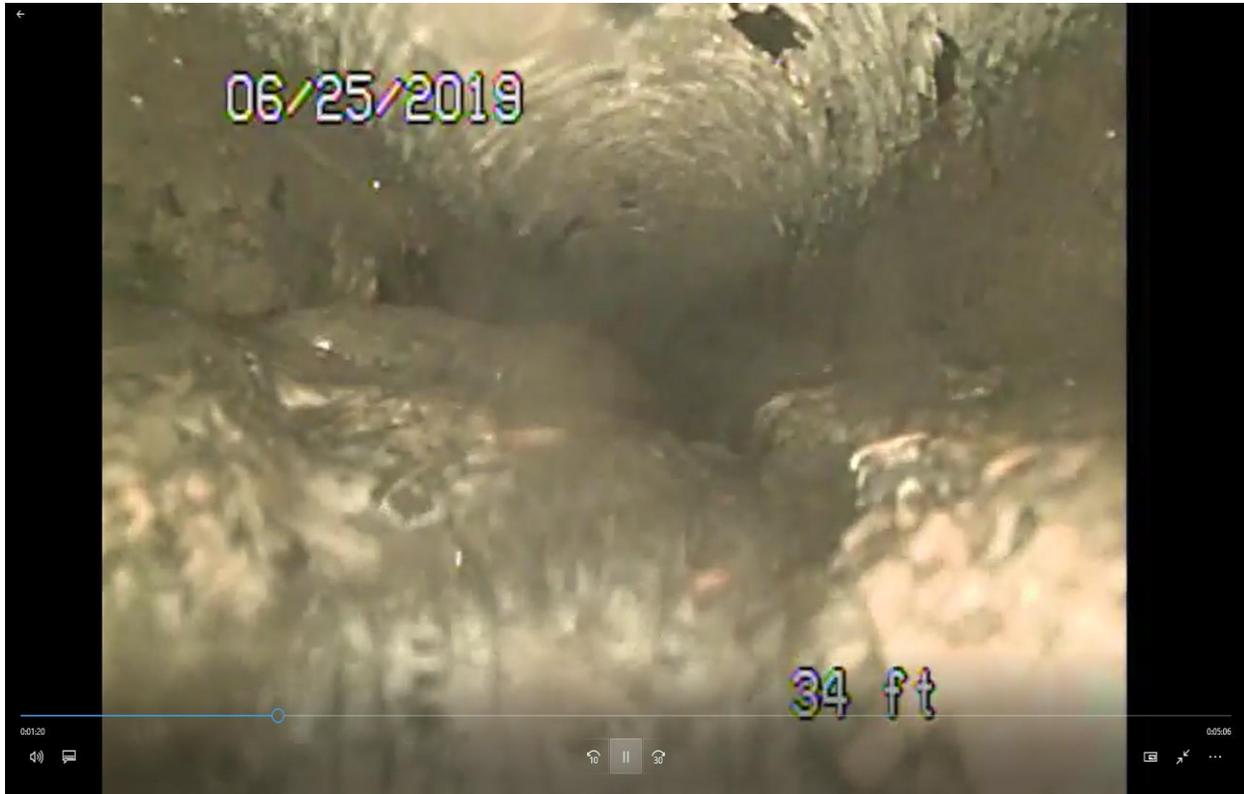
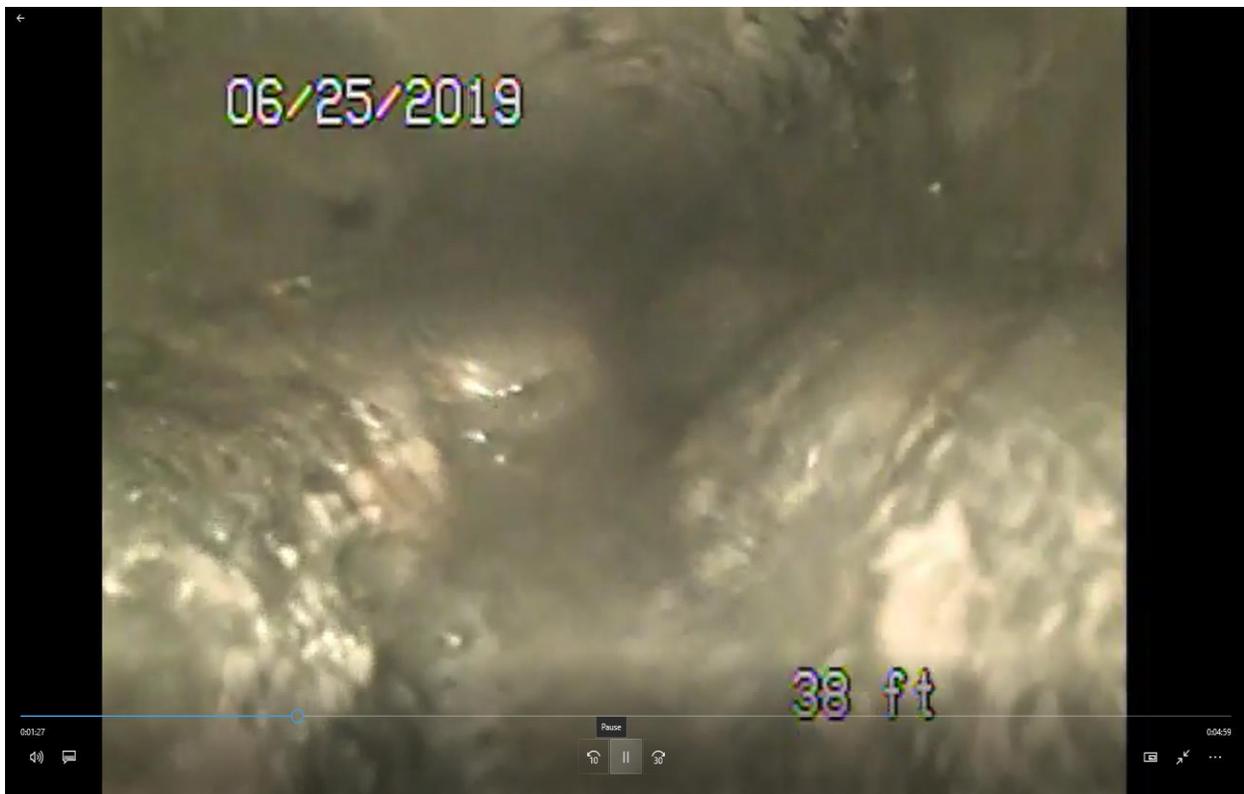
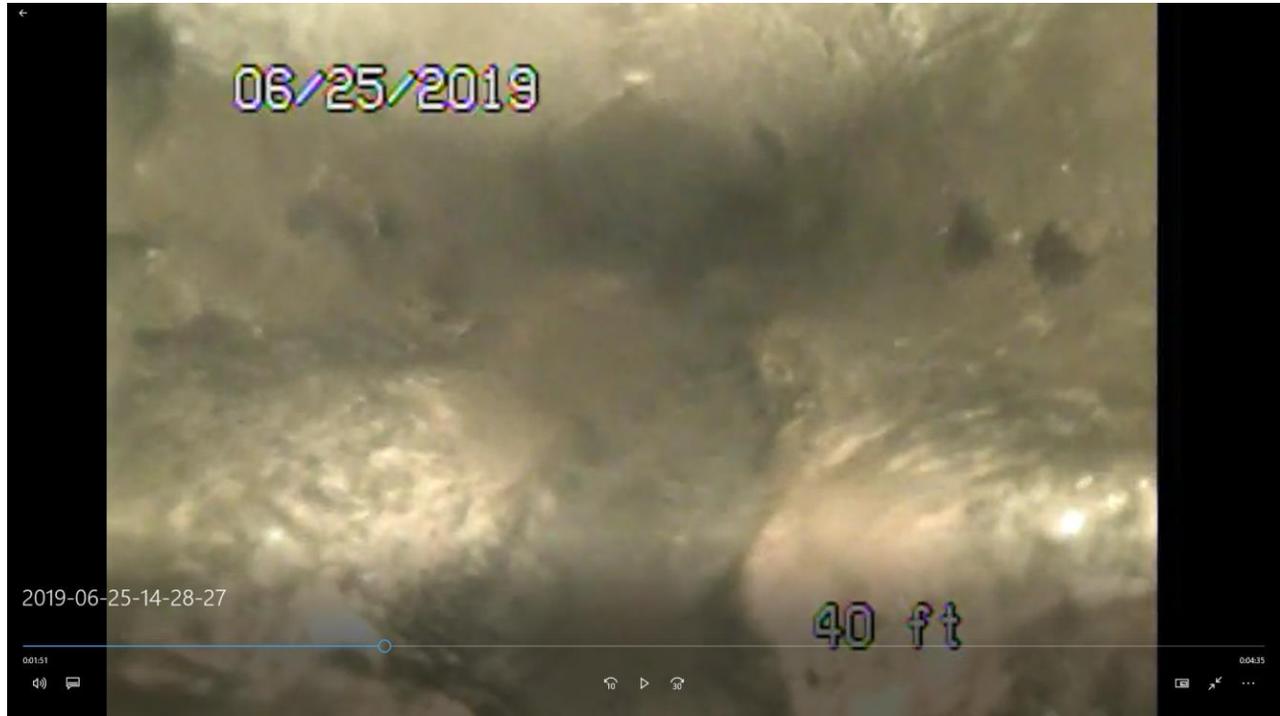
The service connection from #9 Brazil Street is approximately 58-feet in length from the house to the mainline. Small deposits of grease begin to appear 3- to 4-feet into the push camera inspection. The service connection has large amounts of grease throughout its entire length as evidenced by the following photographs.

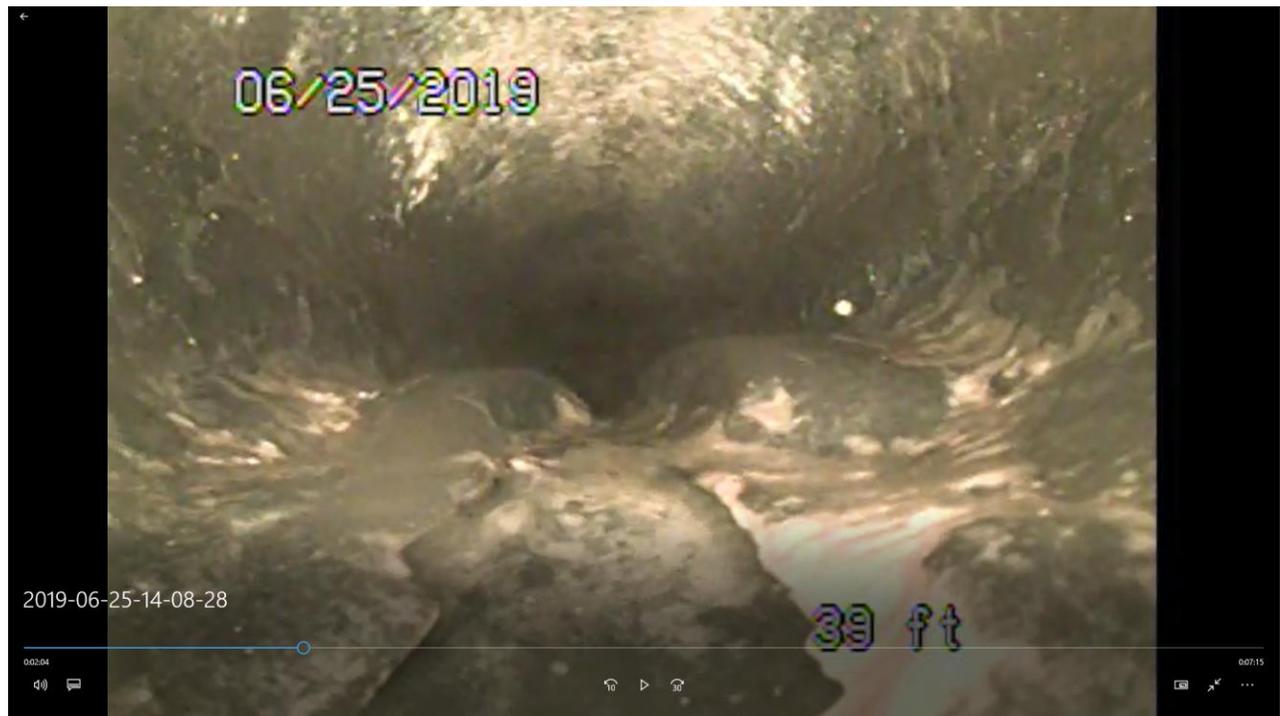
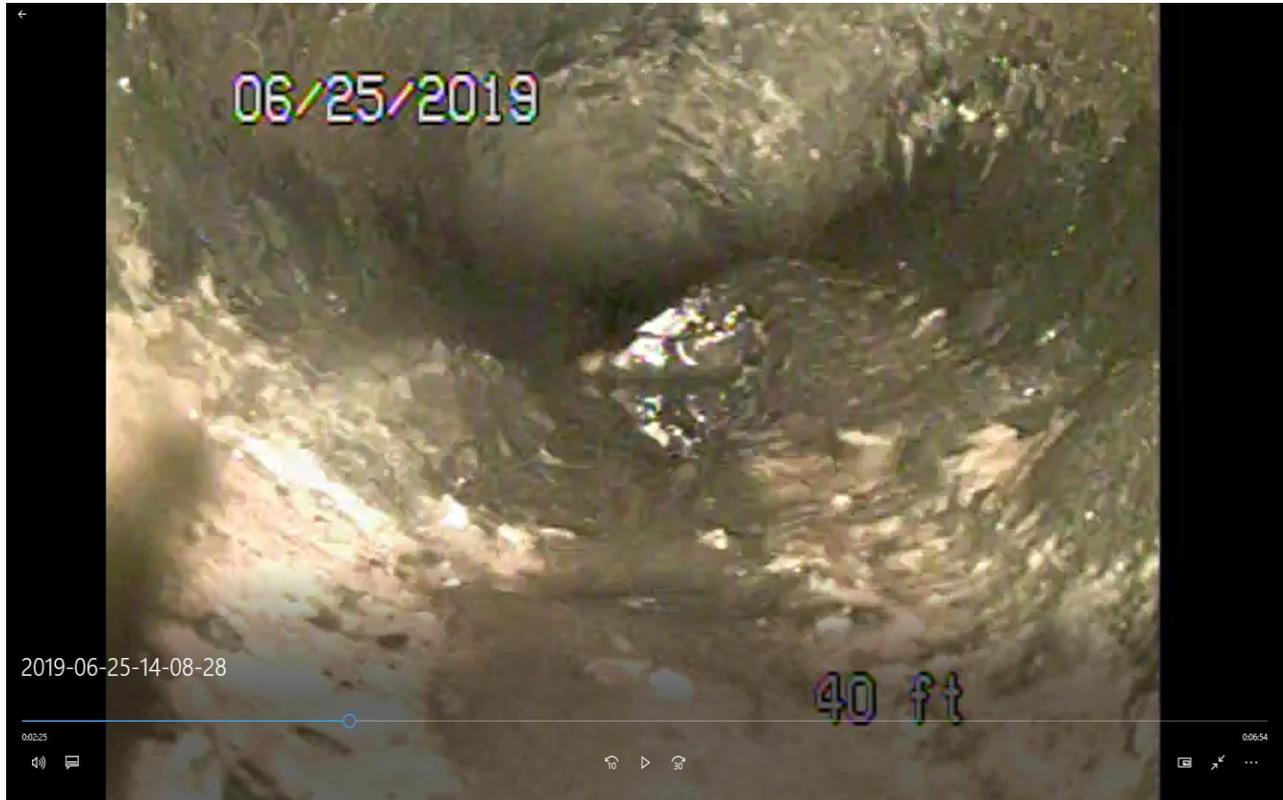
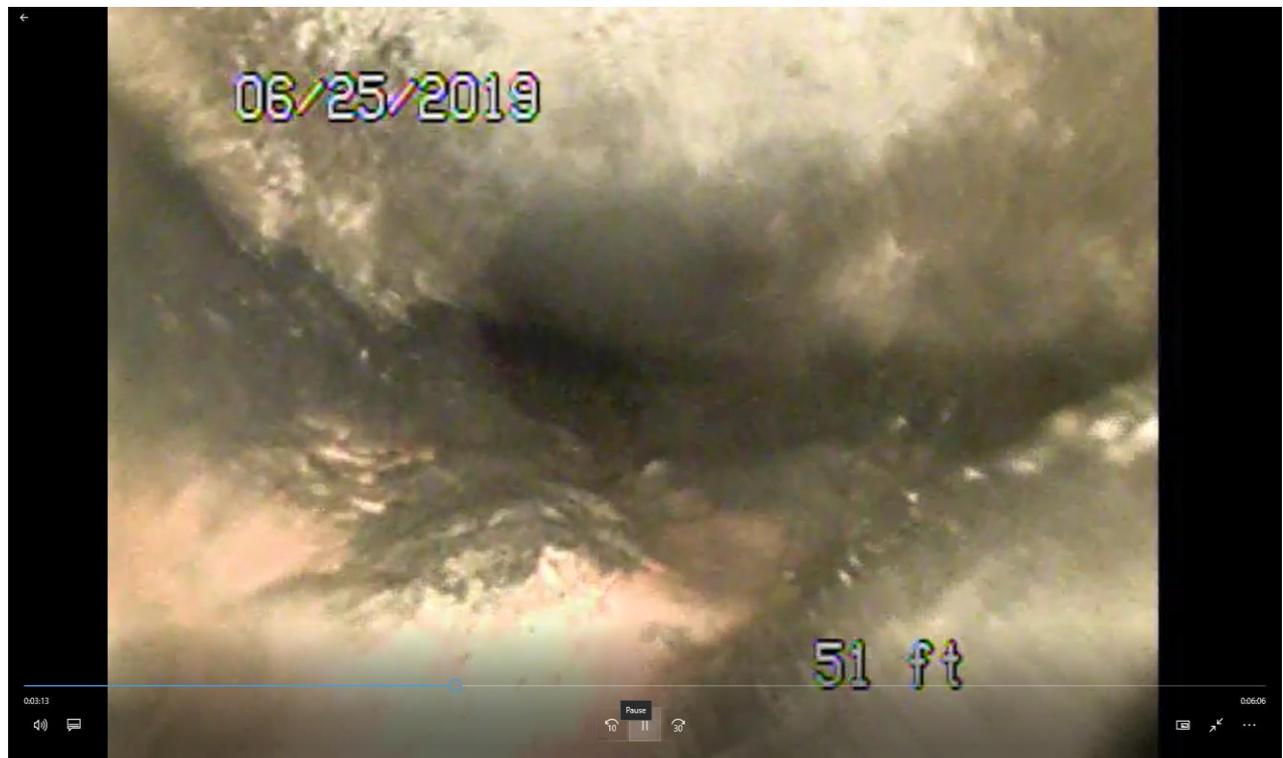
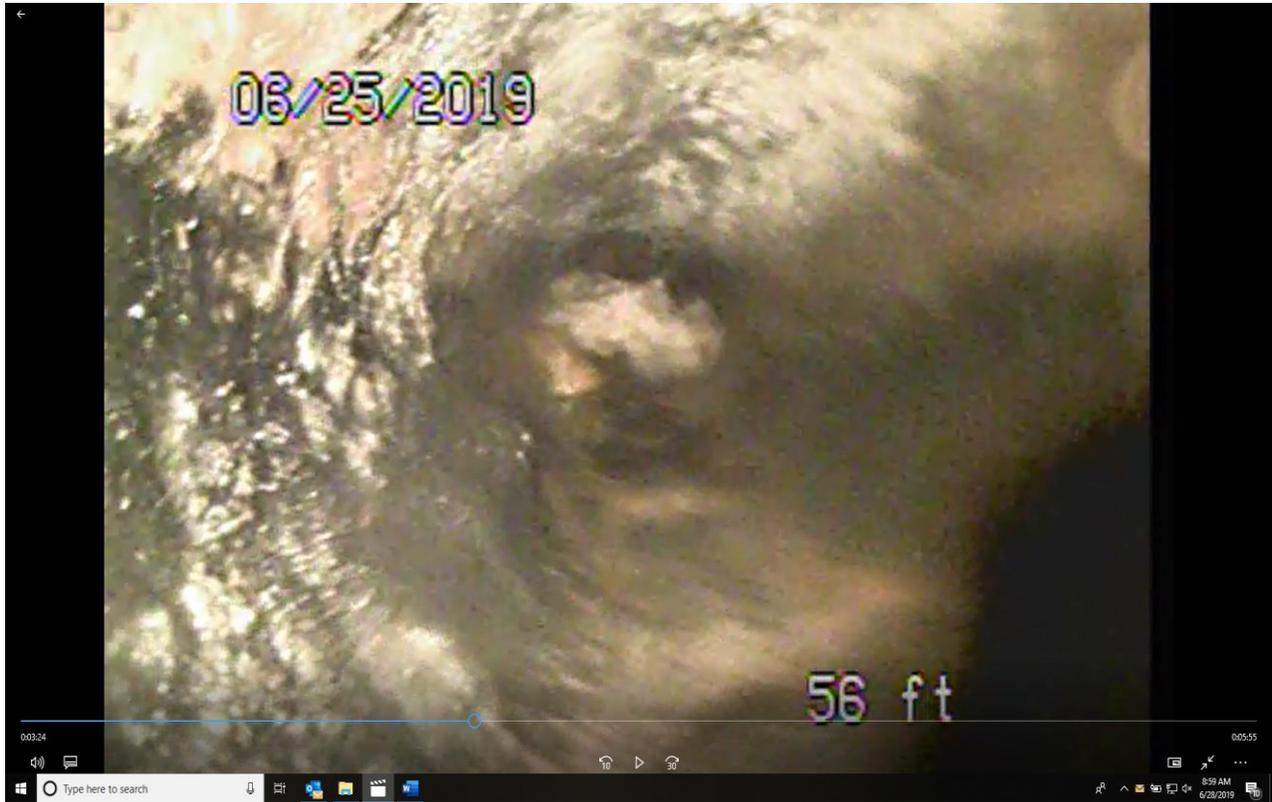
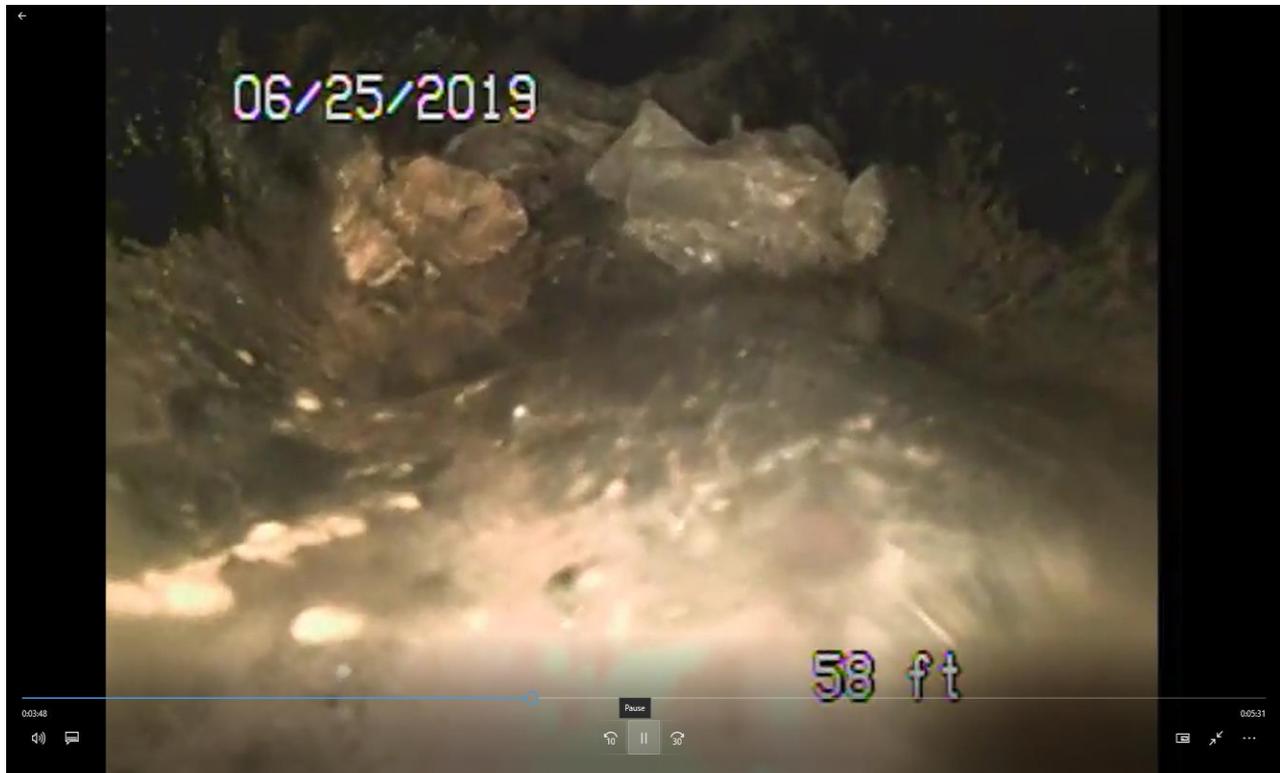
The service connection from #12 Brazil Street is approximately 64-feet in length from the house to the mainline. The service connection has large amounts of grease throughout its entire length as evidenced by the following photographs.

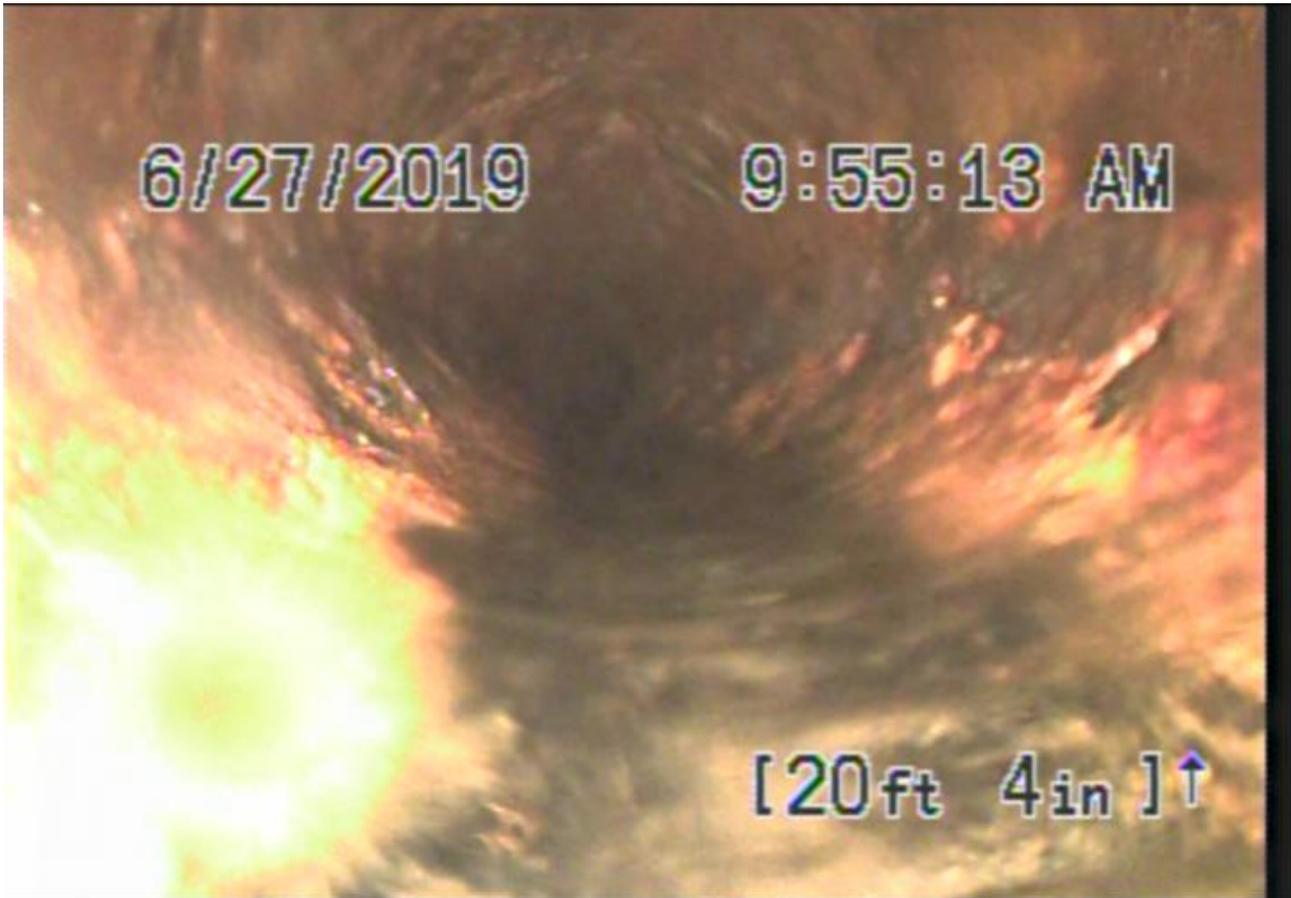
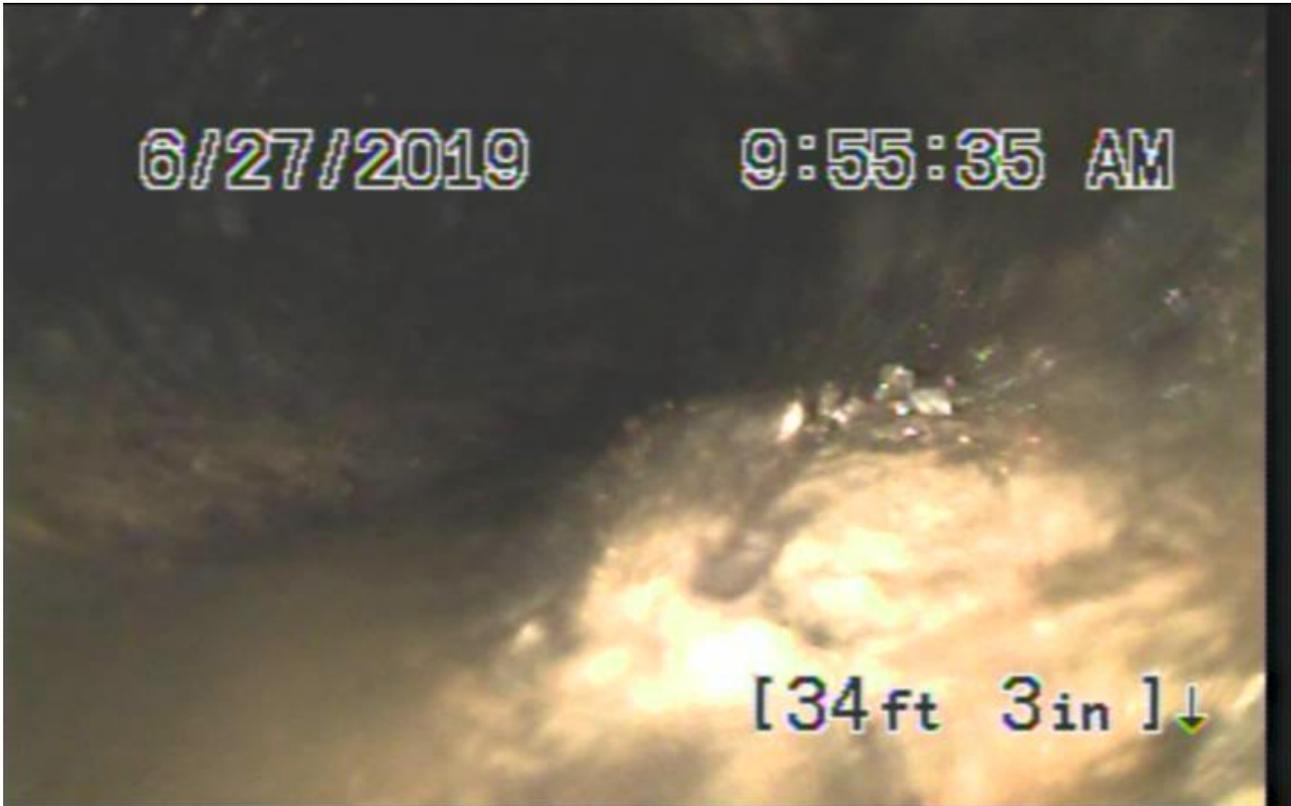
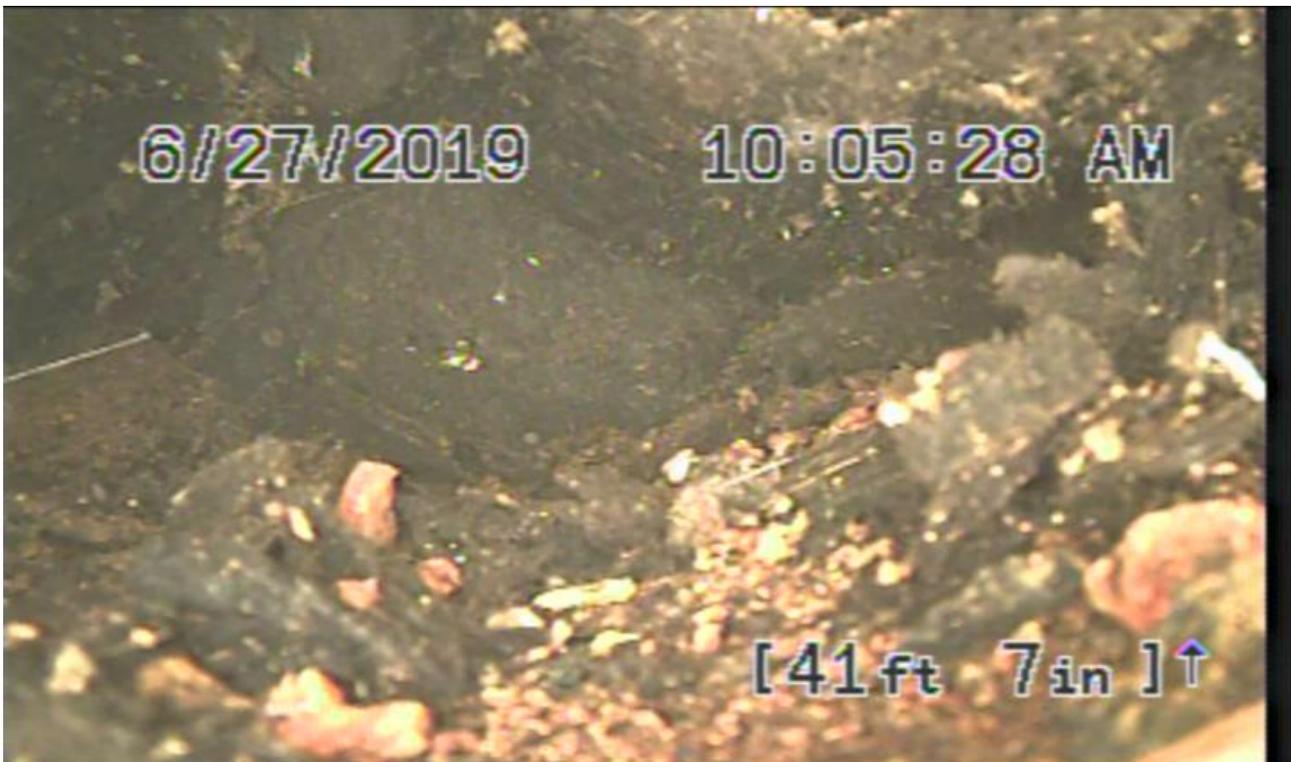
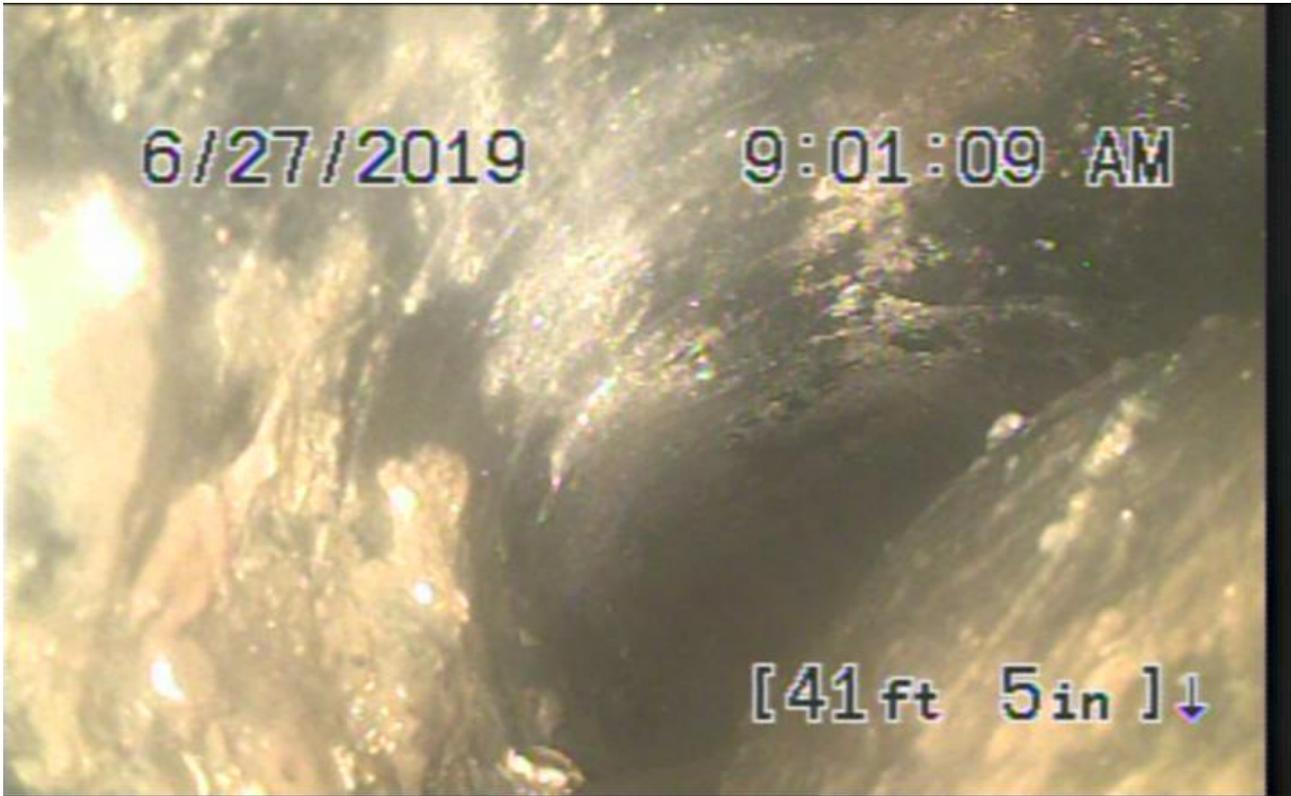
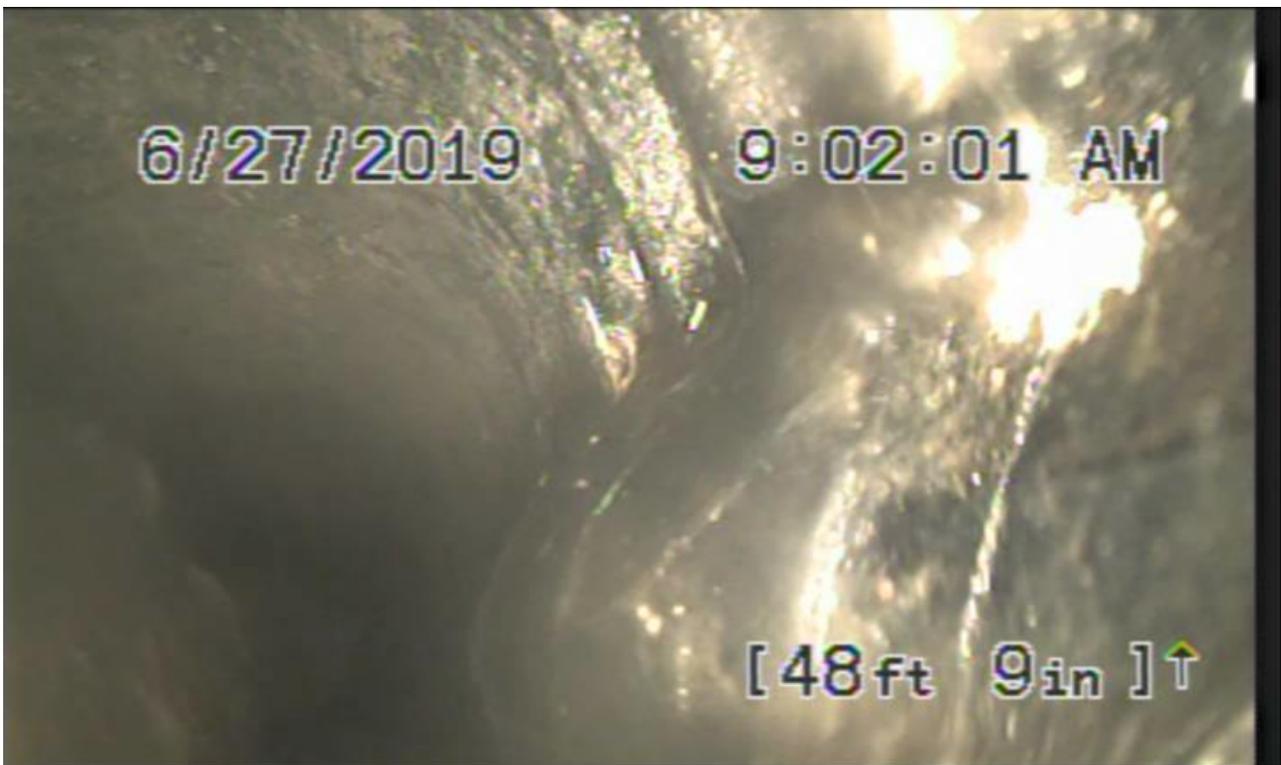
The service connection from #13 Brazil Street has heavy pockets of grease from the house to approximately STA 0+48. A broken section of pipe was found at STA 0+41 where the bottom of the pipe appeared to be rotted out and prevented the push camera from continuing with the inspection to the mainline in the street. Despite the broken pipe, flow was continuing to the 6-inch VC sewer main. The following photographs depict the existing condition of this service connection.

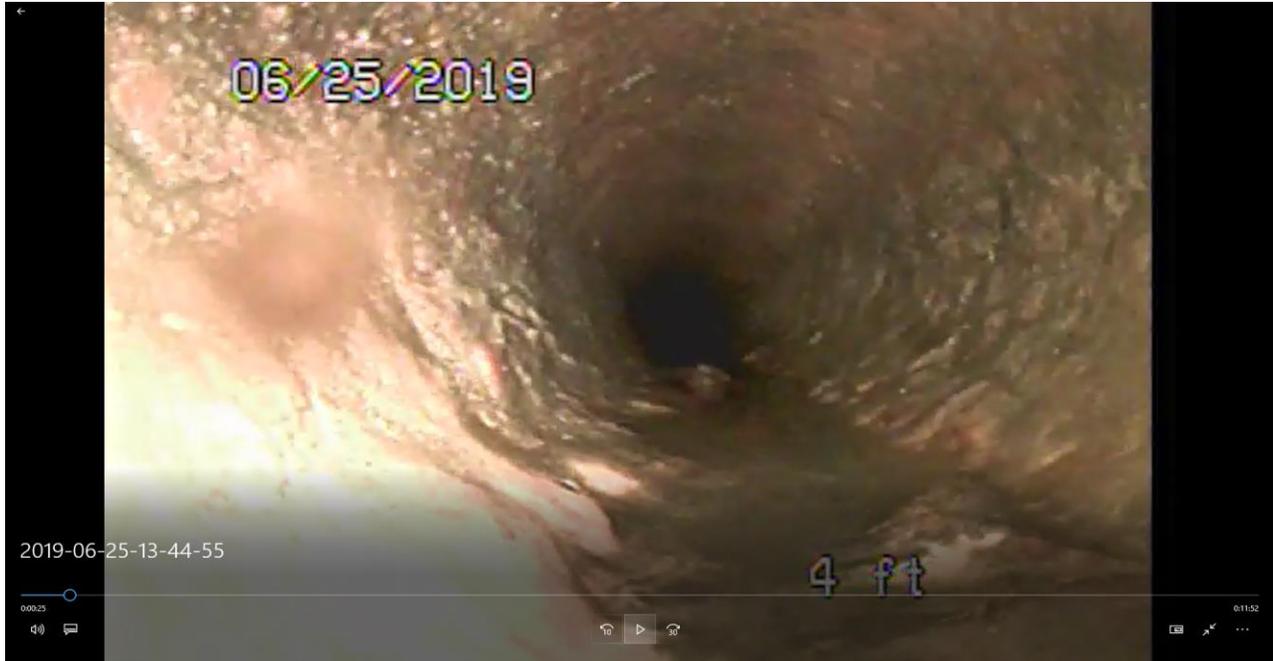
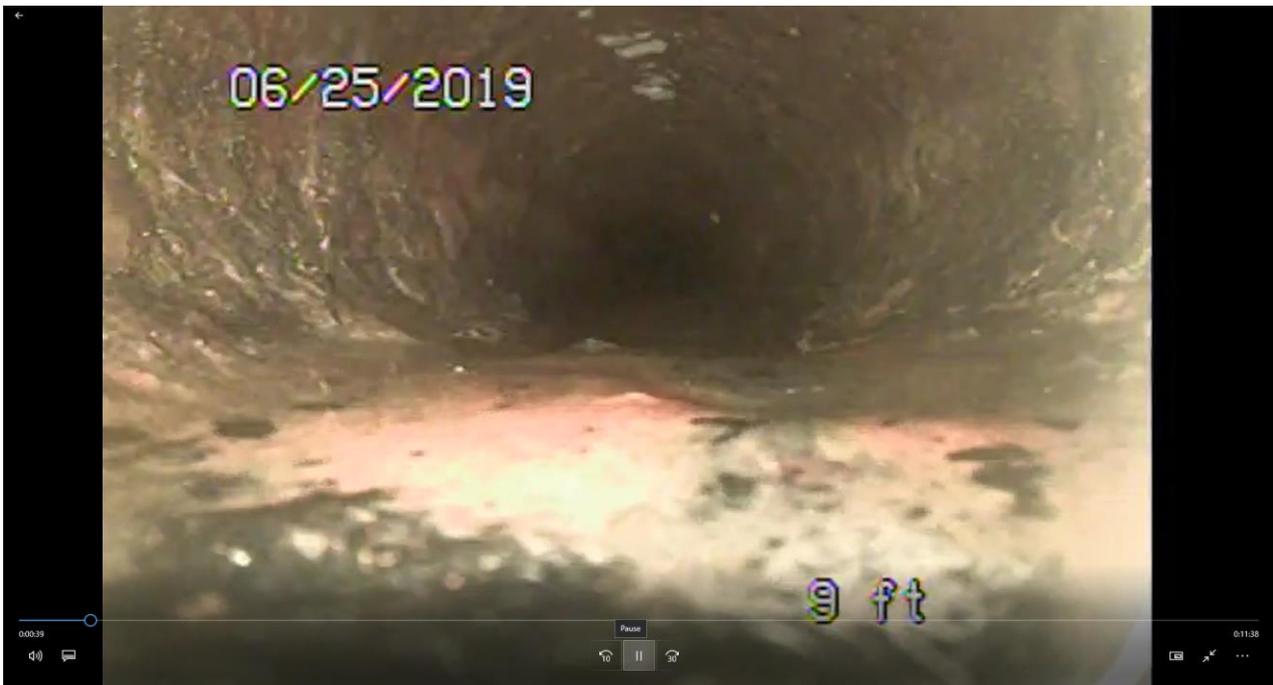
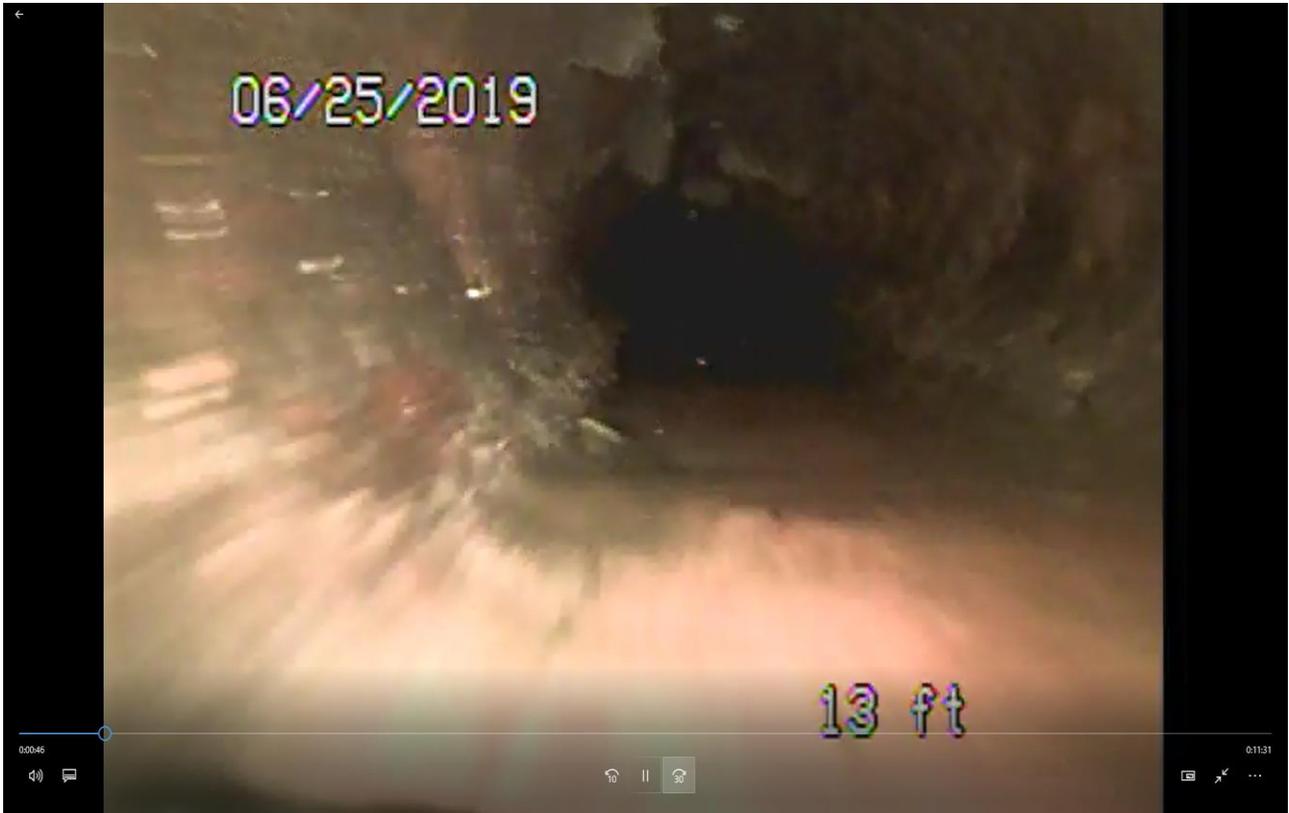
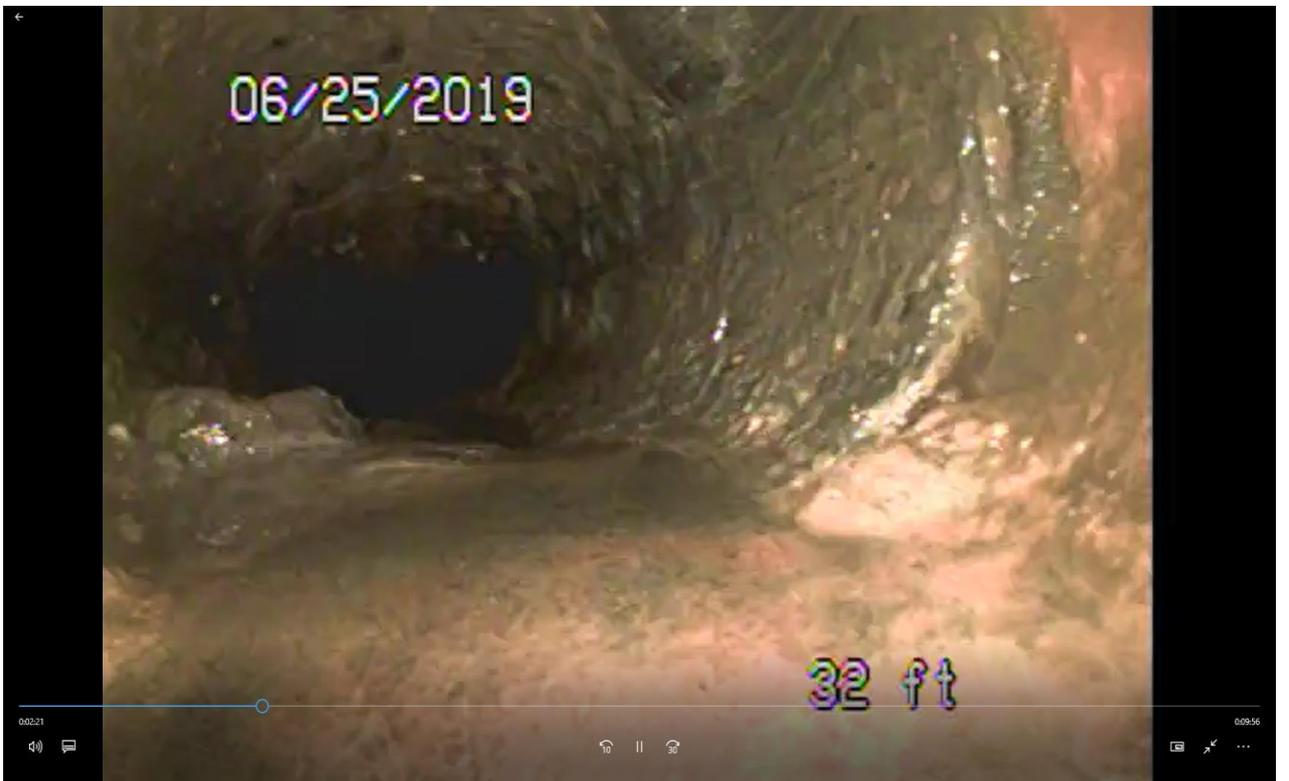
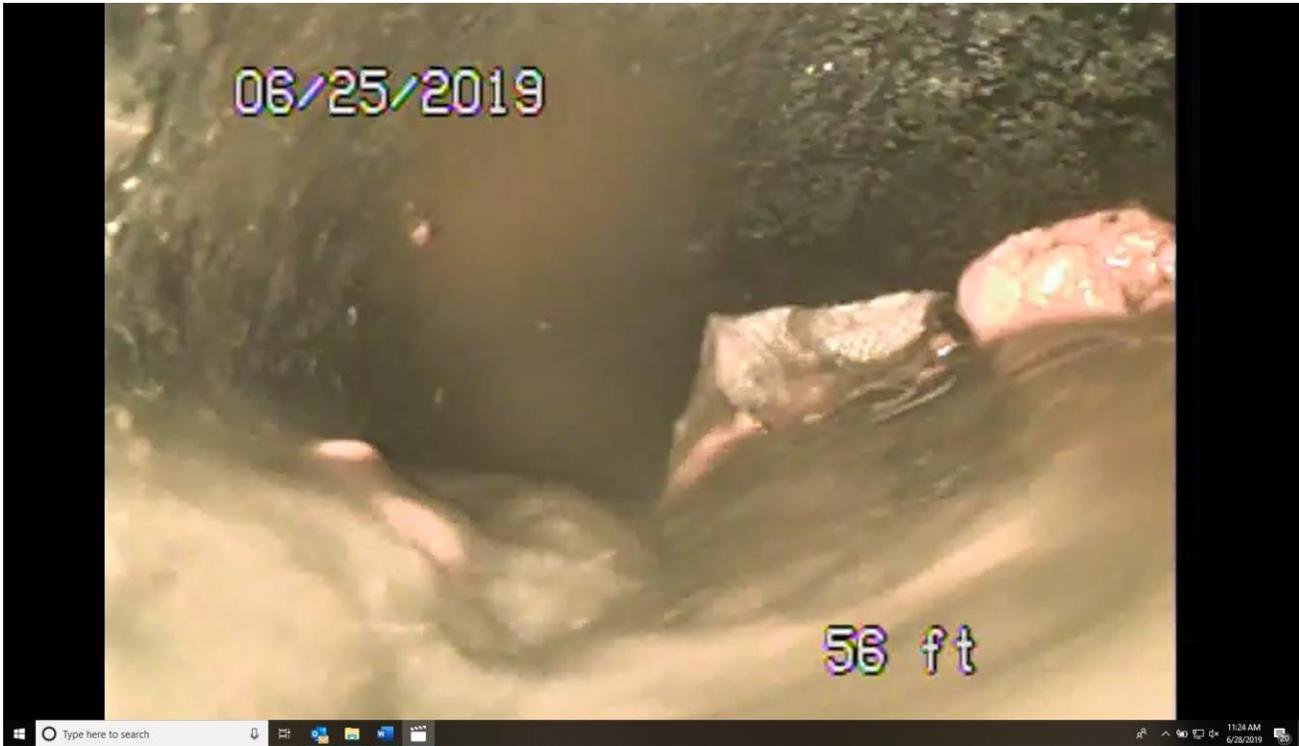
The service connection from #18 Brazil Street is approximately 62-feet in length from the house to the mainline. The service connection has grease throughout its entire length as evidenced by the following photographs.
