# ADA Self-Evaluation and Transition Plan for the City of Melrose

Part 2 of 2

## Part 2: Reports:

January, 2023

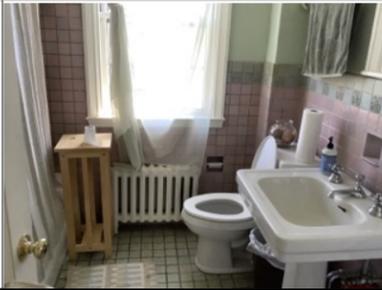
ID	Location	Floor	Room	Element	Type	Photo	Issues	Current Measure	Recommendations	Quantity	Price	Cost Estimation
<b>Overall Access</b>												
20	Single-User Toilet Room	2	BB-09	Overall Access	Toilet Room

Turning space not provided Accessible plumbing fixtures or stalls not provided	- -	IHCD team was told that members of the public do not use this toilet.	1	-	\$0
<b>Lavatory</b>												
21	Single-User Toilet Room	1	106	Lavatory	N/A

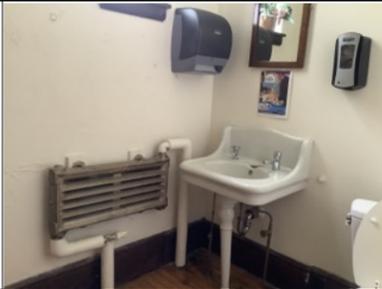
ID	Location	Floor	Room	Element	Type	Photo	Issues	Current Measure	Recommendations	Quantity	Price	Cost Estimation
46	Single-User Toilet Room - North Stage	L		Lavatory	N/A

Toe or knee clearances not provided	-	Provide a lavatory with knee and toe clearance positioned for a forward approach.  See ID #41.	1	-	\$0
<b>Toilet Compartment</b>												
47	Women's Toilet Room	Basement		Toilet Compartment	Ambulatory Compartment

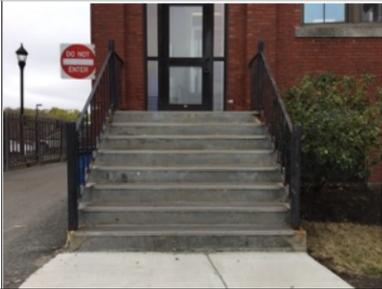
Toe and knee clearances not provided Non-compliant faucets Exposed plumbing underneath sink	25.5" - -	Ensure there is a 27" min. knee clearance positioned for a forward approach. Install faucets that do not require tight grasping, pinching, or twisting of the wrist. Insulate or otherwise configure pipes at sink.	1	1686	\$1686
<b>Best Practice</b>												
<b>Stairs</b>												
22	Main Entrance	Ext.		Stairs	N/A

Recommend providing contrasting strips on stairs treads.	1	-	\$0

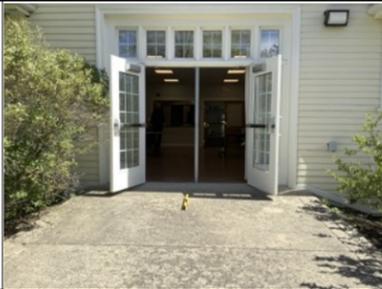
ID	Location	Floor	Room	Element	Type	Photo	Issues	Current Measure	Recommendations	Quantity	Price	Cost Estimation
11	Patio to Egress Door #15	Ext.		Entrance	Secondary Entrance

Maneuvering clearance at door > 1:50 (2.00%) Door requires > 15 lbs. of force to open	3.9% 20 lbs	Alter so that the slope in all directions is no greater than 1:50 (2.00%). Or provide an automatic door opener. Adjust closers so doors do not require more than 15 pounds of force.	1	-	\$0
<b>Access to Goods and Services</b>												
<b>Means of Egress</b>												
12	Egress Door #13 From Basement	1		Means of Egress	N/A

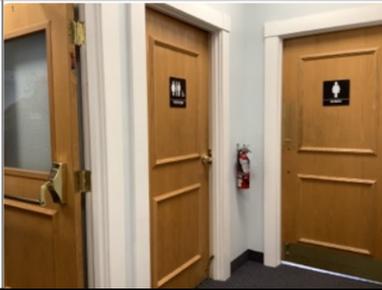
ID	Location	Floor	Room	Element	Type	Photo	Issues	Current Measure	Recommendations	Quantity	Price	Cost Estimation
<b>Doors, Doorways, &amp; Gates</b>												
21	Corridor by Toilet Rooms	1	110	Doors, Doorways, & Gates	Toilet Room

Maneuvering clearance(s) not provided	-	Relocate fire extinguisher to maintain maneuvering clearance at the door.	1	Labor	\$0
22	Women's Toilet Room	1	112	Doors, Doorways, & Gates	Toilet Room

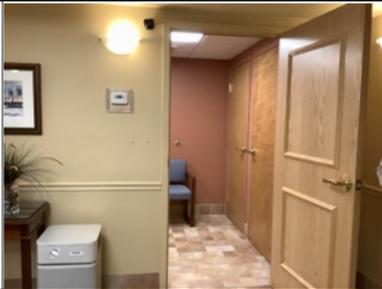
ID	Location	Floor	Room	Element	Type	Photo	Issues	Current Measure	Recommendations	Quantity	Price	Cost Estimation
36	Wellness Office	Basement		Signage	Designation

Signage is not provided	-	Locate compliant signage alongside the door on the latch side.	1	232	\$232
37	Single-User Toilet Room	Basement		Signage	Designation

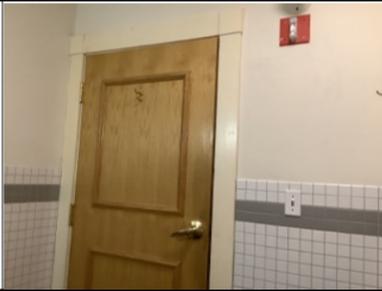
ID	Location	Floor	Room	Element	Type	Photo	Issues	Current Measure	Recommendations	Quantity	Price	Cost Estimation
50	Women's Toilet Room	2	207	Single-User Toilet	N/A

Hook located > 54" high	65"	Locate the coat hook no higher than 48" above the finished floor. Recommend fixing malfunctioning door handle.	1	150	\$150
51	Single-User Toilet Room	Basement		Single-User Toilet	N/A

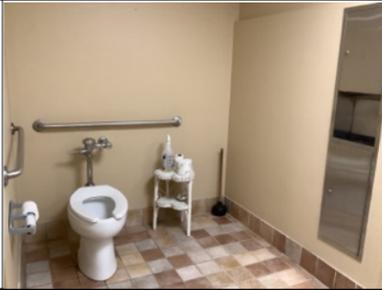
Flush control not on open side Centerline < or > 18" (MAAB) Clearance at toilet < 60" clear width	- 19.5" -	Relocate the flush control to the open side. Relocate toilet so that the centerline is 18" from the side wall. Relocate table to maintain the required 60" wide min. clear floor space at the toilet.	1	2828	\$2828
<b>Toilet Compartment</b>												
52	Single-User Toilet Room	Basement		Toilet Compartment	Accessible Compartment

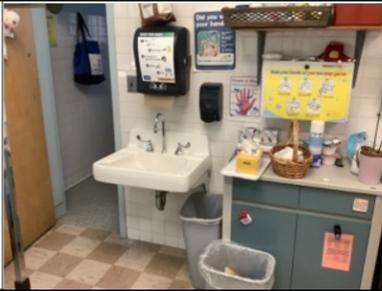
ID	Location	Floor	Room	Element	Type	Photo	Issues	Current Measure	Recommendations	Quantity	Price	Cost Estimation
111	Nurse's Office	1		Sink	Other

Exposed plumbing underneath sink	-	Insulate or otherwise configure pipes at sink.	1	92	\$92
<b>Sinks for Children's Use</b>												
112	Fifth Grade Classroom	2		Sinks for Children's Use	Classroom

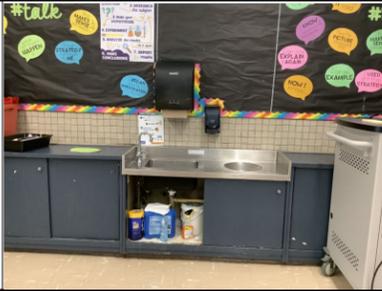
ID	Location	Floor	Room	Element	Type	Photo	Issues	Current Measure	Recommendations	Quantity	Price	Cost Estimation
116	Third Grade Classroom	1		Sinks for Children's Use	Classroom

Exposed plumbing underneath Knee/toe clearance <27" at sink > 31" high	- -	Insulate or otherwise configure pipes to prevent contact, for at least one sink. Provide at least one sink with 27" high knee and toe clearance positioned for a forward approach (per 521 CMR 12.2.2.c).	1	1686	\$1686
<b>Play and Sport Areas</b>												
<b>Play Areas</b>												
117	Playground	Ext.		Play Areas	N/A

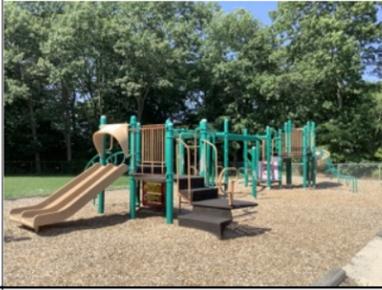
Accessible route not provided around playground Accessible route not provided to play components Surface not stable, firm, and slip-resistant	- - -	Provide an accessible route around the play area. Provide a compliant impact-attenuating surface to and around the play components. Repair surface and ensure that surface is firm, stable and slip-resistant (to areas around play components).	1	-	\$0

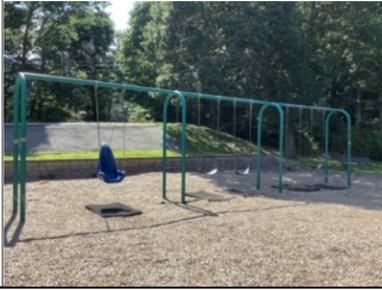
118	Playground	Ext.		Play Areas	N/A

Accessible route not provided at play components Surface not stable, firm, and slip-resistant	- -	Provide a compliant impact-attenuating surface under and around the play components. Repair the surface and ensure that surface is firm, stable and slip-resistant (to areas under and around play components).	1	-	\$0
<b>Best Practice</b>												
<b>Bench</b>												
119	Benches	Ext.		Bench	N/A

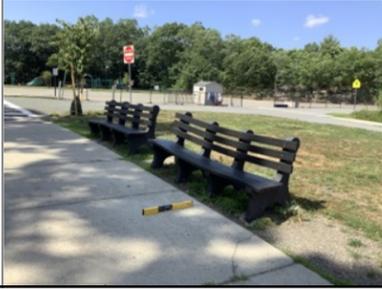
Recommend providing a stable and firm clear floor space at one of the benches.	1	-	\$0

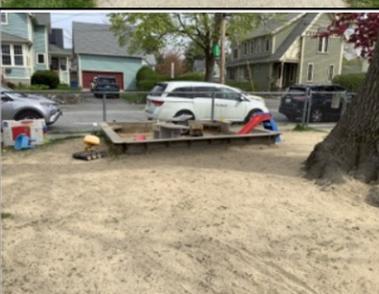
Accessible route not provided	-	Ensure an accessible route is provided to the sandbox.	1	-	\$0
