# ADA Self-Evaluation and Transition Plan for the City of Melrose

Part 2 of 2

## Part 2: Reports:

January, 2023

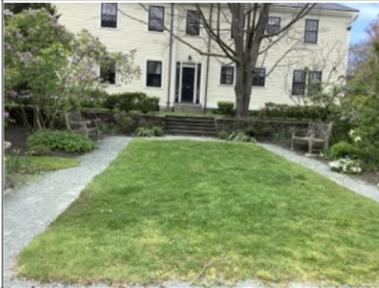
Exterior route < 48" wide	30"	Ensure that a clear width of 48" min. is maintained at the accessible route.	1	-	\$0
2	Route to Main Entrance (North Side)	Ext.		Exterior Access Route	Walkway

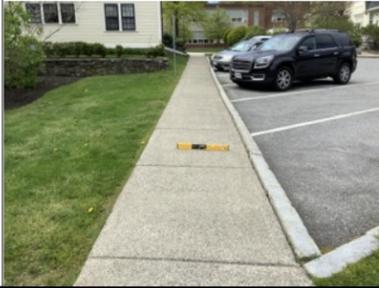
Cross slope > 1:50 (2.00%)	4.7%	Reduce cross slope to be no steeper than 1:50 (2.00%).	1	-	\$0
3	Route to Main Entrance From West Foster Street	Ext.		Exterior Access Route	Sidewalk

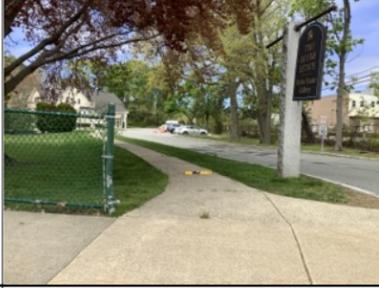
Level changes > 1/4"	1"	Alter change in level to be 1/4" high max.	1	-	\$0
4	Route to Garden	Ext.		Exterior Access Route	Sidewalk

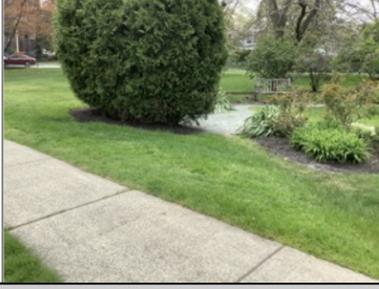
Accessible route not provided	-	Ensure an accessible route is provided.	1	-	\$0
<b>Curb Ramp</b>												
5	By Parking (North Side)	Ext.		Curb Ramp	N/A

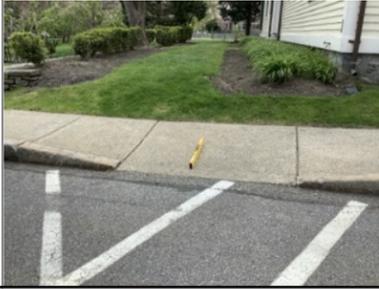
Curb ramp flares > 1:12 (8.33%) (if no landing) Cross slope > 1:50 (2.00%) (MAAB)	3% 8.7% 10.9%	Reduce slope at curb ramp flares to be no steeper than 1:12 (8.33%). Reduce cross slope at curb ramp to be no steeper than 1:50 (2.00%).	1	-	\$0

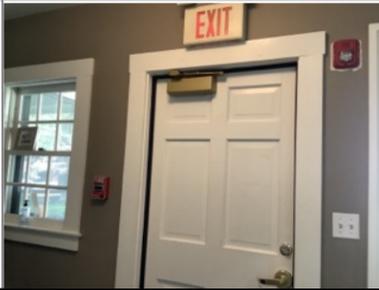
Illuminated ISA symbol not provided (MAAB)	-	Provide an illuminated sign with the International Symbol of Accessibility (ISA).	1	200	\$200
<b>Interior Access Route</b>												
7	Great Room	1	108	Interior Access Route	N/A

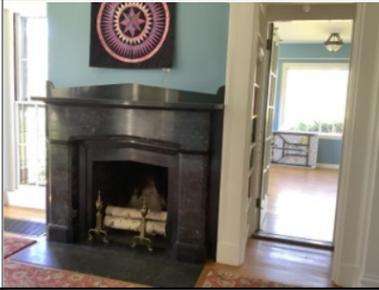
Obstructed by protruding objects	8"	Provide a cane-detectable barrier.	2	-	\$0
8	By Staircase A	2	BB-07	Interior Access Route	N/A

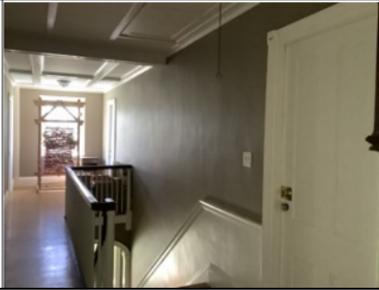
Obstructed by protruding objects	70.5"	Recess the string or pin it to the side wall.	1	Labor	\$0
<b>Doors, Doorways, &amp; Gates</b>												
9	Council on Aging	1	102	Doors, Doorways, & Gates	Office

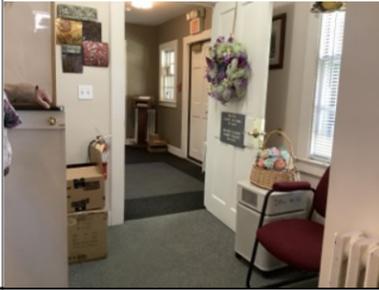
Maneuvering clearance(s) not provided	-	Remove various items to maintain the required maneuvering clearance at the door.	1	Labor	\$0
10	To Staircase A	1	104	Doors, Doorways, & Gates	Vestibule

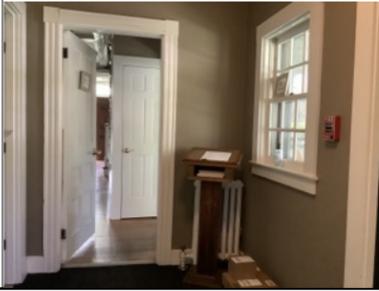
Threshold not beveled Threshold > 1/2" high	- .75"	Bevel the threshold. Alter the threshold to be 1/2" high max.	1	300	\$300

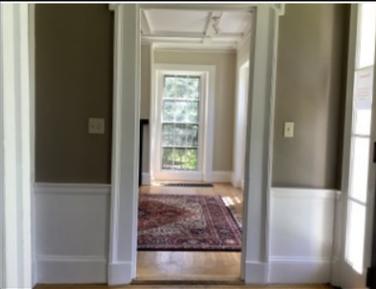
Threshold not beveled Threshold > 1/2" high	- 1.5"	Bevel the threshold. Alter the threshold to be 1/2" high max.	1	300	\$300
12	Great Room to Sun Porch	1	112	Doors, Doorways, & Gates	Circulation

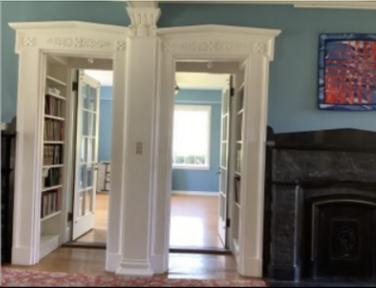
Threshold > 1/2" high Clear width at door < 32"	28" 1.5"	Provide signage directing users to an accessible entrance./Install offset hinges to ensure that the door has a clear width of 32 inches./Widen the door so that there is 32" min. clear width. Alter the threshold to be 1/2" high max.	1	-	\$0
13	Street Facing Egress Door 11	1	109	Doors, Doorways, & Gates	N/A

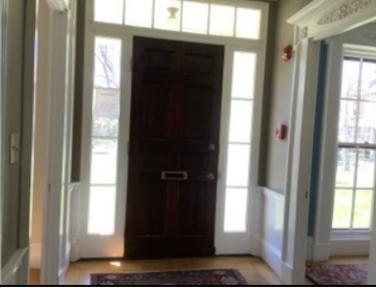
Hardware not operable with a closed fist	-	Provide hardware that can be operable with one hand and not require tight grasping, pinching, or twisting of the wrist.	1	484	\$484

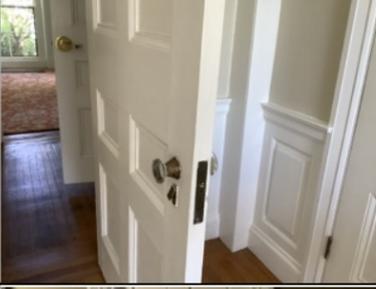
14	Parlor	1	111	Doors, Doorways, & Gates

Hardware not operable with a closed fist	-	Provide hardware that can be operable with one hand and not require tight grasping, pinching, or twisting of the wrist.	1	484	\$484
15	Conference Room	2	BB-09	Doors, Doorways, & Gates	Meeting Room

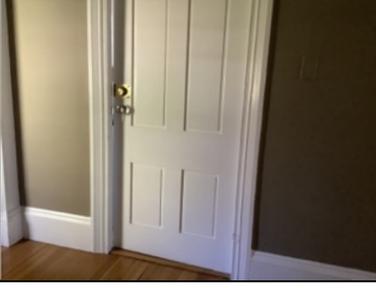
Threshold > 1/2" high Hardware not operable with a closed fist	1.5" -	Alter the threshold to be 1/2" high max. Provide hardware that can be operable with one hand and not require tight grasping, pinching, or twisting of the wrist.	1	634	\$634

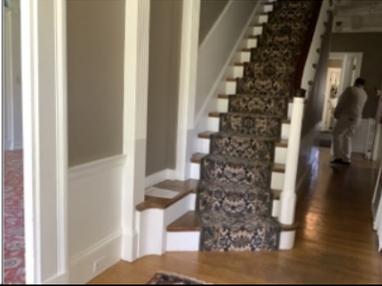
Handrail not provided on both sides Handrails do not extend 12" from stairs	- -	Provide handrail on one side. Top: Ensure handrails extend horizontally above the landing for 12" min. beginning above the first riser nosing. Bottom: Ensure handrails extend to one tread depth beyond the last riser.	1	-	\$0
<b>Signage</b>												
17	Council on Aging	1	104	Signage	Designation

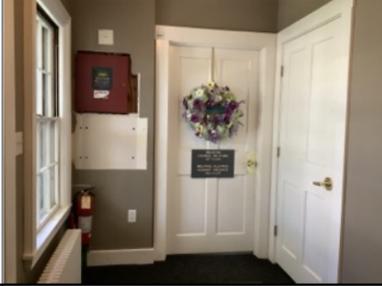
Sign not located on the latch side of the door	-	Locate the sign at permanent rooms alongside the door on the latch side.	1	Labor	\$0
18	Toilet Room	1	106	Signage	Designation

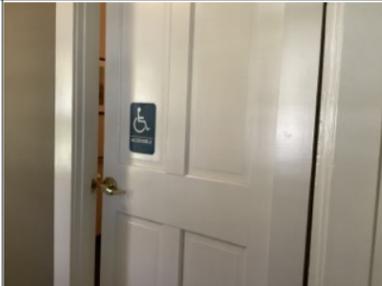
Sign not located on the latch side of the door	-	Locate the sign at permanent rooms alongside the door on the latch side.	1	Labor	\$0
<b>Service Counter</b>

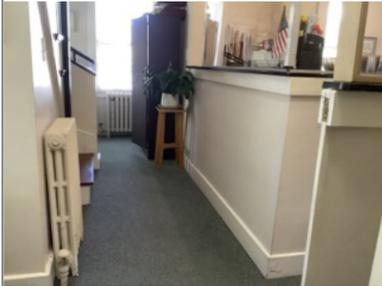
19	Council on Aging	1	102	Service Counter	N/A

Counter > 36" high	44.5"	Provide a counter that is 36" max. above the ground or finished floor.	1	-	\$0
<b>Toilet &amp; Bathing Rooms</b>

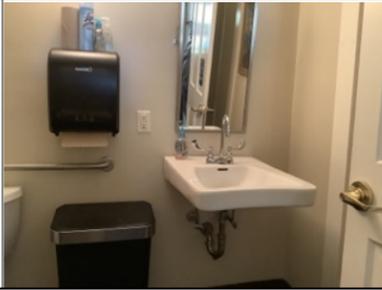
Plumbing underneath is exposed	-	Insulate or otherwise configure pipes to prevent contact for at least one lavatory.	1	92	\$92
<b>Single-User Toilet</b>												
22	Single-User Toilet Room	1	106	Single-User Toilet	N/A

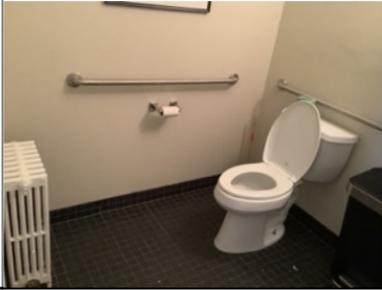
Flush control not on open side Centerline < 16" or > 18" Hook located > 54" high Clearance in front of the toilet < 42" clear depth	- 24" 69.6" 39.5"	Relocate the flush control to the open side. Relocate toilet so that the centerline is 18" from the side wall. Locate the coat hook no higher than 48" above the finished floor. Ensure there is a 42" min. clearance between the toilet and the nearest obstacle.	1	2978	\$2978

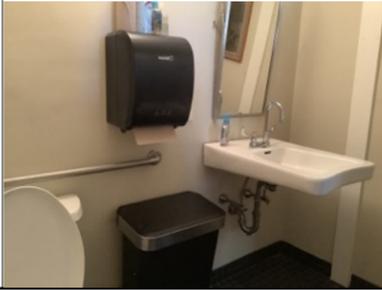
23	Single-User Toilet Room	1	106	Single-User Toilet	N/A

Clearance at toilet < 60" clear width	-	Relocate trash can to maintain the required 60" wide min. clear floor space at the toilet.	1	Labor	\$0
<b>Best Practice</b>

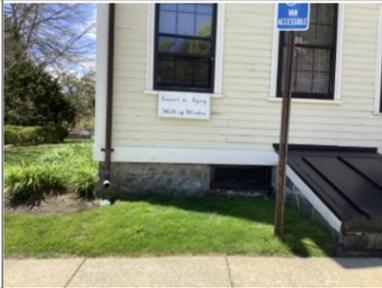
-	If the window is used to provide information to members of the public, recommend providing an accessible route.	1	-	\$0
<b>Accessible Route</b>												
25	Route to Main Entry	Ext.		Accessible Route	N/A

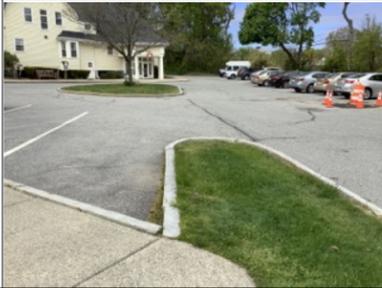
Recommend providing a curb ramp and a pedestrian crossing at this location.	1	-	\$0
<b>Lectern</b>												
26	Vestibule	1		Lectern	N/A

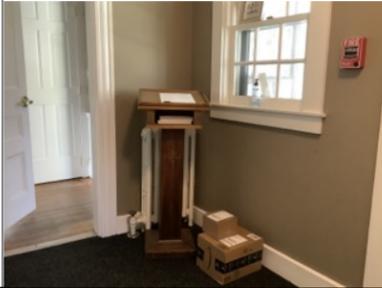
Recommend providing a lower lectern.	1	-	\$0

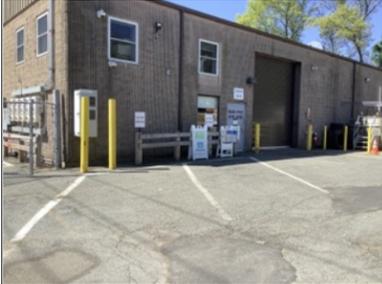
Total # of parking Access aisle not provided Sign not provided	2 - -	Provide a marked access aisle that is at least 96" wide. Provide a sign with the bottom of the sign 60" min. above the ground and the top 96" max. above the ground. Add the designation "Van Accessible" to the sign.	1	-	\$0
<b>Entrance</b>												
2	Public Main Entry	Ext.		Entrance	Main Entrance

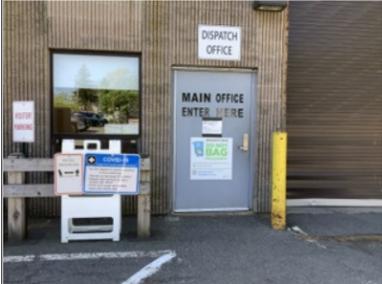
Maneuvering clearance is not provided	-	Provide an automatic door opener.	1	3060	\$3060
3	Public Main Entry	Ext.		Entrance	Main Entrance

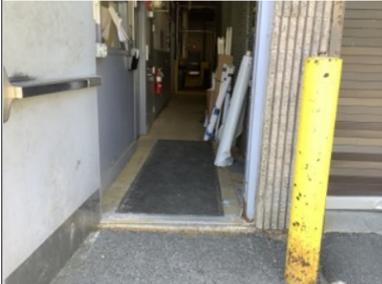
Mat not securely attached Threshold > 3/4" high	- 1.5"	Ensure the mat is securely attached to the floor to prevent tripping hazard Alter threshold to be 3/4" high max.	1	150	\$150

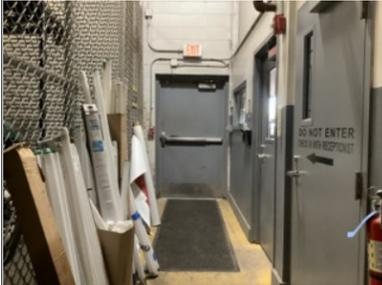
Tactile exit sign not provided	-	Ensure tactile exit signs with raised characters and braille are provided at exit doors. Mount signs between 48"- 60" above the finished floor located on the latch side of the door.	1	232	\$232

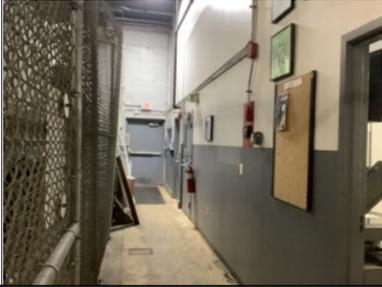
Route < 36" wide	-	Ensure that a clear width of 36" min. is maintained at the accessible route.	1	Labor	\$0
<b>Doors, Doorways, &amp; Gates</b>												
6	Meeting Room	1		Doors, Doorways, & Gates	Meeting Room

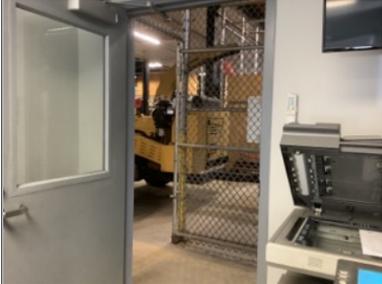
Maneuvering clearance(s) not provided	-	Relocate printer to maintain the required 18" min. maneuvering clearance at the door.	1	Labor	\$0
<b>Signage</b>												
7	Meeting Room	1		Signage	Designation

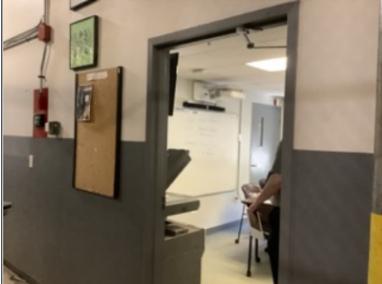
Signage is not provided	-	Locate compliant signage alongside the door on the latch side.	1	232	\$232
<b>Service Counter</b>												
8	Counter at Entry	1		Service Counter	N/A

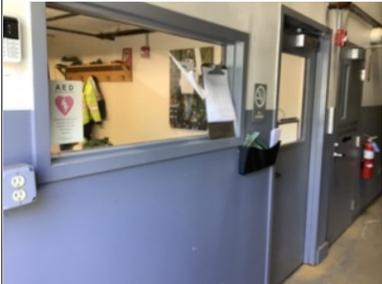
Counter > 36" high	50"	Provide a counter that is 36" max. above the ground or finished floor.	1	880	\$880

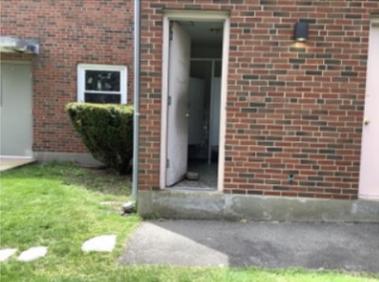
Accessible route not provided	-	Ensure an accessible route is provided to the toilet room.	1		\$0
2	Route to Toilet Room	Ext.		Exterior Access Route	Exterior

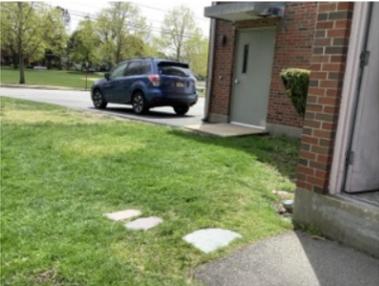
Accessible route not provided	-	Ensure an accessible route is provided.	1	-	\$0
<b>Toilet &amp; Bathing Rooms</b>												
<b>Overall Access</b>												
3	Toilet Room	1		Overall Access	Toilet Room

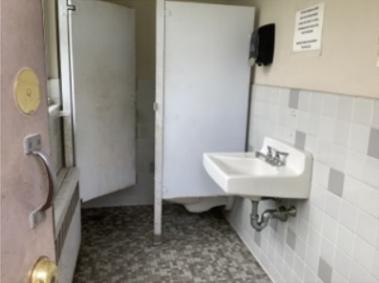
Accessible plumbing fixtures or stalls not provided	-	Provide a single-user toilet room.	1	24604	\$24604
<b>Best Practice</b>												
4	Route to Toilet Room	Ext.

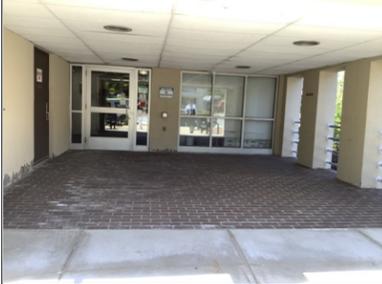
Threshold > 3/4" high	1"	Alter threshold to be 3/4" high max.	1	150	\$150
<b>Access to Goods and Services</b>												
<b>Signage</b>												
2	Women's Toilet Room	1		Signage	Designation

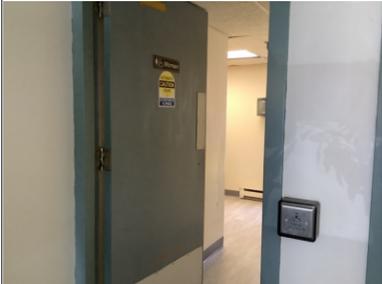
Raised characters not provided on sign Braille not provided on sign Sign not located on the latch side of the door	- - -	Provide text with raised characters duplicated in braille on sign. Locate the sign at permanent rooms alongside the door on the latch side.	1	232	\$232
3	Men's Toilet Room	1		Signage	Designation

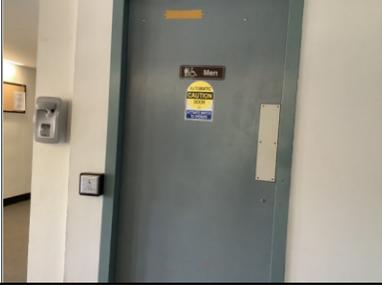
Raised characters not provided on sign Braille not provided on sign Sign not located on the latch side of the door	- - -	Provide text with raised characters duplicated in braille on sign. Locate the sign at permanent rooms alongside the door on the latch side.	1	232	\$232

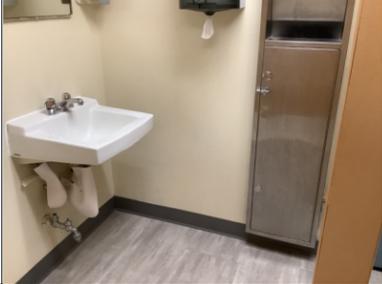
<b>Toilet &amp; Bathing Rooms</b>												
<b>Lavatory</b>												
4	Men's Toilet Room	1		Lavatory	N/A

Clear floor space not provided at lavatory	33"	Relocate partition to provide at least 48" min. clear floor space positioned for a forward approach at the lavatory.	1	256	\$256

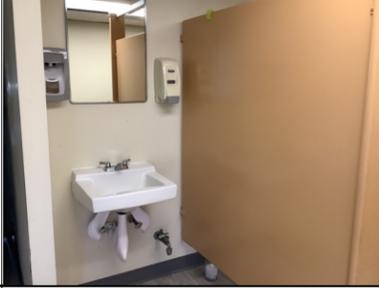
Mirror above lavatory w/reflective surface > 40"	49"	Lower mirror so that the bottom surface is at 40" max. above the finished floor.	1	256	\$256
6	Men's Toilet Room	1		Lavatory	N/A

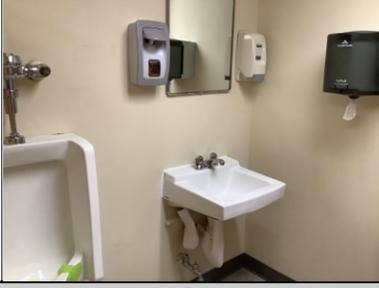
Mirror above lavatory w/reflective surface > 40"	48"	Lower mirror so that the bottom surface is at 40" max. above the finished floor.	1	256	\$256
<b>Toilet Compartment</b>												
7	Men's Toilet Room	1		Toilet Compartment	Accessible Compartment

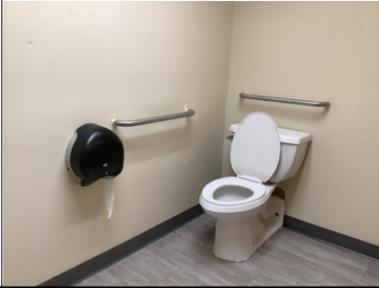
Side grab bar < 42" long Rear grab bar < 42" long (MAAB) Flush control not on open side Non-compliant toilet paper dispenser	24" 24" - -	Provide a side wall grab bar that is 42" long min. located 12" max. from the rear wall. Provide a rear wall grab bar that is 42" long min. and extends from the toilet 12" min. on one side and 24" min. on the open side. Provide the flush control on the open side of the toilet (transfer side). Relocate toilet paper so that it is 24" min. high, located under the grab bar, and between 7" and 9" from the front of the toilet.	1	2426	\$2426

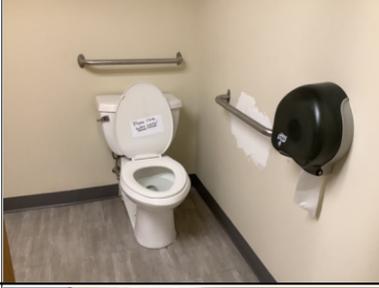
8	Women's Toilet Room	1		Toilet Compartment	Accessible Compartment

Rear grab bar < 42" long (MAAB) Side or rear grab bar < 33" or >36" high Rear grab bar < 24" from toilet centerline Non-compliant toilet paper dispenser	38" 25" 25" -	Locate grab bars between 33"- 36" above the finished floor. Provide a side wall grab bar that is 42" long min. located 12" max. from the rear wall. Provide a rear wall grab bar that is 42" long min. and extends from the toilet 12" min. on one side and 24" min. on the open side. Relocate toilet paper so that it is 24" min. high, located under the grab bar, and between 7" and 9" from the front of the toilet.	1	2052	\$2052
9	Men's Toilet Room	1		Toilet Compartment	Accessible Compartment

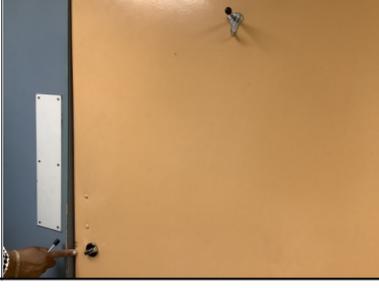
Coat hook > 48" (2010 ADA)	65"	Locate the coat hook no higher than 48" above the finished floor.	1	150	\$150

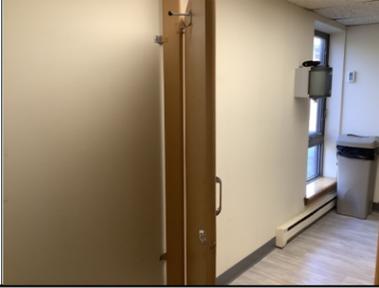
Coat hook > 48" (2010 ADA) Door pull not provided	64" -	Locate the coat hook no higher than 48" above the finished floor. Provide a door pull on each side of the door between 34" to 48" above the finished floor that does not require tight grasping, pinching or twisting of the wrist.	1	220	\$220
<b>Urinal</b>												
11	Men's Toilet Room	1		Urinal	N/A

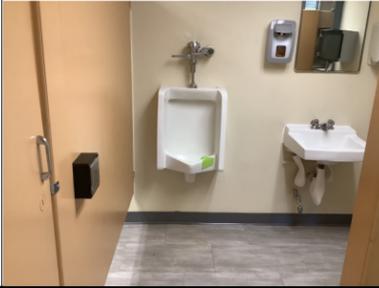
Rim > 17" high	24"	Provide an urinal with the rim no higher than 17" above the finished floor.	1	3248	\$3248
<b>Dispensers</b>												
12	Women's Toilet Room	1		Dispensers	Paper Towel Dispenser

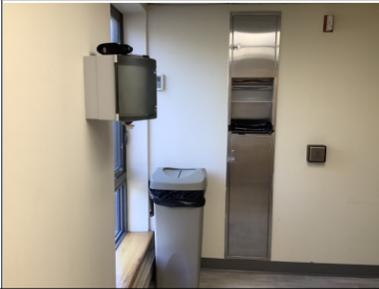
Dispenser acts as a protruding object	-	Relocate dispenser out of the circulation path.	1	256	\$256
<b>Best Practice</b>												
<b>Signage</b>

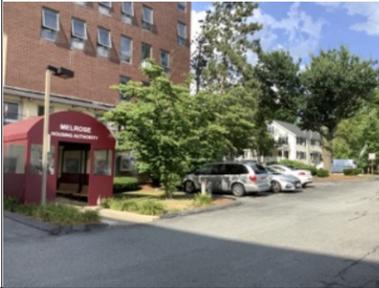
13	Towards Main Entrance - South Side	Ext.		Signage	N/A

Recommend providing a sign directing members of the public to the main entrance.	1	-	\$0

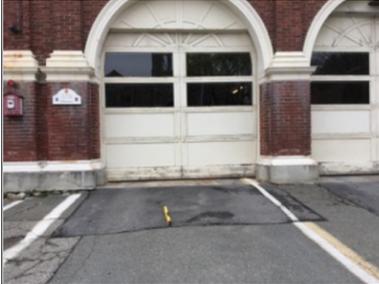
Running slope > 1:20 (5.00%)	10%	Reduce running slope to be no steeper than 1:20 (5.00%).	1	-	\$0
<b>Off-Street Parking Lot or Garage</b>												
2	Parking Lot	Ext.		Off-Street Parking Lot or Garage	Visitor

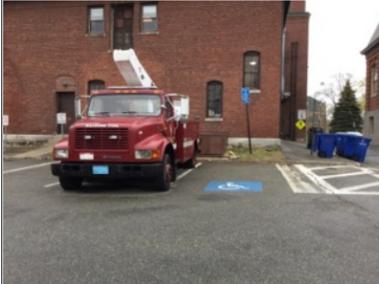
Total # of parking Total # of designated van accessible spaces Access aisle does not adjoin an accessible route Running or cross slope at access aisle > 1:50 (2.00%) Sign top > 96" above finished grade	12 1 - 4.2% 107"	Ensure the access aisle adjoins an accessible route. Reduce running and cross slope to be no steeper than 1:50 (2.00%). Locate sign with the top of the sign 96" above the ground.	1	-	\$0
<b>Entrance</b>												
3	Entrance	Ext.		Entrance	Main Entrance

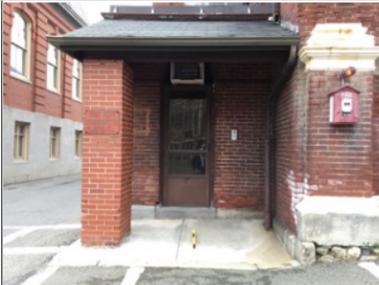
Entrance not on an accessible route Maneuvering clearance at door > 1:50 (2.00%)	- 9%	Provide an accessible entrance or relocate the program as needed. Alter so that the slope in all directions is no greater than 1:50 (2.00%)./Provide an automatic door opener.	1	-	\$0

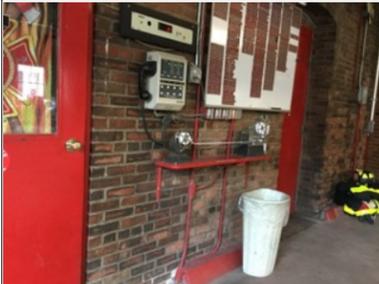
<b>Access to Goods and Services</b>												
<b>Interior Access Route</b>												
4	Garage Area	1		Interior Access Route	N/A

Obstructed by protruding objects	8.5"	Provide a cane-detectable barrier.	1	256	\$256

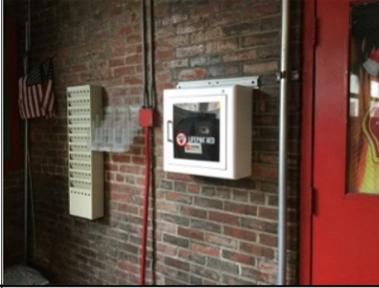
Obstructed by protruding objects	6.7"	Relocate AED so it does not protrude into the circulation path.	1	256	\$256
6	Garage	1		Interior Access Route	N/A

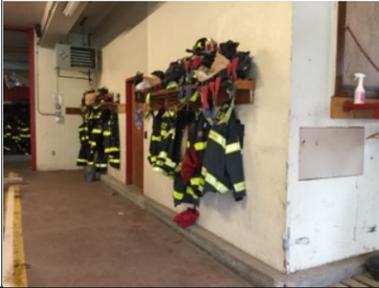
Obstructed by protruding objects	11"	Provide a cane-detectable barrier.	2	256	\$512
7		2		Interior Access Route

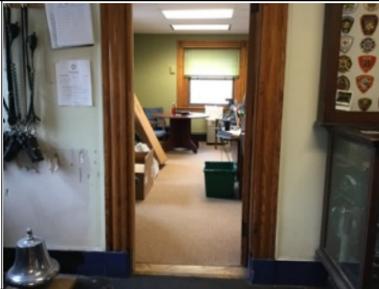
Route < 36" wide	29.5"	Ensure that a clear width of 36" min. is maintained at the accessible route.	1	Labor	\$0
<b>Doors, Doorways, &amp; Gates</b>												
8	Garage Area	1		Doors, Doorways, & Gates

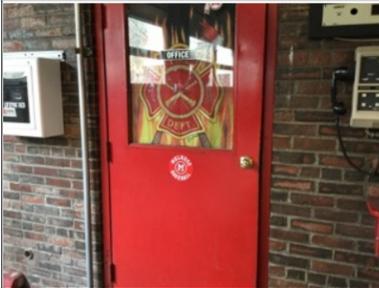
Hardware not operable with a closed fist		Provide hardware that can be operable with one hand and not require tight grasping, pinching, or twisting of the wrist.	1	484	\$484
9	Reception/ Dispatch	1		Doors, Doorways, & Gates

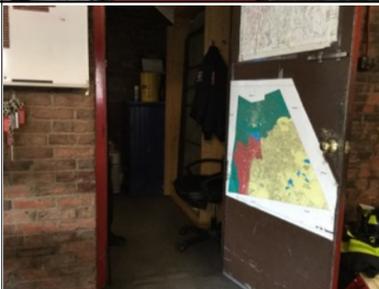
Hardware not operable with a closed fist Clear width at door < 32"	31"	Install offset hinges to ensure that the door has a clear width of 32 inches. Provide hardware that can be operable with one hand and not require tight grasping, pinching, or twisting of the wrist.	1	2716	\$2716

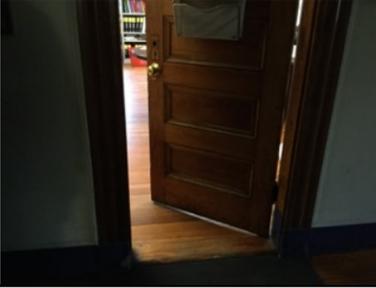
Clear width at door < 32" Threshold > 1/2" high Hardware not operable with a closed fist	30" 0.75" -	Widen the door so that there is 32" min. clear width. Alter the threshold to be 1/2" high max. Provide hardware that can be operable with one hand and not require tight grasping, pinching, or twisting of the wrist.	1	-	\$0
11	Towards Chief's Office and Fire Prevention Office	2		Doors, Doorways, & Gates

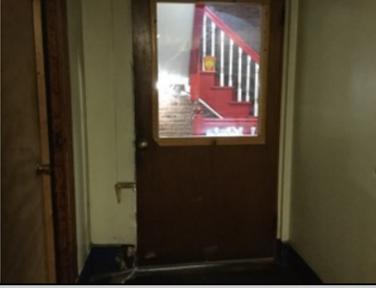
Hardware not operable with a closed fist		Provide hardware that can be operable with one hand and not require tight grasping, pinching, or twisting of the wrist.	1	484	\$484
<b>Stairways</b>												
12	Chief's Office and Fire Prevention Office	1		Stairways	Egress

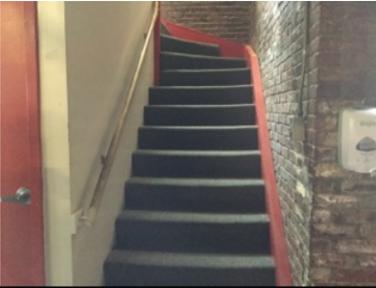
Handrail not provided on both sides	1	Provide handrail on one side.	1	-	\$0

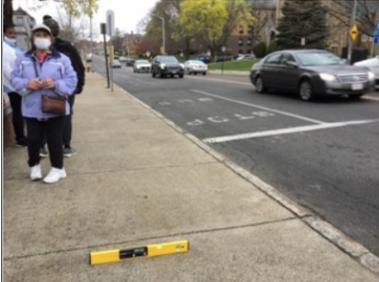
Cross slope > 1:50 (2.00%)	3.9%	Reduce cross slope to be no steeper than 1:50 (2.00%).	1	-	\$0
2	By Accessible Entrance - South Side	Ext.		Exterior Access Route	Exterior

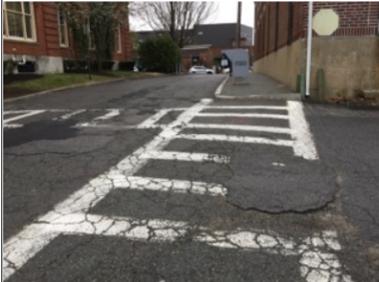
Route not maintained in operable working condition	-	Ensure the accessible route is maintained in operable working condition.	1	-	\$0
3	Main Street	Ext.		Exterior Access Route	Exterior

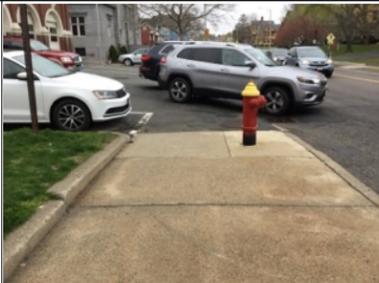
Route not maintained in operable working condition	-	Ensure the accessible route is maintained in operable working condition.	1	-	\$0
<b>Curb Ramp</b>												
4	Access From Street Side	Ext.		Curb Ramp	N/A

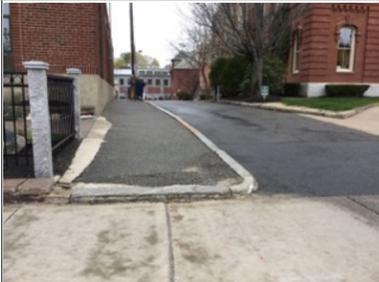
Curb ramp not provided		Provide a curb ramp.	1	-	\$0
5	City Hall Plaza By Accessible Entrance	Ext.		Curb Ramp	N/A

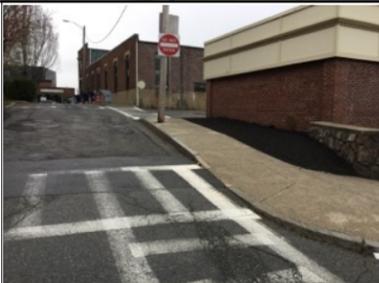
Curb ramp flares > 1:12 (8.33%) (if no landing) Cross slope > 1:50 (2.00%) (MAAB)	20.5% 13.2%	Reduce slope at curb ramp flares to be no steeper than 1:12 (8.33%).  Reduce cross slope at curb ramp to be no steeper than 1:50 (2.00%).	1	-	\$0

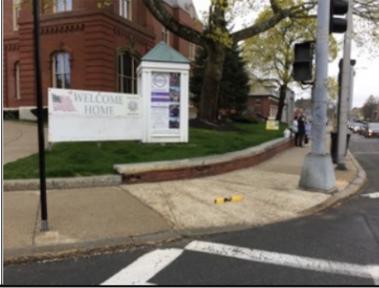
Cross slope > 1:50 (2.00%) (MAAB)	3.2%	Reduce cross slope at curb ramp to be no steeper than 1:50 (2.00%).	1	-	\$0
<b>Exterior Stair</b>												
7	Main Street Entrance	1		Exterior Stair	N/A

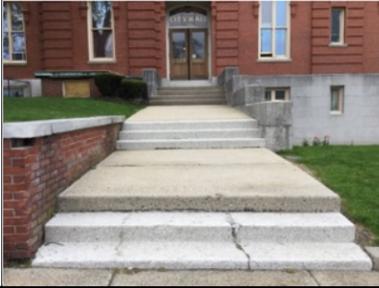
Handrail not provided on both sides		Provide a handrail on one side.	1	-	\$0
<b>Entrance</b>												
8	Essex Street Entrance	1		Entrance	Secondary Entrance

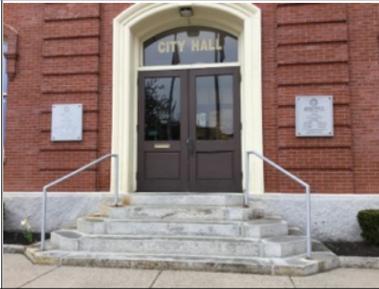
Entrance not on an accessible route Directional sign to accessible entrance not provided	- -	Provide a directional sign indicating the location of the nearest accessible entrance.	1	-	\$0
9	Main Street Entrance	1		Entrance	Secondary Entrance

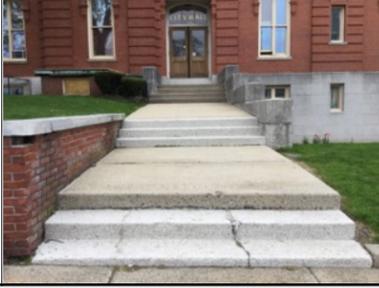
Entrance not on an accessible route Directional sign to accessible entrance not provided	- -	Provide a directional sign indicating the location of the nearest accessible entrance.	1	-	\$0

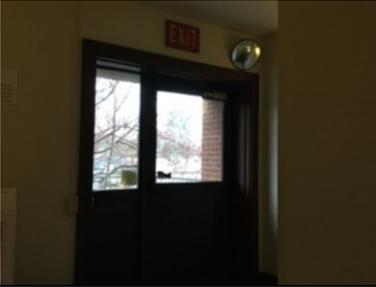
ID	Location	Floor	Room	Element	Type	Photo	Issues	Current Measure	Recommendations	Quantity	Price	Cost Estimation
<b>Means of Egress</b>												
10	Egress by Engineering Department	1		Means of Egress	N/A

Tactile exit sign not provided Directional sign to accessible emergency exit not provided		Ensure tactile exit signs with raised characters and braille are provided at exit doors. Mount signs between 48"- 60" above the finished floor located on the latch side of the door. Provide a directional sign indicating the location of the nearest accessible emergency exit.	1	464	\$464
11	Egress by Election Commission Office	1		Means of Egress	N/A

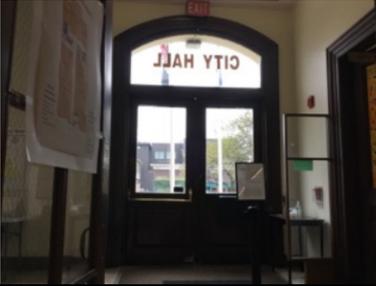
Tactile exit sign not provided Directional sign to accessible emergency exit not provided	- -	Ensure tactile exit signs with raised characters and braille are provided at exit doors. Mount signs between 48"- 60" above the finished floor located on the latch side of the door. Provide a directional sign indicating the location of the nearest accessible emergency exit.	1	464	\$464

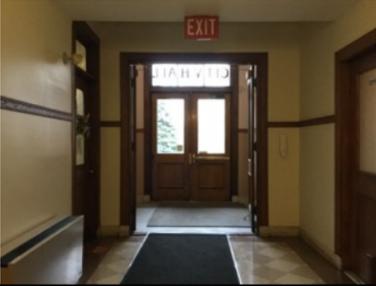
12	Egress by Clerk of Committees for City Council	1		Means of Egress	N/A

Tactile exit sign not provided Directional sign to accessible emergency exit not provided		Ensure tactile exit signs with raised characters and braille are provided at exit doors. Mount signs between 48"- 60" above the finished floor located on the latch side of the door. Provide a directional sign indicating the location of the nearest accessible emergency exit.	1	464	\$464
13	Engineering Staircase	2		Means of Egress	N/A

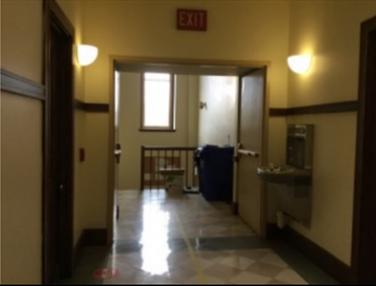
Tactile exit sign not provided		Ensure tactile exit signs with raised characters and braille are provided at exit doors. Mount signs between 48"- 60" above the finished floor located on the latch side of the door.	1	232	\$232
14	Egress Stair by Engineering Department	B		Means of Egress	N/A

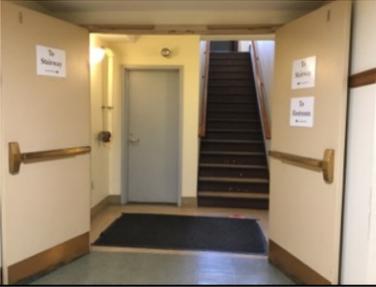
Tactile exit sign not provided		Ensure tactile exit signs with raised characters and braille are provided at exit doors. Mount signs between 48"- 60" above the finished floor located on the latch side of the door.	1	232	\$232

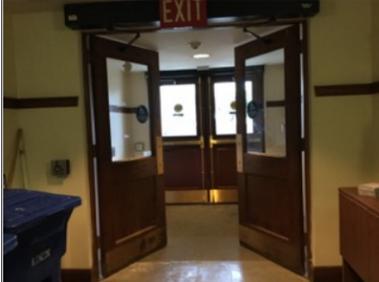
ID	Location	Floor	Room	Element	Type	Photo	Issues	Current Measure	Recommendations	Quantity	Price	Cost Estimation
15	Accessible Entrance - Rear Side	B		Means of Egress	N/A

Tactile exit sign not provided Illuminated ISA symbol not provided (MAAB)		Ensure tactile exit signs with raised characters and braille are provided at exit doors. Mount signs between 48"- 60" above the finished floor located on the latch side of the door. Provide an illuminated sign with the International Symbol of Accessibility (ISA).	1	432	\$432
16	Egress by Recreation Department	B		Means of Egress	N/A

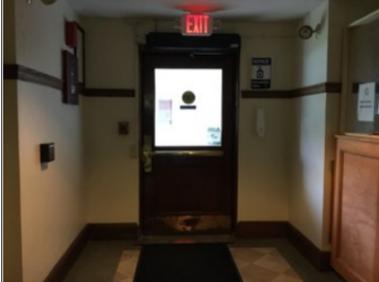
Tactile exit sign not provided Illuminated ISA symbol not provided (MAAB)		Ensure tactile exit signs with raised characters and braille are provided at exit doors. Mount signs between 48"- 60" above the finished floor located on the latch side of the door. Provide an illuminated sign with the International Symbol of Accessibility (ISA).	1	432	\$432

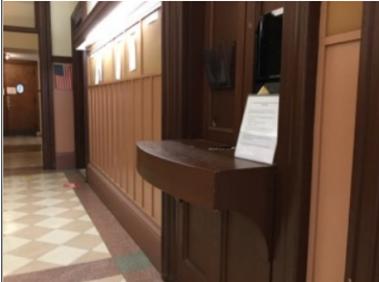
<b>Interior Access Route</b>												
17	By Tax Collector's Office	1		Interior Access Route	N/A

Obstructed by protruding objects	11"	Provide a cane-detectable barrier on each side of the counter.	2	306	\$612
18	By Elevator	1		Interior Access Route	N/A

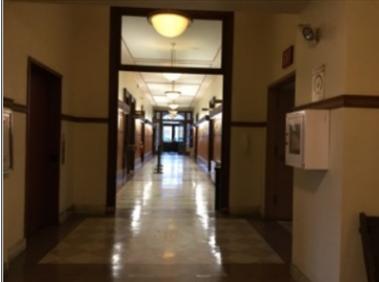
Obstructed by protruding objects	7"	Provide a cane-detectable barrier.	1	256	\$256
19	Assessor's Office	1		Interior Access Route	N/A

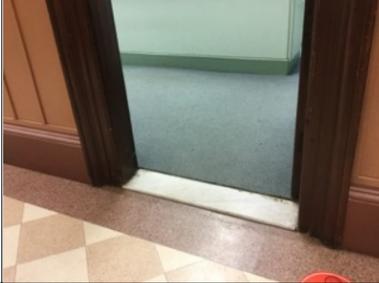
Surface not stable, firm, and slip-resistant	-	Ensure carpet is securely attached to the floor to prevent tripping hazard.	1	Labor	\$0

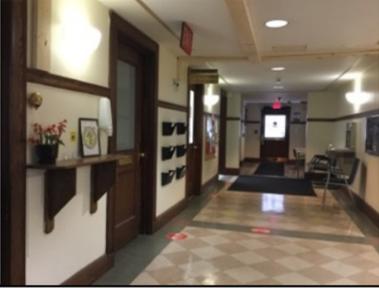
ID	Location	Floor	Room	Element	Type	Photo	Issues	Current Measure	Recommendations	Quantity	Price	Cost Estimation
20	Corridor	B		Interior Access Route	N/A

Obstructed by protruding objects	8.5"	Provide a cane-detectable barrier on each side of the shelf.	2	306	\$612
<b>Doors, Doorways, &amp; Gates</b>												
21	Emergency Management	1		Doors, Doorways, & Gates	Office

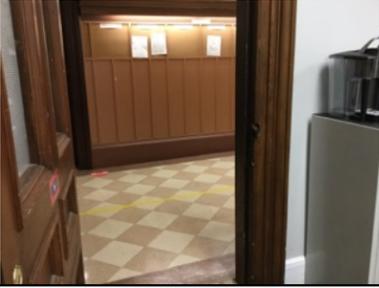
Maneuvering clearance(s) not provided	4"	Relocate cabinet to maintain the maneuvering clearance at the door.	1	Labor	\$0
22	Men's Toilet Room	2		Doors, Doorways, & Gates	Toilet Room

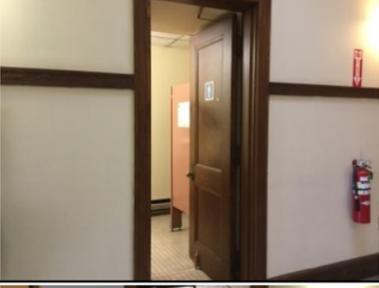
Clear width at door < 32" Hardware not operable with a closed fist	27.5" -	Widen the door so that there is 32" min. clear width. Provide hardware that can be operable with one hand and not require tight grasping, pinching, or twisting of the wrist.	1	-	\$0
23	Women's Toilet Room	2		Doors, Doorways, & Gates	Toilet Room

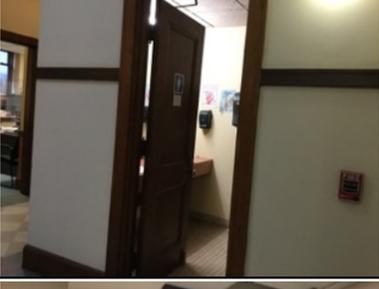
Clear width at door < 32" Hardware not operable with a closed fist	27.5" -	Widen the door so that there is 32" min. clear width. Provide hardware that can be operable with one hand and not require tight grasping, pinching, or twisting of the wrist.	1	-	\$0

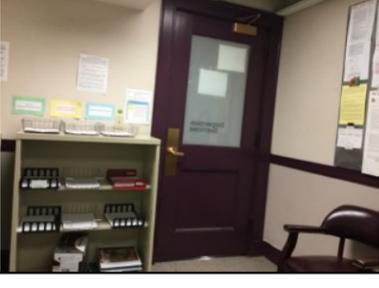
24	Building Commissioner	B		Doors, Doorways, & Gates	Office

Maneuvering clearance(s) not provided		Relocate cabinet to maintain the required 18" maneuvering clearance at the door.	1	Labor	\$0

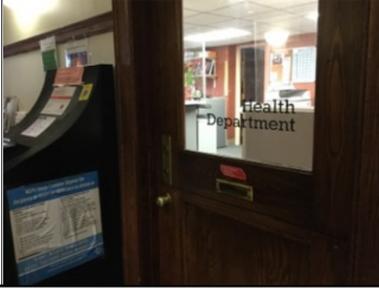
ID	Location	Floor	Room	Element	Type	Photo	Issues	Current Measure	Recommendations	Quantity	Price	Cost Estimation
25	Health Department & Various Offices	B		Doors, Doorways, & Gates	Office

Hardware not operable with a closed fist	-	Provide hardware that can be operable with one hand and not require tight grasping, pinching, or twisting of the wrist.	6	484	\$2904
<b>Stairways</b>												
26	By Cassidy Conference Room	2		Stairways	Other

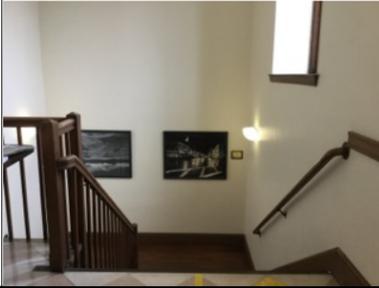
Handrails do not extend 12" from stairs Handrail height < 34" or > 38"	32" -	Alter so the handrails are 34"- 38" high above the floor. Top: Ensure handrails extend horizontally above the landing for 12" min. beginning above the first riser nosing. Bottom: Ensure handrails extend to one tread depth beyond the last riser.	1	-	\$0
27	By Engineering Department	B		Stairways

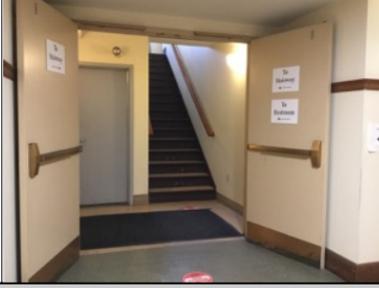
Handrails do not extend 12" from stairs		Top: Ensure handrails extend horizontally above the landing for 12" min. beginning above the first riser nosing. Bottom: Ensure handrails extend to one tread depth beyond the last riser.	1	-	\$0

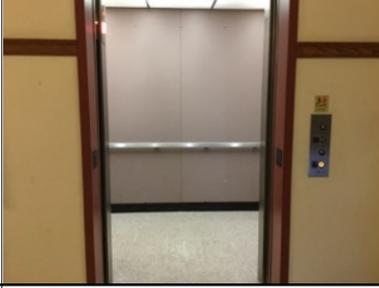
<b>Elevator</b>												
28	Elevator	1		Elevator	Interior

Hoistway signs < 48" > 60" Tactile stars not provided at main entry level	36.7" -	Install hoistway signs on the inside of the door frame 60" above the finished floor. Provide a tactile star on both sides of jambs at main floor. At other floors, provide appropriate number.	1	384	\$384
29	Elevator	2		Elevator	Interior

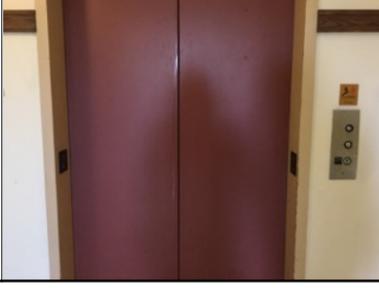
Hoistway signs < 48" > 60"	37"	Install hoistway signs on the inside of the door frame 60" above the finished floor.	2	96	\$192

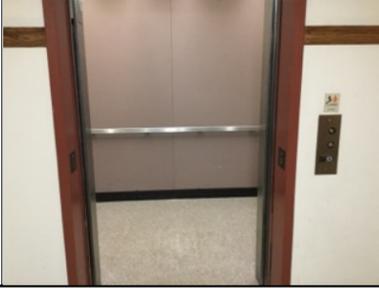
ID	Location	Floor	Room	Element	Type	Photo	Issues	Current Measure	Recommendations	Quantity	Price	Cost Estimation
30	Elevator	B		Elevator	Interior

Hoistway signs < 48" > 60"	37"	Install hoistway signs on the inside of the door frame 60" above the finished floor.	2	96	\$192
<b>Signage</b>												
31	Women's Toilet Room & Men's Toilet Room	1		Signage	Designation

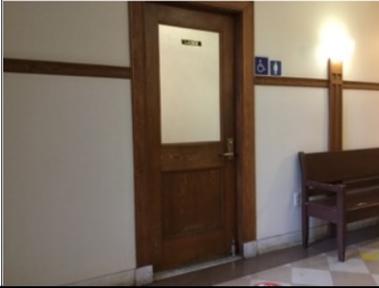
Raised characters not provided on sign Raised characters < 48" or > 60" above ground Braille not provided on sign	- - 65"	Provide text with raised characters duplicated in braille on sign. Mount signs so that the baseline of the lowest tactile character is 48" min. above finished floor and the baseline of the highest tactile character is 60" max. above the finished floor.	2	232	\$464
32	Men's Toilet Room	2		Signage	Designation

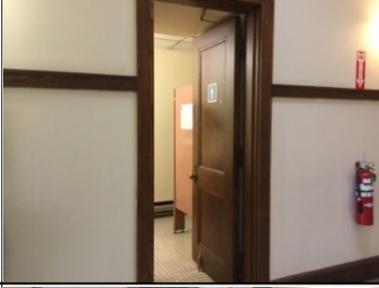
Raised characters not provided on sign Braille not provided on sign Sign not located on the latch side of the door Directional sign to access. toilet not provided	- - - -	Provide text with raised characters duplicated in braille on sign. Locate the sign at permanent rooms alongside the door on the latch side. Install a sign indicating the location of the nearest accessible toilet room.	1	464	\$464

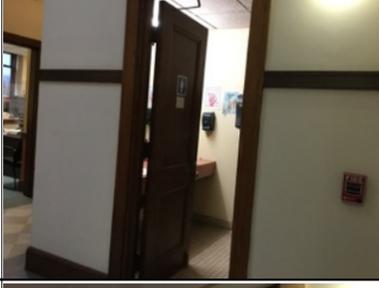
33	Women's Toilet Room	2		Signage	Designation

Raised characters not provided on sign Braille not provided on sign Sign not located on the latch side of the door Directional sign to access. toilet not provided	- - - -	Provide text with raised characters duplicated in braille on sign. Locate the sign at permanent rooms alongside the door on the latch side. Install a sign indicating the location of the nearest accessible toilet room.	1	464	\$464
34	Health Department	B		Signage	Designation

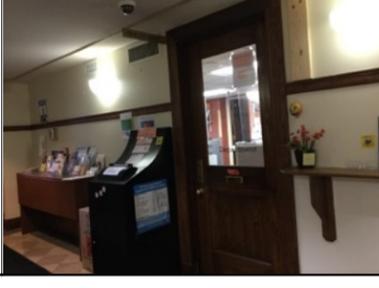
Raised characters not provided on sign Braille not provided on sign Sign not located on the latch side of the door		Provide text with raised characters duplicated in braille on sign. Locate the sign at permanent rooms alongside the door on the latch side.	1	232	\$232

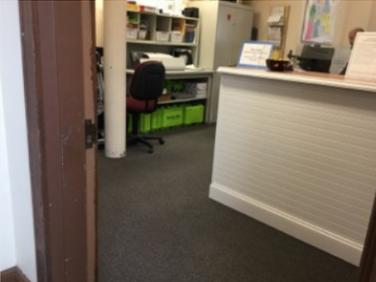
ID	Location	Floor	Room	Element	Type	Photo	Issues	Current Measure	Recommendations	Quantity	Price	Cost Estimation
<b>Service Counter</b>												
35	Election Commission Office	1		Service Counter

Counter > 36" high	42"	Provide a counter that is 36" max. above the ground or finished floor.	1	880	\$880
36	City Clerk Office	1		Service Counter	N/A

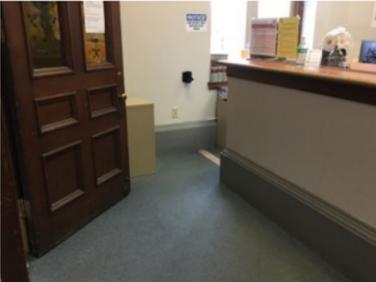
Counter > 36" high	44"	Provide a counter that is 36" max. above the ground or finished floor.	1	880	\$880
37	Treasurer /Parking Clerk	1		Service Counter	N/A

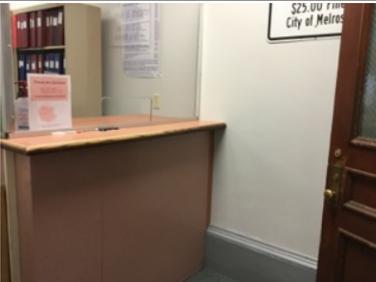
Counter > 36" high	43.5"	Provide a counter that is 36" max. above the ground or finished floor.	1	880	\$880
38	Tax Collector's Office	1		Service Counter

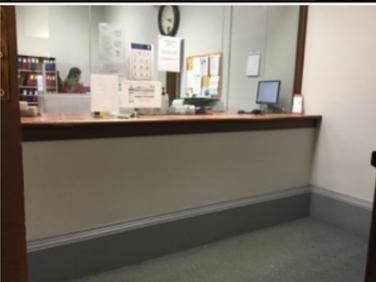
Counter > 36" high	44.5"	Provide a counter that is 36" max. above the ground or finished floor.	1	880	\$880
39	Assessor's Office	1		Service Counter

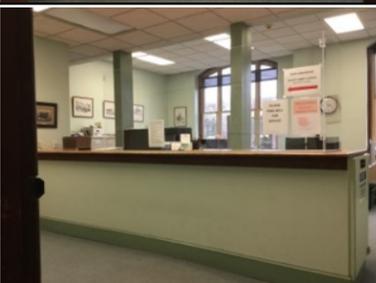
Counter > 36" high	44"	Provide a counter that is 36" max. above the ground or finished floor.	1	880	\$880

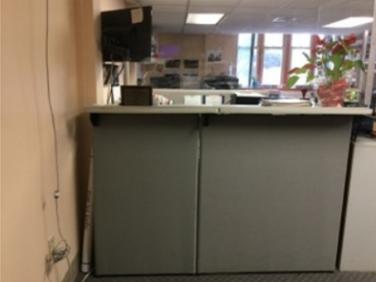
ID	Location	Floor	Room	Element	Type	Photo	Issues	Current Measure	Recommendations	Quantity	Price	Cost Estimation
40	Health Department	B		Service Counter	N/A

Counter > 36" high	44"	Provide a counter that is 36" max. above the ground or finished floor.	1	880	\$880
41	Building Commissioner	B		Service Counter	N/A

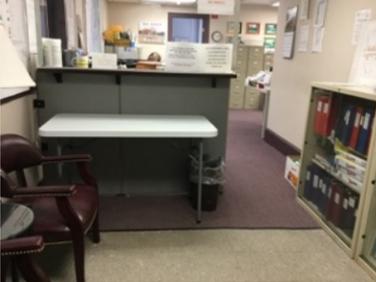
Counter > 36" high	43.7"	Relocate chair to maintain a clear floor space at the auxiliary counter.	1	-	\$0
42	Recreation	B		Service Counter	N/A

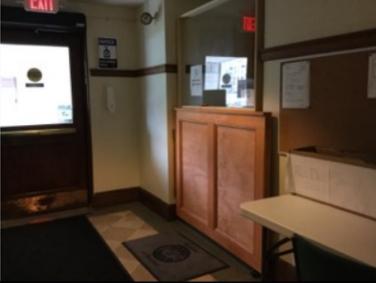
Counter > 36" high	46.7"	Provide a counter that is 36" max. above the ground or finished floor.	1	880	\$880
43	Engineering Department	B		Service Counter	N/A

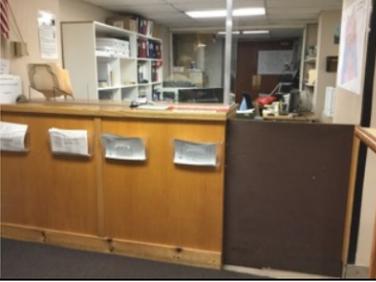
Counter > 36" high	43"	Provide a counter that is 36" max. above the ground or finished floor.	1	880	\$880
44	Water Department	B		Service Counter	N/A

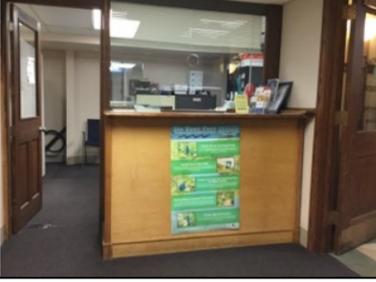
Counter > 36" high	44.5"	Provide a counter that is 36" max. above the ground or finished floor.	1	880	\$880

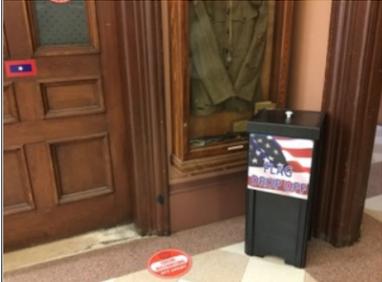
ID	Location	Floor	Room	Element	Type	Photo	Issues	Current Measure	Recommendations	Quantity	Price	Cost Estimation
<b>Operable Parts</b>												
45	By Emergency Management	1		Operable Parts	Other

Not operable with a closed fist	-	Provide a drop off box with hardware that does not require tight grasping, or pinching, or twisting of the wrist.	1	-	\$0
46	Engineering	B		Operable Parts	Other

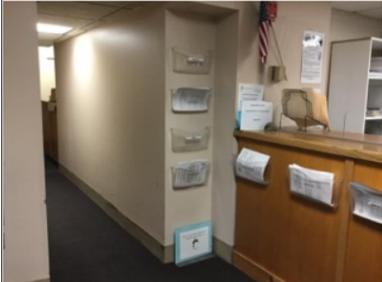
Reach < 15" or > 48"(forward/side approach)	67.5"	Relocate wall file organizers to ensure they are mounted between 15"- 48" above the finished floor.	1	Labor	\$0
<b>Dining or Work Surfaces</b>												
47	Alderman Chambers	1		Dining or Work Surfaces	Work Surface

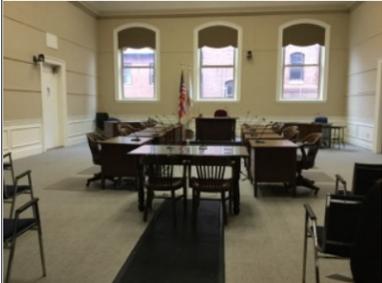
Knee or toe clearance not provided	24"	Provide at least one dining or work surface with 27" min. knee and toe clearance.	1	700	\$700
<b>Toilet &amp; Bathing Rooms</b>												
<b>Overall Access</b>												
48	Men's Toilet Room	2		Overall Access	Toilet Room

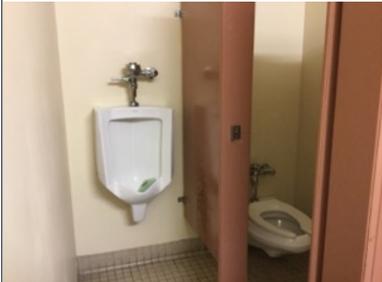
Turning space not provided Accessible plumbing fixtures or stalls not provided	- -	Renovate toilet room to provide turning space. Provide one accessible wheelchair compartment. Ensure urinal is mounted 17" max. above the finished floor.	1	-	\$0

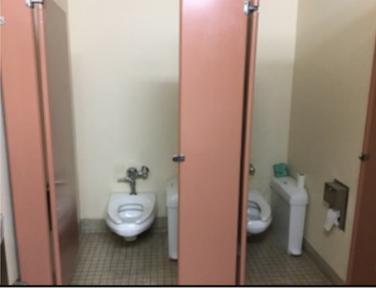
ID	Location	Floor	Room	Element	Type	Photo	Issues	Current Measure	Recommendations	Quantity	Price	Cost Estimation
49	Women's Toilet Room	2		Overall Access	Toilet Room

Turning space not provided Accessible plumbing fixtures or stalls not provided	- -	Renovate toilet room to provide turning space. Provide one accessible wheelchair compartment.	1	-	\$0
<b>Lavatory</b>												
50	Women's Toilet Room	1		Lavatory

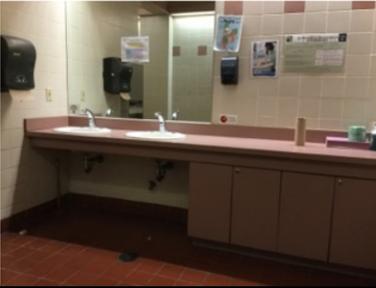
Plumbing underneath is exposed		Insulate or otherwise configure pipes to prevent contact for at least one lavatory.	1	92	\$92
51	Men's Toilet Room	1		Lavatory	N/A

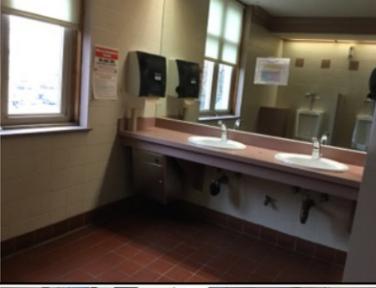
Plumbing underneath is exposed	-	Insulate or otherwise configure pipes to prevent contact for at least one lavatory.	1	92	\$92
52	Men's Toilet Room	2		Lavatory	N/A

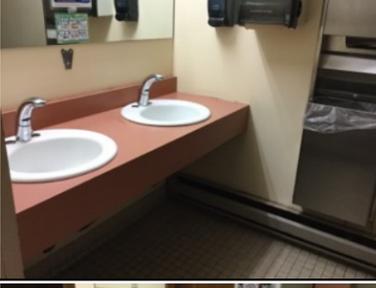
Plumbing underneath is exposed	-	Insulate or otherwise configure pipes to prevent contact for at least one lavatory.	1	-	\$0
53	Women's Toilet Room	2		Lavatory	N/A

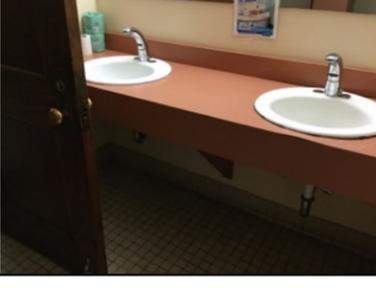
Plumbing underneath is exposed	-	Insulate or otherwise configure pipes to prevent contact for at least one lavatory.	1	-	\$0

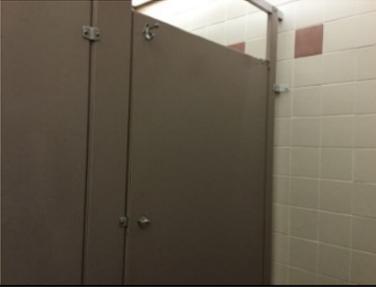
ID	Location	Floor	Room	Element	Type	Photo	Issues	Current Measure	Recommendations	Quantity	Price	Cost Estimation
<b>Toilet Compartment</b>												
54	Women's Toilet Room	1		Toilet Compartment	Accessible Compartment

Door has malfunctioning self-closing hinge Coat hook > 48" (2010 ADA) Door pull not provided	- 67" -	Repair hinge. Locate the coat hook no higher than 48" above the finished floor. Provide a door pull on each side of the door between 34" to 48" above the finished floor that does not require tight grasping, pinching or twisting of the wrist.	1	220	\$220
55	Men's Toilet Room	1		Toilet Compartment	Accessible Compartment

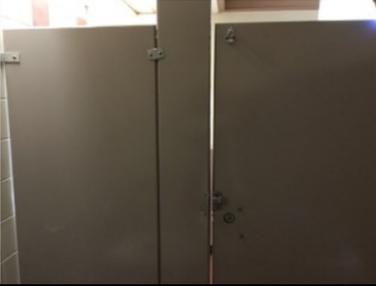
Door has malfunctioning self-closing hinge Coat hook > 48" (2010 ADA) Door pull not provided	70"	Repair hinge. Locate the coat hook no higher than 48" above the finished floor. Provide a door pull on each side of the door between 34" to 48" above the finished floor that does not require tight grasping, pinching or twisting of the wrist.	1	220	\$220

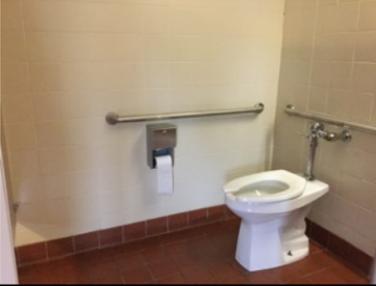
56	Men's Toilet Room	1		Toilet Compartment	Accessible Compartment

Flush control not on open side Centerline < or > 18" (MAAB) Clearance at toilet < 60" clear width	18" 59" 21"	Provide the flush control on the open side of the toilet (transfer side). Provide a wheelchair accessible compartment that is 60" wide min. Relocate toilet so the centerline is 18" from the side wall.	1	3202	\$3202
57	Women's Toilet Room	1		Toilet Compartment

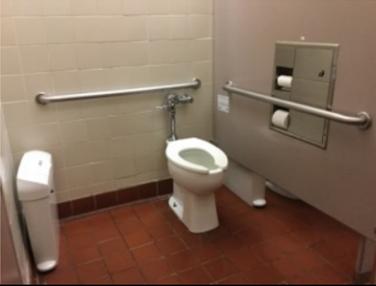
Clearance at toilet < 60" clear width Centerline < or > 18" (MAAB)	58" 15"	Provide a wheelchair accessible compartment that is 60" wide min. Relocate toilet so the centerline is 18" from the side wall.	1	2828	\$2828
<b>Urinal</b>												
58	Men's Toilet Room	1		Urinal	N/A

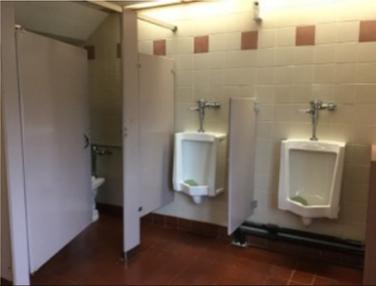
Rim > 17" high	21.7"	Provide at least one urinal with the rim no higher than 17" above the finished floor.	1	3248	\$3248
<b>Additional Access</b>

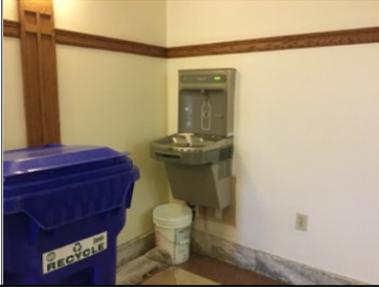
ID	Location	Floor	Room	Element	Type	Photo	Issues	Current Measure	Recommendations	Quantity	Price	Cost Estimation
<b>Drinking Fountains</b>												
59	By Retirement Office	1		Drinking Fountains	High

No drinking fountain provided for seated users	-	Provide an additional drinking fountain for seated users or install a Hi-Lo drinking fountain.	1	4028	\$4028
60	By Elevator	2		Drinking Fountains	High

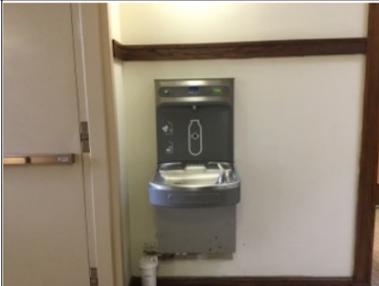
No drinking fountain provided for seated users	-	Provide an additional drinking fountain for seated users or install a Hi-Lo drinking fountain.	1	4028	\$4028
61	By Building Commissioner	B		Drinking Fountains	High

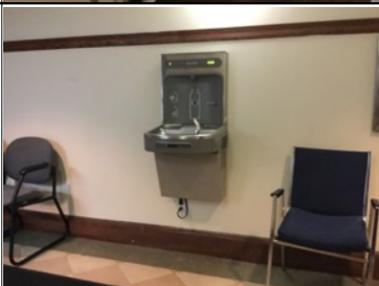
No drinking fountain provided for seated users	-	Provide an additional drinking fountain for seated users or install a Hi-Lo drinking fountain.	1	4028	\$4028
<b>Best Practice</b>												
<b>Parking</b>												
62	Between City Hall and Central Fire Station - Northeast Side	Ext.		Parking	N/A

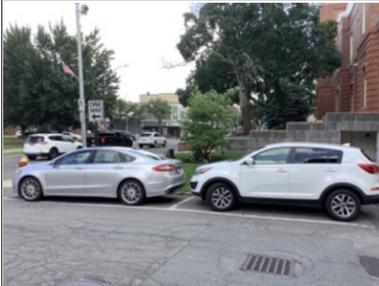
Recommend making one of the parking spaces an accessible parking space. Provide a sign with the International Symbol of Accessibility (ISA).	1	-	\$0

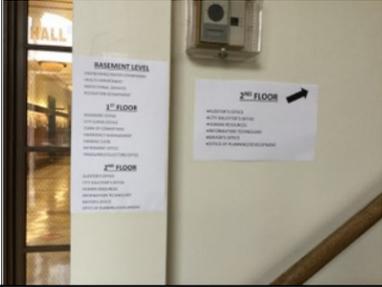
ID	Location	Floor	Room	Element	Type	Photo	Issues	Current Measure	Recommendations	Quantity	Price	Cost Estimation
<b>Signage</b>												
63	By Cassidy Conference Room	1		Signage	N/A

Recommend locating these directional signs near the elevator or near the accessible entrances.	1	-	\$0
64	By Engineering Department	B		Signage	N/A

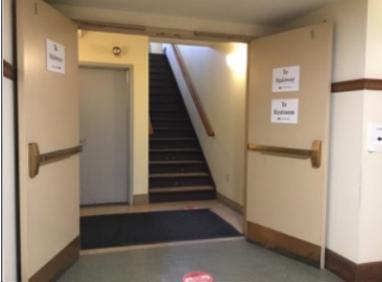
Recommend locating the signs on the wall so a person coming down the stairs is able to see the directional signs.	1	-	\$0
<b>Stairs</b>												
65	Essex Street Entrance	Ext.		Stairs	N/A
