# ADA Self-Evaluation and Transition Plan for the City of Melrose

Part 2 of 2

## Part 2: Reports:

January, 2023

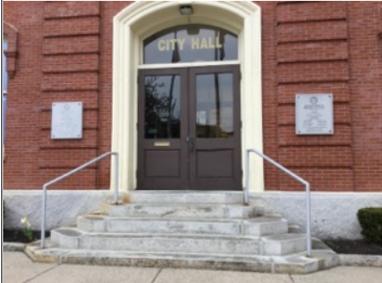
Recommend providing contrasting color strips at the edge of each step at the exterior and the interior stairs.	1	-	\$0

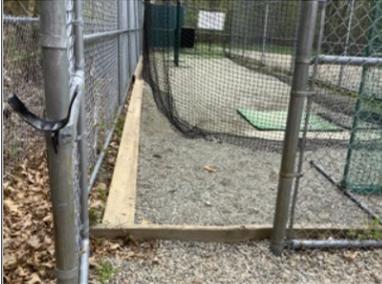
ID	Location	Floor	Room	Element	Type	Photo	Issues	Current Measure	Recommendations	Quantity	Price	Cost Estimation
<b>Approach and Entrance</b>												
<b>Exterior Access Route</b>												
1	Bullpen and Batting Cage Area	Ext.		Exterior Access Route	Exterior

Level changes > 1/4"	2"	Alter the change in level to be 1/4" high max.	1	-	\$0
2	Ravine Terrace Entry	Ext.		Exterior Access Route	Walkway

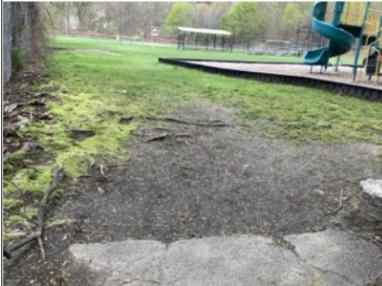
Level changes > 1/4" Surface is not stable, firm, and slip-resistant	2" -	Alter the change in level to be 1/4" high max. Repair the surface. Ensure an accessible route is provided from the Ravine Terrace entry point, along this path and connecting to all park amenities.	1	-	\$0
3	Ravine Terrace Entry	Ext.		Exterior Access Route	Walkway

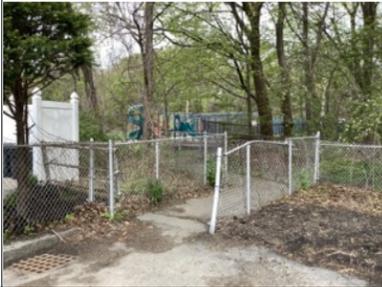
Route not maintained in operable working condition	-	Ensure that the accessible route is maintained in operable working condition.	1	-	\$0
4	Bullpen and Batting Cage Area	Ext.		Exterior Access Route	Exterior

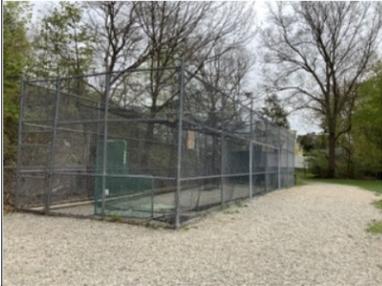
Accessible route not provided	-	Ensure an accessible route is provided to the bullpen and batting cage area.	1	-	\$0

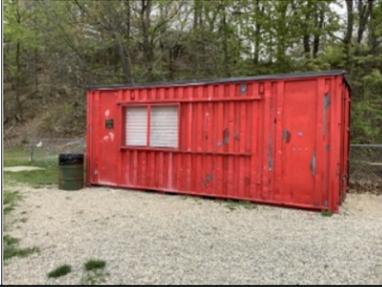
ID	Location	Floor	Room	Element	Type	Photo	Issues	Current Measure	Recommendations	Quantity	Price	Cost Estimation
<b>Service Counter</b>												
5	Concession Stand	Ext.		Service Counter	N/A

Not connected to a accessible route Counter > 36" high	- 45"	Ensure that the counter is connected to an accessible route. Provide a counter that is 36" max. above the ground.	1	-	\$0
<b>Bike Racks</b>												
6	Bike Rack	Ext.		Bike Racks	N/A

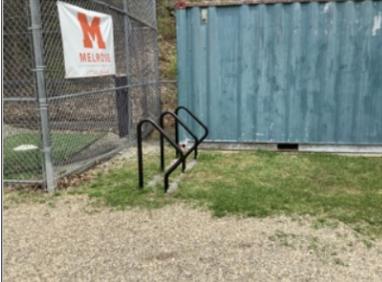
Bike rack is not connected to an accessible route	-	Ensure the bike rack is connected to an accessible route.	1	-	\$0
<b>Toilet &amp; Bathing Rooms</b>												
<b>Portable Toilet</b>												
7	Portable Toilet by Conant Street Entry	Ext.		Portable Toilet	N/A

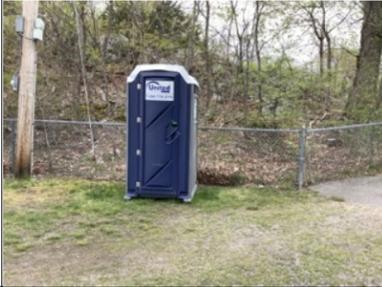
Not located on an accessible route Accessible portable toilets not provided	- -	Locate portable toilet on an accessible route. Ensure that at least 5% of portable toilets (with a minimum of one) are accessible.	1	-	\$0

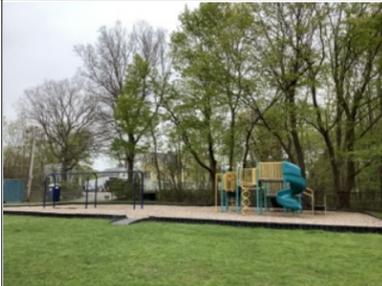
<b>Play and Sport Areas</b>												
<b>Play Areas</b>												
8	Playground	Ext.		Play Areas	N/A

Accessible route not provided around playground Accessible route not provided at play components Surface not stable, firm, and slip-resistant	- - -	Install an accessible route to and around the playground. Provide a compliant impact-attenuating surface under and around the play components.	1	-	\$0

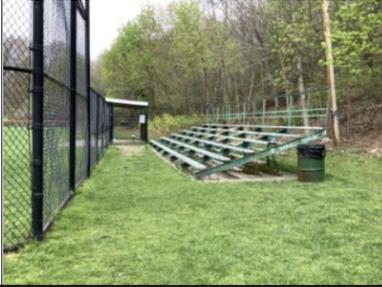
ID	Location	Floor	Room	Element	Type	Photo	Issues	Current Measure	Recommendations	Quantity	Price	Cost Estimation
<b>Field</b>												
9	Baseball Fan Bleacher Seating	Ext.		Field	Baseball

Accessible spaces not provided at sidelines seating Not connected to an accessible-route	- -	Provide a 36" x 60" stable and firm clear floor space at sideline seating positioned so a visitor using a wheeled mobility device can sit with his or her shoulders aligned with someone sitting at the end of the lowest row of the bleachers. Also provide a stable and firm accessible route to the sideline seating bleachers. Provide an accessible route to the boundary of sport activity at the baseball field.	1	-	\$0
10	First and Third Base Dugouts	Ext.		Field	Baseball

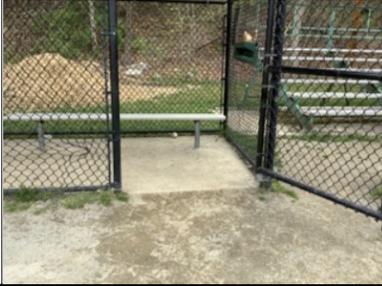
Not connected to an accessible-route	2"	Provide an accessible route to the field. (Maintain transition from dugouts to field so that the change in level when entering or exiting the dugout is not greater than 1/4".)	2	-	\$0

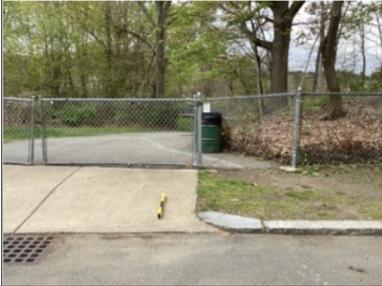
<b>Best Practice</b>												
<b>Entry</b>												
11	Conant Street Entry	Ext.		Entry	N/A

Recommend providing a sign indicating that an accessible entrance to the field can be found off Ravine Terrace and including this information on municipal websites as well.	1	-	\$0

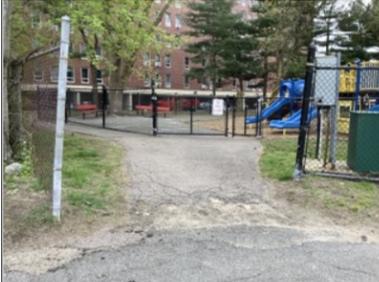
ID	Location	Floor	Room	Element	Type	Photo	Issues	Current Measure	Recommendations	Quantity	Price	Cost Estimation
<b>Approach and Entrance</b>												
<b>Exterior Access Route</b>												
1	Route to Playground Main Entry	Ext.		Exterior Access Route	Walkway

Route not maintained in operable working condition	-	Ensure that the accessible route to the playground is maintained in operable working condition.	1	-	\$0
2	Right Entry From Parking Lot to Open Field	Ext.		Exterior Access Route	N/A

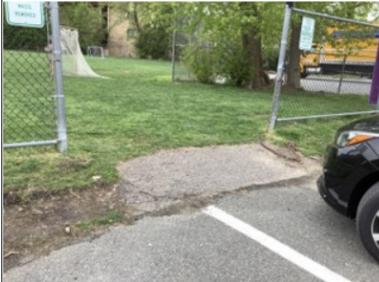
Route not maintained in operable working condition Accessible route not provided	- -	Ensure that the accessible route is maintained in operable working condition. Ensure an accessible route is provided from the parking area to a path connecting to the boundary of sport activity at the open field and to the playground entry.	1	-	\$0
<b>Off-Street Parking Lot or Garage</b>												
3	Parking Lot	Ext.		Off-Street Parking Lot or Garage	Visitor

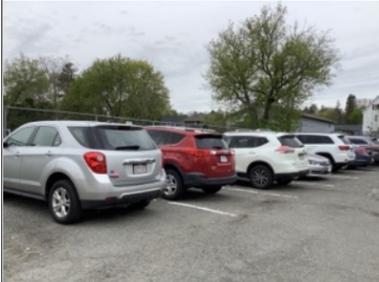
Total # of parking Total # of designated accessible parking spaces Total # of designated van accessible spaces Access aisle not provided Sign not provided Sign does not have the designation "Van Accessible"	37 - - - -	Provide one compliant van and one compliant standard accessible parking space. Provide a marked access aisle that is at least 96" wide at the van accessible space and at least 60" wide at the standard accessible space. Provide a sign with the International Symbol of Accessibility (ISA) at both spaces. Add the designation "Van Accessible" to the sign located at the van accessible space.	1	-	\$0

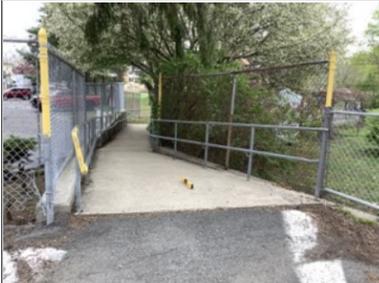
<b>Access to Goods and Services</b>												
<b>Ramps</b>												
4	Top of Ramp to Playground	Ext.		Ramps	Exterior

Handrails do not extend 12" past top & bottom Landing has a slope > 1:50 (2.00%) (MAAB) Edge protection < 4" high	10.3% - 5.6% -	Alter handrails to extend horizontally above the landing for 12" min. beyond the top ramp run. Alter so that the slope in all directions is no greater than 1:50 (2.00%) at the ramp landing. Provide edge protection on the right side of the ramp as shown in this image that prevents the passage of a 4" diameter sphere.	1	-	\$0

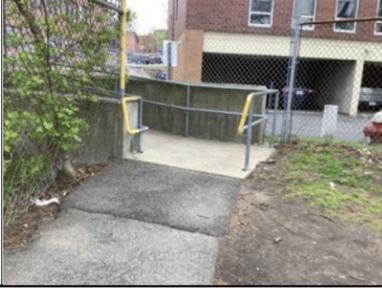
ID	Location	Floor	Room	Element	Type	Photo	Issues	Current Measure	Recommendations	Quantity	Price	Cost Estimation
5	Bottom of Ramp to Playground	Ext.		Ramps	Exterior

Not maintained in operable working condition	1" 1"	Ensure that the ramp is maintained in operable working condition. (Reduce change in level where ramp landing transitions to the walkway to 1/2 in max. beveled of 1/4" max. if the transition is not beveled.)	1	-	\$0
<b>Bike Racks</b>												
6	Near Center Entry at Parking Lot	Ext.		Bike Racks	N/A

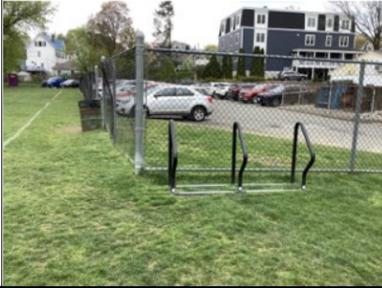
Bike rack is not connected to an accessible route	-	Ensure bike rack is connected to an accessible route.	1	-	\$0
<b>Play and Sport Areas</b>												
<b>Play Areas</b>												
7	Playground	Ext.		Play Areas	N/A

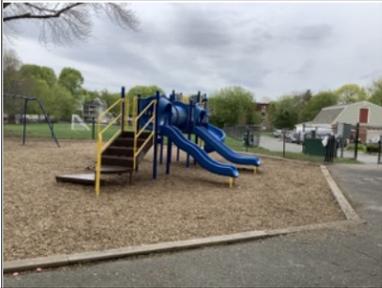
Accessible route not provided around playground Accessible route not provided at play components Not connected to an accessible route Surface not stable, firm, and slip-resistant	- - 2" -	Install an accessible route to and around all sides of the playground. Provide a compliant impact-attenuating surface under and around the play components. Provide an accessible route to play areas.	1	-	\$0

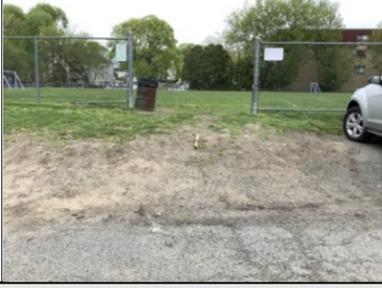
<b>Field</b>												
8	Center Entry from Parking Lot to Open Field	Ext.		Field	Soccer

Trash container not connected to an accessible route Not connected to an accessible-route	16% -	Ensure trash container is located on an accessible route. Provide an accessible route to the boundary of sport activity at the open field and to the entry point at the playground.	1	-	\$0
<b>Best Practice</b>

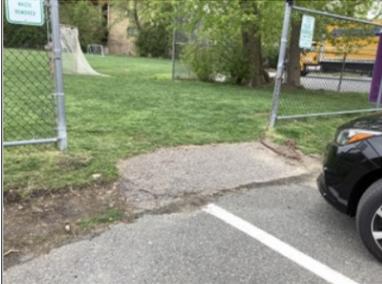
ID	Location	Floor	Room	Element	Type	Photo	Issues	Current Measure	Recommendations	Quantity	Price	Cost Estimation
<b>Park Entry</b>												
9	Right Entry From Parking Lot to Open Field	Ext.		Park Entry	N/A

Recommend putting striping at the parking space that is directly in front of a park entry point (located on the right side of the parking lot when facing the park) so cars do not park in front of and blocking the entry point.	1	-	\$0

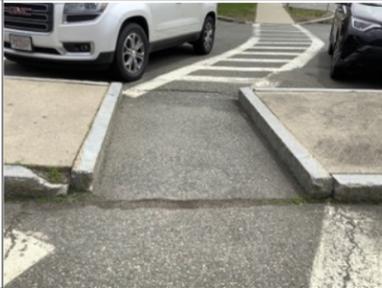
ID	Location	Floor	Room	Element	Type	Photo	Issues	Current Measure	Recommendations	Quantity	Price	Cost Estimation
<b>Approach and Entrance</b>												
<b>Exterior Access Route</b>												
1	Accessible Parking in Municipal Lot	Ext.		Exterior Access Route	Sidewalk

Route not maintained in operable working condition	-	Ensure the accessible route is maintained in operable working condition.	1	-	\$0
2	Route to Accessible Parking by Stage Door	Ext.		Exterior Access Route	Sidewalk

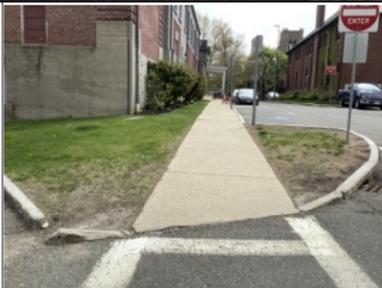
Route not maintained in operable working condition	-	Ensure the accessible route is maintained in operable working condition.	1	-	\$0
3	Main Street - Towards Accessible Entrance	Ext.		Exterior Access Route	Sidewalk

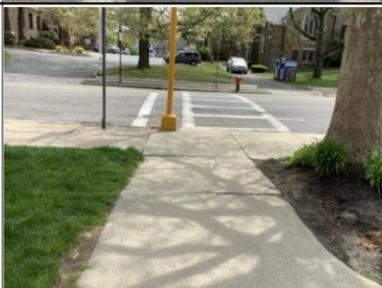
Route not maintained in operable working condition	-	Ensure the accessible route is maintained in operable working condition.	1	-	\$0
<b>Off-Street Parking Lot or Garage</b>												
4	Parking by Stage Door	Ext.		Off-Street Parking Lot or Garage	Visitor

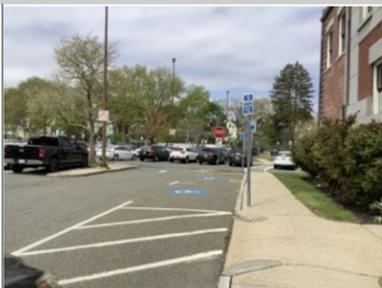
Total # of designated accessible parking spaces Access aisle not provided Sign does not have the designation "Van Accessible"	2 - -	Provide a marked access aisle that is at least 60" wide. Add the designation "Van Accessible" to the sign located at the van accessible space.	1	-	\$0

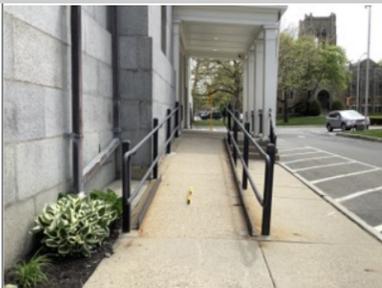
<b>Exterior Ramp</b>												
5	Towards Main Entrance	Ext.		Exterior Ramp	N/A

Running slope > 1:12 (8.33%) Cross slope of ramp > 1:50 (2.00%)	12.8% 5.6%	Reduce running slope to be no steeper than 1:12 (8.33%). Reduce cross slope to be no steeper than 1:50 (2.00%).	1	-	\$0

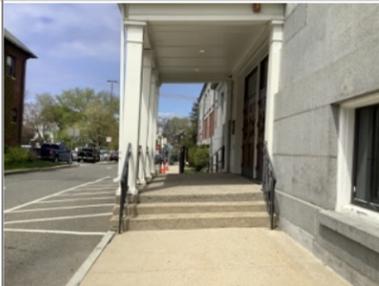
ID	Location	Floor	Room	Element	Type	Photo	Issues	Current Measure	Recommendations	Quantity	Price	Cost Estimation
<b>Exterior Stair</b>												
6	Towards Main Entrance From Main Street	Ext.		Exterior Stair	N/A

Handrails do not extend 12" from stair Cross section of handrail is not compliant	- -	Top: Ensure handrails extend horizontally above the landing for 12" min. beginning above the first riser nosing. Bottom: Ensure that the sloped bottom extension extends one tread depth min. beyond last riser nosing in same direction as stair flight. Provide handrails with 1 1/4" - 2" circular cross sections or 4"- 6 1/4" non-circular cross sections.	1	-	\$0
7	Driveway/Deliveries	Ext.		Exterior Stair	N/A

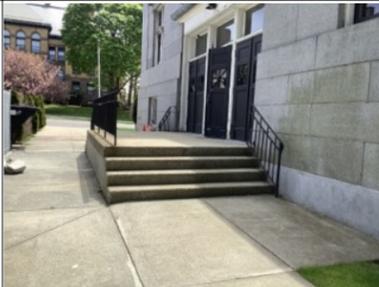
Handrails do not extend 12" from stair Handrail not provided on both sides	- -	Top: Ensure handrails extend horizontally above the landing for 12" min. beginning above the first riser nosing. Bottom: Ensure that the sloped bottom extension extends one tread depth min. beyond last riser nosing in same direction as stair flight. Provide a handrail on one side. Recommendation applies to both sides of the stairs.	1	-	\$0

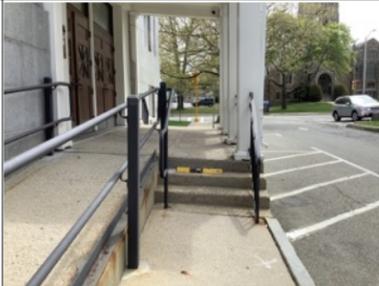
8	Towards Main Entrance	Ext.		Exterior Stair	N/A

Not maintained in operable working condition	-	Reduce cross slope to be no steeper than 1:50 (2.00%) to ensure stairs are maintained in operable working condition.	1	-	\$0
9	Right Stage Egress	Ext.		Exterior Stair	N/A

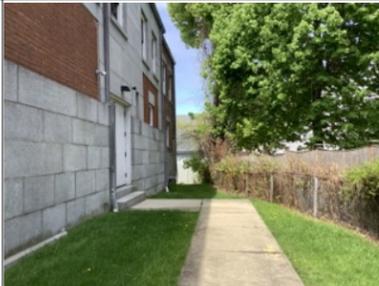
Handrails not provided	-	Provide handrail on one side.	1	-	\$0
10	Exit Stage Doors	Ext.		Exterior Stair	N/A

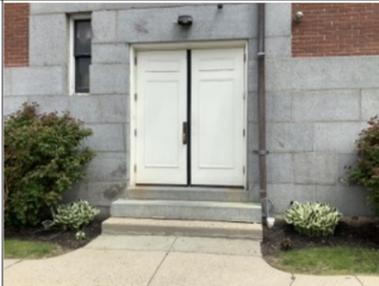
Handrails not provided	-	Provide handrail on both sides.	1	-	\$0

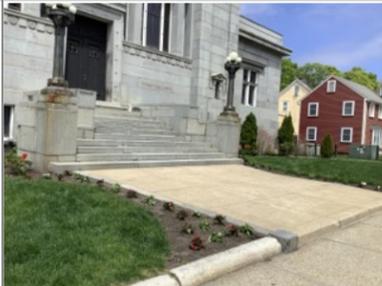
ID	Location	Floor	Room	Element	Type	Photo	Issues	Current Measure	Recommendations	Quantity	Price	Cost Estimation
<b>Entrance</b>												
11	Main Street	Ext.		Entrance	Other

Entrance not on an accessible route Directional sign to accessible entrance not provided	- -	Provide a directional sign indicating the location of the nearest accessible entrance.	1	-	\$0
12	Driveway/ Deliveries	Ext.		Entrance	Other

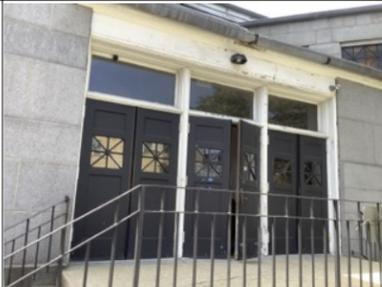
Entrance not on an accessible route Directional sign to accessible entrance not provided	- -	Provide a directional sign indicating the location of the nearest accessible entrance.	1	-	\$0
13	Main Entrance	Ext.		Entrance	Main Entrance

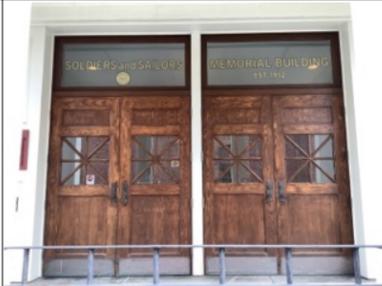
International Symbol of Accessibility not provided Threshold > 3/4" high	- 1"	Provide a sign with the International Symbol of Accessibility (ISA). Alter threshold to be 3/4" high max.	1	-	\$0
14	Main Entrance	Ext.		Entrance	Main Entrance

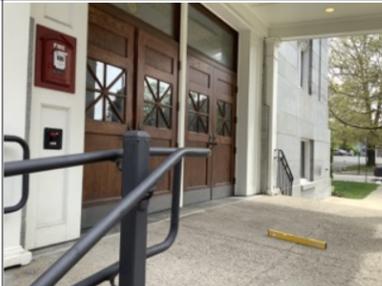
Maneuvering clearance at door > 1:50 (2.00%)	6%	Provide an automatic door opener.	1	-	\$0

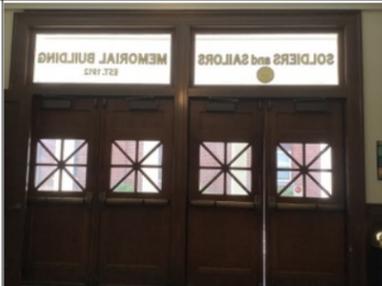
15	Main Entrance	L		Entrance	Other

Door requires > 15 lbs. of force to open	20 lbs	Adjust closers so doors do not require more than 15 pounds of force.	1	Labor	\$0

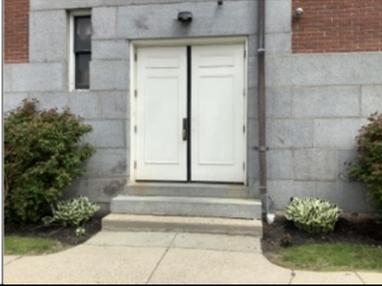
ID	Location	Floor	Room	Element	Type	Photo	Issues	Current Measure	Recommendations	Quantity	Price	Cost Estimation
<b>Emergency Exit</b>												
16	Exit Stage Doors	Ext.		Emergency Exit	112

Directional sign to accessible entrance not provided	-	Provide a directional sign indicating the location of the nearest accessible entrance.	1	-	\$0
<b>Access to Goods and Services</b>												
<b>Means of Egress</b>												
17	Egress From South Stage	1		Means of Egress	N/A

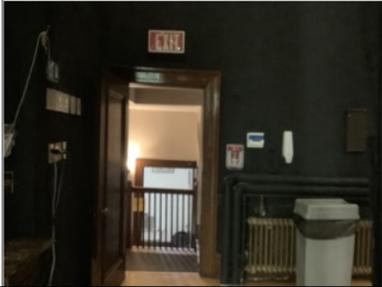
Tactile exit sign not provided Directional sign to accessible emergency exit not provided	- -	Ensure tactile exit signs with raised characters and braille are provided at exit doors. Mount signs between 48"- 60" above the finished floor located on the latch side of the door. Provide a directional sign indicating the location of the nearest accessible emergency exit.	1	464	\$464
18	GAR Room - Exit to Main Street Egress	1		Means of Egress	N/A

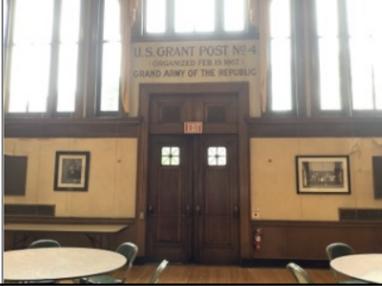
Tactile exit sign not provided Directional sign to accessible emergency exit not provided		Ensure tactile exit signs with raised characters and braille are provided at exit doors. Mount signs between 48"- 60" above the finished floor located on the latch side of the door. Provide a directional sign indicating the location of the nearest accessible emergency exit.	1	464	\$464

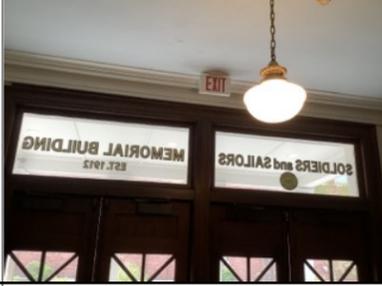
19	Front Lobby Main Entrance	L		Means of Egress	N/A

Tactile exit sign not provided Illuminated ISA symbol not provided (MAAB)	- -	Ensure tactile exit signs with raised characters and braille are provided at exit doors. Mount signs between 48"- 60" above the finished floor located on the latch side of the door. Provide an illuminated sign with the International Symbol of Accessibility (ISA).	1	432	\$432
20	North Egress Door, Near North Stage	L		Means of Egress	N/A

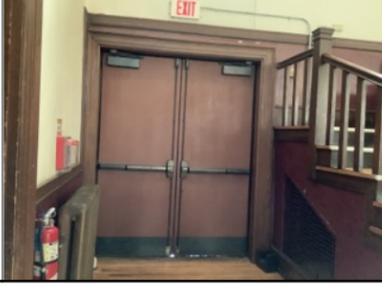
Tactile exit sign not provided Threshold > 3/4" high Directional sign to accessible emergency exit not provided	- 1"	Ensure tactile exit signs with raised characters and braille are provided at exit doors. Mount signs between 48"- 60" above the finished floor located on the latch side of the door. Alter the threshold to be 3/4" high max. Provide a directional sign indicating the location of the nearest accessible emergency exit.	1	614	\$614

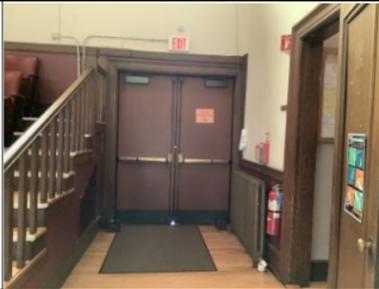
ID	Location	Floor	Room	Element	Type	Photo	Issues	Current Measure	Recommendations	Quantity	Price	Cost Estimation
21	South Egress Door	L		Means of Egress	N/A

Tactile exit sign not provided Directional sign to accessible emergency exit not provided	- -	Ensure tactile exit signs with raised characters and braille are provided at exit doors. Mount signs between 48"- 60" above the finished floor located on the latch side of the door. Provide a directional sign indicating the location of the nearest accessible emergency exit.	1	464	\$464
22	Driveway/ Deliveries Egress Door	L		Means of Egress	N/A

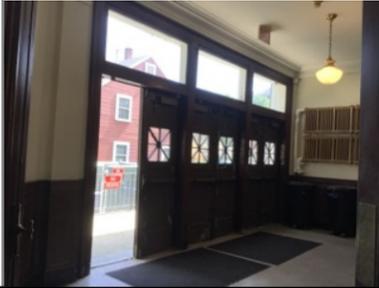
Tactile exit sign not provided Directional sign to accessible emergency exit not provided	- -	Ensure tactile exit signs with raised characters and braille are provided at exit doors. Mount signs between 48"- 60" above the finished floor located on the latch side of the door. Provide a directional sign indicating the location of the nearest accessible emergency exit.	1	464	\$464

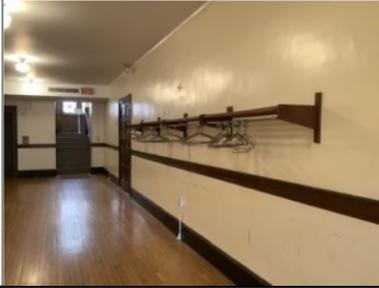
<b>Interior Access Route</b>												
23	Lower Lobby	Basement		Interior Access Route	N/A

Obstructed by protruding objects	12.5"	Provide a cane-detectable barrier on both sides.	2	256	\$512
24	Dressing Room - North Stage	L		Interior Access Route	N/A

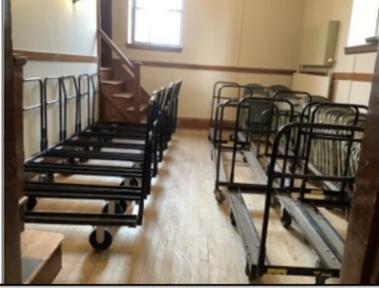
Accessible route not provided	-	Provide an accessible route.	1	-	\$0
<b>Doors, Doorways, &amp; Gates</b>												
25	Dressing Room Towards Toilet Room	L		Doors, Doorways, & Gates	Circulation

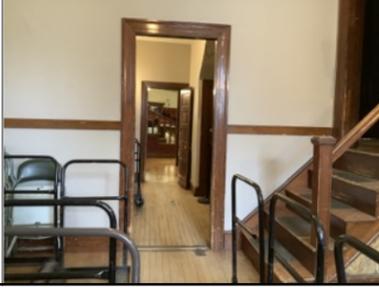
Clear width at door < 32" Hardware not operable with a closed fist	31" -	Install offset hinges to ensure that the door has a clear width of 32 inches. Provide hardware that can be operable with one hand and not require tight grasping, pinching, or twisting of the wrist.	1	2716	\$2716

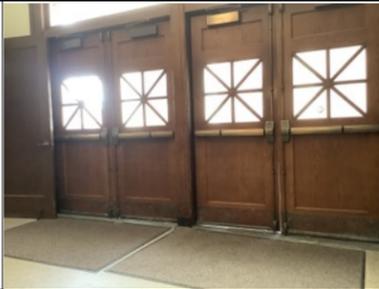
ID	Location	Floor	Room	Element	Type	Photo	Issues	Current Measure	Recommendations	Quantity	Price	Cost Estimation
26	Main Entrance	L		Doors, Doorways, & Gates	Vestibule

Mat not securely attached	-	Secure the mat to prevent tripping hazard.	1	Labor	\$0
27	To Office & South Stage	L		Doors, Doorways, & Gates	Assembly Space

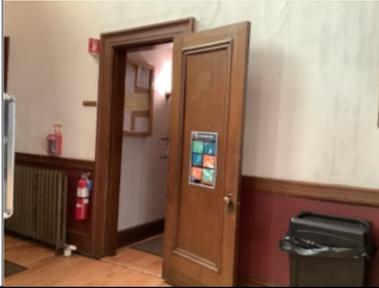
Threshold not beveled Threshold > 1/2" high Hardware not operable with a closed fist	- 1.5" -	Bevel the threshold. Alter the threshold to be 1/2" high max. Provide hardware that can be operable with one hand and not require tight grasping, pinching, or twisting of the wrist.	1	784	\$784
28	Single-User Toilet Room - North Stage	L		Doors, Doorways, & Gates	Toilet Room

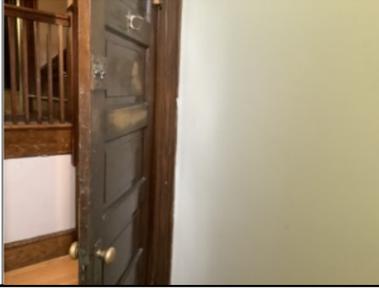
Hardware not operable with a closed fist	-	Provide hardware that can be operable with one hand and not require tight grasping, pinching, or twisting of the wrist.	1	484	\$484
<b>Ramps</b>

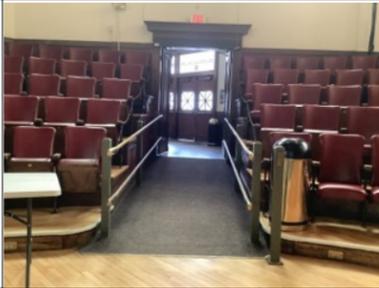
29	Main Floor	L		Ramps	Interior

Handrails do not extend 12" past top & bottom	-	Alter handrails to extend horizontally above the landing for 12" min. beyond the top and bottom of ramp runs.	2	-	\$0
<b>Stairways</b>												
30	Lower Lobby to Deliveries/ Driveway	Basement		Stairways	Egress

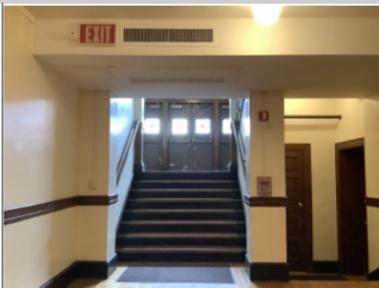
Handrails do not extend 12" from stairs Handrails have non-compliant cross section	- -	Top: Ensure handrails extend horizontally above the landing for 12" min. beginning above the first riser nosing. Bottom: Ensure handrails extend to one tread depth beyond the last riser. Provide handrails with 1 1/4" - 2" circular cross sections.	1	-	\$0

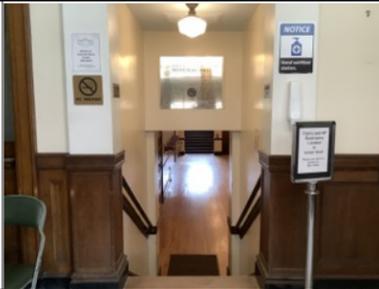
ID	Location	Floor	Room	Element	Type	Photo	Issues	Current Measure	Recommendations	Quantity	Price	Cost Estimation
31	Front Lobby to Lower Lobby	L		Stairways	Other

Handrails do not extend 12" from stairs	-	Top: Ensure handrails extend horizontally above the landing for 12" min. beginning above the first riser nosing. Bottom: Ensure handrails extend to one tread depth beyond the last riser.	1	-	\$0
32	Stairs to South Stage	L		Stairways	Other

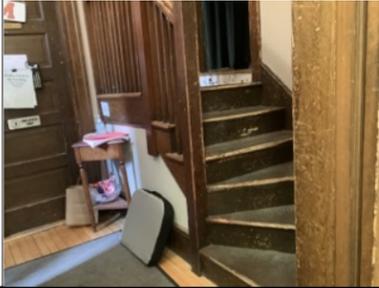
Handrails do not extend 12" from stairs Handrails have non-compliant cross section Handrail not provided on both sides	- - -	Provide handrail on one side. Top: Ensure handrails extend horizontally above the landing for 12" min. beginning above the first riser nosing. Bottom: Ensure handrails extend to one tread depth beyond the last riser. Provide handrails with 1 1/4" - 2" circular cross sections.	1	-	\$0
<b>Platform Lift or LULA Elevator</b>

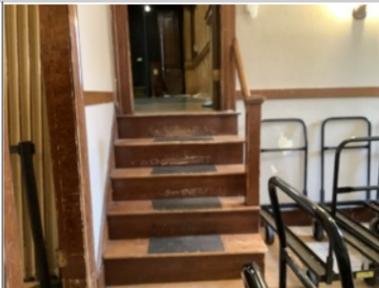
33	To North Stage From Main Stage	L		Platform Lift or LULA Elevator	Interior

Recommended location for accessible lift for stage access.	1	-	\$0
<b>Elevator</b>												
34	Elevator	1		Elevator	Interior

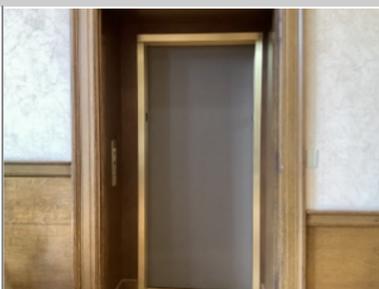
Hoistway signs < 48" > 60"	62"	Install hoistway signs on the inside of the door frame 60" above the finished floor.	1	Labor	\$0
<b>Signage</b>												
35	Women's Toilet Room	Basement		Signage	Designation

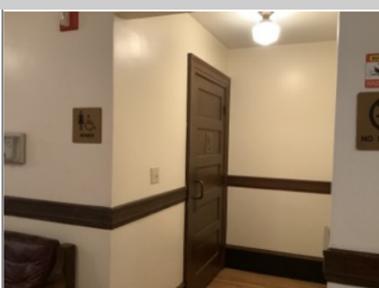
Sign not located on the latch side of the door	-	Locate sign at permanent rooms alongside the door on the latch side.	1	Labor	\$0

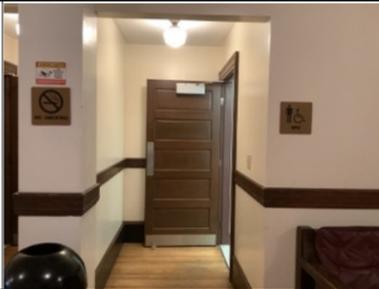
ID	Location	Floor	Room	Element	Type	Photo	Issues	Current Measure	Recommendations	Quantity	Price	Cost Estimation
36	Men's Toilet Room	Basement		Signage	Designation

Sign not located on the latch side of the door Signage lacks 18" by 18" clear floor space	- -	Locate the sign at permanent rooms alongside the door on the latch side. Relocate couch to ensure the required 18" min. by 18" min. clear floor space is maintained at the designation sign.	1	Labor	\$0
37	Single-User Toilet Room - North Stage	L		Signage	Designation

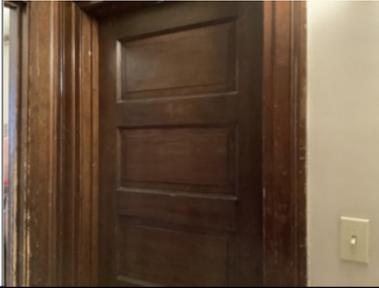
Signage is not provided Directional sign to access toilet not provided	- -	Locate compliant signage alongside the door on the latch side. Install a sign indicating the location of the nearest accessible toilet room.	1	464	\$464
38	To Office & South Stage	L		Signage	Designation

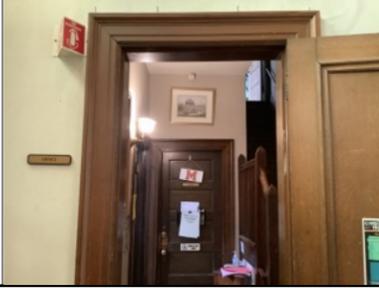
Raised characters not provided on sign Braille not provided on sign	- -	Provide text with raised characters duplicated in braille on sign.	1	232	\$232

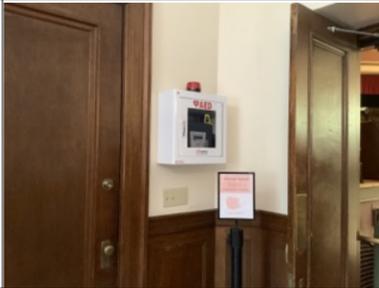
<b>Operable Parts</b>												
39	Front Lobby	L		Operable Parts	Other

Reach < 15" or > 48"(forward/side approach)	63"	Relocate AED so that controls are mounted 48" above the finished floor.	1	256	\$256
<b>Assembly Area</b>												
40	Main Floor	L		Assembly Area	N/A

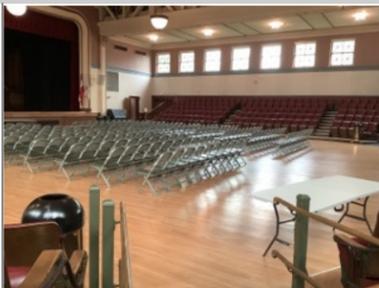
Number of seats Number of designated wheelchair spaces Wheelchair spaces not on accessible route Accessible route to stage not provided Acc. rt. from dressing room to stage not provided Assistive listening devices not provided	434 3 - - -	Six wheelchair spaces plus companion seats are required. Ensure the wheelchair spaces are on an accessible route. Provide an accessible route to the stage or provide an interior lift to the stage. Provide an accessible route between the dressing room and stage or provide an interior lift. If audible communication is integral to the use of the space, provide an assistive listening system.	1	-	\$0

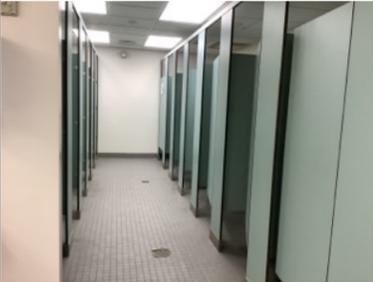
ID	Location	Floor	Room	Element	Type	Photo	Issues	Current Measure	Recommendations	Quantity	Price	Cost Estimation
<b>Overall Access</b>												
41	Women's Toilet Room	Basement		Overall Access	Toilet Room

6 fixtures, but no ambulatory compartment provided	-	Provide one ambulatory accessible compartment.  See ID #46.	1	-	\$0
42	Single-User Toilet Room - North Stage	L		Overall Access	Toilet Room

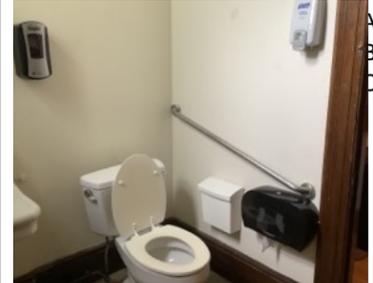
A. Not on an accessible route B. Turning space not provided C. Accessible plumbing fixtures or stalls not provided	- - -	Provide an accessible single-user toilet room.	1	24604	\$24604
<b>Lavatory</b>												
43	Men's Toilet Room	Basement		Lavatory	N/A

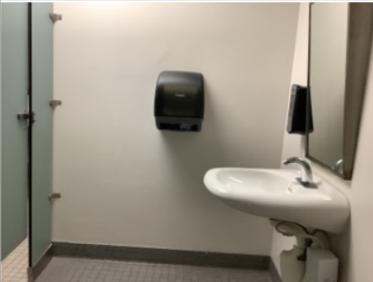
Clear floor space not provided at lavatory	-	Relocate lavatory to ensure a 30" min. by 48" min. clear floor space positioned for a forward approach is provided at the lavatory.	1	-	\$0
44	Women's Toilet Room	Basement		Lavatory	N/A

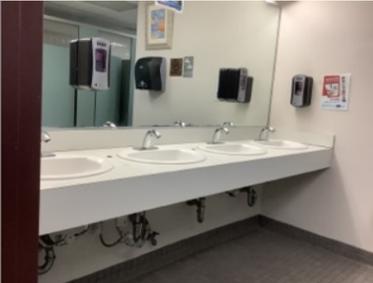
Plumbing underneath is exposed	-	Insulate or otherwise configure pipes to prevent contact for at least one lavatory.	1	92	\$92

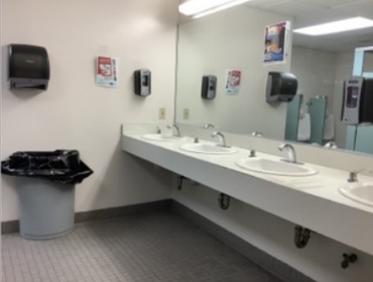
45	Men's Toilet Room	Basement		Lavatory	N/A

Plumbing underneath is exposed	-	Insulate or otherwise configure pipes to prevent contact for at least one lavatory.	1	92	\$92

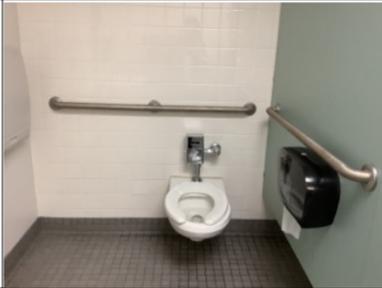
Grab bars not provided	-	Provide one grab bar on the side wall of the water closet and one on the rear wall.	2	898	\$1796
48	Men's Toilet Room	Basement		Toilet Compartment	Accessible Compartment

Clearance at toilet < 60" clear width	57.2"	Relocate partition to ensure the required 60" wide min. is provided.	1	256	\$256
49	Women's Toilet Room	Basement		Toilet Compartment	Accessible Compartment

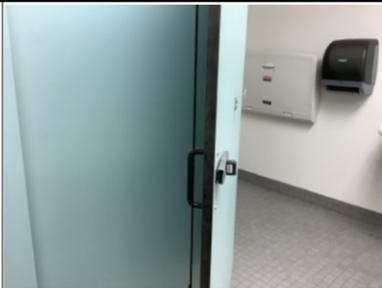
Door pull not provided	-	Provide a door pull on each side of the door between 34" to 48" above the finished floor that does not require tight grasping, pinching or twisting of the wrist.	1	70	\$70

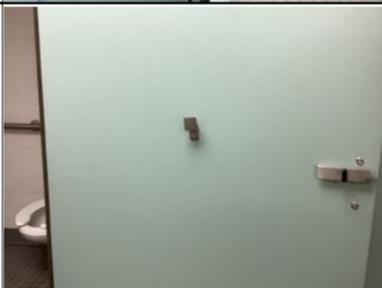
50	Men's Toilet Room	Basement		Toilet Compartment	Accessible Compartment

Door pull not provided	-	Provide a door pull on each side of the door between 34" to 48" above the finished floor that does not require tight grasping, pinching or twisting of the wrist.	1	70	\$70

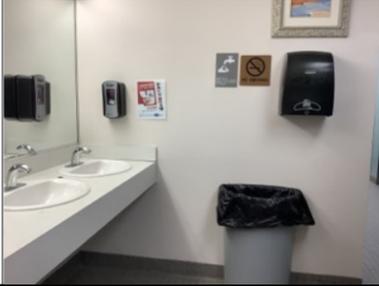
ID	Location	Floor	Room	Element	Type	Photo	Issues	Current Measure	Recommendations	Quantity	Price	Cost Estimation
<b>Dispensers</b>												
51	Women's Toilet Room	Basement		Dispensers	Paper Towel Dispenser

Clear floor space not provided at accessory	-	Relocate trash can to ensure a 30" min. by 48" min. clear floor space is provided.	1	Labor	\$0
52	Men's Toilet Room	Basement		Dispensers	Paper Towel Dispenser

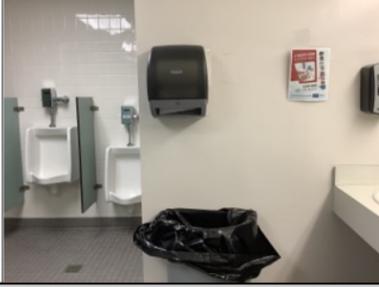
Clear floor space not provided at accessory	-	Relocate trash can to ensure the required clear floor space is provided at the paper towel.	1	Labor	\$0
<b>Baby Changing Table</b>												
53	Women's Toilet Room	Basement		Baby Changing Table	N/A

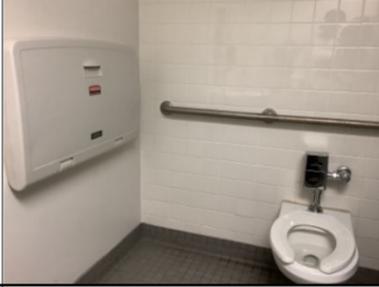
See ID #54.	1		\$0
54	Men's Toilet Room	Basement		Baby Changing Table	N/A

30" x 48" clear floor space not provided	-	Relocate baby changing table to ensure the required 30" min. by 48" min. clear floor space is provided.	1	Labor	\$0

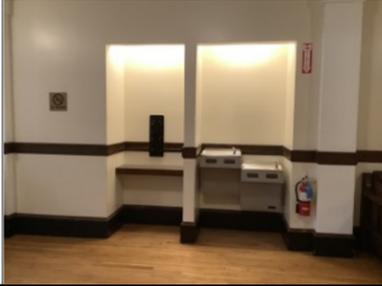
ID	Location	Floor	Room	Element	Type	Photo	Issues	Current Measure	Recommendations	Quantity	Price	Cost Estimation
<b>Drinking Fountains</b>												
56	Lower Lobby	Basement		Drinking Fountains	Hi-Lo

Clear floor space not provided	-	Ensure the 30" by 48" clear floor space positioned for a forward approach is centered on the lower drinking fountain.	1	-	\$0
<b>Best Practice</b>												
57	Main Floor	L

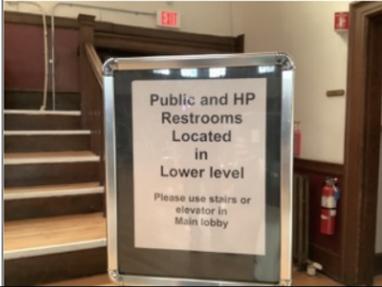
Recommend relocating informational sign to avoid glare.	1	-	\$0
<b>Stairways</b>												
58	Front Lobby to South Parlor & GAR Room	L		Stairways	N/A

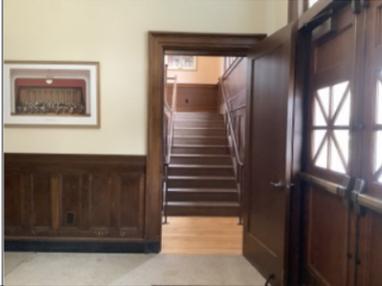
Recommend adding a contrast strip on the stair treads.	1	-	\$0

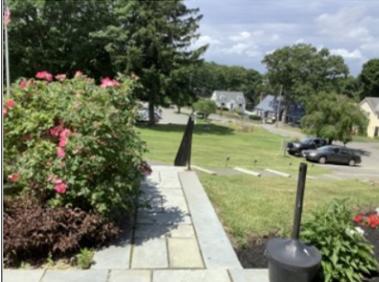
ID	Location	Floor	Room	Element	Type	Photo	Issues	Current Measure	Recommendations	Quantity	Price	Cost Estimation
<b>Approach and Entrance</b>												
<b>Exterior Access Route</b>												
1	Patio	Ext.		Exterior Access Route	Walkway

Exterior route < 36" wide Obstructed by protruding objects	30" -	Ensure that a clear width of 36" min. is maintained at the accessible route. Trim vegetation to maintain a clear 36" wide route.	1	-	\$0
2	Walkway to Pro Shop	Ext.		Exterior Access Route	Walkway

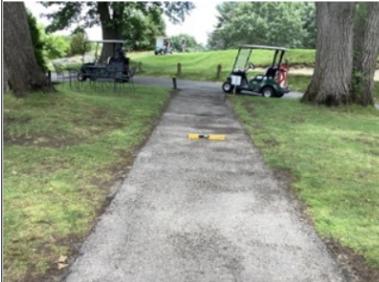
Cross slope > 1:50 (2.00%)	2.5%	Reduce the cross slope to be no steeper than 1:50 (2.00%).	1	-	\$0
3	SW Walkway	Ext.		Exterior Access Route	Walkway

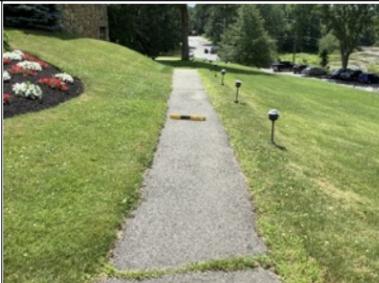
Cross slope > 1:50 (2.00%)	9%	Reduce the cross slope to be no steeper than 1:50 (2.00%).	1	-	\$0
4	Hole 10 East of Pro Shop	Ext.		Exterior Access Route	Walkway

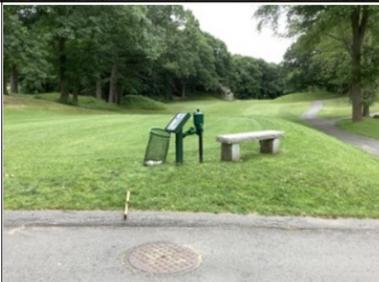
Running slope > 1:20 (5.00%)	21.8%	Reduce the running slope to be no steeper than 1:20 (5.00%).	1	-	\$0

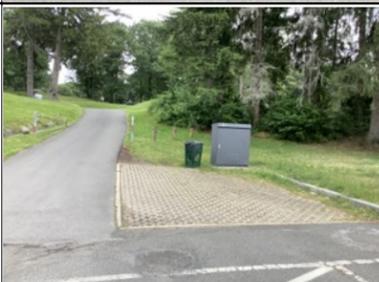
5	By SW Accessible Parking	Ext.		Exterior Access Route	Sidewalk

Level changes > 1/4"	1.5"	Alter change in level to be 1/4" high max.	1	-	\$0

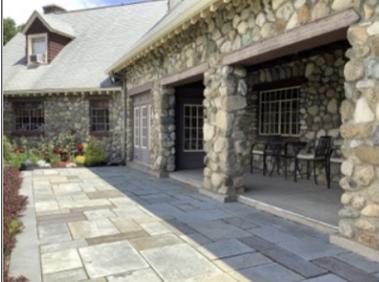
ID	Location	Floor	Room	Element	Type	Photo	Issues	Current Measure	Recommendations	Quantity	Price	Cost Estimation
6	Patio by Large Function Room	Ext.		Exterior Access Route	Walkway

Level changes > 1/4"	5"	Alter the change in level to be 1/4" high max.	1	-	\$0
7	Walkway to Pro Shop	Ext.		Exterior Access Route	Walkway

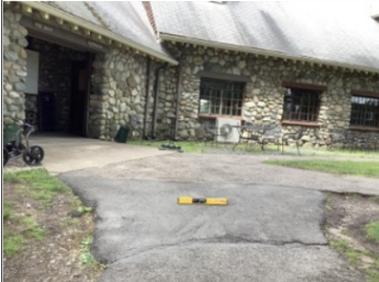
Route not maintained in operable working condition	-	Ensure that the accessible route is maintained in operable working condition.	1	-	\$0
<b>Off-Street Parking Lot or Garage</b>												
8	Parking Lot Southwest Side	Ext.		Off-Street Parking Lot or Garage	Visitor

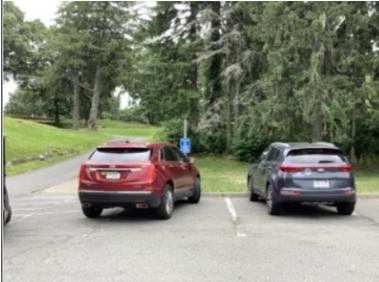
Sign bottom < 60" above finished grade	47.2	Locate sign with the bottom of the sign 60" above the ground.	1	-	\$0
<b>Exterior Ramp</b>												
9	Snack Bar - Southeast Egress	Ext.		Exterior Ramp	198

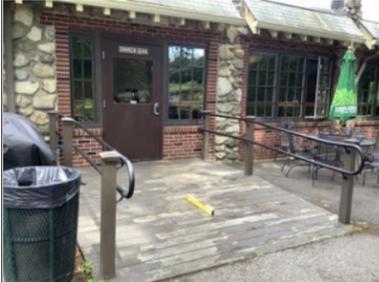
Lower handrails < 18" or > 20" above ramp surface	25"	Provide a lower handrail located between 18" min. - 20" min. high. Ensure extensions are at least 12" long.	1	-	\$0

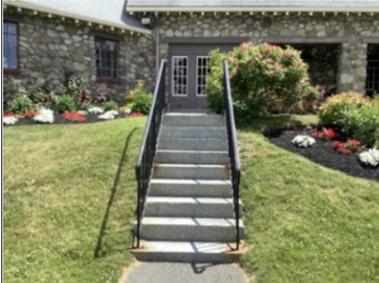
<b>Exterior Stair</b>												
10	To Patio From Parking Lot - Northwest Side	Ext.		Exterior Stair	N/A

Handrails do not extend 12" from stair	-	Top: Ensure handrails extend horizontally above the landing for 12" min. beginning above the first riser nosing. Bottom: Ensure that the sloped bottom extension extends one tread depth min. beyond last riser nosing in same direction as stair flight.	1	-	\$0

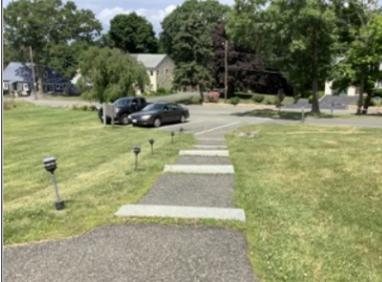
ID	Location	Floor	Room	Element	Type	Photo	Issues	Current Measure	Recommendations	Quantity	Price	Cost Estimation
11	Towards Parking - Southwest Side	Ext.		Exterior Stair	N/A

Handrail not provided on both sides	-	Provide a handrail on one side.	1	-	\$0
12	Towards Parking Lot - West Side	Ext.		Exterior Stair	N/A

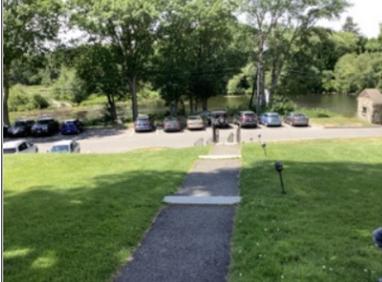
Handrail not provided on both sides	-	Provide handrails on both sides.	1	-	\$0
<b>Entrance</b>												
13	Entrance to Large Function Room	1		Entrance	Main Entrance

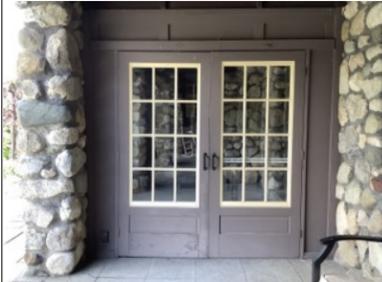
Entrance not on an accessible route Directional sign to accessible entrance not provided	- -	Provide a directional sign indicating the location of the nearest accessible entrance. Provide a portable ramp as needed.	1	-	\$0
14	Small Function Hall, Southwest Egress	Ext.		Entrance	Secondary Entrance

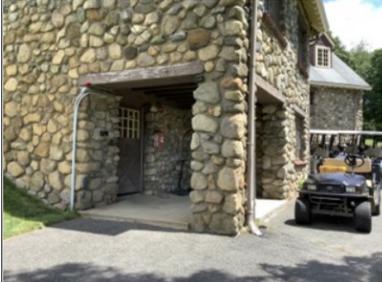
Entrance not on an accessible route Directional sign to accessible entrance not provided	- -	Provide a directional sign indicating the location of the nearest accessible entrance.	1	-	\$0

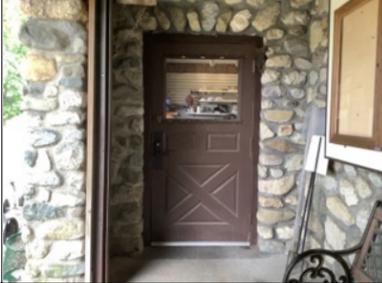
15	Pro Shop Entrance	1		Entrance	Other

Entrance not on an accessible route Directional sign to accessible entrance not provided	- -	Provide a directional sign indicating the location of the nearest accessible entrance.	1	-	\$0

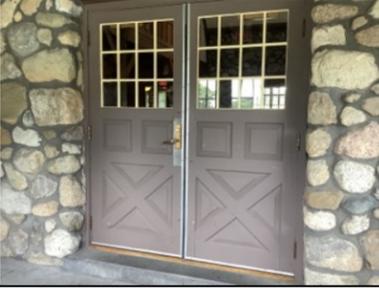
ID	Location	Floor	Room	Element	Type	Photo	Issues	Current Measure	Recommendations	Quantity	Price	Cost Estimation
16	Main Entrance	1		Entrance	Main Entrance

Entrance not on an accessible route Level changes > 1/4"	- 4"	Provide a directional sign indicating the location of the nearest accessible entrance.	1	-	\$0
17	Entrance - to Function Hall	1		Entrance	Secondary Entrance

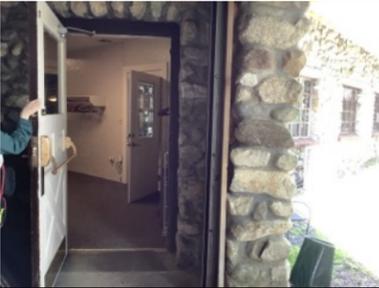
International Symbol of Accessibility not provided	-	Provide a sign with the International Symbol of Accessibility (ISA).	1	-	\$0
18	Parks and Recreation Department	1		Entrance	Other

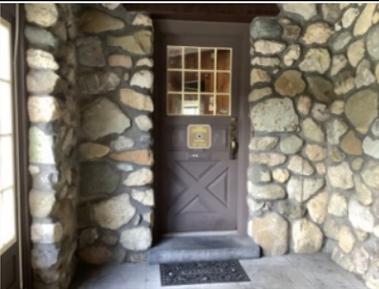
Level changes > 1/4"	4"	Provide a portable ramp as needed.	1	500	\$500
<b>Access to Goods and Services</b>												
<b>Means of Egress</b>												
19	Snack Bar	1		Means of Egress	N/A

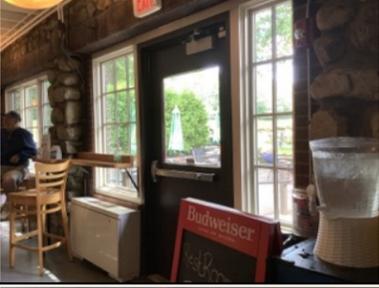
Tactile exit sign not provided Illuminated ISA symbol not provided (MAAB)	- -	Ensure tactile exit signs with raised characters and braille are provided at exit doors. Mount signs between 48"- 60" above the finished floor located on the latch side of the door. Provide an illuminated sign with the International Symbol of Accessibility (ISA).	1	432	\$432

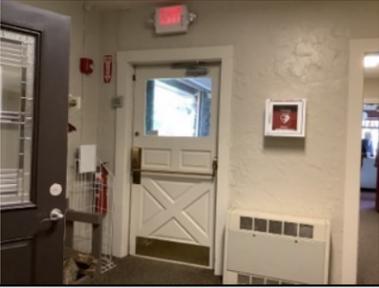
20	Exit by the Toilet Rooms	1		Means of Egress	N/A

Tactile exit sign not provided Illuminated ISA symbol not provided (MAAB)	- -	Ensure tactile exit signs with raised characters and braille are provided at exit doors. Mount signs between 48"- 60" above the finished floor located on the latch side of the door. Provide an illuminated sign with the International Symbol of Accessibility (ISA).	1	464	\$464

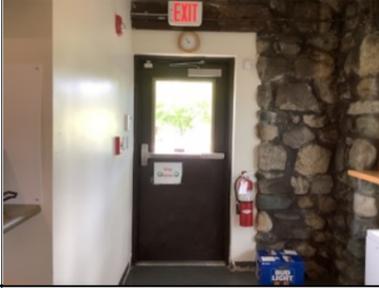
ID	Location	Floor	Room	Element	Type	Photo	Issues	Current Measure	Recommendations	Quantity	Price	Cost Estimation
21	Exit - Snack Bar	1		Means of Egress	N/A

Tactile exit sign not provided Directional sign to accessible emergency exit not provided	- -	Ensure tactile exit signs with raised characters and braille are provided at exit doors. Mount signs between 48"- 60" above the finished floor located on the latch side of the door. Provide a directional sign indicating the location of the nearest accessible emergency exit.	1	464	\$464
22	Large Function Hall to Patio	1		Means of Egress	N/A

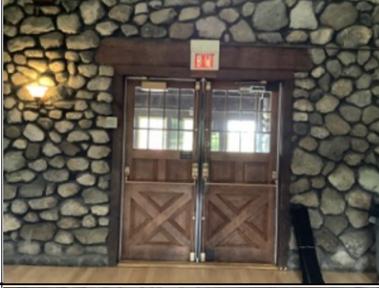
Tactile exit sign not provided Directional sign to accessible emergency exit not provided	- -	Ensure tactile exit signs with raised characters and braille are provided at exit doors. Mount signs between 48"- 60" above the finished floor located on the latch side of the door. Provide a directional sign indicating the location of the nearest accessible emergency exit.	1	464	\$464

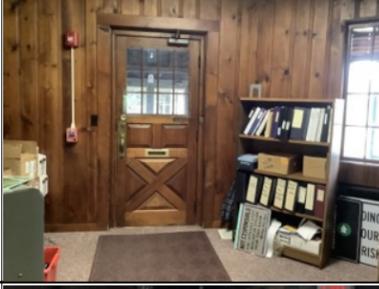
23	Parks and Recreation Department	1		Means of Egress	N/A

Tactile exit sign not provided Directional sign to accessible emergency exit not provided	- -	Ensure tactile exit signs with raised characters and braille are provided at exit doors. Mount signs between 48"- 60" above the finished floor located on the latch side of the door. Provide a directional sign indicating the location of the nearest accessible emergency exit.	1	464	\$464
24	Large Function Hall - Exit to Patio	1		Means of Egress	N/A

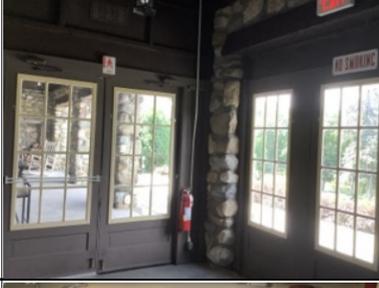
Tactile exit sign not provided Directional sign to accessible emergency exit not provided	- -	Ensure tactile exit signs with raised characters and braille are provided at exit doors. Mount signs between 48"- 60" above the finished floor located on the latch side of the door. Provide a directional sign indicating the location of the nearest accessible emergency exit.	1	464	\$464
25	Exit From Small Function Hall	1		Means of Egress	N/A

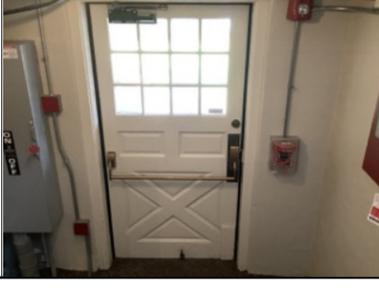
Tactile exit sign not provided Directional sign to accessible emergency exit not provided	- -	Ensure tactile exit signs with raised characters and braille are provided at exit doors. Mount signs between 48"- 60" above the finished floor located on the latch side of the door. Provide a directional sign indicating the location of the nearest accessible emergency exit.	1	464	\$464

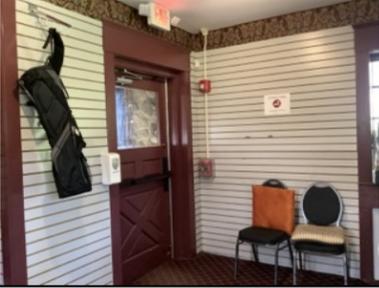
ID	Location	Floor	Room	Element	Type	Photo	Issues	Current Measure	Recommendations	Quantity	Price	Cost Estimation
26	Exit From Pro Shop	1		Means of Egress	N/A

Tactile exit sign not provided Directional sign to accessible emergency exit not provided	- -	Ensure tactile exit signs with raised characters and braille are provided at exit doors. Mount signs between 48"- 60" above the finished floor located on the latch side of the door. Provide a directional sign indicating the location of the nearest accessible emergency exit.	1	464	\$464
<b>Interior Access Route</b>												
27	By Toilet Rooms and Large Function Hall	1		Interior Access Route	N/A

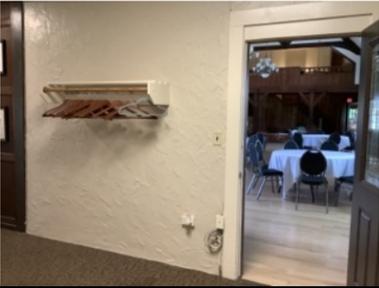
Obstructed by protruding objects	14"	Provide a cane-detectable barrier under the coat rack.	1	256	\$256
28	By Toilet Rooms and Large Function Hall	1		Interior Access Route	N/A

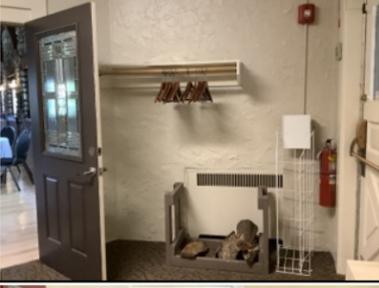
Obstructed by protruding objects	14"	Provide a cane-detectable barrier under the coat rack.	1	256	\$256

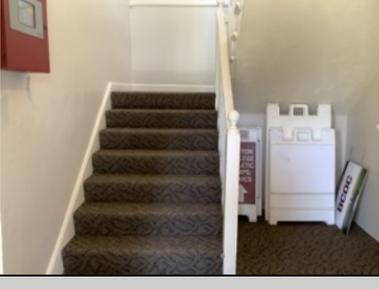
29	Small Function Hall Staircase to Southwest Egress	1		Interior Access Route	N/A

Vertical clearance < 80" above finished floor	-	Provide a cane-detectable barrier.	1	256	\$256
<b>Doors, Doorways, &amp; Gates</b>												
30	Exit by Toilet Rooms	1		Doors, Doorways, & Gates	Emergency Egress

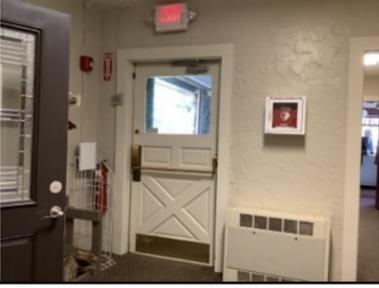
Maneuvering clearance(s) not provided	-	Relocate fire extinguisher to maintain the required 12" on the push side of the door.	1	Labor	\$0

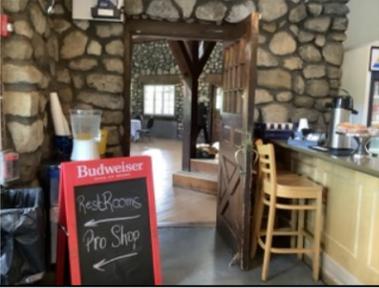
ID	Location	Floor	Room	Element	Type	Photo	Issues	Current Measure	Recommendations	Quantity	Price	Cost Estimation
31	Snack Bar to Large Function Hall	1		Doors, Doorways, & Gates	Circulation

Maneuvering clearance(s) not provided Hardware not operable with a closed fist	- -	Relocate the stand to maintain the maneuvering clearance on the pull side of the door. Provide hardware that can be operable with one hand and not require tight grasping, pinching, or twisting of the wrist.	1	484	\$484
32	Parks and Recreation Department to Egress	1		Doors, Doorways, & Gates	Office

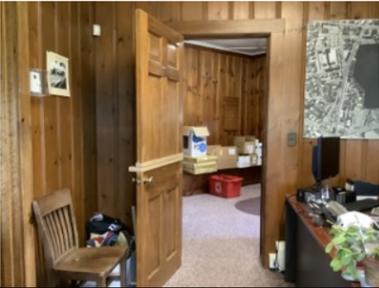
Maneuvering clearance(s) not provided Hardware not operable with a closed fist	5.5" -	Keep door open during business hours. Provide hardware that can be operable with one hand and not require tight grasping, pinching, or twisting of the wrist.	1	484	\$484
33	Pro Shop to Toilet Rooms	1		Doors, Doorways, & Gates	Other

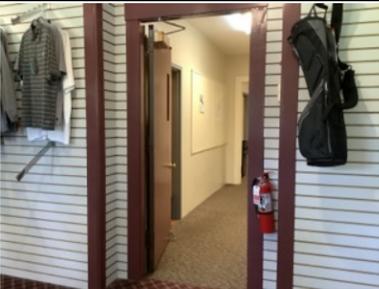
Maneuvering clearance not provided at recess > 6"	-	Remove the fire extinguisher to maintain the required 12" maneuvering clearance on the push side of the door.	1	Labor	\$0

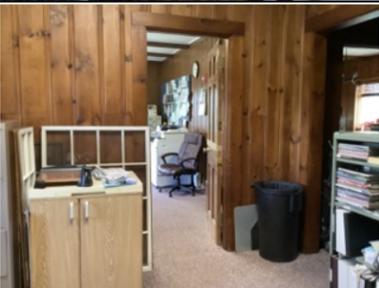
34	Parks and Recreation Department to Office	1		Doors, Doorways, & Gates	Office

Hardware not operable with a closed fist	-	Provide hardware that can be operable with one hand and not require tight grasping, pinching, or twisting of the wrist.	1	484	\$484
35	Parks and Recreation Department to Office	1		Doors, Doorways, & Gates	Office

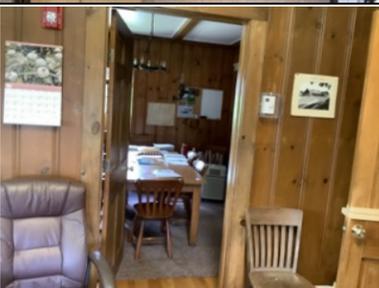
Hardware not operable with a closed fist	-	Provide hardware that can be operable with one hand and not require tight grasping, pinching, or twisting of the wrist.	1	484	\$484

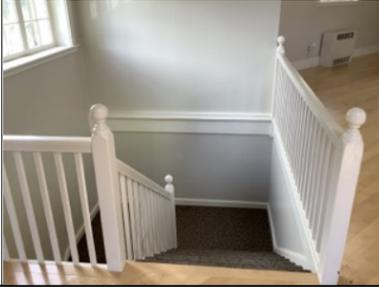
ID	Location	Floor	Room	Element	Type	Photo	Issues	Current Measure	Recommendations	Quantity	Price	Cost Estimation
<b>Stairways</b>												
36	Small Function Room Staircase to Southwest Exit	1		Stairways	Other

Handrails not compliant Handrail height < 34" or > 38"	- 30"	Provide compliant handrails on both sides of the staircase. Alter so the handrails are 34"- 38" high above the floor.	1	-	\$0
<b>Signage</b>												
37	Snack Bar Entrance	Ext.		Signage	Designation

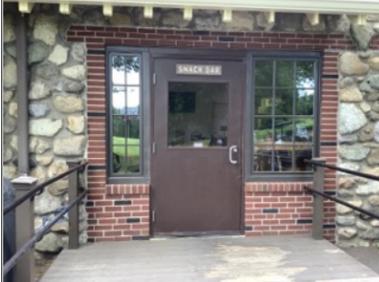
Raised characters not provided on sign Braille not provided on sign Sign not located on the latch side of the door International Symbol of Acc. not provided	- - - -	Provide text with raised characters duplicated in braille on sign. Mount signs so that the baseline of the lowest tactile character is 48" min. above finished floor and the baseline of the highest tactile character is 60" max. above the finished floor. Locate the sign at permanent rooms alongside the door on the latch side. Provide a sign containing the International Symbol of Accessibility (ISA).	1	-	\$0
