# ADA Self-Evaluation and Transition Plan for the City of Melrose

Part 2 of 2

## Part 2: Reports:

January, 2023

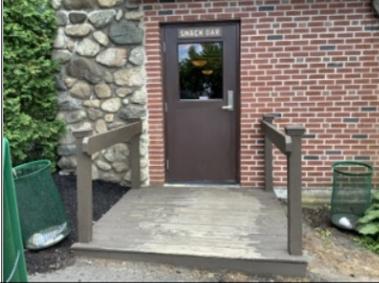
38	To Snack Bar	Ext.		Signage	Designation

Raised characters not provided on sign Braille not provided on sign Sign not located on the latch side of the door Directional sign to accessible entrance not provided	- - -	Provide text with raised characters duplicated in braille on sign. Mount signs so that the baseline of the lowest tactile character is 48" min. above finished floor and the baseline of the highest tactile character is 60" max. above the finished floor. Locate the sign at permanent rooms alongside the door on the latch side. Provide a directional sign indicating the location of the nearest accessible entrance.	1	-	\$0
39	Large Function Room Egress to Toilet Rooms	1		Signage	Directional

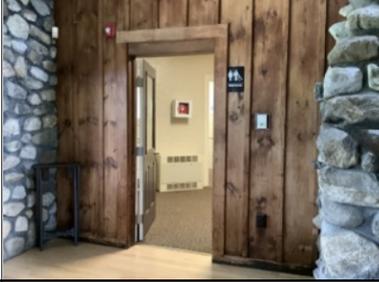
Raised characters < 48" or > 60" above ground	64.7"	Mount signs so that the baseline of the lowest tactile character is 48" min. above finished floor and the baseline of the highest tactile character is 60" max. above the finished floor.	1	Labor	\$0

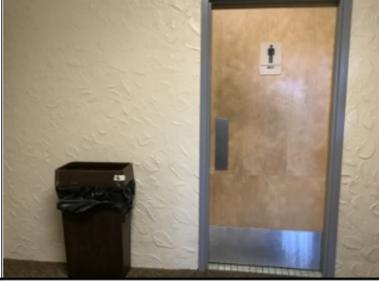
40	Men's Toilet Room	1		Signage	Designation

Sign not located on the latch side of the door	-	Locate the sign at permanent rooms alongside the door on the latch side. Mount signs so that the baseline of the lowest tactile character is 48" min. above finished floor and the baseline of the highest tactile character is 60" max. above the finished floor.	1	Labor	\$0

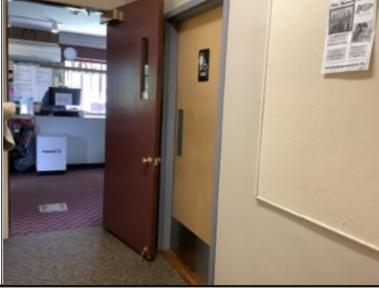
ID	Location	Floor	Room	Element	Type	Photo	Issues	Current Measure	Recommendations	Quantity	Price	Cost Estimation
41	Women's Toilet Room	1		Signage	Designation

Sign not located on the latch side of the door	-	Locate the sign at permanent rooms alongside the door on the latch side. Mount signs so that the baseline of the lowest tactile character is 48" min. above finished floor and the baseline of the highest tactile character is 60" max. above the finished floor.	1	Labor	\$0
<b>Service Counter</b>												
42	Pro Shop	1		Service Counter	N/A

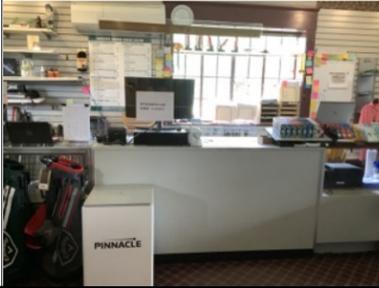
Counter > 36" high	38.3"	Provide a counter that is 36" max. above the ground or finished floor.	1	880	\$880
<b>Operable Parts</b>												
43	Hole #10 East of Pro Shop	Ext.		Operable Parts	Equipment

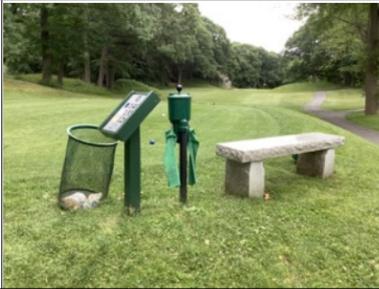
Not operable with a closed fist	-	Provide hardware that can be operable with one hand and not require tight grasping, pinching, or twisting of the wrist.	1	-	\$0

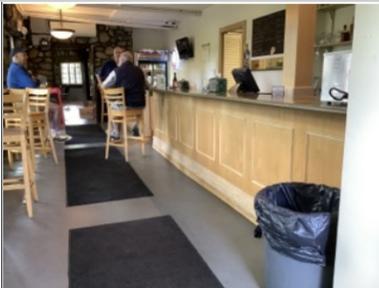
<b>Dining or Work Surfaces</b>												
44	Snack Bar	1		Dining or Work Surfaces	Dining Surface

Top of dining/work surface < 28" or > 34"	42"	Provide a portion of the bar between 28"- 34" above the floor and 27" clear height underneath.	1	880	\$880

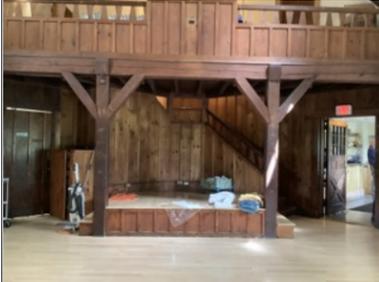
ID	Location	Floor	Room	Element	Type	Photo	Issues	Current Measure	Recommendations	Quantity	Price	Cost Estimation
<b>Assembly Area</b>												
45	Large Function Hall	1		Assembly Area	N/A

Accessible route to stage not provided Assistive listening devices not provided	- - -	Provide an accessible route to the stage. If audible communication is integral to the use of the space, provide an assistive listening system.	1	1688	\$1688
46	Small Function Hall	1		Assembly Area	N/A

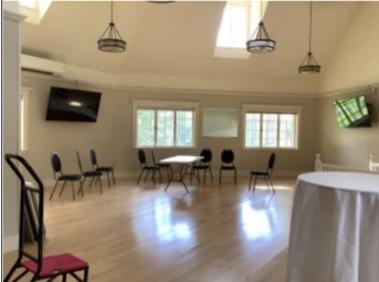
Assistive listening devices not provided	-	If audible communication is integral to the use of the space, provide an assistive listening system.	1	1688	\$1688
<b>Exterior Benches</b>												
47	Hole #10 East of Pro Shop	Ext.		Exterior Benches	N/A

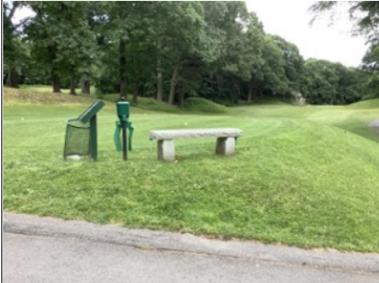
No accessible route to one bench in area	-	Relocate bench to an accessible route.	1	-	\$0
48	Park/Playground	Ext.		Exterior Benches	N/A

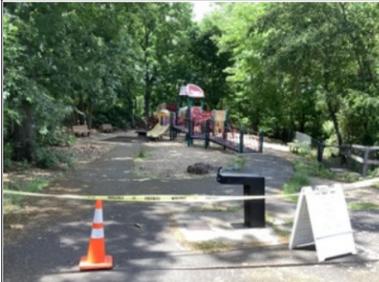
No accessible route to one bench in area	-	Provide an accessible route to one bench in this area.	1	-	\$0

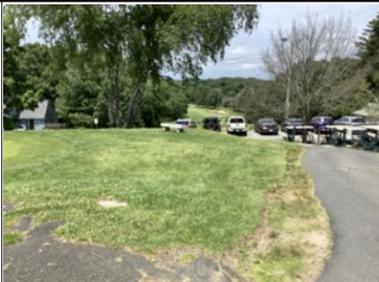
49	Practice Green	Ext.		Exterior Benches	N/A

No accessible route to one bench in area	-	Relocate bench to an accessible route.	1	-	\$0
<b>Toilet &amp; Bathing Rooms</b>

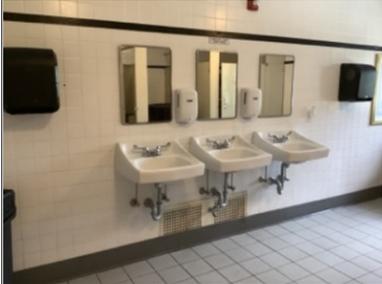
ID	Location	Floor	Room	Element	Type	Photo	Issues	Current Measure	Recommendations	Quantity	Price	Cost Estimation
<b>Lavatory</b>												
50	Women's Toilet Room	1		Lavatory	N/A

Plumbing underneath is exposed	-	Insulate or otherwise configure pipes to prevent contact for at least one lavatory.	1	92	\$92
51	Men's Toilet Room	1		Lavatory	N/A

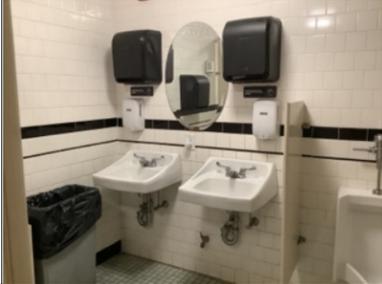
Plumbing underneath is exposed Mirror above lavatory w/reflective surface > 40" Dispensers not within reach range	- 45.5" 59.8"	Insulate or otherwise configure pipes to prevent contact for at least one lavatory. Lower mirror so that the bottom surface is at 40" max. above the finished floor. Lower dispensers to 48" max. above the finished floor.	1	798	\$798
<b>Toilet Compartment</b>												
52	Women's Toilet Room	1		Toilet Compartment	Accessible Compartment

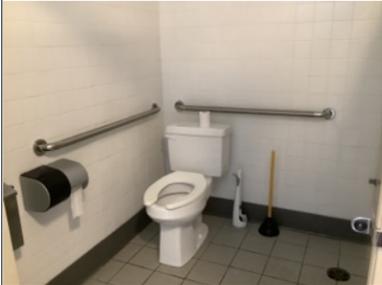
Flush control not on open side Centerline < or > 18" (MAAB)	- 15.7"	Provide the flush control on the open side of the toilet (transfer side). Relocate toilet so the centerline is 18" from the side wall.	1	2828	\$2828

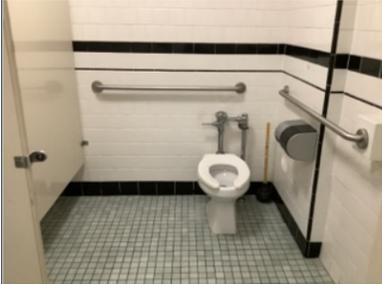
53	Men's Toilet Room	1		Toilet Compartment	Accessible Compartment

Clearance at toilet < 72" clear depth (MAAB)	70.7"	Relocate partition to provide a wheelchair accessible compartment that is 60" wide and 72" deep.	1	256	\$256
54	Women's Toilet Room	1		Toilet Compartment	Accessible Compartment

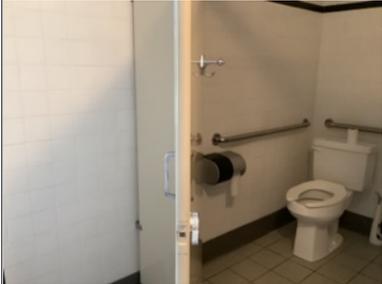
Door pull not provided	-	Provide a door pull on each side of the door between 34" to 48" above the finished floor that does not require tight grasping, pinching or twisting of the wrist.	1	70	\$70

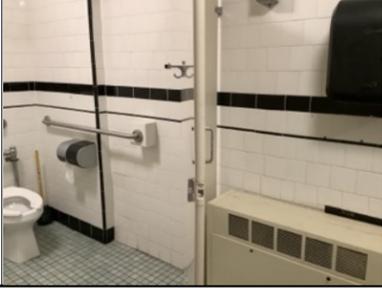
ID	Location	Floor	Room	Element	Type	Photo	Issues	Current Measure	Recommendations	Quantity	Price	Cost Estimation
55	Men's Toilet Room	1		Toilet Compartment	Accessible Compartment

Door pull not provided	-	Provide a door pull on each side of the door between 34" to 48" above the finished floor that does not require tight grasping, pinching or twisting of the wrist.	1	70	\$70
<b>Portable Toilet</b>												
56	Portable Toilet by Hole 5	Ext.		Portable Toilet	N/A

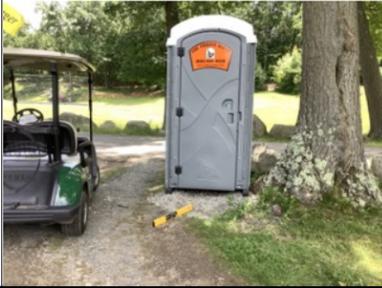
Not located on an accessible route Accessible portable toilets not provided	- -	Locate portable toilet on an accessible route. Provide one accessible portable toilet.	1	-	\$0
57	Portable Toilet by Hole 15	Ext.		Portable Toilet	N/A

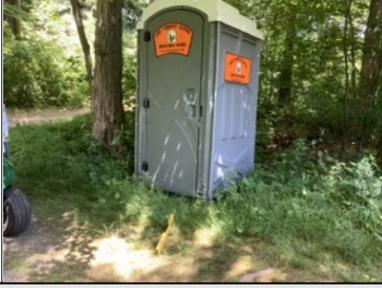
Not located on an accessible route Accessible portable toilets not provided	- -	Locate portable toilet on an accessible route. Provide one accessible portable toilet.	1	-	\$0
<b>Best Practice</b>

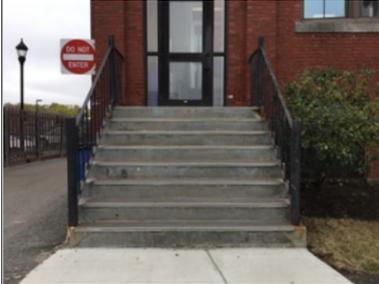
ID	Location	Floor	Room	Element	Type	Photo	Issues	Current Measure	Recommendations	Quantity	Price	Cost Estimation
<b>Approach and Entrance</b>												
<b>Exterior Stair</b>												
1	Main Entrance	Ext.		Exterior Stair

Handrail height < 34" or > 38" Handrails do not extend 12" from stair	32.5" -	Alter so the handrails are 34"- 38" high above the finished floor or ground. Top: Ensure handrails extend horizontally above the landing for 12" min. beginning above the first riser nosing. Bottom: Ensure that the sloped bottom extension extends one tread depth min. beyond last riser nosing in same direction as stair flight.	1	-	\$0
<b>Entrance</b>												
2	Police Personnel Entrance (Used by Officers as an Entrance for Detainees)	1		Entrance	Secondary Entrance

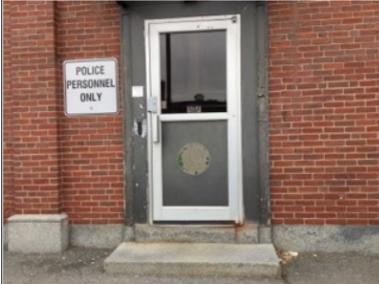
Entrance not on an accessible route	-	Provide a directional sign indicating the location of the nearest accessible entrance.	1	346	\$346

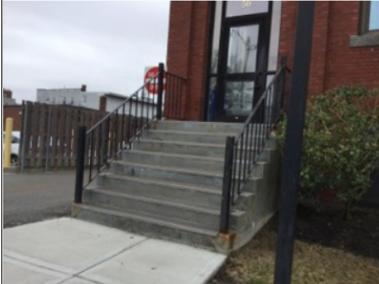
3	Main Entrance	Ext.		Entrance	Main Entrance

Entrance not on an accessible route	- -	Provide an accessible route to the main entrance. (Either by way of an exterior ramp or a lift.)	1	-	\$0
<b>Emergency Exit</b>												
4	Main Entrance	Ext.		Emergency Exit

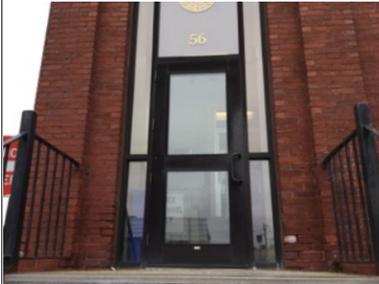
Door requires > 15 lbs. of force to open	20 lbs	Adjust closers of exterior doors so doors do not require more than 15 pounds of force.	1	Labor	\$0
<b>Access to Goods and Services</b>

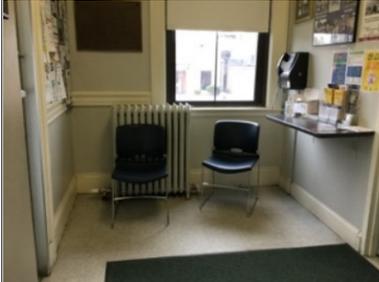
ID	Location	Floor	Room	Element	Type	Photo	Issues	Current Measure	Recommendations	Quantity	Price	Cost Estimation
<b>Interior Access Route</b>												
5	Reception	1		Interior Access Route	N/A

Obstructed by protruding objects	15"	Provide a cane-detectable barrier.	1	306	\$306
6	Interview Room	1		Interior Access Route	N/A

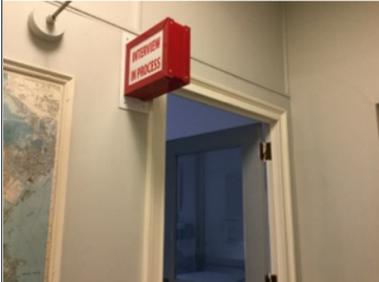
Obstructed by protruding objects Vertical clearance < 80" above finished floor	11.7" 77.8"	Relocate sign to maintain the min. vertical clearance at the circulation path.	1	256	\$256
7	To Women's/Juvenile Cell	B		Interior Access Route

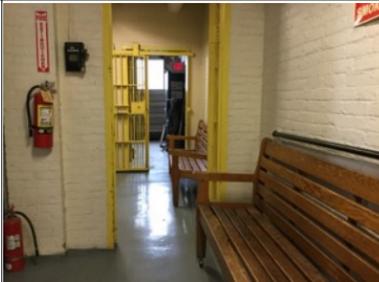
Route < 36" wide	27"	Relocate bench to maintain the clear width of 36" min. at the accessible route.	1	Labor	\$0
8	Women's/Juvenile Cell Egress	B		Interior Access Route	N/A

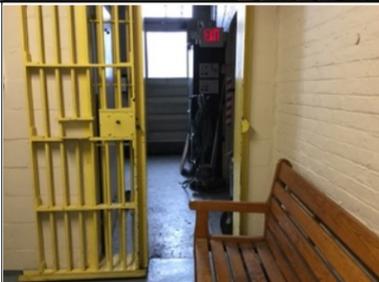
Route < 36" wide	-	Ensure that a clear width of 36" min. is maintained at the accessible route.	1	Labor	\$0
9	Women's/Juvenile Cell	B		Interior Access Route

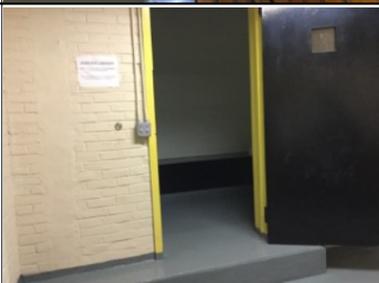
Level changes > 1/4"	9"	Provide a portable ramp as needed.	1	500	\$500

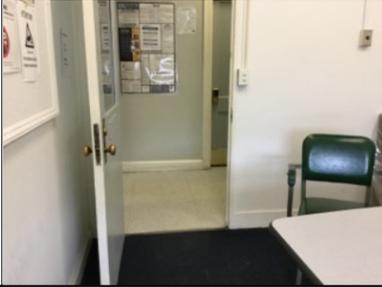
ID	Location	Floor	Room	Element	Type	Photo	Issues	Current Measure	Recommendations	Quantity	Price	Cost Estimation
<b>Doors, Doorways, &amp; Gates</b>												
10	Interview Room	1		Doors, Doorways, & Gates	Office

Maneuvering clearance(s) not provided	-	Rearrange furniture to maintained the maneuvering clearance at the door.	1	Labor	\$0
11	Interview Room	1		Doors, Doorways, & Gates

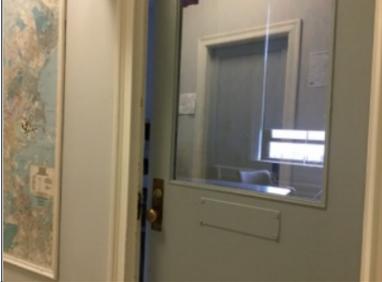
Hardware not operable with a closed fist		Provide hardware that can be operable with one hand and not require tight grasping, pinching, or twisting of the wrist.	1	484	\$484
12	Booking	B		Doors, Doorways, & Gates	Office

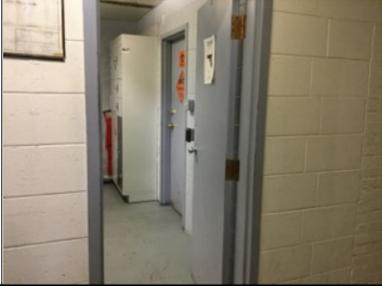
Hardware not operable with a closed fist	-	Provide hardware that can be operable with one hand and not require tight grasping, pinching, or twisting of the wrist.	1	484	\$484
<b>Stairways</b>												
13	Entrance			Stairways	Egress

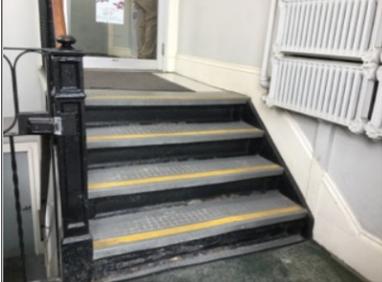
Handrail height < 34" or > 38" Handrail not provided on both sides Handrails do not extend 12" from stairs	30"	Alter so the handrails are 34"- 38" high above the floor. Provide handrail on one side. Top: Ensure handrails extend horizontally above the landing for 12" min. beginning above the first riser nosing. Bottom: Ensure handrails extend to one tread depth beyond the last riser.	1	-	\$0

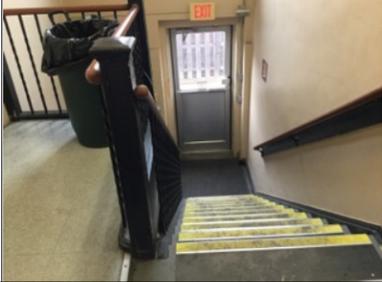
14	Prisoner Entrance	1		Stairways	Egress

Handrails do not extend 12" from stairs	-	Top: Ensure handrails extend horizontally above the landing for 12" min. beginning above the first riser nosing. Bottom: Ensure handrails extend to one tread depth beyond the last riser.	1	-	\$0

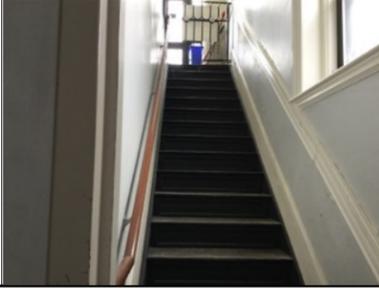
ID	Location	Floor	Room	Element	Type	Photo	Issues	Current Measure	Recommendations	Quantity	Price	Cost Estimation
15	Egress Door to Main Entrance	B		Stairways	Egress

Handrail not provided on both sides		Provide handrail on one side.	1	-	\$0
<b>Signage</b>												
16	Interview Room	1		Signage	Designation

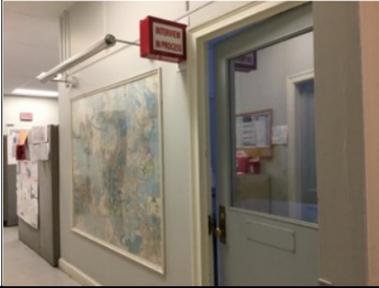
Raised characters not provided on sign Braille not provided on sign Sign not located on the latch side of the door		Provide text with raised characters duplicated in braille on sign. Locate the sign at permanent rooms alongside the door on the latch side.	1	232	\$232
17	Egress Door to Main Entrance	B		Signage	Egress

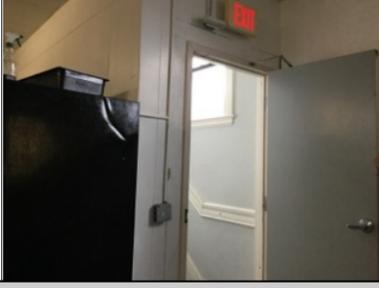
Signage is not provided	-	Locate compliant signage alongside the door on the latch side.	1	232	\$232
<b>Service Counter</b>												
18	Booking	B		Service Counter	N/A

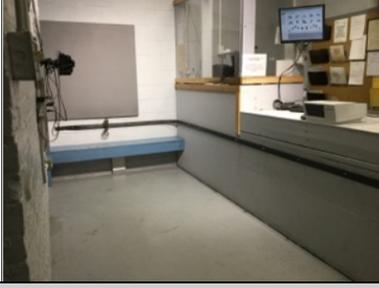
Counter > 36" high	40"	Provide a counter that is 36" max. above the ground or finished floor.	1	880	\$880

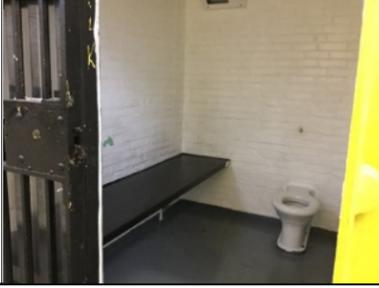
<b>Detention Facilities</b>												
19	Male Cell	B		Detention Facilities	Men's

< 3% of holding cells have mobility features	-	Ensure that at least one holding cell has mobility features.	1	-	\$0

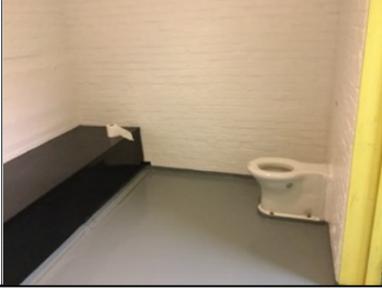
ID	Location	Floor	Room	Element	Type	Photo	Issues	Current Measure	Recommendations	Quantity	Price	Cost Estimation
20	Women's/Juvenile Cell	B		Detention Facilities	Women's

< 3% of holding cells have mobility features		Ensure that at least one holding cell has mobility features.	1	-	\$0
<b>Additional Access</b>												
<b>Sink</b>												
21	Outside Male Cell	B		Sink	Other

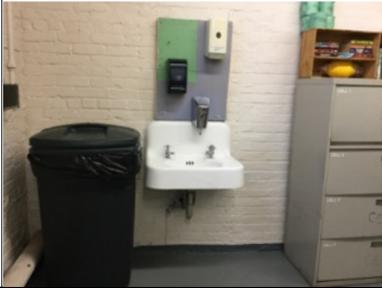
Toe and knee clearances not provided Non-compliant faucets Exposed plumbing underneath sink	25.5" - -	Ensure there is a 27" min. knee clearance positioned for a forward approach. Install faucets that do not require tight grasping, pinching, or twisting of the wrist. Insulate or otherwise configure pipes at sink.	1	1686	\$1686
<b>Best Practice</b>												
<b>Stairs</b>												
22	Main Entrance	Ext.		Stairs	N/A

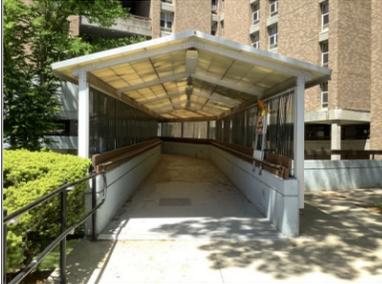
ID	Location	Floor	Room	Element	Type	Photo	Issues	Current Measure	Recommendations	Quantity	Price	Cost Estimation
<b>Approach and Entrance</b>												
<b>Exterior Access Route</b>												
1	Route to Main Entry	Ext.		Exterior Access Route	Walkway

Level changes > 1/4"	1"	Alter change in level to be 1/4" high max.	1	-	\$0
<b>Off-Street Parking Lot or Garage</b>												
2	Visitor Parking	Ext.		Off-Street Parking Lot or Garage	Visitor

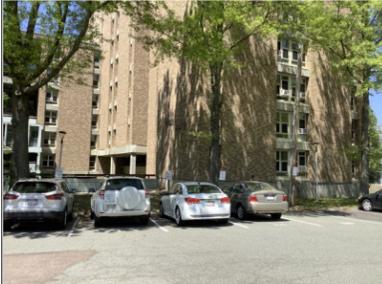
Total # of parking Total # of designated accessible parking spaces Total # of designated van accessible spaces Access aisle not provided Sign not provided	1 0 0 - -	Provide a van accessible spaces that is 96" wide with a marked access aisle that is at least 96" wide. Provide a sign with the bottom of the sign 60" min. above the ground and the top 96" max. above the ground. Add the designation "Van Accessible" to the sign.	1	-	\$0
<b>Exterior Ramp</b>

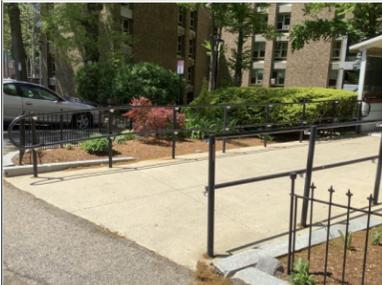
3	Route to Main Entrance	Ext.		Exterior Ramp	N/A

Handrails do not extend 12" past top & bottom	-	Alter handrails to extend horizontally above the landing for 12" min. beyond the top and bottom of ramp runs.	1	-	\$0
<b>Access to Goods and Services</b>												
<b>Means of Egress</b>												
4	Egress	Ext.		Means of Egress	N/A

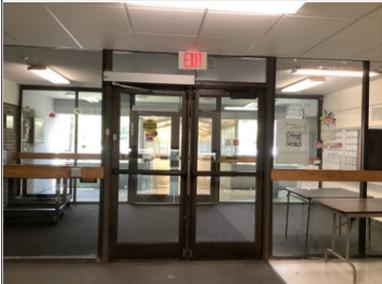
Tactile exit sign not provided Illuminated ISA symbol not provided (MAAB)	- -	Ensure tactile exit signs with raised characters and braille are provided at exit doors. Mount signs between 48"- 60" above the finished floor located on the latch side of the door. Provide an illuminated sign with the International Symbol of Accessibility (ISA).	1	432	\$432

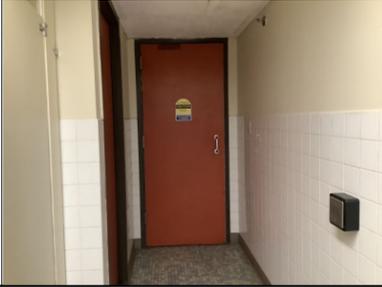
ID	Location	Floor	Room	Element	Type	Photo	Issues	Current Measure	Recommendations	Quantity	Price	Cost Estimation
<b>Doors, Doorways, &amp; Gates</b>												
5	Men's Toilet Room	1		Doors, Doorways, & Gates	Toilet Room

**Note:** The entry doors to the toilet rooms have automatic door openers. On the day of the survey the automatic door at the men's toilet room was not in operable working condition,

Automatic door opener not operable	-	Repair or replace the door opener.	1	-	\$0
<b>Signage</b>												
6	Women's Toilet Room	1		Signage	Designation

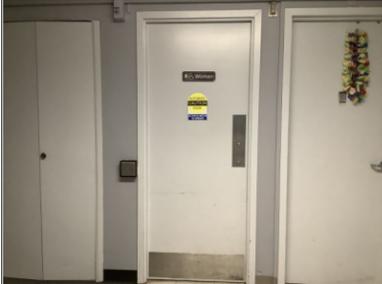
Raised characters not provided on sign Braille not provided on sign Sign not located on the latch side of the door	- - -	Provide text with raised characters duplicated in braille on sign. Locate the sign at permanent rooms alongside the door on the latch side.	1	232	\$232
7	Men's Toilet Room	1		Signage	Designation

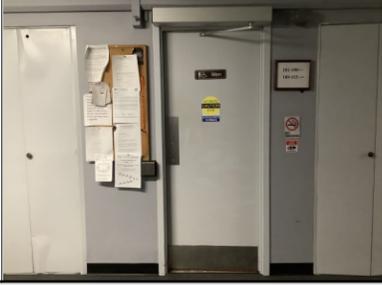
Raised characters not provided on sign Braille not provided on sign Sign not located on the latch side of the door	- - -	Provide text with raised characters duplicated in braille on sign. Locate the sign at permanent rooms alongside the door on the latch side.	1	232	\$232

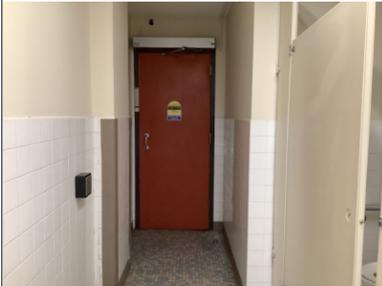
<b>Toilet &amp; Bathing Rooms</b>												
<b>Overall Access</b>												
8	Women's Toilet Room	1		Overall Access	Toilet Room

Audible and visible alarms not provided	-	When fire system is updated, ensure that a visible and audible fire alarm is installed.	1	-	\$0

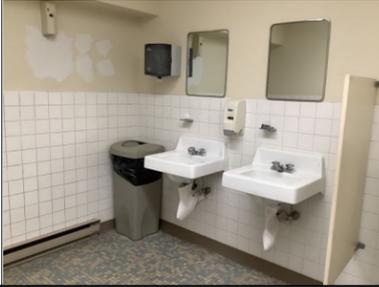
ID	Location	Floor	Room	Element	Type	Photo	Issues	Current Measure	Recommendations	Quantity	Price	Cost Estimation
<b>Lavatory</b>												
9	Men's Toilet Room	1		Lavatory	N/A

Faucet is not operable with a closed fist Mirror above lavatory w/reflective surface > 40" Dispensers not within reach range	- 52" 58"	Provide a faucet that can be operable with one hand and not require tight grasping, pinching, or twisting of the wrist for at least one lavatory. Lower mirror so that the bottom surface is at 40" max. above the finished floor. Lower dispensers to 48" max. above the finished floor.	1	1498	\$1498
10	Women's Toilet Room	1		Lavatory	N/A

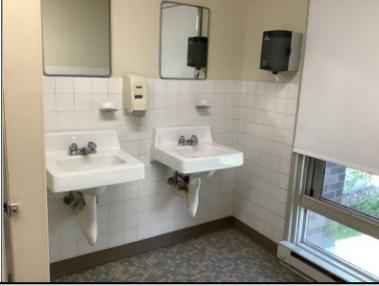
Mirror above lavatory w/reflective surface > 40"	52"	Lower mirror so that the bottom surface is at 40" max. above the finished floor.	1	256	\$256
<b>Toilet Compartment</b>												
11	Women's Toilet Room	1		Toilet Compartment	Accessible Compartment

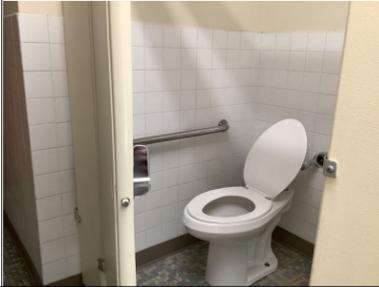
Door has malfunctioning self-closing hinge Door pull not provided	- -	Repair hinge. Provide a door pull on each side of the door between 34" to 48" above the finished floor that does not require tight grasping, pinching or twisting of the wrist.	1	70	\$70

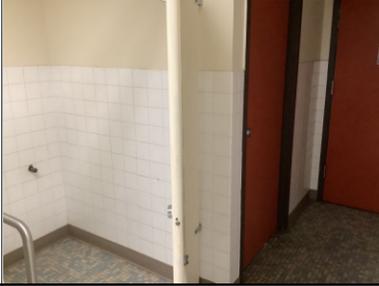
12	Men's Toilet Room	1		Toilet Compartment	Accessible Compartment

Door has malfunctioning self-closing hinge Door pull not provided	- -	Repair hinge. Provide a door pull on each side of the door between 34" to 48" above the finished floor that does not require tight grasping, pinching or twisting of the wrist.	1	70	\$70
13	Men's Toilet Room	1		Toilet Compartment	Accessible Compartment

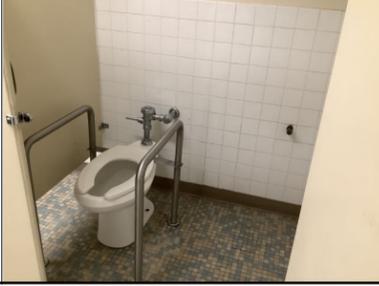
Grab bars not provided Flush control not on open side Clearance at toilet < 72" clear depth (MAAB)	- - 47"	Provide one grab bar on the side wall of the water closet and one on the rear wall. Ensure toilet paper dispenser is mounted below the side grab bar. Provide the flush control on the open side of the toilet (transfer side). Provide a wheelchair accessible compartment that is 60" wide and 72" deep. Remove railings to maintain the required clearance around the toilet.	1	6182	\$6182

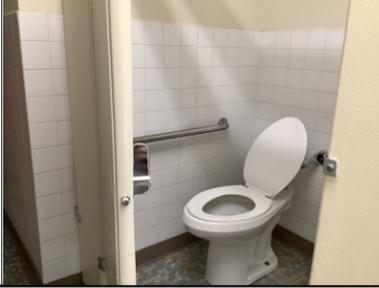
ID	Location	Floor	Room	Element	Type	Photo	Issues	Current Measure	Recommendations	Quantity	Price	Cost Estimation
14	Women's Toilet Room	1		Toilet Compartment	Accessible Compartment

Grab bars not provided Clearance at toilet < 72" clear depth (MAAB)	- 46.5"	Provide a grab bar on the rear wall. Provide a wheelchair accessible compartment that is 60" wide and 72" deep. Ensure the toilet paper dispenser is mounted below the side grab bar.	1	6182	\$6182
<b>Urinal</b>												
15	Men's Toilet Room	1		Urinal	N/A

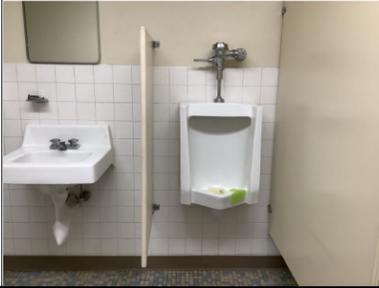
Rim > 17" high	24"	Provide a urinal with the rim no higher than 17" above the finished floor.	1	3248	\$3248
<b>Best Practice</b>												
<b>Signage</b>												
16	Corridor Towards Toilet Rooms	1		Signage	N/A

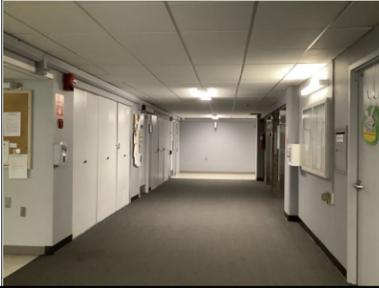
Recommend providing a wall mounted overhead sign indicating the location of the toilet rooms.	1	-	\$0

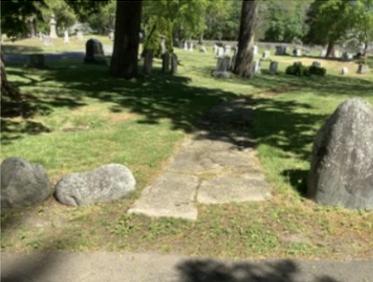
Exterior route < 48" wide Level changes > 1/4" Route not maintained in operable working condition	44" 1" -	Ensure that a clear width of 48" min. is maintained at the accessible route. Alter the change in level to be 1/4" high max. Ensure that the accessible route is maintained in operable working condition.	1	-	\$0
2	Evergreen Avenue Towards Lakeside Avenue	Ext.		Exterior Access Route	Walkway

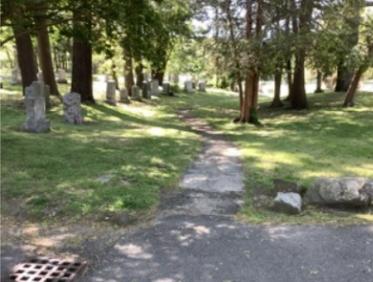
Exterior route < 48" wide Level changes > 1/4" Route not maintained in operable working condition	44" 1" -	Ensure that a clear width of 48" min. is maintained at the accessible route. Alter the change in level to be 1/4" high max. Ensure that the accessible route is maintained in operable working condition.  Recommendation applies to all the accessible routes.	1	-	\$0

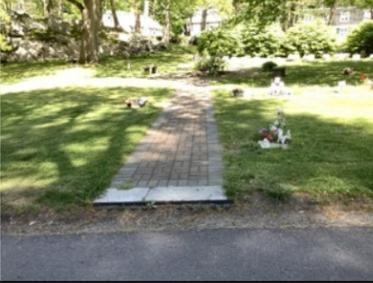
3	By Business Office	Ext.		Exterior Access Route	Walkway

Level changes > 1/4"	2"	Alter the change in level to be 1/4" high max.	1	-	\$0
4	Sylvan Avenue	Ext.		Exterior Access Route	Exterior

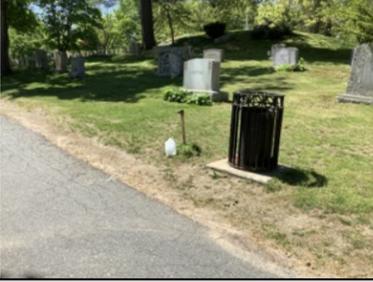
Level changes > 1/4" Accessible route not provided	1" -	Alter the change in level to be 1/4" high max. Ensure an accessible route is provided to the trash can and the water spigot.	1	-	\$0
<b>Entrance</b>												
5	Business Office	Ext.		Entrance	Main Entrance

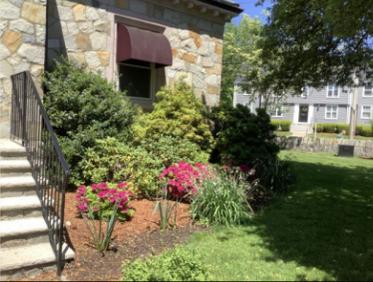
Entrance not on an accessible route	-	See ID #6.	1	-	\$0

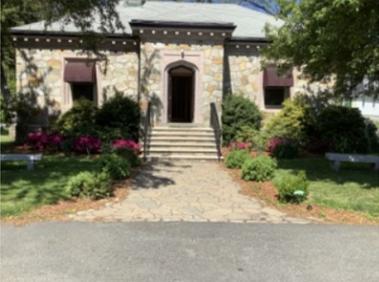
Entrance not on an accessible route	-	Recommend exploring the possibility of a switch back ramp.	1	-	\$0
7	Main Entry to Business Office	Ext.		Entrance	Main Entrance

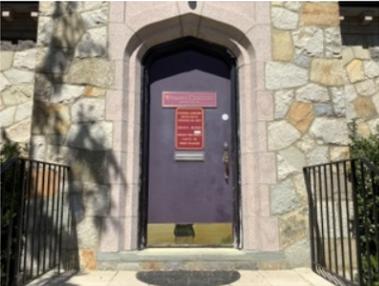
Threshold > 3/4" high Hardware not operable with a closed fist	4" -	Alter threshold to be 3/4" high max. Provide hardware that can be operable with one hand and not require tight grasping, pinching, or twisting of the wrist.  See ID #6 for additional recommendations.	1	-	\$0
<b>Access to Goods and Services</b>												
<b>Doors, Doorways, &amp; Gates</b>												
8	Main Entrance	1		Doors, Doorways, & Gates	N/A

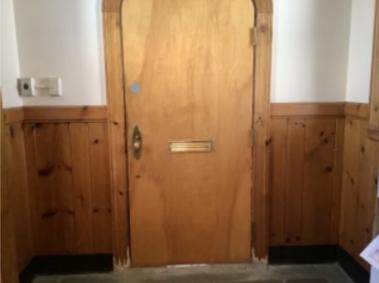
Threshold not beveled Hardware not operable with a closed fist	- -	Bevel the threshold. Provide hardware that can be operable with one hand and not require tight grasping, pinching, or twisting of the wrist.	1	634	\$634

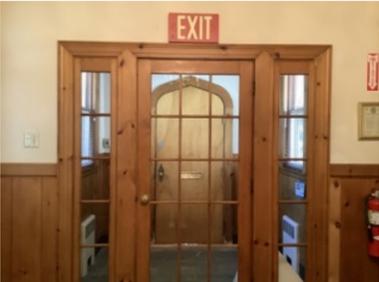
9	Main Entrance	1		Doors, Doorways, & Gates	N/A

Hardware not operable with a closed fist	-	Provide hardware that can be operable with one hand and not require tight grasping, pinching, or twisting of the wrist.	1	484	\$484
10	Commissioner's Office	1		Doors, Doorways, & Gates	N/A

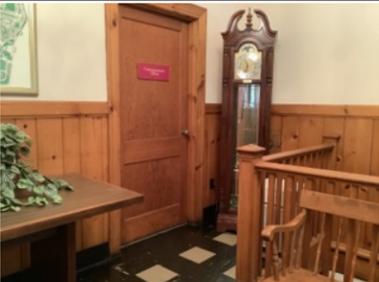
Hardware not operable with a closed fist	-	Provide hardware that can be operable with one hand and not require tight grasping, pinching, or twisting of the wrist. Relocate table to maintain the minimum 36" width at the accessible route.	1	484	\$484

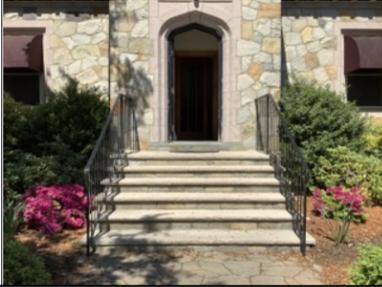
Handrails do not extend 12" from stairs	-	Bottom: Ensure that the sloped bottom extension extends one tread depth minimum beyond last riser nosing in same direction as stair flight.	1	-	\$0
<b>Signage</b>												
12	Main Entrance	1		Signage	Egress

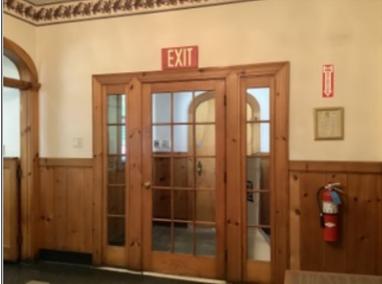
Not provided	-	Locate room identification signage alongside the door on the latch side.	1	232	\$232
13	Commissioner's Office	1		Signage	Designation

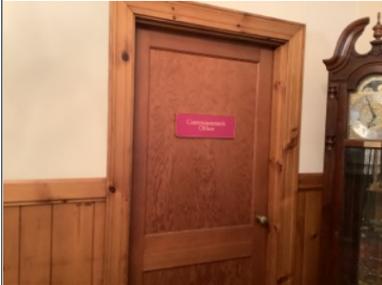
Raised characters not provided Braille not provided Sign not located on the latch side of the door	- - -	Provide text with raised characters duplicated in braille. Locate signs at permanent rooms alongside the door on the latch side.	1	232	\$232
14	Business Office	Ext.		Signage	Informational

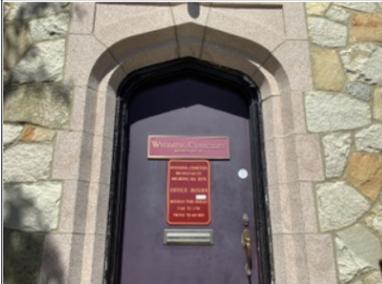
Non-glare finish and contrast not provided	-	Provide signs with characters that have a high contrast to the background.	1	-	\$0

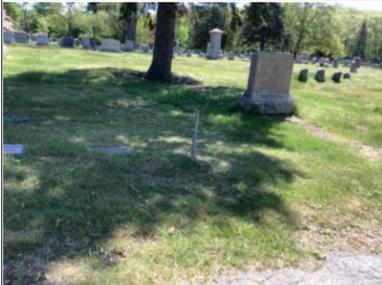
<b>Operable Parts</b>												
15	Central Avenue	Ext.		Operable Parts	N/A

Element not on an accessible route Not operable with a closed fist	- -	Ensure water spigot is located on an accessible route. Provide hardware that can be operable with one hand and does not require tight grasping, pinching, or twisting of the wrist.  Recommendation applies to all water spigots.	1	-	\$0

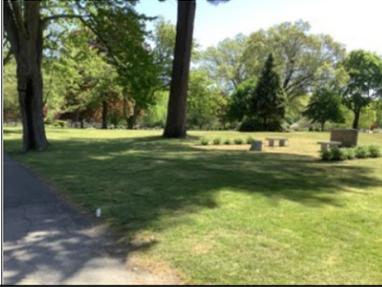
No accessible route to one bench in this area	-	Provide an accessible route to at least one bench in this area.	1	-	\$0
<b>Toilet &amp; Bathing Rooms</b>												
<b>Overall Access</b>												
17	Single-User Toilet Room	1		Overall Access	Toilet Room

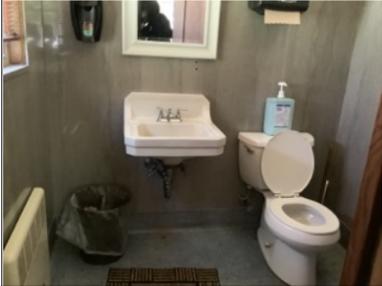
Turning space not provided	-	Provide an accessible single-user toilet room.	1	24604	\$24604
<b>Best Practice</b>												
<b>Benches</b>												
18	Willow Avenue	Ext.		Benches	N/A

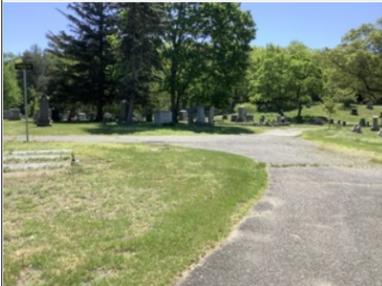
Recommend providing at least one bench on each street.	1	-	\$0
19	By Business Office	Ext.		Benches	N/A

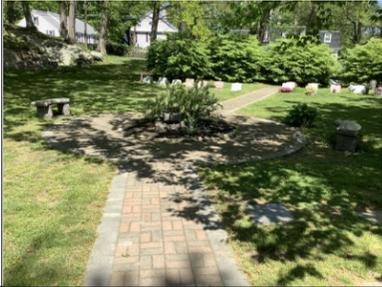
Recommend providing a 36" by 48" clear floor space alongside the bench.	1	-	\$0

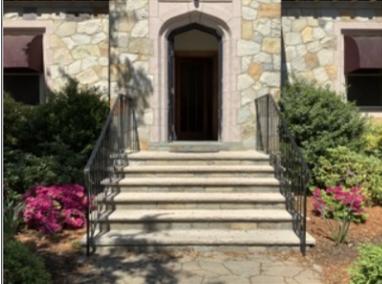
-	Recommend providing contrasting color strips at the edge of each step at the exterior stairs. Until an accessible route is provided, recommend providing a second informational sign at the bottom of the stairs with the contact phone number for the cemetery office on the sign. In addition, recommend alerting members of the public on the cemetery website about procedures on how to obtain information.	1	-	\$0

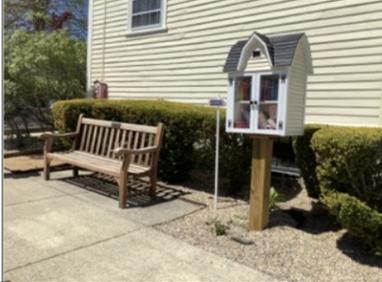
Accessible route not provided	-	Locate the book house closer to the accessible route.	1	-	\$0
2	Route From Milano Center Back Parking	Ext.		Exterior Access Route	Sidewalk

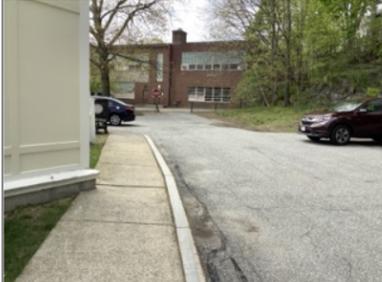
Cross slope > 1:50 (2.00%)	6.7%	Reduce cross slope to be no steeper than 1:50 (2.00%).	1	-	\$0
<b>Curb Ramp</b>												
3	Main Entry	Ext.		Curb Ramp	Blended Transition

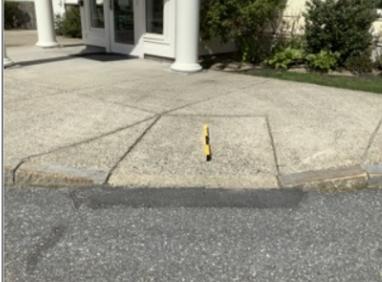
Running slope > 1:12 (8.33%) Transition from curb ramp to street not flush Surface not stable, firm and slip-resistant	12.3% - -	Reduce running slope to be no steeper than 1:12 (8.33%). Ensure transition from curb ramp to street is flush or free of changes in level. Repair surface.  See ID #4 for additional recommendations.	1	-	\$0

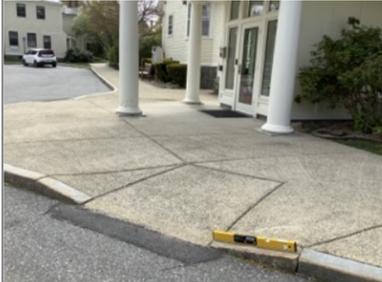
4	Main Entrance	Ext.		Curb Ramp	Blended Transition

Curb ramp flares > 1:10 (10%)	18.1%	Reduce slope at curb ramp flares to be no steeper than 1:10 (10%).  See ID #3 for additional recommendations.	2	-	\$0
5	Main Entrance	Ext.		Curb Ramp	Blended Transition

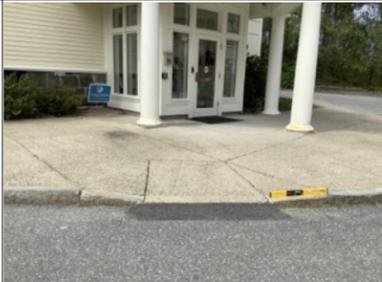
Curb ramp flares > 1:10 (10%) Surface not stable, firm and slip-resistant	9.6% -	Reduce slope at curb ramp flares to be no steeper than 1:10 (10%). Repair surface.	2	-	\$0

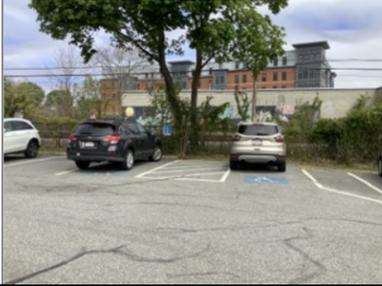
Total # of parking Total # of designated accessible parking spaces Sign bottom < 60" above finished grade	45 3 38.5"	Locate sign with the bottom of the sign 60" above the ground.	1	-	\$0
7	Parking by Beebe Estate	Ext.		Off-Street Parking Lot or Garage	Visitor

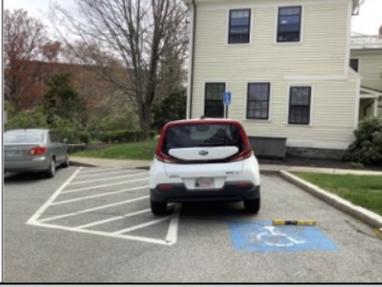
Running or cross slope at space > 1:50 (2.00%) Running or cross slope at access aisle > 1:50 (2.00%)	5.2% 6.3%	Reduce running or cross slope to be no steeper than 1:50 (2.00%). Reduce running or cross slope to be no steeper than 1:50 (2.00%).	1	-	\$0
<b>Exterior Stair</b>												
8	Egress Door #16	Ext.		Exterior Stair	N/A

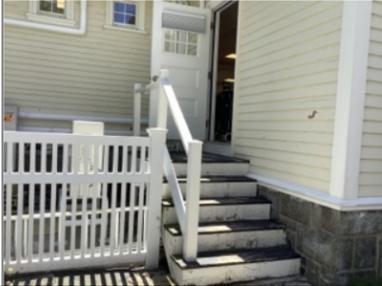
Handrails do not extend 12" from stair Cross section of handrail is not compliant Handrail not provided on both sides Not maintained in operable working condition	- - - -	Top: Ensure handrails extend horizontally above the landing for 12" min. beginning above the first riser nosing. Bottom: Ensure that the sloped bottom extension extends one tread depth min. beyond last riser nosing in same direction as stair flight. Provide handrails with 1 1/4" - 2" circular cross sections. Provide a handrail on both sides and ensure stairs are maintained in operable working condition.	1	-	\$0

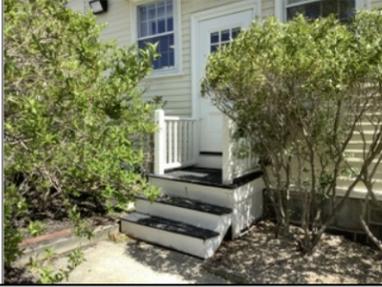
9	Egress Door #14	Ext.		Exterior Stair	N/A

Handrails not provided	-	Provide handrail on both sides.	1	-	\$0
<b>Entrance</b>												
10	Egress Door #13	Ext.		Entrance	Secondary Entrance

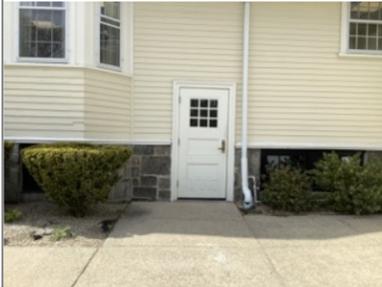
Directional sign to accessible entrance not provided	-	Provide a directional sign indicating the location of the nearest accessible entrance.	1	-	\$0

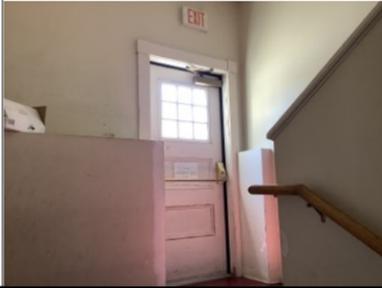
Tactile exit sign not provided	-	Ensure tactile exit signs with raised characters and braille are provided at exit doors. Mount signs between 48"- 60" above the finished floor located on the latch side of the door.	1	232	\$232
13	Main Entrance	1		Means of Egress	N/A

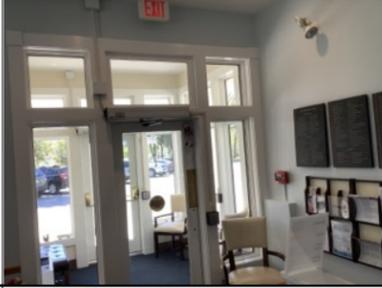
Tactile exit sign not provided Illuminated ISA symbol not provided (MAAB)	- -	Ensure tactile exit signs with raised characters and braille are provided at exit doors. Mount signs between 48"- 60" above the finished floor located on the latch side of the door. Provide an illuminated sign with the International Symbol of Accessibility (ISA).	1	432	\$432

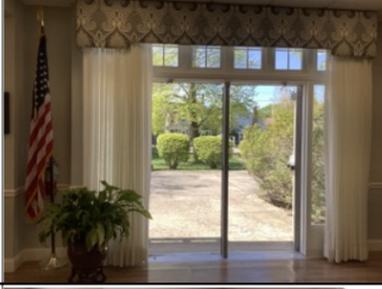
14	Egress Door #15 to Patio	1	113	Means of Egress	N/A

Tactile exit sign not provided Illuminated ISA symbol not provided (MAAB)	- -	Ensure tactile exit signs with raised characters and braille are provided at exit doors. Mount signs between 48"- 60" above the finished floor located on the latch side of the door. After the exterior landing is fixed, provide an illuminated sign with the International Symbol of Accessibility (ISA).  See ID #11.	1	432	\$432
15	To Stair #2	1		Means of Egress	N/A

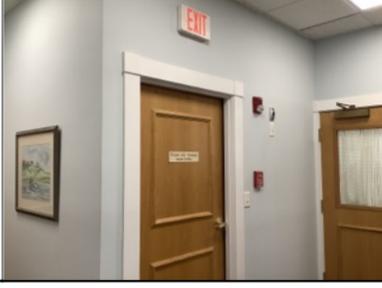
Tactile exit sign not provided Directional sign to accessible emergency exit not provided	- -	Ensure tactile exit signs with raised characters and braille are provided at exit doors. Mount signs between 48"- 60" above the finished floor located on the latch side of the door. Provide a directional sign indicating the location of the nearest accessible emergency exit.	1	464	\$464

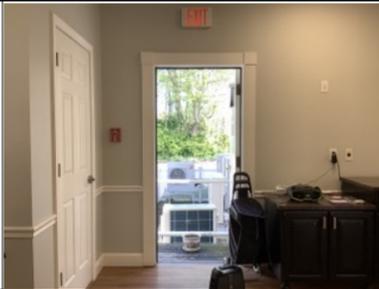
Tactile exit sign not provided Directional sign to accessible emergency exit not provided	- -	Ensure tactile exit signs with raised characters and braille are provided at exit doors. Mount signs between 48"- 60" above the finished floor located on the latch side of the door. Provide a directional sign indicating the location of the nearest accessible emergency exit.	1	464	\$464
17	Egress Door #14	1	113	Means of Egress	N/A

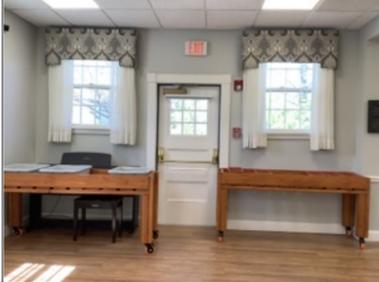
Tactile exit sign not provided Directional sign to accessible emergency exit not provided	- -	Ensure tactile exit signs with raised characters and braille are provided at exit doors. Mount signs between 48"- 60" above the finished floor located on the latch side of the door. Provide a directional sign indicating the location of the nearest accessible emergency exit.	1	464	\$464

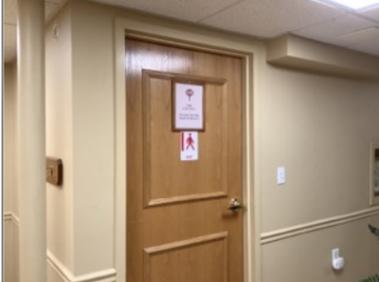
18	To Stair #2	Basement		Means of Egress	N/A

Tactile exit sign not provided	-	Ensure tactile exit signs with raised characters and braille are provided at exit doors. Mount signs between 48"- 60" above the finished floor located on the latch side of the door.	1	232	\$232
<b>Interior Access Route</b>												
19	Corridor by Elevator	2	203	Interior Access Route	N/A

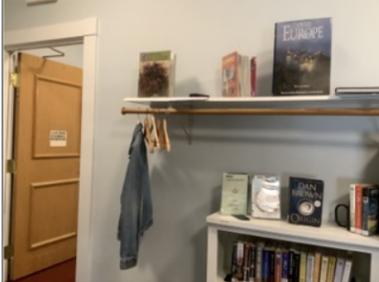
Obstructed by protruding objects	12"	Provide a cane-detectable barrier.	1	306	\$306
20	Stair #2	Basement		Interior Access Route	N/A

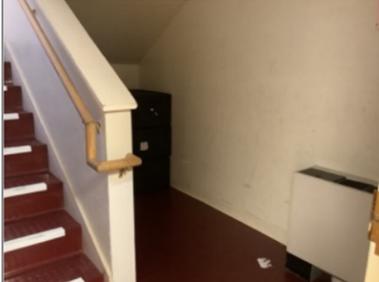
Vertical clearance < 80" above finished floor	-	Provide a cane-detectable barrier underneath stair.	1	960	\$960

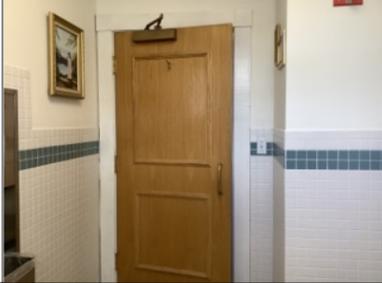
Door requires > 5 lbs. of force to open	10 lbs	Adjust closers so doors do not require more than 5 pounds of force to open.	1	Labor	\$0
23	Vestibule	1		Doors, Doorways, & Gates	Emergency Egress

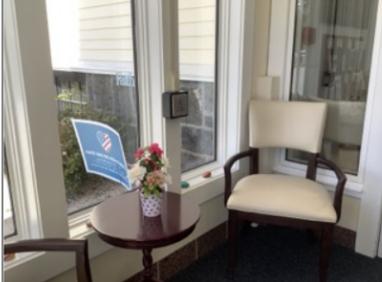
Clear floor space at opener not provided	-	Relocate furniture to maintain the required 30" min. by 48" min. clear floor space at automatic door opener.	1	Labor	\$0
24	Main Entry Egress #4	Ext.		Doors, Doorways, & Gates	Emergency Egress

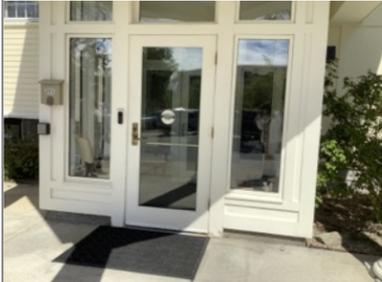
Clear width at door < 32" Mat not securely attached	28" -	Install offset hinges to ensure that the door has a clear width of 32 inches. Or widen the door so that there is 32" min. clear width. Secure the mat to prevent tripping hazard.	1	-	\$0

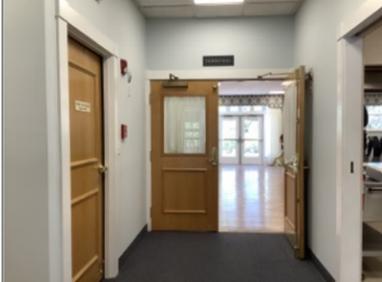
<b>Signage</b>												
25	To Tierney Hall	1	106	Signage	Designation

Raised characters not provided on sign Braille not provided on sign Sign not located on the latch side of the door	- - -	Provide text with raised characters duplicated in braille on sign. Locate the sign at permanent rooms alongside the door on the latch side.	1	232	\$232

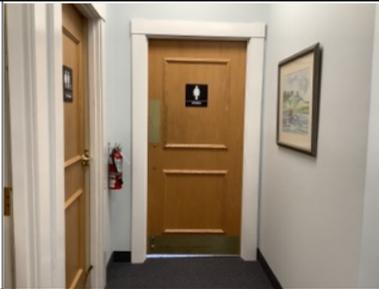
Sign not located on the latch side of the door	-	Locate the sign at permanent rooms alongside the door on the latch side.	1	Labor	\$0
27	Corridor by Toilet Rooms	1	110	Signage	Designation

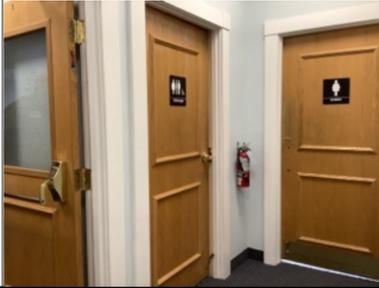
Sign not located on the latch side of the door	-	Locate the sign at permanent rooms alongside the door on the latch side.	1	Labor	\$0
28	Stair #2	2		Signage	Egress

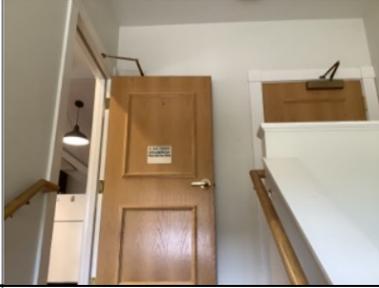
Signage is not provided	-	Locate compliant signage alongside the door on the latch side.	1	232	\$232
29	Egress Door #22 From Classroom to Stair #2	2	208	Signage	Egress

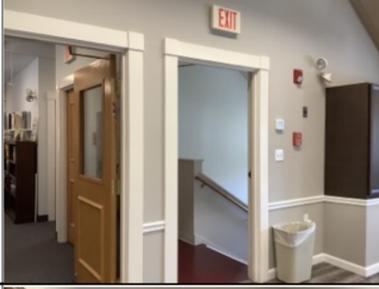
Signage is not provided	-	Locate compliant signage alongside the door on the latch side.	1	232	\$232
30	To Classroom	2	204	Signage	Designation

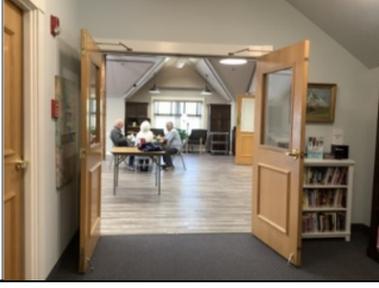
Signage is not provided	-	Locate compliant signage alongside the door on the latch side.	1	232	\$232

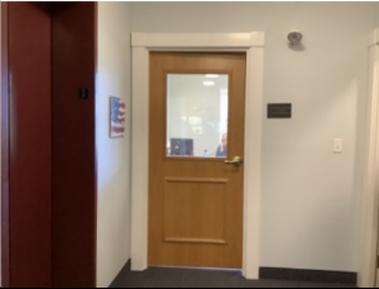
Raised characters not provided on sign Braille not provided on sign	- -	Provide text with raised characters duplicated in braille on sign.	1	232	\$232
32	Women's Toilet Room	2	207	Signage	Designation

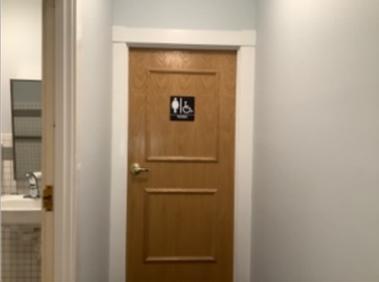
Sign not located on the latch side of the door	-	Locate the sign at permanent rooms alongside the door on the latch side.	1	Labor	\$0
33	Egress Door #20 From Library to Stair #2	2	204	Signage	Egress

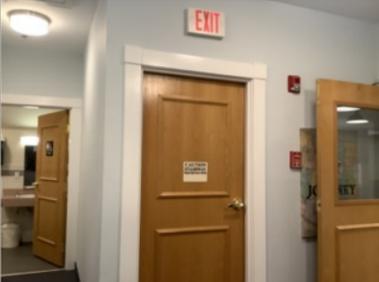
Sign not located on the latch side of the door	-	Locate the sign at permanent rooms alongside the door on the latch side.	1	Labor	\$0
34	Egress Door #17 to Stair #1	2	203	Signage	Egress

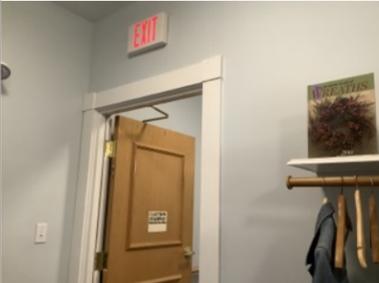
Sign not located on the latch side of the door	-	Locate the sign at permanent rooms alongside the door on the latch side.	1	Labor	\$0
35	By Elevator	Basement		Signage	Egress

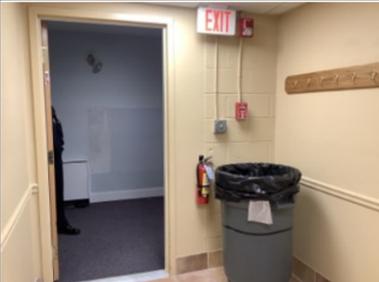
Signage is not provided	-	Locate compliant signage alongside the door on the latch side.	1	232	\$232

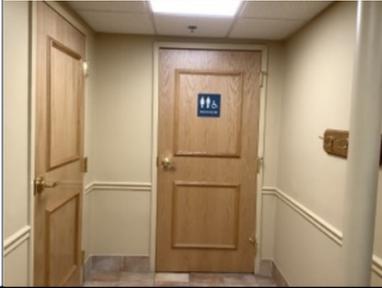
Sign not located on the latch side of the door	-	Locate the sign at permanent rooms alongside the door on the latch side.	1	Labor	\$0
<b>Dining or Work Surfaces</b>												
38	Lobby Check in Area	1		Dining or Work Surfaces	Work Surface

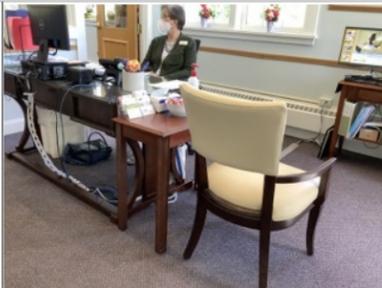
See ID #39.	1	-	\$0
39	Lobby Check in Area	1		Dining or Work Surfaces	Work Surface

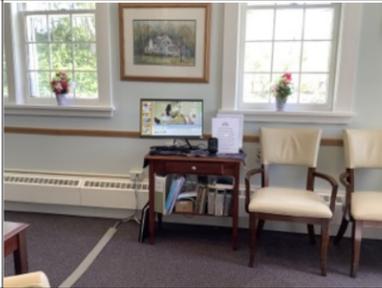
Knee or toe clearance not provided	-	Provide a work surface with 27" min. knee and toe clearance.  IHCD team was told that the table near the desk (See ID #38.) would be moved to this location.	1	-	\$0
40	Computer Stations	Basement		Dining or Work Surfaces	Work Surface

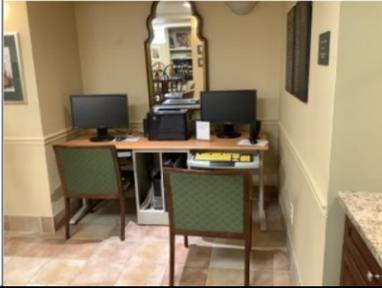
Knee or toe clearance not provided	25"	Provide at least one dining or work surface with 27" min. knee and toe clearance.	1	700	\$700

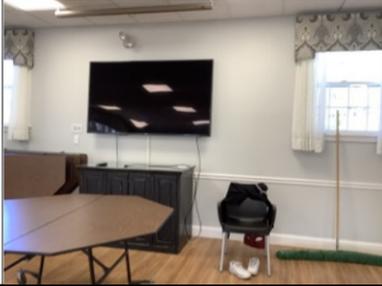
Assistive listening devices not provided	-	If audible communication is integral to the use of the space, provide an assistive listening system.	1	1214	\$1214
42	Conference Room	2	209	Assembly Area	N/A

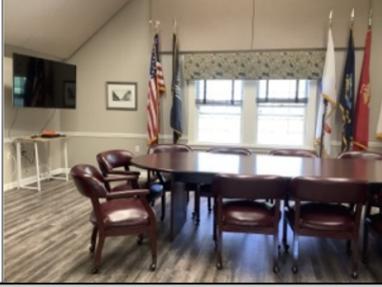
Assistive listening devices not provided	-	If audible communication is integral to the use of the space, provide an assistive listening system.	1	1214	\$1214
<b>Kitchens and Kitchenettes</b>												
43	Kitchen	1	109	Kitchens and Kitchenettes	N/A

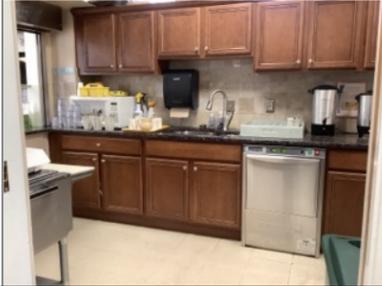
If members of the public use the kitchen, knee and toe clearance at the sink is required.	1	-	\$0
<b>Toilet &amp; Bathing Rooms</b>												
<b>Lavatory</b>												
44	Single-User Toilet Room	Basement		Lavatory	N/A

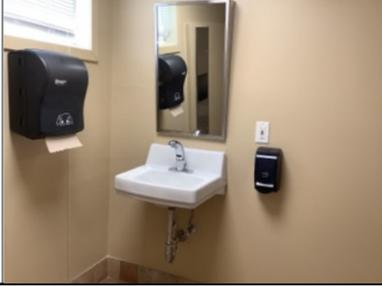
Plumbing underneath is exposed	-	Insulate or otherwise configure pipes to prevent contact for at least one lavatory.	1	92	\$92

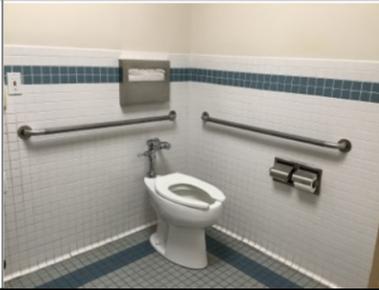
Toilet cover dispenser is not compliant	-	Relocate toilet cover dispenser so the operable parts are no higher than 42" on the side of the toilet. Ensure is located under the rear grab bar.	1	353	\$353
46	Single-User Toilet Room	1	111	Single-User Toilet	N/A

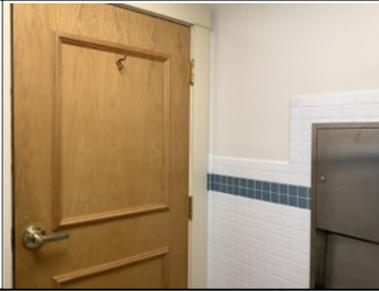
Hook located > 48" high (2010 ADA)	70.5"	Locate the coat hook no higher than 48" above the finished floor.	1	150	\$150
47	Men's Toilet Room	2	206	Single-User Toilet	N/A
