# ADA Self-Evaluation and Transition Plan for the City of Melrose

Part 2 of 2

## Part 2: Reports:

January, 2023

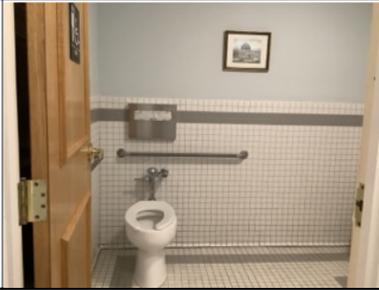
Flush control not on open side Toilet cover dispenser is not compliant	- -	Relocate the flush control to the open side. Relocate toilet cover dispenser so the operable parts are no higher than 42" on the side of the toilet. Ensure is located under the rear grab bar.	1	727	\$727

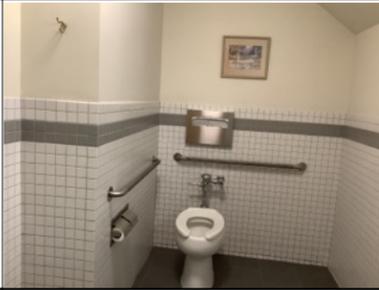
48	Women's Toilet Room	2	207	Single-User Toilet	N/A

Flush control not on open side Toilet cover dispenser is not compliant	- -	Relocate the flush control to the open side. Relocate toilet cover dispenser so the operable parts are no higher than 42" on the side of the toilet. Ensure is located under the rear grab bar.	1	727	\$727
49	Men's Toilet Room	2	206	Single-User Toilet	N/A

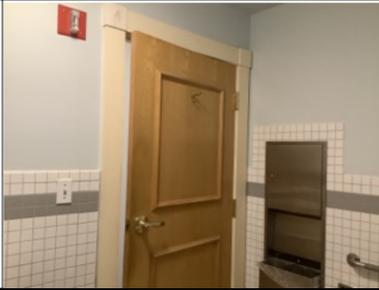
Hook located > 54" high	69.5"	Locate the coat hook no higher than 48" above the finished floor.	1	150	\$150

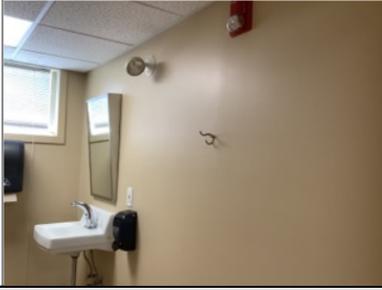
Coat hook > 48" (2010 ADA)	58"	Locate the coat hook no higher than 48" above the finished floor.	1	150	\$150

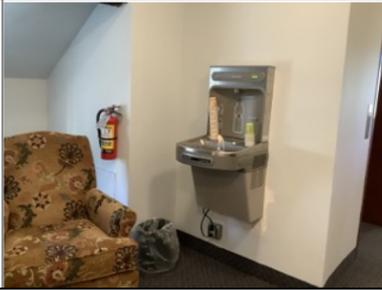
Clear floor space not provided No drinking fountain provided for seated users	- -	Relocate chair to maintain the required 30" min. by 48" min. clear floor space positioned for a forward approach at the drinking fountain. Provide an additional drinking fountain for seated users or install a Hi-Lo drinking fountain.	1	4028	\$4028
<b>Sink</b>												
54	Kitchen	Basement		Sink	Kitchenette

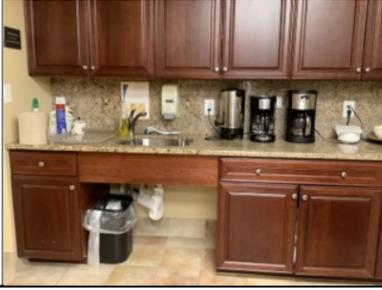
If members of the public use sink, ensure the knee clearance is maintained at all times.	1	-	\$0

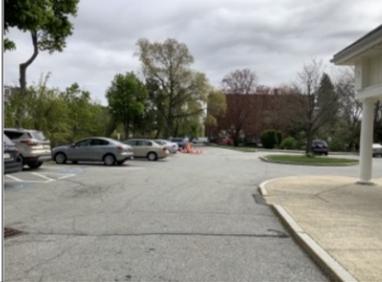
Recommend connecting island to curb ramp at main entry with pedestrian cross walk.	1	-	\$0
<b>Elevator</b>												
56	Lobby Check-in Area	1		Elevator	Interior

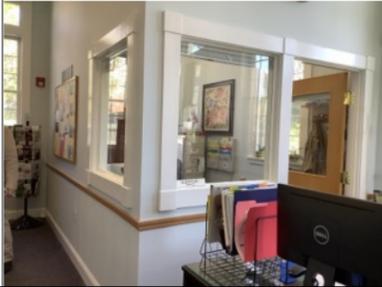
Recommend locating sign for elevator higher and increase volume of elevator bell.	1	-	\$0
<b>Exterior Ramp</b>												
57	Patio Towards Egress #14	Ext.		Exterior Ramp	Exterior

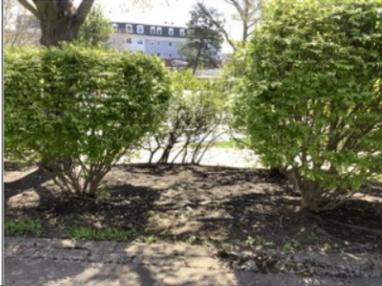
Recommend providing a ramp at this location.	1	-	\$0
<b>Elevator</b>												
58	By Elevator	Basement	001	Elevator	N/A

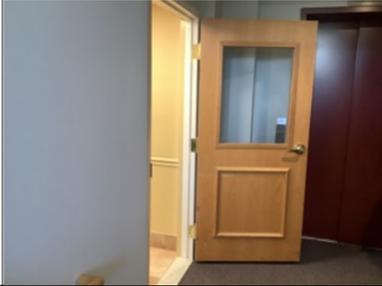
Recommend keeping door closed to provide access to the elevator call buttons.	1	-	\$0

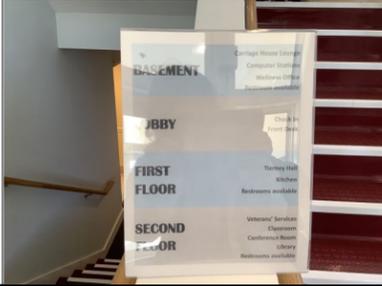
Recommend relocating sign to prevent glare.	1	-	\$0
60	Storage	Basement		Signage	N/A

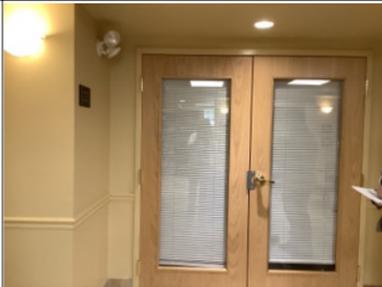
Recommend replacing the sign that reads, "Conference Room" with a sign that reads, "Storage", to reflect the actual use of the room.	1	-	\$0
<b>Stop Wheel</b>												
61	Parking by Milano Center	Ext.		Stop Wheel	N/A

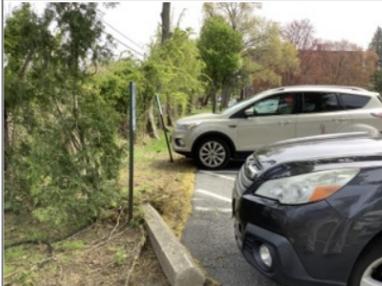
Recommend adding wheel stops at the end of parking spaces in the parking lot (east side) to help prevent cars from blocking the accessible route on the walkway.	1	-	\$0

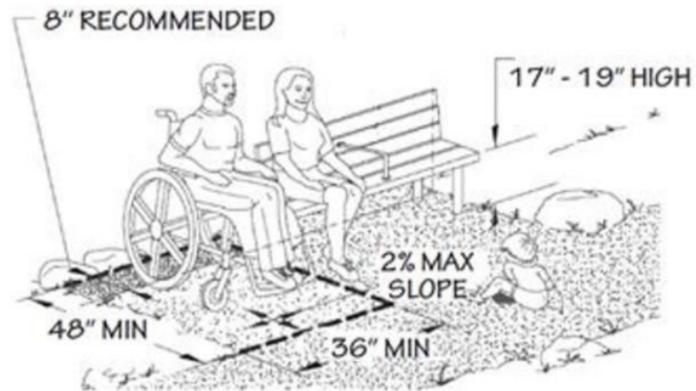
- Recommend providing a 36" x 48" stable, firm and slip-resistant surface adjacent to the bench near the basketball court positioned to allow a person in a wheeled mobility device and a person sitting on the bench to have their shoulders aligned in a manner that is substantially similar to what is shown in Figure 1 below:

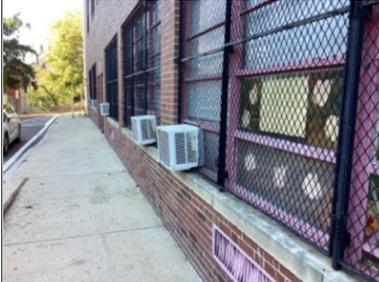
ID	Location	Floor	Room	Element	Type	Photo	Issues	Current Measure	Recommendations	Quantity	Price	Cost Estimation
<b>Approach and Entrance</b>												
<b>Exterior Access Route</b>												
1	By Staff Side Parking	Ext.		Exterior Access Route	Exterior

Obstructed by protruding objects	5.5"	Provide a cane-detectable barrier 27" max. above the ground below the air conditioners.	1	-	\$0
2	Towards Entrance by the Lower Third Playground	Ext.		Exterior Access Route	Sidewalk

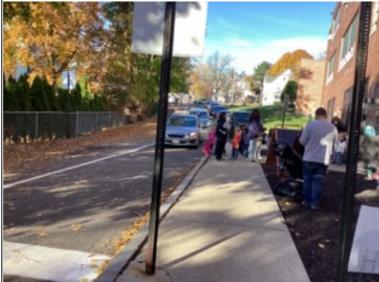
Obstructed by protruding objects Vertical clearance < 80" above ground	10" 73"	Reposition so the base of the sign is at least 80" above the ground.	1	-	\$0
3	By Playground Entry	Ext.		Exterior Access Route	Exterior

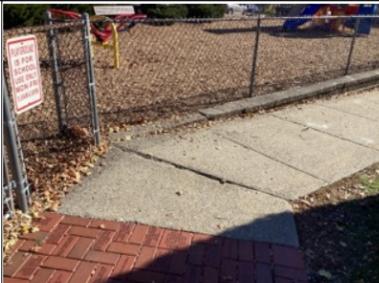
Surface openings > 1/2"	1"	Replace or reposition so that openings are 1/2" max. and the long opening dimension is perpendicular to the dominant direction of travel.	1	-	\$0
4	Drain by Playground	Ext.		Exterior Access Route	Exterior

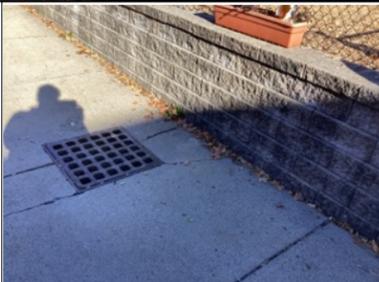
Surface openings > 1/2"	2.5"	Replace or reposition drain cover so that openings are 1/2" max. and the long opening dimension is perpendicular to the dominant direction of travel.	1	-	\$0

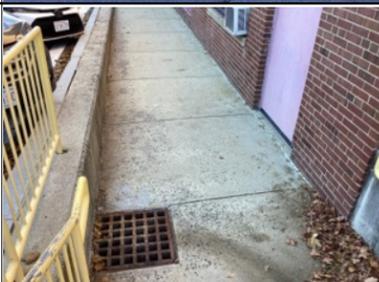
5	By Side Staff Parking	Ext.		Exterior Access Route	Walkway

Surface openings > 1/2"	2"	Replace or reposition drain cover so that openings are 1/2" max. and the long opening dimension is perpendicular to the dominant direction of travel.	1	-	\$0

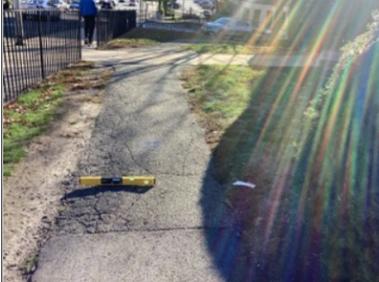
ID	Location	Floor	Room	Element	Type	Photo	Issues	Current Measure	Recommendations	Quantity	Price	Cost Estimation
6	Towards Staff Parking	Ext.		Exterior Access Route	Walkway

Cross slope > 1:50 (2.00%)	7.7%	Reduce cross slope to be no steeper than 1:50 (2.00%).	1	-	\$0
7	Towards Entrance by the Lower Third Playground	Ext.		Exterior Access Route	Sidewalk

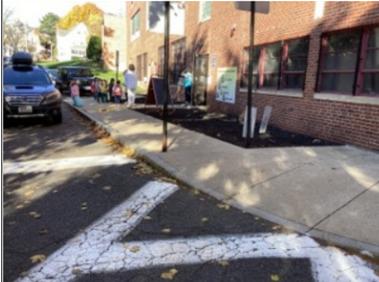
Cross slope > 1:50 (2.00%)	6%	Reduce cross slope to be no steeper than 1:50 (2.00%).	1	-	\$0
8	Near Doors 11 and 12	Ext.		Exterior Access Route	Sidewalk

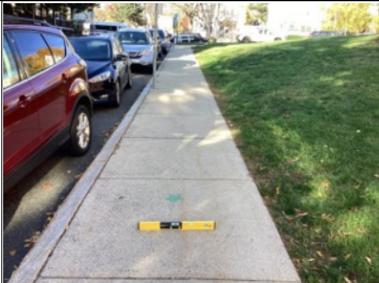
Cross slope > 1:50 (2.00%)	5.5%	Reduce cross slope to be no steeper than 1:50 (2.00%).	1	-	\$0
9	From Top of Handicap Drop-Off Area Towards Main Entrance	Ext.		Exterior Access Route	Walkway

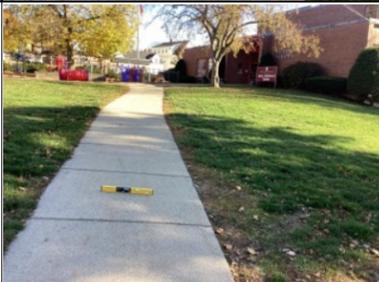
Cross slope > 1:50 (2.00%) Running slope > 1:20 (5.00%)	8.5% 7.2%	Reduce cross slope to be no steeper than 1:50 (2.00%). Reduce running slope to be no steeper than 1:20 (5.00%).	1	-	\$0

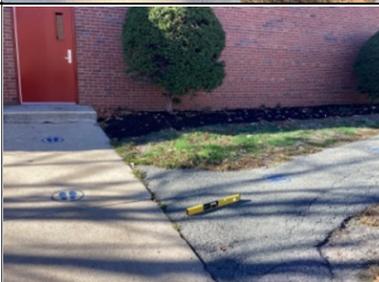
10	Near Side Parking	Ext.		Exterior Access Route	Exterior

Running slope > 1:20 (5.00%)	9.2%	Reduce running slope to be no steeper than 1:20 (5.00%).	1	-	\$0

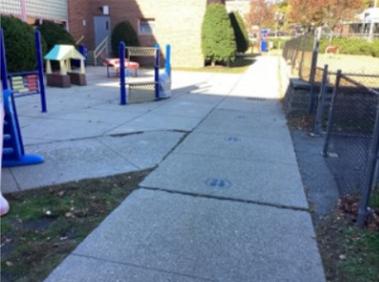
ID	Location	Floor	Room	Element	Type	Photo	Issues	Current Measure	Recommendations	Quantity	Price	Cost Estimation
11	Towards Playground	Ext.		Exterior Access Route	Walkway

Level changes > 1/4"	1"	Alter change in level to be 1/4" high max.	1	-	\$0
12	Towards Early Entry	Ext.		Exterior Access Route	Exterior

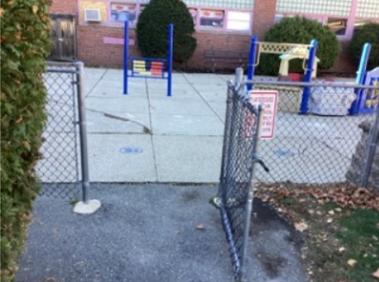
Level changes > 1/4"	1"	Alter change in level to be 1/4" high max.	1	-	\$0
13	Towards Early Entry	Ext.		Exterior Access Route	Walkway

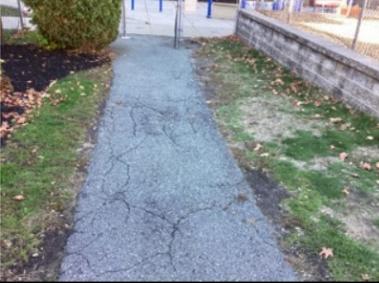
Route not maintained in operable working condition	-	Ensure the accessible route is maintained in operable working condition.	1	-	\$0
14	By Main Entrance	Ext.		Exterior Access Route	Exterior

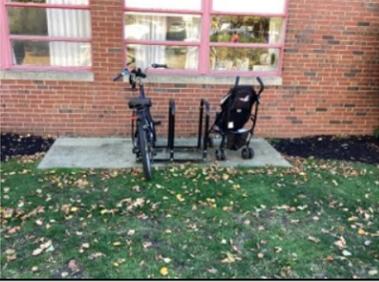
Accessible route not provided	-	Ensure an accessible route is provided to the bike rack.	1	-	\$0
<b>Curb Ramp</b>												
15	By Designated Accessible Entrance	Ext.		Curb Ramp	N/A

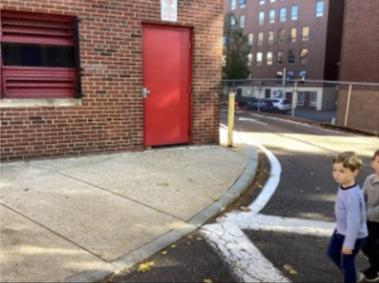
Landing not provided at top of curb ramp	-	Provide a compliant landing at top of curb ramp or reconfigure ramp.	1	-	\$0

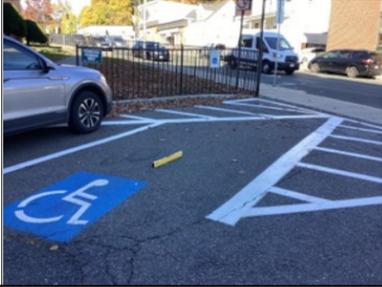
ID	Location	Floor	Room	Element	Type	Photo	Issues	Current Measure	Recommendations	Quantity	Price	Cost Estimation
<b>Off-Street Parking Lot or Garage</b>												
16	Accessible Parking in Staff Lot at Side of Building	Ext.		Off-Street Parking Lot or Garage	Employee

Total # of parking Access aisle not compliant Running or cross slope at access aisle > 1:50 (2.00%) Sign does not have the designation "Van Accessible" Sign bottom < 60" above finished grade	6 - 6.2% - 30"	Provide a marked access aisle that is at least 60" wide./Provide a marked access aisle that is at least 60" wide at the car accessible space and 96" wide at the van accessible space. Reduce running or cross slope to be no steeper than 1:50 (2.00%). Add the designation "Van Accessible" to the sign located at the van accessible space. Locate sign with the bottom of the sign 60" above the ground.	1	-	\$0
<b>Access to Goods and Services</b>

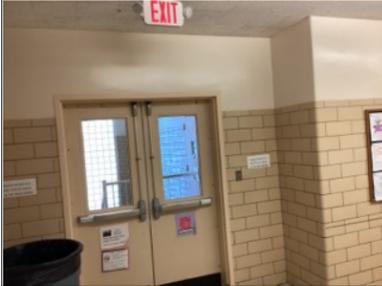
<b>Means of Egress</b>												
17	Egress to Stairs	UL		Means of Egress	N/A

Tactile exit sign not provided	-	Ensure tactile exit signs with raised characters and braille are provided at exit doors. Mount signs between 48"- 60" above the finished floor located on the latch side of the door.	1	232	\$232
18	Hallway Doors	UL		Means of Egress	N/A

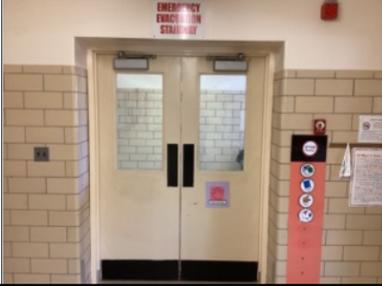
Tactile exit sign not provided	-	Ensure tactile exit signs with raised characters and braille are provided at exit doors. Mount signs between 48"- 60" above the finished floor located on the latch side of the door. If the door has two active leafs, mount sign to the right of the door on the right side.	1	232	\$232
19	Hallway	ML		Means of Egress	N/A

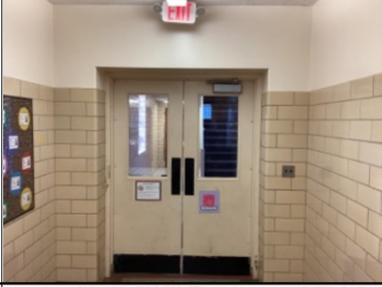
Tactile exit sign not provided	-	Ensure tactile exit signs with raised characters and braille are provided at exit doors. Mount signs between 48"- 60" above the finished floor located on the latch side of the door.	1	232	\$232

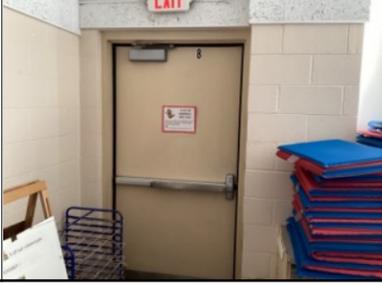
20	Door 8	LL	3	Means of Egress	N/A

Tactile exit sign not provided	-	Ensure tactile exit signs with raised characters and braille are provided at exit doors. Mount signs between 48"- 60" above the finished floor located on the latch side of the door. When the exterior landing has been made accessible, provide an illuminated sign with the International Symbol of Accessibility (ISA).	1	232	\$232

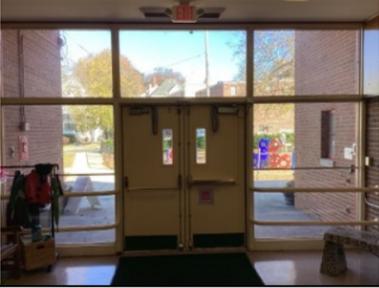
ID	Location	Floor	Room	Element	Type	Photo	Issues	Current Measure	Recommendations	Quantity	Price	Cost Estimation
21	Main Entrance/Exit	ML		Means of Egress	N/A

Tactile exit sign not provided Illuminated ISA symbol not provided (MAAB)	- -	Ensure tactile exit signs with raised characters and braille are provided at exit doors. Mount signs between 48"- 60" above the finished floor located on the latch side of the door. When the illuminated exit sign is repaired or replaced, provide an illuminated sign with the International Symbol of Accessibility (ISA).	1	232	\$232
22	Hallway	ML		Means of Egress	N/A

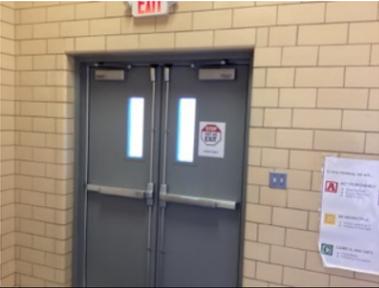
Tactile exit sign not provided Illuminated ISA symbol not provided (MAAB)	- -	Ensure tactile exit signs with raised characters and braille are provided at exit doors. Mount signs between 48"- 60" above the finished floor located on the latch side of the door. When the illuminated exit sign is repaired or replaced provide an illuminated sign with the International Symbol of Accessibility (ISA).	1	232	\$232

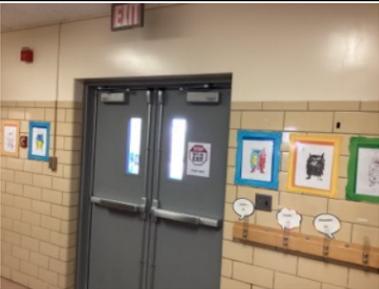
23	Near Room 26	ML		Means of Egress	N/A

Tactile exit sign not provided Illuminated ISA symbol not provided (MAAB)	- -	Ensure tactile exit signs with raised characters and braille are provided at exit doors. Mount signs between 48"- 60" above the finished floor located on the latch side of the door. When the illuminated exit sign is repaired or replaced provide an illuminated sign with the International Symbol of Accessibility (ISA).	1	232	\$232
24	STEM Door 12	LL	1	Means of Egress	N/A

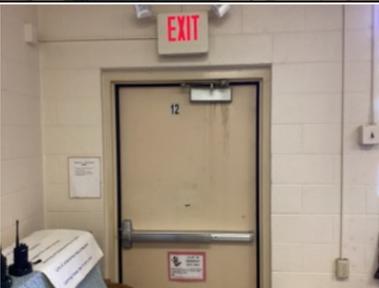
Tactile exit sign not provided Illuminated ISA symbol not provided (MAAB)	- -	Ensure tactile exit signs with raised characters and braille are provided at exit doors. Mount signs between 48"- 60" above the finished floor located on the latch side of the door. When the illuminated exit sign is repaired or replaced provide an illuminated sign with the International Symbol of Accessibility (ISA).	1	232	\$232

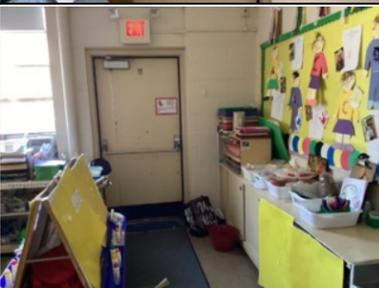
25	Classroom 2	LL	2	Means of Egress	N/A

Tactile exit sign not provided Illuminated ISA symbol not provided (MAAB)	- -	Ensure tactile exit signs with raised characters and braille are provided at exit doors. Mount signs between 48"- 60" above the finished floor located on the latch side of the door. When the illuminated exit sign is repaired or replaced provide an illuminated sign with the International Symbol of Accessibility (ISA).	1	232	\$232

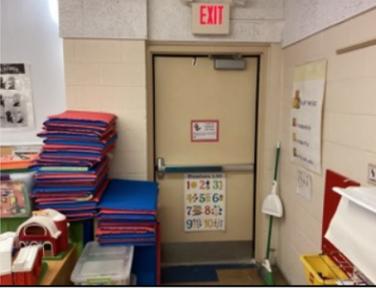
ID	Location	Floor	Room	Element	Type	Photo	Issues	Current Measure	Recommendations	Quantity	Price	Cost Estimation
26	Door 7	LL	4	Means of Egress	N/A

Tactile exit sign not provided Illuminated ISA symbol not provided (MAAB)	-	Ensure tactile exit signs with raised characters and braille are provided at exit doors. Mount signs between 48"- 60" above the finished floor located on the latch side of the door. When the exterior landing has been made accessible, provide an illuminated sign with the International Symbol of Accessibility (ISA).	1	232	\$232
27	Exit by Staff Toilet Room	ML		Means of Egress	N/A

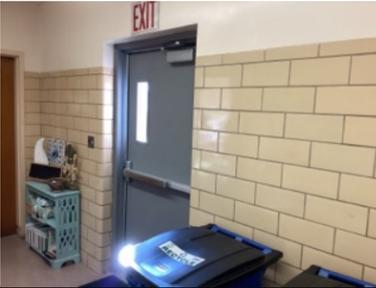
Tactile exit sign not provided Directional sign to accessible emergency exit not provided	- -	Ensure tactile exit signs with raised characters and braille are provided at exit doors. Mount signs between 48"- 60" above the finished floor located on the latch side of the door. Provide a directional sign indicating the location of the nearest accessible emergency exit.	2	232	\$464

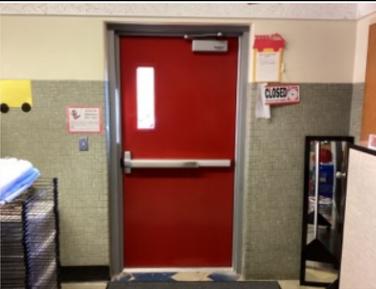
28	Pre-K	ML	26	Means of Egress	N/A

Tactile exit sign not provided Directional sign to accessible emergency exit not provided	- -	Ensure tactile exit signs with raised characters and braille are provided at exit doors. Mount signs between 48"- 60" above the finished floor located on the latch side of the door. Provide a directional sign indicating the location of the nearest accessible emergency exit.	2	232	\$464
29	Door 10	LL		Means of Egress	N/A

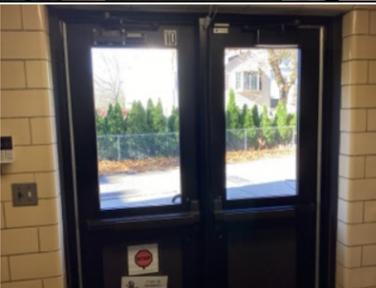
Tactile exit sign not provided Directional sign to accessible emergency exit not provided	- -	Ensure tactile exit signs with raised characters and braille are provided at exit doors. Mount signs between 48"- 60" above the finished floor located on the latch side of the door. Widen at least one leaf of the door so that there is 32" min. clear width or provide a directional sign indicating the location of the nearest accessible emergency exit.	2	232	\$464

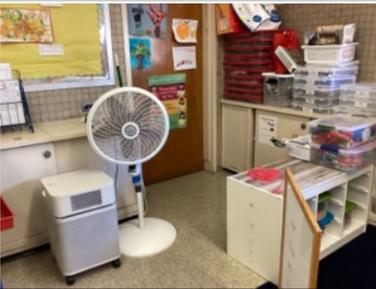
<b>Interior Access Route</b>												
30	Near Passage Connecting to Room 22	ML	21	Interior Access Route	N/A

Route < 36" wide	14"	Ensure that a clear width of 36" min. is maintained at the accessible route.	1	Labor	\$0

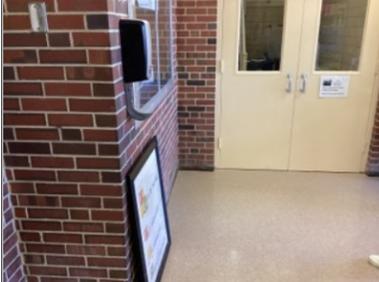
ID	Location	Floor	Room	Element	Type	Photo	Issues	Current Measure	Recommendations	Quantity	Price	Cost Estimation
31	Hallway	UL		Interior Access Route	N/A

Obstructed by protruding objects	-	Relocate object out of the accessible route or provide a cane-detectable barrier 27" max. above the floor below the dispenser.	1	306	\$306
32	Cafeteria	ML		Interior Access Route	N/A

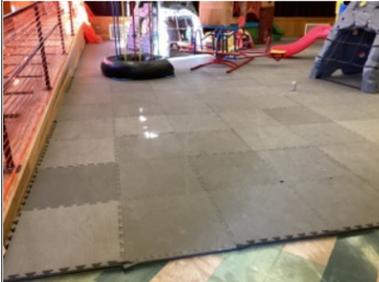
Level changes > 1/4"	1"	Alter change in level to be 1/4" high max.	1	Labor	\$0
33	Stairwell	ML		Interior Access Route	N/A

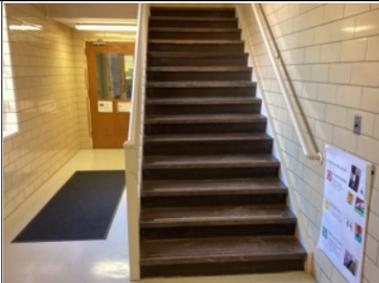
Accessible route not provided	- -	Provide an accessible route to all floors of the school. (Cost based on adding a new exterior shaft and elevator to the building.) <b>Note:</b> Precise costing of this recommendation is beyond the scope of this project.	1	282,008	\$282008
<b>Doors, Doorways, &amp; Gates</b>												
34	Entrance on the Southwest Side of the School by the Third Lower Playground	Ext.		Doors, Doorways, & Gates	Other

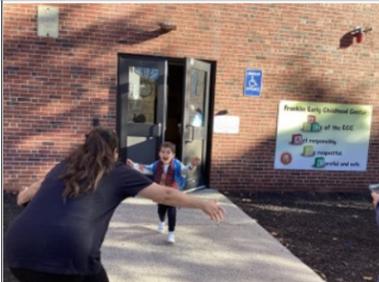
Clear width at door < 32"	29"	Widen at least one leaf of the door so that there is 32" min. clear width.	1	-	\$0

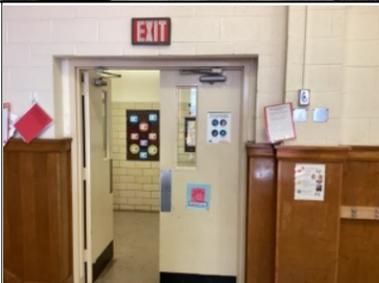
35	Cafeteria	ML		Doors, Doorways, & Gates	N/A

Clear width at door < 32"	28"	Widen the door so that there is 32" min. clear width for at least one leaf in the door.	1	3366	\$3366

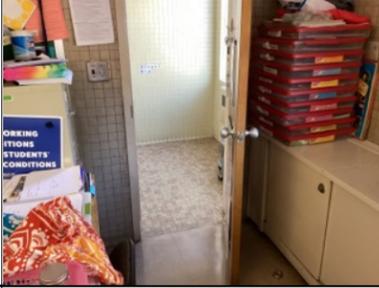
ID	Location	Floor	Room	Element	Type	Photo	Issues	Current Measure	Recommendations	Quantity	Price	Cost Estimation
36	Gender Neutral Toilet Room	ML	22	Doors, Doorways, & Gates	Toilet Room

Clear width at door < 32" Maneuvering clearance(s) not provided Hardware not operable with a closed fist	26" 13.5" -	Widen the door so that there is 32" min. clear width. Relocate the filing cabinet and desk to provide 18" min. pull-side maneuvering clearance at the door. Provide hardware that can be operable with one hand and not require tight grasping, pinching, or twisting of the wrist.	1	3850	\$3850
37	Pre-K	ML	26	Doors, Doorways, & Gates	Toilet Room

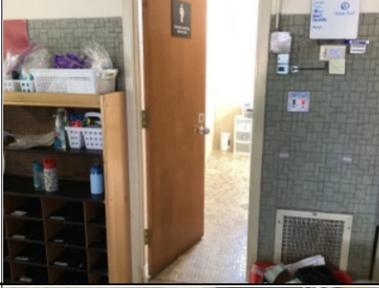
Clear width at door < 32" Hardware not operable with a closed fist	27" -	Widen the door so that there is 32" min. clear width. Provide hardware that can be operable with one hand and not require tight grasping, pinching, or twisting of the wrist.	1	3850	\$3850

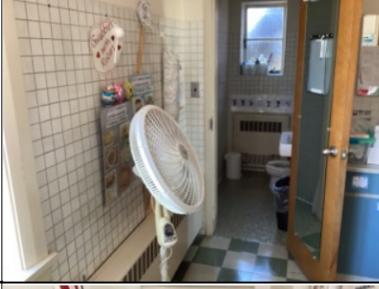
38	Gender Neutral Toilet Room in Nurse's Office	ML		Doors, Doorways, & Gates	Toilet Room

Clear width at door < 32" Hardware not operable with a closed fist	24" -	Widen the door so that there is 32" min. clear width. Provide hardware that can be operable with one hand and not require tight grasping, pinching, or twisting of the wrist. Note: Cost to widen door and to replace the door hardware is included in the cost for providing an accessible single-user toilet room at or near this location.	1	-	\$0
39	Classroom	ML	20	Doors, Doorways, & Gates	Classroom

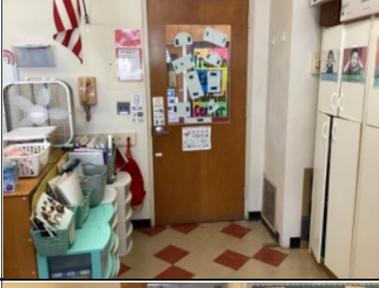
Maneuvering clearance(s) not provided	-	Relocate the desk and stored objects to provide 18" min. pull-side maneuvering clearance at the door.	1	Labor	\$0
40	Door Connecting to Room 21	ML	22	Doors, Doorways, & Gates	Classroom

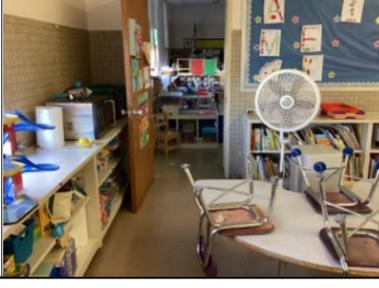
Maneuvering clearance(s) not provided	7"	Relocate the bookshelf to provide maneuvering clearance at the door.	1	Labor	\$0

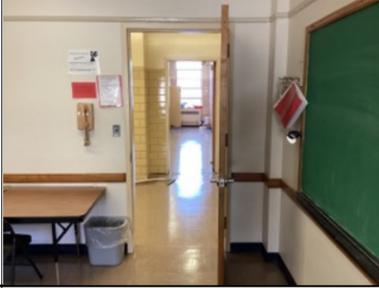
Maneuvering clearance(s) not provided	-	Relocate the desk to provide 18" min. pull-side maneuvering clearance at the door.	1	Labor	\$0
42	Library	UL		Doors, Doorways, & Gates	Other

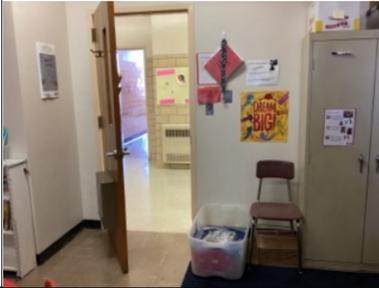
Maneuvering clearance(s) not provided	-	Relocate the plastic bin to provide 18" min. pull-side maneuvering clearance at the door.	1	Labor	\$0
43	Kindergarten	UL	32	Doors, Doorways, & Gates	Classroom

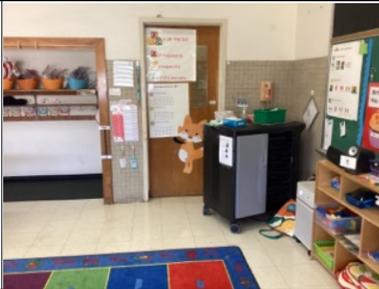
Maneuvering clearance(s) not provided	-	Relocate the cart to provide maneuvering clearance at the door.	1	Labor	\$0
44	Classroom Near the Girls' Toilet Room	UL	35	Doors, Doorways, & Gates	Classroom

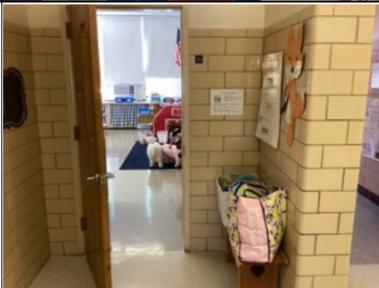
Maneuvering clearance(s) not provided	-	Relocate the bench and stored items to provide 18' min. pull-side maneuvering clearance at the door.	1	Labor	\$0

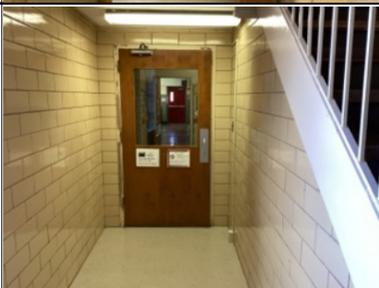
45	Hallway	ML		Doors, Doorways, & Gates	Circulation

Maneuvering clearance(s) not provided	9.5"	Provide an automatic door opener.	1	3060	\$3060

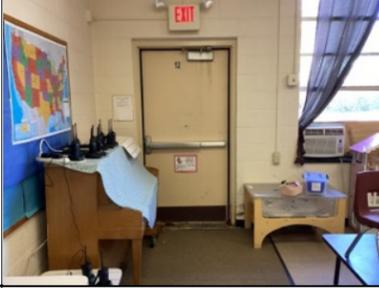
Maneuvering clearance(s) not provided	-	Relocate the piano to provide 12" min. push side maneuvering clearance at the door.	1	Labor	\$0
47	Girls' Toilet Room	UL		Doors, Doorways, & Gates	Toilet Room

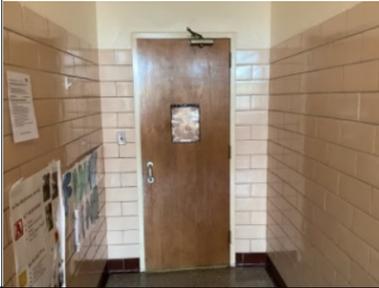
Maneuvering clearance(s) not provided Door requires > 5 lbs. of force to open	14.5" 12 lbs	Provide an automatic door opener. Adjust closers so doors do not require more than 5 pounds of force to open and so that the door remains open for at least five seconds.	1	3060	\$3060
48	Boys' Toilet Room	UL		Doors, Doorways, & Gates	Toilet Room

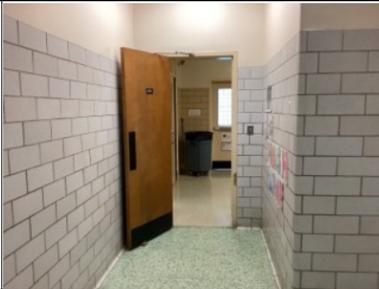
Maneuvering clearance(s) not provided Door requires > 5 lbs. of force to open	12" 16 lbs.	Provide an automatic door opener. Adjust closers so doors do not require more than 5 pounds of force to open.	1	3060	\$3060

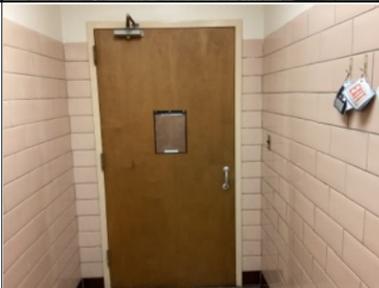
49	Girls' Toilet Room	LL		Doors, Doorways, & Gates	Toilet Room

Maneuvering clearance(s) not provided Door requires > 5 lbs. of force to open	8.5" 14 lbs.	Provide an automatic door opener. Adjust closers so doors do not require more than 5 pounds of force to open.	1	3060	\$3060
50	Men's Toilet Room	ML		Doors, Doorways, & Gates	Toilet Room

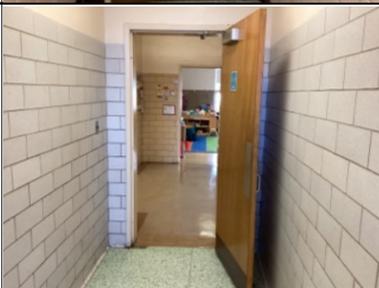
Maneuvering clearance not provided at recess > 6"	9"	Install an automatic door opener.	1	3060	\$3060

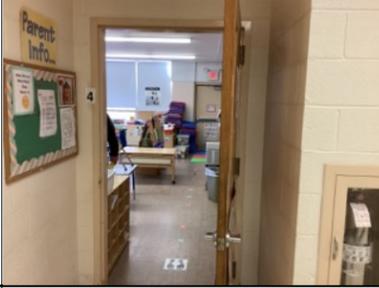
Maneuvering clearance not provided at recess > 6"	-	Install an automatic door opener.	1	3060	\$3060
52	Doors 7 and 8	Ext.		Doors, Doorways, & Gates	Other

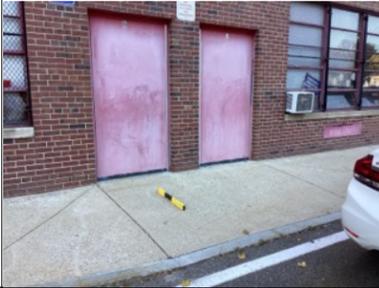
Maneuvering clearance at door > 1:50 (2.00%)	11.4%	Alter so that the slope in all directions is no greater than 1:50 (2.00%).	1	-	\$0
53	Near Passage to Room 22	ML	21	Doors, Doorways, & Gates	Classroom

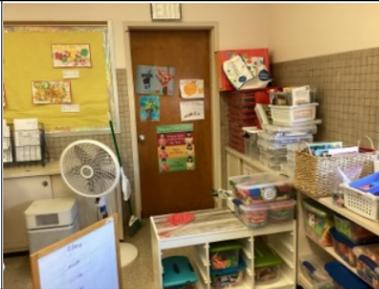
Hardware not operable with a closed fist	-	Provide hardware that can be operable with one hand and not require tight grasping, pinching, or twisting of the wrist.	1	484	\$484
54	Towards Cafeteria	ML		Doors, Doorways, & Gates	Circulation

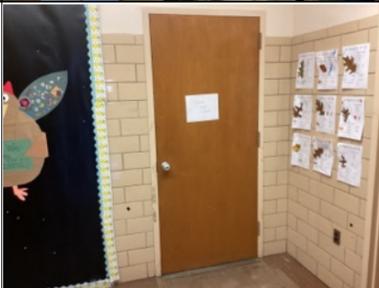
Hardware not operable with a closed fist	-	Provide hardware that can be operable with one hand and not require tight grasping, pinching, or twisting of the wrist.	1	484	\$484

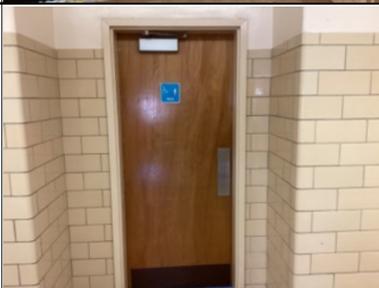
55	Men's Toilet Room	ML		Doors, Doorways, & Gates	Toilet Room

Door requires > 5 lbs. of force to open	10 lbs	Adjust closers so doors do not require more than 5 pounds of force to open.	1	Labor	\$0

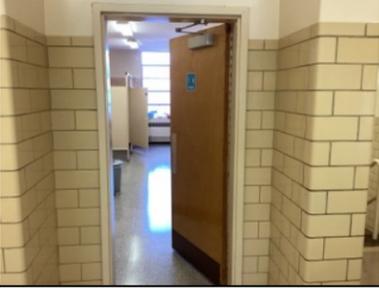
Door requires > 5 lbs. of force to open	14 lbs	Adjust closers so doors do not require more than 5 pounds of force to open.	1	Labor	\$0
57	Hallway Doors	UL		Doors, Doorways, & Gates	Circulation

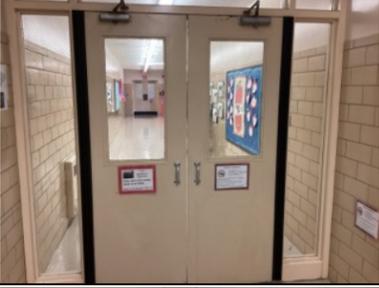
Door requires > 5 lbs. of force to open	20 lbs.	Adjust closers so doors do not require more than 5 pounds of force to open.	1	Labor	\$0
58	Hallway Doors	UL		Doors, Doorways, & Gates	Emergency Egress

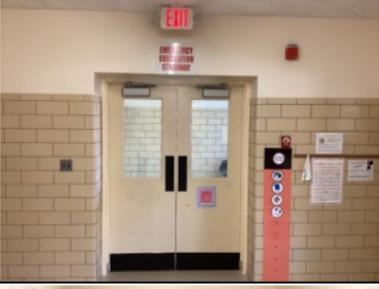
Door requires > 5 lbs. of force to open	15 lbs	Adjust closers so doors do not require more than 5 pounds of force to open.	1	Labor	\$0
59	Gentlemen's Toilet Room	LL		Doors, Doorways, & Gates	Toilet Room

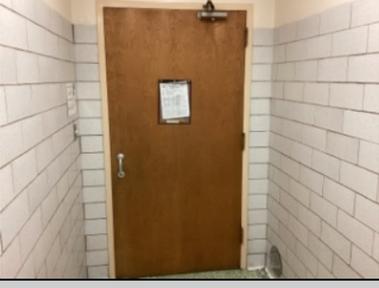
Door requires > 5 lbs. of force to open	14 lbs	Adjust closers so doors do not require more than 5 pounds of force to open.	1	Labor	\$0

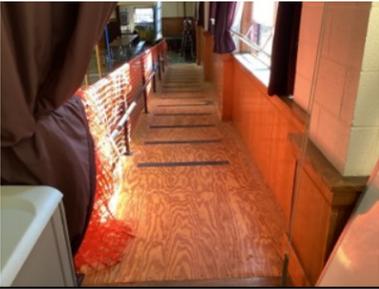
<b>Ramps</b>												
60	Cafeteria - Ramped Route to Stage	ML		Ramps	Interior

Handrails not provided at both sides if rise is > 6" Edge protection < 4" high	- -	Provide handrails on both sides. Provide edge protection that prevents the passage of a 4" diameter sphere, where any portion of the sphere is within 4" of the finished floor or ground surface. (Cost based on 30' of edge protection on one side of ramp.)	1	1260	\$1260

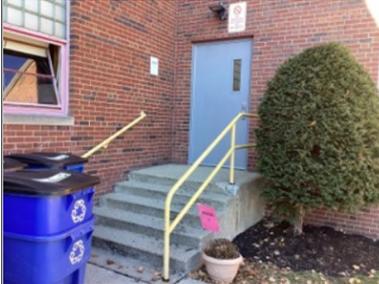
Handrails do not extend 12" from stairs	-	Top: Ensure handrails extend horizontally above the landing for 12" min. beginning above the first riser nosing on the hinge side of the door. Bottom: Ensure handrails extend to one tread depth beyond the last riser.	1	-	\$0
62	By Side Staff Parking	Ext.		Stairways	Egress

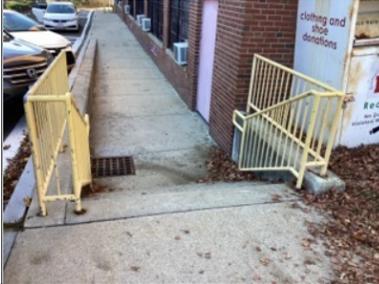
Handrails do not extend 12" from stairs	-	Top: Ensure handrails extend horizontally above the landing for 12" min. beginning above the first riser nosing.	1	-	\$0
63	Towards Cafeteria	ML		Stairways	Other

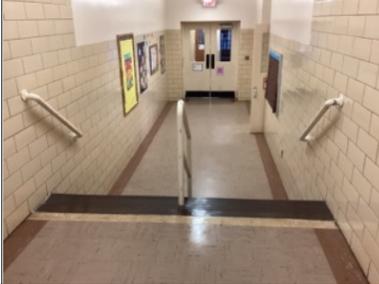
Handrails do not extend 12" from stairs	-	Top: Ensure handrails extend horizontally above the landing for 12" min. beginning above the first riser nosing. Bottom: Ensure handrails extend to one tread depth beyond the last riser.	1	-	\$0

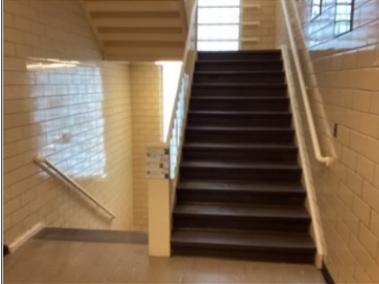
64	Stairwell	ML		Stairways	Egress

Handrails do not extend 12" from stairs	-	Top: Ensure handrails extend horizontally above the landing for 12" min. beginning above the first riser nosing. Bottom: Ensure handrails extend to one tread depth beyond the last riser.	1	-	\$0
65	Stairwell	ML		Stairways	Egress

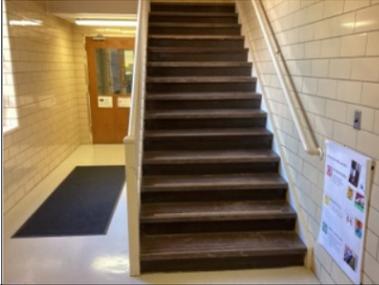
Handrails do not extend 12" from stairs	-	Top: Ensure handrails extend horizontally above the landing for 12" min. beginning above the first riser nosing. Bottom: Ensure handrails extend to one tread depth beyond the last riser.	1	-	\$0

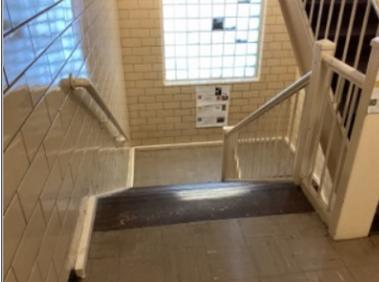
Handrails do not extend 12" from stairs	-	Top: Ensure handrails extend horizontally above the landing for 12" min. beginning above the first riser nosing. Bottom: Ensure handrails extend to one tread depth beyond the last riser.	1	-	\$0
67	Stairwell	UL		Stairways	Egress

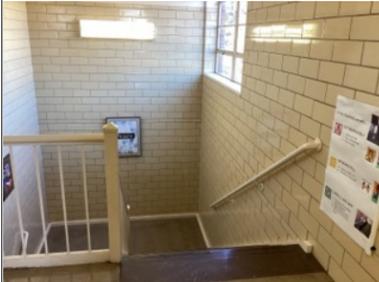
Handrails do not extend 12" from stairs Handrails not continuous where required	- -	Top: Ensure handrails extend horizontally above the landing for 12" min. beginning above the first riser nosing. Bottom: Ensure handrails extend to one tread depth beyond the last riser. Provide continuous handrails.	1	-	\$0
68	Near Side Parking	Ext.		Stairways	Other

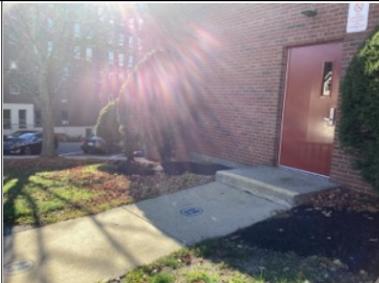
Handrails not provided	-	Provide compliant handrails for the step.	1	-	\$0
69	Cafeteria - Route to Stage	ML		Stairways	Other

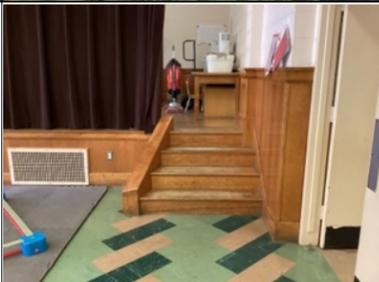
Handrails not provided	-	Provide handrails.	1	-	\$0

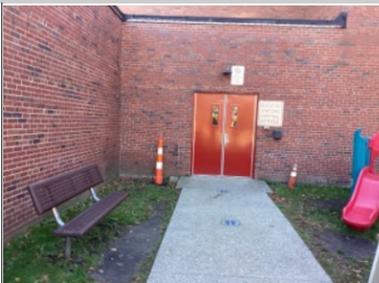
<b>Signage</b>												
70	Early Entry/Education Station Central Office Entry	Ext.		Signage	Designation

Raised characters not provided on sign Braille not provided on sign	- -	Provide text with raised characters duplicated in braille on sign.	1	-	\$0

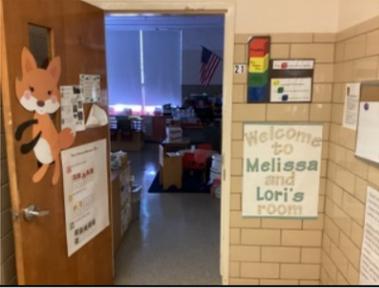
Raised characters not provided on sign Braille not provided on sign	- -	Provide text with raised characters duplicated in braille on sign.	1	232	\$232
72	Preschool	ML	22	Signage	Designation

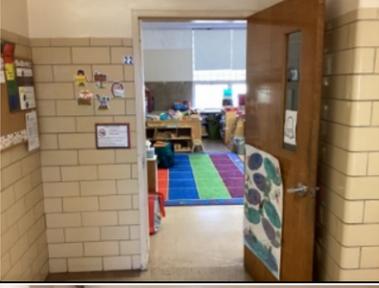
Raised characters not provided on sign Braille not provided on sign	- -	Provide text with raised characters duplicated in braille on sign.	1	232	\$232
73	Where Main Level Meets Hallway Stairs	ML		Signage	N/A

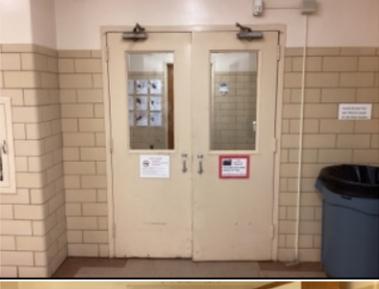
Raised characters not provided on sign Braille not provided on sign	- -	Provide a sign with raised characters and braille indication the location of the accessible route through the main level. With double doors that have two active leaves, locate sign to the right of the right side door.	1	232	\$232
74	Kindergarten	UL	32	Signage	Designation

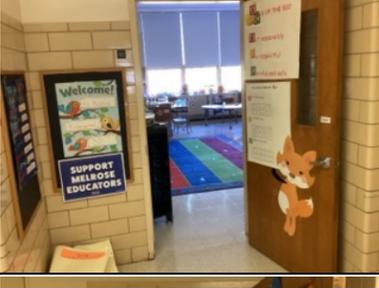
Raised characters not provided on sign Braille not provided on sign	- -	Provide text with raised characters duplicated in braille on sign.	1	232	\$232

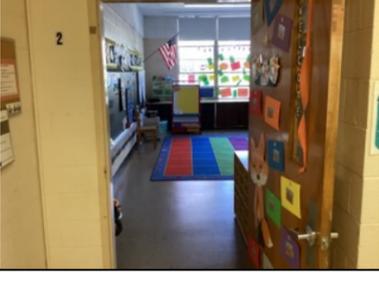
75	Classroom 2	LL	2	Signage	Designation

Raised characters not provided on sign Braille not provided on sign	- -	Provide text with raised characters duplicated in braille on sign.	1	232	\$232

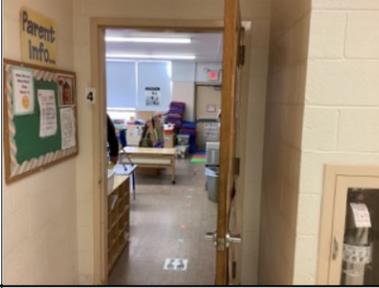
Raised characters not provided on sign Braille not provided on sign	- -	Provide text with raised characters duplicated in braille on sign.	1	232	\$232
77	Main Entry Area	ML	20	Signage	Designation

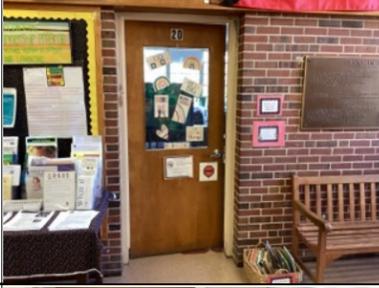
Raised characters not provided on sign Braille not provided on sign Sign not located on the latch side of the door	- - -	Provide text with raised characters duplicated in braille on sign. Locate the sign at permanent rooms alongside the door on the latch side.	1	232	\$232
78	School Nurse	ML		Signage	Designation

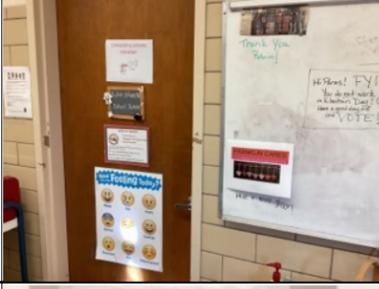
Raised characters not provided on sign Braille not provided on sign Sign not located on the latch side of the door	- - -	Provide text with raised characters duplicated in braille on sign. Locate the sign at permanent rooms alongside the door on the latch side.	1	232	\$232

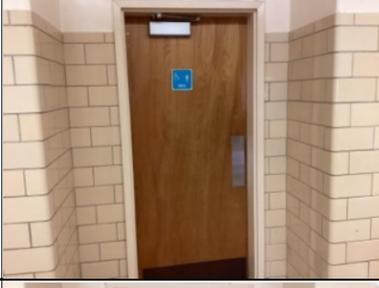
79	Men's Toilet Room	ML		Signage	Designation

Raised characters not provided on sign Braille not provided on sign Sign not located on the latch side of the door	- - -	Provide text with raised characters duplicated in braille on sign. Locate the sign at permanent rooms alongside the door on the latch side.	1	232	\$232
80	Women's Toilet Room	ML		Signage	Designation

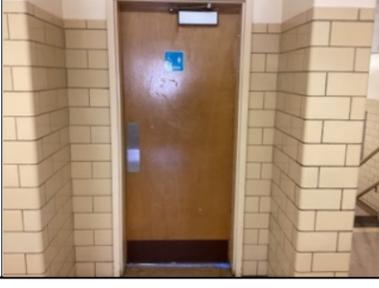
Raised characters not provided on sign Braille not provided on sign Sign not located on the latch side of the door	- - -	Provide text with raised characters duplicated in braille on sign. Locate the sign at permanent rooms alongside the door on the latch side.	1	232	\$232

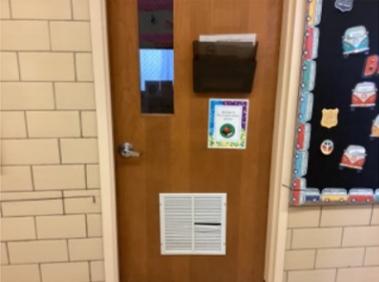
ID	Location	Floor	Room	Element	Type	Photo	Issues	Current Measure	Recommendations	Quantity	Price	Cost Estimation
81	Library	UL		Signage	Designation

Raised characters not provided on sign Braille not provided on sign Sign not located on the latch side of the door	- - -	Provide text with raised characters duplicated in braille on sign. Locate the sign at permanent rooms alongside the door on the latch side.	1	232	\$232
82	Girls' Toilet Room	UL		Signage	Designation

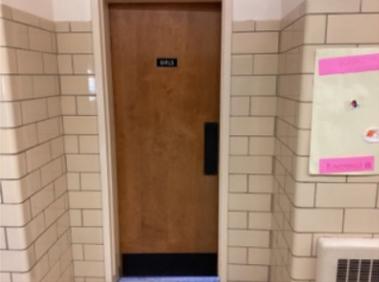
Raised characters not provided on sign Braille not provided on sign Sign not located on the latch side of the door	- - -	Provide text with raised characters duplicated in braille on sign. Locate the sign at permanent rooms alongside the door on the latch side.	1	232	\$232
83	Boys' Toilet Room	UL		Signage	Designation

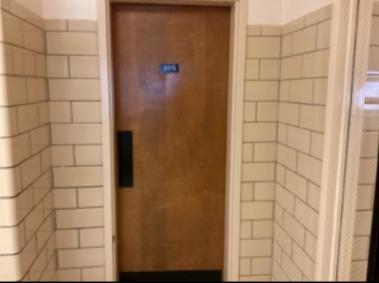
Raised characters not provided on sign Braille not provided on sign Sign not located on the latch side of the door	- - -	Provide text with raised characters duplicated in braille on sign. Locate the sign at permanent rooms alongside the door on the latch side.	1	232	\$232

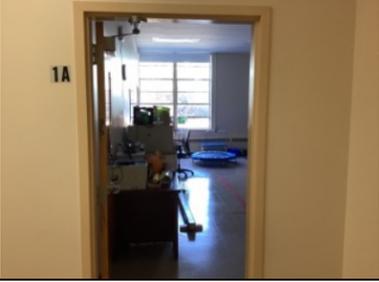
84	OT/PT	LL	1A	Signage	Designation

Raised characters not provided on sign Braille not provided on sign Sign not located on the latch side of the door	- - -	Provide text with raised characters duplicated in braille on sign. Locate the sign at permanent rooms alongside the door on the latch side.	1	232	\$232
85	STEM	LL	1	Signage	Designation

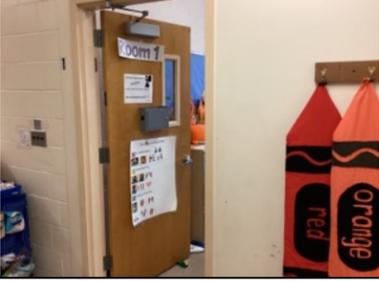
Raised characters not provided on sign Braille not provided on sign Sign not located on the latch side of the door	- - -	Provide text with raised characters duplicated in braille on sign. Locate the sign at permanent rooms alongside the door on the latch side.	1	232	\$232

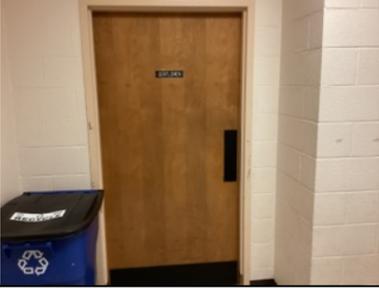
ID	Location	Floor	Room	Element	Type	Photo	Issues	Current Measure	Recommendations	Quantity	Price	Cost Estimation
86	Gentlemen's Toilet Room	LL		Signage	Designation

Raised characters not provided on sign Braille not provided on sign Sign not located on the latch side of the door	- - -	Provide text with raised characters duplicated in braille on sign. Locate the sign at permanent rooms alongside the door on the latch side.	1	232 Labor	\$232
87	Girls' Toilet Room	LL		Signage	Designation

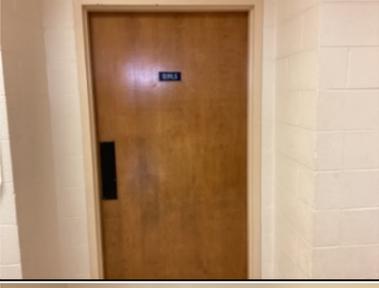
Raised characters not provided on sign Braille not provided on sign Sign not located on the latch side of the door	- - -	Provide text with raised characters duplicated in braille on sign. Locate the sign at permanent rooms alongside the door on the latch side.	1	232	\$232
88	Gender Neutral Toilet Room in Nurse's Office	ML		Signage	Designation

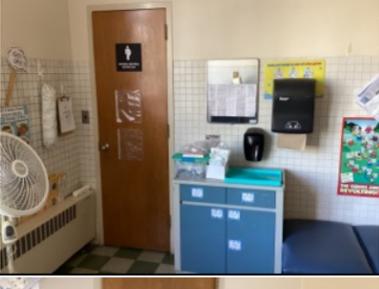
Raised characters < 48" or > 60" above ground Sign not located on the latch side of the door	65" -	Mount signs so that the baseline of the lowest tactile character is 48" min. above finished floor and the baseline of the highest tactile character is 60" max. above the finished floor. Locate the sign at permanent rooms alongside the door on the latch side.	1	Labor	\$0

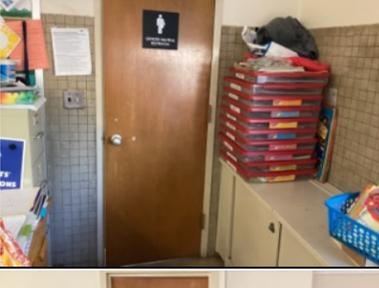
89	Gender Neutral Toilet Room	ML	22	Signage	Designation

Raised characters < 48" or > 60" above ground Sign not located on the latch side of the door	61" -	Mount signs so that the baseline of the lowest tactile character is 48" min. above finished floor and the baseline of the highest tactile character is 60" max. above the finished floor. Locate the sign at permanent rooms alongside the door on the latch side.	1	Labor	\$0
90	Pre-K	ML	26	Signage	Designation

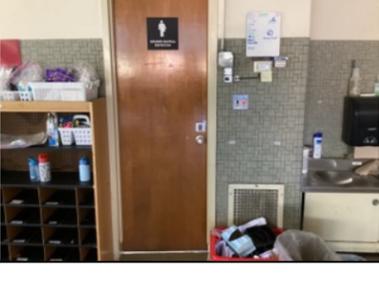
Raised characters < 48" or > 60" above ground Sign not located on the latch side of the door	65" -	Mount signs so that the baseline of the lowest tactile character is 48" min. above finished floor and the baseline of the highest tactile character is 60" max. above the finished floor. Locate the sign at permanent rooms alongside the door on the latch side.	1	Labor	\$0

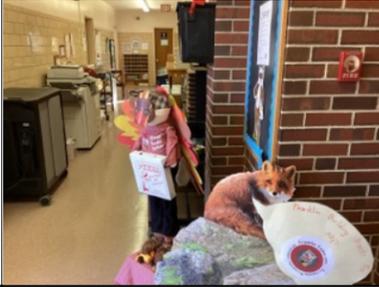
ID	Location	Floor	Room	Element	Type	Photo	Issues	Current Measure	Recommendations	Quantity	Price	Cost Estimation
<b>Operable Parts</b>												
91	Hallway	ML		Operable Parts	Other

Obstructed by protruding objects Reach < 15" or > 48"(forward/side approach)	65"	Relocate mailbox out of accessible route or provide a cane-detectable barrier 27" max. above the ground under the mailbox. Relocate mailbox so that controls are between 15"- 48" above the finished floor.	1	562	\$562
92	Main Entrance Door 1	Ext.		Operable Parts	Other

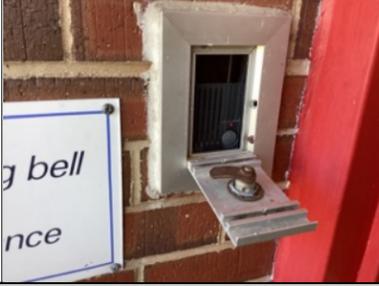
Not operable with a closed fist	-	Provide hardware at the intercom that can be operable with one hand and not require tight grasping, pinching, or twisting of the wrist. (IHCD tested the call button on the intercom to see if it could be operated with a closed fist and found the call button difficult to access. If a new intercom is installed, ensure the operable parts are not more than 48" above the ground.)	1	-	\$0

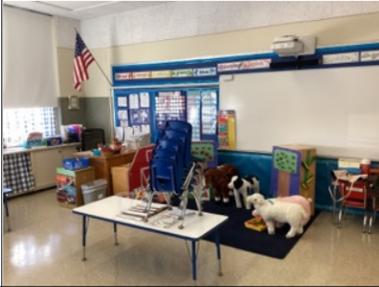
<b>Assembly Area</b>												
93	Classroom Near the Girls' Toilet Room	UL	35	Assembly Area

Assistive listening devices not provided	-	If audible communication is integral to the use of the space, provide an assistive listening system.	1	1214	\$1214
<b>Exterior Benches</b>												
94	Playground	Ext.		Exterior Benches	N/A

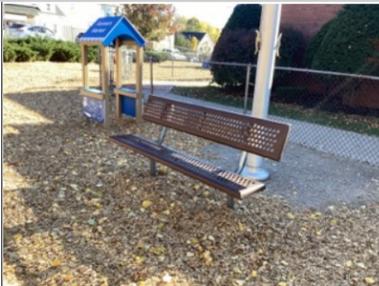
No accessible route to one bench in area	-	Provide an accessible route to one bench in this area or bench to an accessible route.	1	-	\$0
95	By Early Entry/Education Station Central Office Entry	Ext.		Exterior Benches	N/A

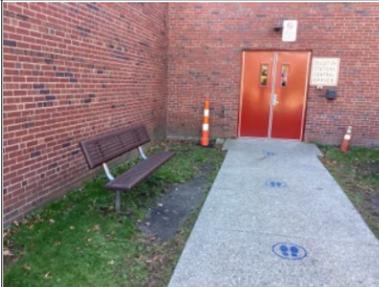
No accessible route to one bench in area	-	Relocate bench to an accessible route or provide an accessible route to one bench in this area. Recommend providing a 36" x 48" stable, firm and slip-resistant surface adjacent to the bench.	1	-	\$0

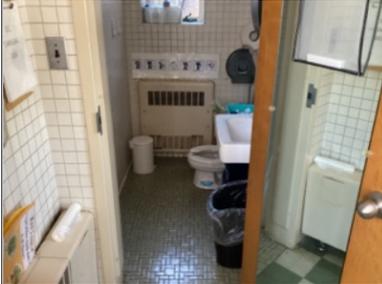
ID	Location	Floor	Room	Element	Type	Photo	Issues	Current Measure	Recommendations	Quantity	Price	Cost Estimation
<b>Toilet &amp; Bathing Rooms</b>												
<b>Overall Access</b>												
96	Gender Neutral Toilet Room in Nurse's Office	ML		Overall Access	Toilet Room

Turning space not provided Accessible plumbing fixtures or stalls not provided	- -	Provide an accessible single-user toilet room. Until the toilet room is made accessible, provide a sign indicating the location of the nearest accessible toilet room.	1	24604	\$24604
<b>Toilet Compartment</b>												
97	Gentlemen's Toilet Room	LL		Toilet Compartment	Accessible Compartment

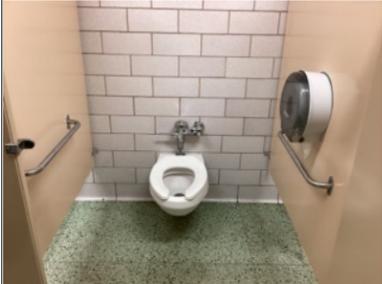
Grab bars not provided Non-compliant toilet paper dispenser Clearance at toilet < 60" clear width Clearance at toilet < 72" clear depth (MAAB)	- - 49" 55"	Provide a wheelchair accessible compartment that is 60" wide min. Provide a wheelchair accessible compartment that is 60" wide and 72" deep.	1	6182	\$6182

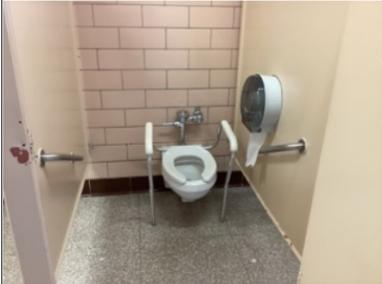
98	Women's Toilet Room	ML		Toilet Compartment	Accessible Compartment

Side or rear grab bar < 33" or >36" high Non-compliant toilet paper dispenser Clearance at toilet < 60" clear width Clearance at toilet < 72" clear depth (MAAB)	- - 43" 55"	Locate grab bars between 33"- 36" above the finished floor. Relocate toilet paper so that it is 24" min high, located under the grab bar, and between 7" and 9" from the front of the toilet. Provide a wheelchair accessible compartment that is 60" wide min.	1	6182	\$6182
99	Men's Toilet Room	ML		Toilet Compartment	Accessible Compartment

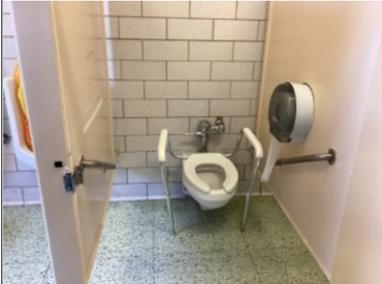
Side or rear grab bar < 33" or >36" high Clearance at toilet < 60" clear width Clearance at toilet < 72" clear depth (MAAB)	- 42" 56"	Locate grab bars between 33"- 36" above the finished floor. Provide a wheelchair accessible compartment that is 60" wide and 72" deep.	1	6182	\$6182

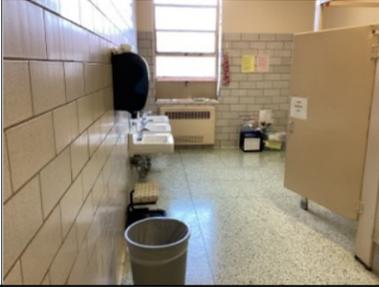
ID	Location	Floor	Room	Element	Type	Photo	Issues	Current Measure	Recommendations	Quantity	Price	Cost Estimation
<b>Dispensers</b>												
100	Men's Toilet Room	ML		Dispensers	Hand Dryer

Dispenser acts as a protruding object	9.5"	Relocate dispenser out of the circulation path.	1	353	\$353
101	Women's Toilet Room	ML		Dispensers	Hand Dryer

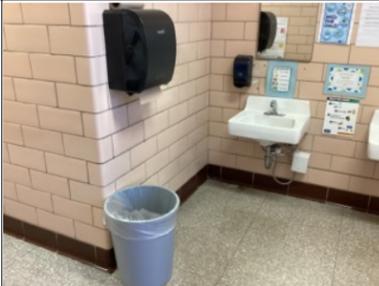
Dispenser acts as a protruding object	9"	Relocate dispenser out of the circulation path.	1	353	\$353
102	Gentlemen's Toilet Room	LL		Dispensers	Paper Towel Dispenser

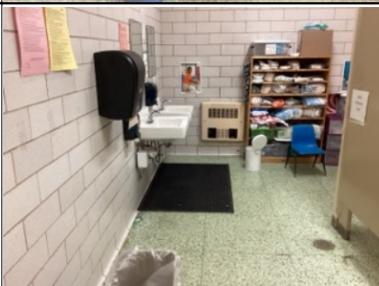
Dispenser acts as a protruding object	-	Relocate dispenser out of the circulation path or provide a cane-detectable barrier under the dispenser that is 27" max. above the finished floor.	1	306	\$306
<b>Toilet Rooms for Children</b>												
<b>Single-User Toilet (Children)</b>												
103	Gender Neutral Toilet Room	ML	22	Single-User Toilet (Children)	N/A

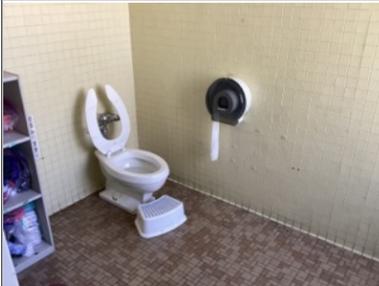
Centerline < 12" or > 15" (K - 3) Side or rear grab bar not provided	17" -	Relocate toilet so that the centerline is between 12" and 15" from the side wall. Provide one grab bar on the side wall of the water closet and one on the rear wall.	1	3726	\$3726
