# ADA Self-Evaluation and Transition Plan for the City of Melrose

Part 2 of 2

## Part 2: Reports:

January, 2023

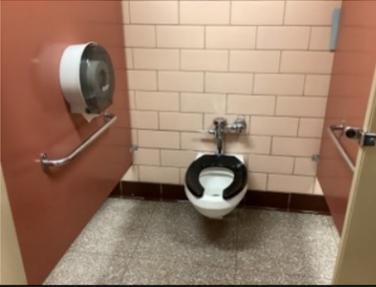
ID	Location	Floor	Room	Element	Type	Photo	Issues	Current Measure	Recommendations	Quantity	Price	Cost Estimation
<b>Toilet Compartment (Children)</b>												
104	Girls' Toilet Room	LL		Toilet Compartment (Children)	Accessible Compartment

Side or rear grab bar not provided Non-compliant toilet paper dispenser	- -	Provide one grab bar on the side wall of the water closet and one on the rear wall. Relocate toilet paper dispenser so that it is between 14"- 19" above the finished floor and between 7"- 9" in front of the toilet. Ensure dispensers and other devices are not mounted above grab bars. Replace dispenser as it does not allow continuous paper flow.	1	2149	\$2149
105	Women's Toilet Room	ML		Toilet Compartment (Children)	Accessible Compartment

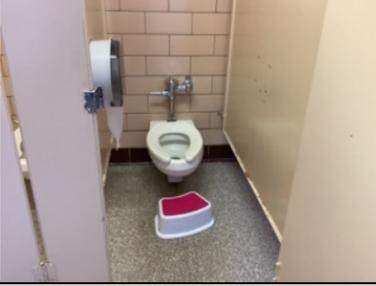
Clearance at toilet < 60" clear width Clearance at toilet 72" clear depth	32" 55"	Provide a wheelchair accessible compartment for children that is 60" wide min. and 72" deep min.	1	6182	\$6182

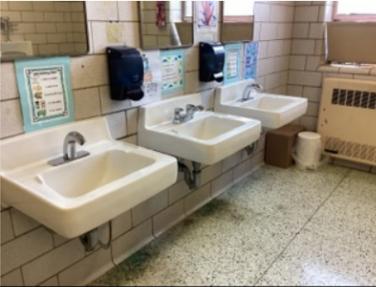
<b>Lavatory (Children)</b>												
107	Men's Toilet Room	ML		Lavatory (Children)	N/A

Toe or knee clearances not provided Exposed plumbing underneath Mirror above lavatory w/reflective surface > 31"	28" - 43"	Provide at least one lavatory with 25" min. knee clearance positioned for a forward approach. Ensure toe clearance is also provided. Insulate or otherwise configure pipes to prevent contact, for at least one lavatory. Lower mirror so that the bottom surface is at 31" above the finished floor.	1	2034	\$2034
106	Women's Toilet Room	ML		Lavatory (Children)	N/A

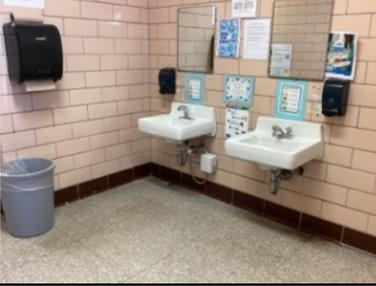
Toe or knee clearances not provided Exposed plumbing underneath Mirror above lavatory w/reflective surface > 31"	21" - 44"	Provide at least one lavatory with 25" min. knee clearance positioned for a forward approach. Ensure toe clearance is also provided. Insulate or otherwise configure pipes to prevent contact, for at least one lavatory. Lower mirror so that the bottom surface is at 31" above the finished floor.	1	2034	\$2034

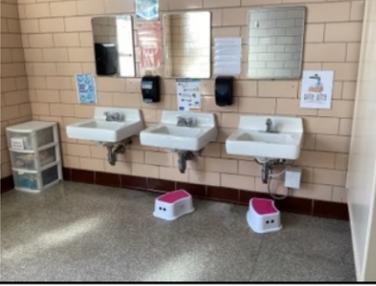
108	Girls' Toilet Room	UL		Lavatory (Children)	N/A

Exposed plumbing underneath Mirror above lavatory w/reflective surface > 31"	- 43"	Insulate or otherwise configure pipes to prevent contact, for at least one lavatory. Lower mirror so that the bottom surface is at 31" above the finished floor.	1	348	\$348

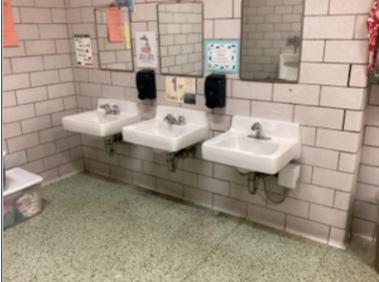
ID	Location	Floor	Room	Element	Type	Photo	Issues	Current Measure	Recommendations	Quantity	Price	Cost Estimation
109	Boys' Toilet Room	UL		Lavatory (Children)	N/A

Exposed plumbing underneath Mirror above lavatory w/reflective surface > 31"	- 43"	Insulate or otherwise configure pipes to prevent contact, for at least one lavatory. Lower mirror so that the bottom surface is at 31" above the finished floor.	1	348	\$348
110	Gentlemen's Toilet Room	LL		Lavatory (Children)	N/A

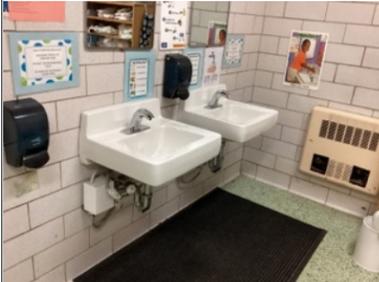
Exposed plumbing underneath Mirror above lavatory w/reflective surface > 31"	- 45"	Insulate or otherwise configure pipes to prevent contact, for at least one lavatory. Lower mirror so that the bottom surface is at 31" above the finished floor.	1	348	\$348
111	Girls' Toilet Room	LL		Lavatory (Children)	N/A

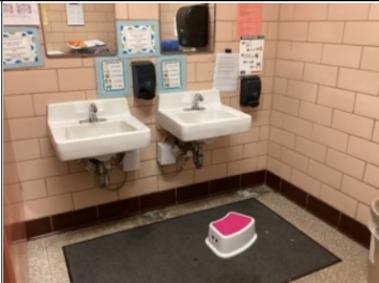
Exposed plumbing underneath Mirror above lavatory w/reflective surface > 31"	- -	Insulate or otherwise configure pipes to prevent contact, for at least one lavatory. Lower mirror so that the bottom surface is at 31" above the finished floor.	1	348	\$348

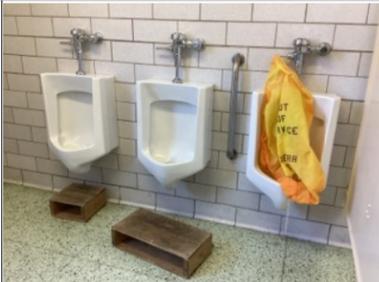
<b>Urinal (Children)</b>												
112	Boys' Toilet Room	ML		Urinal (Children)	N/A

Rim > 15" high (MAAB)	22"	Provide at least one urinal with the rim no higher than 15" above the finished floor.	1	3248	\$3248
113	Boys' Toilet Room	UL		Urinal (Children)	N/A

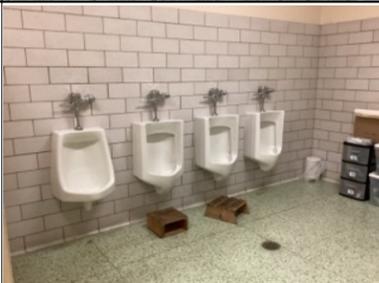
Rim > 15" high (MAAB)	21"	Provide at least one urinal with the rim no higher than 15" above the finished floor.	1	3248	\$3248

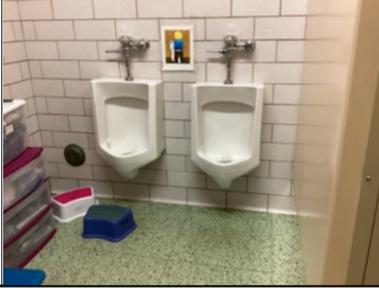
ID	Location	Floor	Room	Element	Type	Photo	Issues	Current Measure	Recommendations	Quantity	Price	Cost Estimation
114	Gentlemen's Toilet Room	LL		Urinal (Children)	N/A

Rim > 15" high (MAAB)	20"	Provide at least one urinal with the rim no higher than 15" above the finished floor.	1	3248	\$3248
<b>Overall Access (Children)</b>												
115	Girls' Toilet Room	UL		Overall Access (Children)	Toilet Room

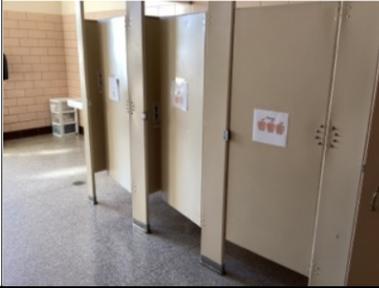
Accessible fixtures or stalls not provided	-	Provide one accessible wheelchair compartment.	1	6182	\$6182
116	Boys' Toilet Room	UL		Overall Access (Children)	Toilet Room

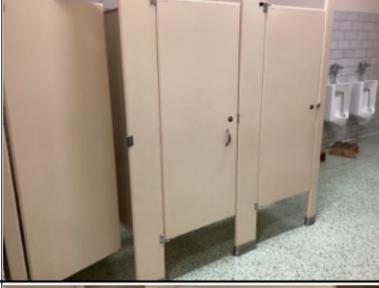
Accessible fixtures or stalls not provided	-	Provide one accessible wheelchair compartment.	1	6182	\$6182
117	Boys' Toilet Room	ML	26	Overall Access (Children)	Toilet Room

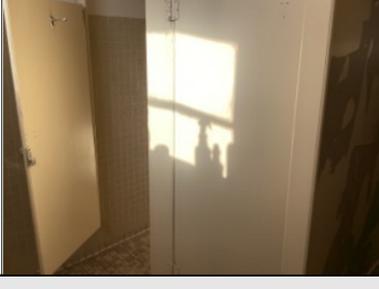
Accessible fixtures or stalls not provided	-	Provide one accessible wheelchair compartment.	1	6182	\$6182
<b>Additional Access</b>

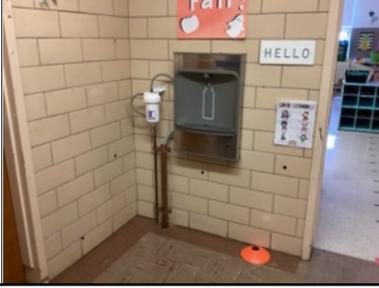
<b>Drinking Fountains</b>												
118	Stairwell	LL	3	Drinking Fountains	N/A

No drinking fountain provided for standing users No drinking fountain provided for seated users	- -	Provide an additional drinking fountain for standing users and for seated users or install a Hi-Lo drinking fountain. (Cost based on a new Hi-Low drinking fountain.)	1	4216	\$4216

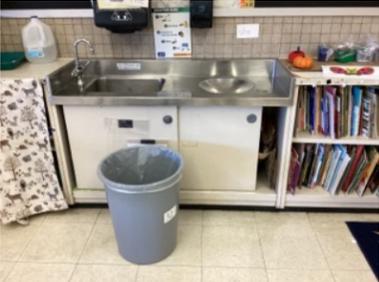
ID	Location	Floor	Room	Element	Type	Photo	Issues	Current Measure	Recommendations	Quantity	Price	Cost Estimation
<b>Sink</b>												
119	Kindergarten	UL	32	Sink	Classroom

Toe and knee clearances not provided	-	Ensure there is a 27" min. knee clearance positioned for a forward approach.	1	1686	\$1686
120	Classroom Near the Girls' Toilet Room	UL	35	Sink	Classroom

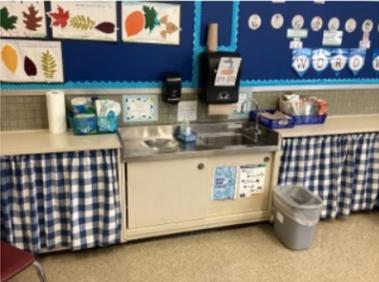
Toe and knee clearances not provided	-	Ensure there is a 27" min. knee clearance positioned for a forward approach.	1	1686	\$1686
121	Pre-K	ML	26	Sink	Classroom

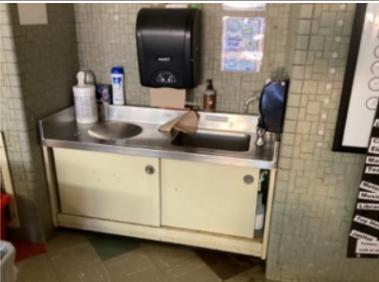
Toe and knee clearances not provided	-	Ensure there is a 27" min. knee clearance positioned for a forward approach.	1	1686	\$1686
122	Classroom 2	LL	2	Sink	Classroom

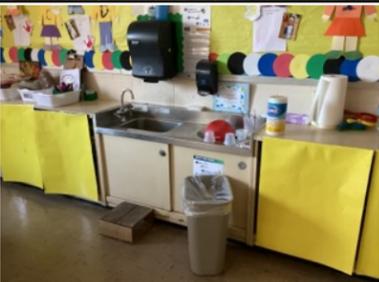
Toe and knee clearances not provided	-	Ensure there is a 27" min. knee clearance positioned for a forward approach.	1	1686	\$1686
123	STEM	LL	1	Sink	Classroom

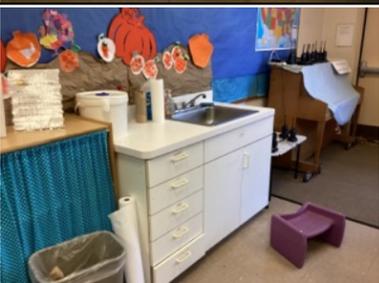
Toe and knee clearances not provided Rim or counter > 34"	- 35"	Ensure there is a 27" min. knee clearance positioned for a forward approach. Relocate sink with the front of the rim or counter no higher than 34" above the finished floor.	1	3094	\$3094

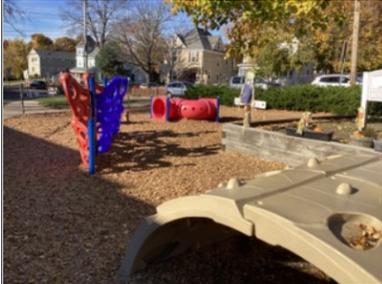
ID	Location	Floor	Room	Element	Type	Photo	Issues	Current Measure	Recommendations	Quantity	Price	Cost Estimation
<b>Play Areas</b>												
124	Playground	Ext.		Play Areas	N/A

Accessible route not provided to play components Surface not stable, firm, and slip-resistant	- -	Provide a compliant impact-attenuating surface to and around the play components. Repair surface and ensure that surface is firm, stable and slip-resistant (to areas around play components).	1	-	\$0
125	Playground 2 by Early Entry	Ext.		Play Areas	N/A

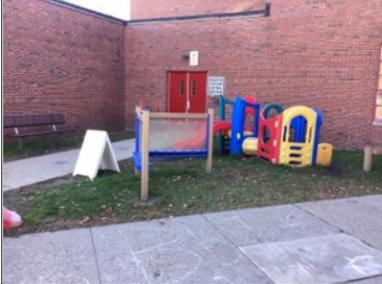
Accessible route not provided to play components Surface not stable, firm, and slip-resistant	- -	Provide a compliant impact-attenuating surface to and around the play components. Repair surface and ensure that surface is firm, stable and slip-resistant (to areas around play components).	1	-	\$0
<b>Best Practice</b>												
<b>Accessible Compartment</b>

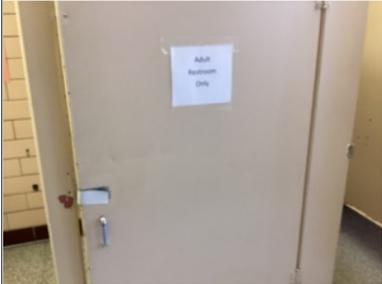
126	Women's Toilet Room	ML		Accessible Compartment	N/A

Recommend providing an accessible compartment for student use.	1	-	\$0
127	Girls' Toilet Room	LL		Accessible Compartment	N/A

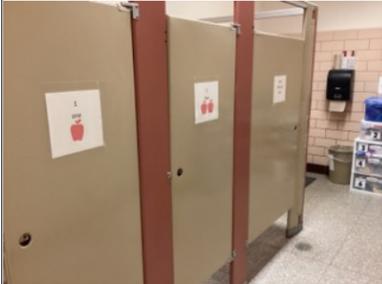
Recommend providing an accessible compartment for student use.	1	-	\$0
128	Boys' Toilet Room	ML		Accessible Compartment	N/A

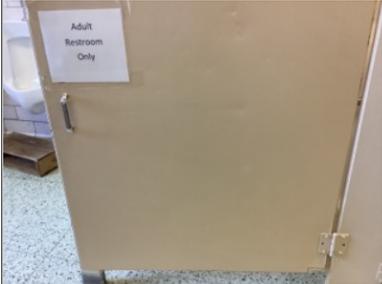
Recommend providing an accessible compartment for student use.	1	-	\$0

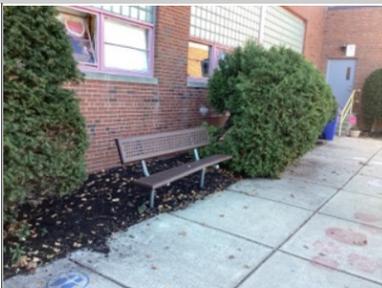
ID	Location	Floor	Room	Element	Type	Photo	Issues	Current Measure	Recommendations	Quantity	Price	Cost Estimation
<b>Bench</b>												
129	By Door 2	Ext.		Bench	N/A

Recommend providing a 36" x 48" stable, firm and slip-resistant surface adjacent to the bench.	1	-	\$0
<b>Curb Ramp</b>												
130	By Side Parking - Accessible Space	Ext.		Curb Ramp	N/A

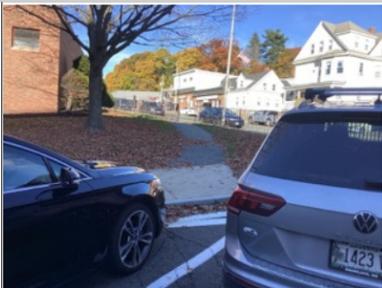
Recommend providing a curb ramp at this location so that there is an accessible route to the walkway that leads towards the school.	1	-	\$0
131	Street Parking Space West Side of School	Ext.		Curb Ramp	N/A

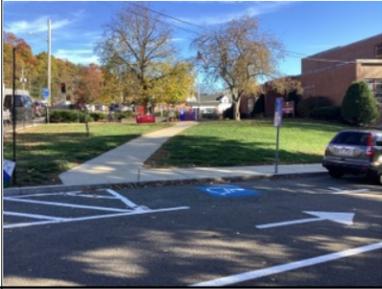
Recommend providing a curb ramp so there is an accessible route from the accessible parking space to the walkway that leads to the main entrance on the main level and the walkway to the designated accessible entrance at the lower level.	1	-	\$0
132	Entrance on the Southwest Side of the School by the Third Lower Playground	Ext.		Curb Ramp	N/A

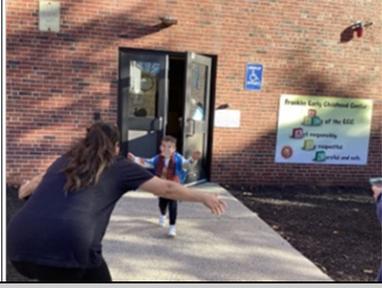
Recommend providing a curb ramp at the closest location possible where this walkway can meet the road.	1	-	\$0

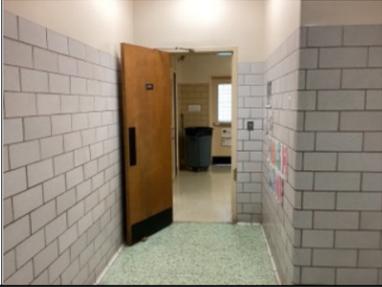
ID	Location	Floor	Room	Element	Type	Photo	Issues	Current Measure	Recommendations	Quantity	Price	Cost Estimation
<b>Door Closer</b>												
134	Boys' Toilet Room	UL		Door Closer	N/A

Recommend repairing the closer.	1	-	\$0
<b>Doors</b>												
135	Interior Doors Near Main Entry	ML		Doors	N/A

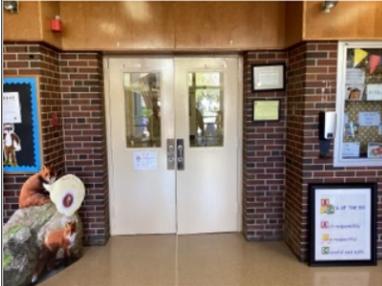
Recommend keeping doors permanently open unless they are closed because of a fire code regulation or for a similar reason related to safety.	1	Labor	\$0
<b>Egress Door</b>												
136	Door 13 by Drop Off	Ext.		Egress Door	N/A

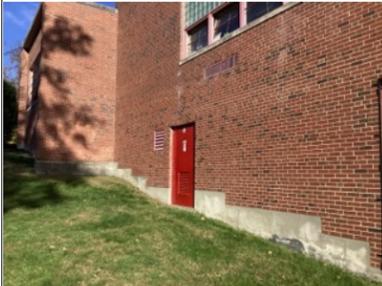
Recommend altering change in level at door threshold to be 1/4" high max. and providing an accessible route to this door.	1	-	\$0

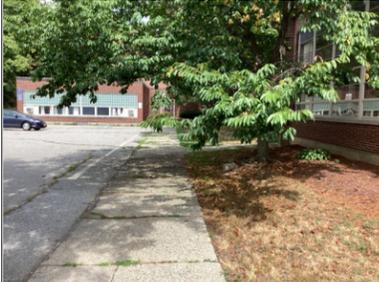
ID	Location	Floor	Room	Element	Type	Photo	Issues	Current Measure	Recommendations	Quantity	Price	Cost Estimation
<b>Approach and Entrance</b>												
<b>Exterior Access Route</b>												
1	By Parking	Ext.		Exterior Access Route	Walkway

Obstructed by protruding objects	35"	Trim low hanging branches in trees to at least 80" min above the ground.	1	-	\$0
2	Egress Door 3	Ext.		Exterior Access Route	Exterior

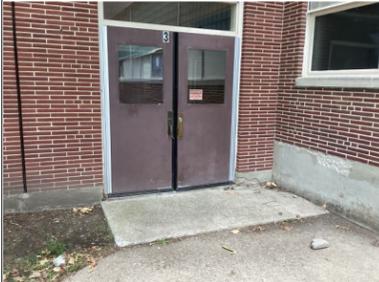
Level changes > 1/4"	2"	Alter change in level to be 1/4" high max.	1	-	\$0
3	By West Parking Lot	Ext.		Exterior Access Route	Walkway

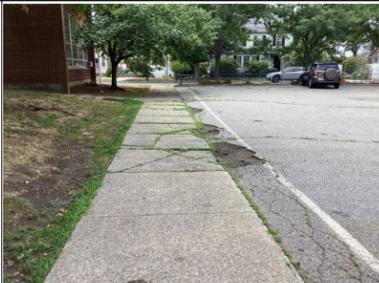
Route not maintained in operable working condition	-	Ensure the accessible route is maintained in operable working condition.	1	-	\$0
4	To Egress Door 2	Ext.		Exterior Access Route	Walkway

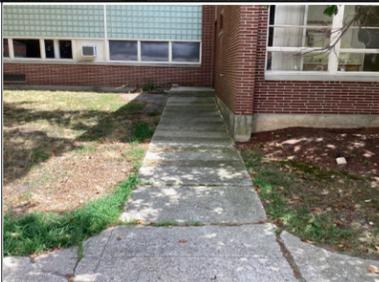
Route not maintained in operable working condition	-	Repair the walkway to ensure the accessible route is maintained in operable working condition.	1	-	\$0

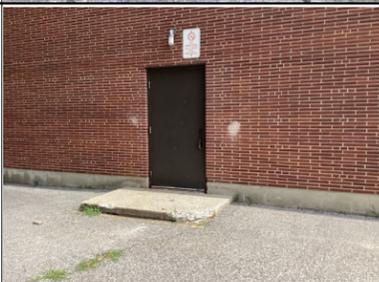
5	Egress Door 5	Ext.		Exterior Access Route	Exterior

Step not maintained in operable working condition		Ensure the step at the egress door is maintained in operable working condition by repairing the deteriorated asphalt.	1	-	\$0

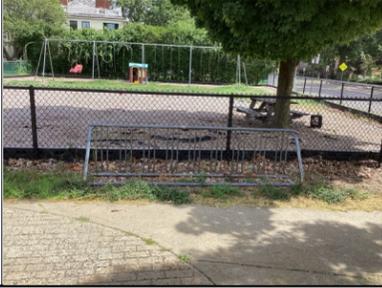
ID	Location	Floor	Room	Element	Type	Photo	Issues	Current Measure	Recommendations	Quantity	Price	Cost Estimation
6	Bike Rack	Ext.		Exterior Access Route	Walkway

Accessible route not provided	-	Ensure an accessible route is provided to the bike rack or relocate bike rack to an accessible route.	1	-	\$0
<b>Off-Street Parking Lot or Garage</b>												
7	West Parking Lot	Ext.		Off-Street Parking Lot or Garage	Visitor

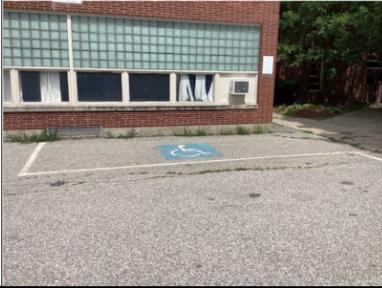
Total # of parking Total # of designated accessible parking spaces Total # of designated van accessible spaces Access aisle not provided Sign not provided Sign does not have the designation "Van Accessible"	18 - 1 - - -	Provide a marked access aisle that is at least 96" wide at the van accessible space. Provide a sign that includes the International Symbol of Accessibility (ISA) at the head of the space. Locate the sign so that the bottom is 60" min. above the ground and the top is 96" max. above the ground. Add the designation "Van Accessible" to the sign located at the van accessible space.	1	-	\$0

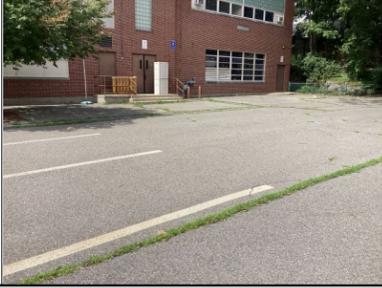
8	East Parking Lot	Ext.		Off-Street Parking Lot or Garage	N/A

Total # of parking Total # of designated accessible parking spaces Total # of designated van accessible spaces Access aisle not provided Sign not provided Sign does not have the designation "Van Accessible"	25 - - - - -	Provide 1 van accessible space with a marked access aisle that is at least 96" wide. Provide a sign that includes the International Symbol of Accessibility (ISA) at the head of the space. Locate the sign so that the bottom is 60" min. above the ground and the top is 96" max. above the ground. Add the designation "Van Accessible" to the sign located at the van accessible space.	1	-	\$0
<b>Exterior Stair</b>												
9	Egress Door 9	Ext.		Exterior Stair	N/A

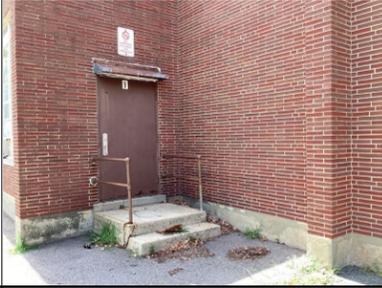
Handrails do not extend 12" from stair	-	Ensure that the sloped bottom extension extends one tread depth min. beyond last riser nosing in same direction as stair flight.	1	-	\$0

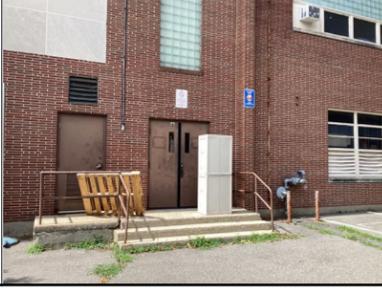
10	Egress Door 7 and Egress Door 8	Ext.		Exterior Stair	N/A

Handrails do not extend 12" from stair	-	Bottom: Ensure that the sloped bottom extension extends one tread depth min. beyond last riser nosing in same direction as stair flight.	1	-	\$0

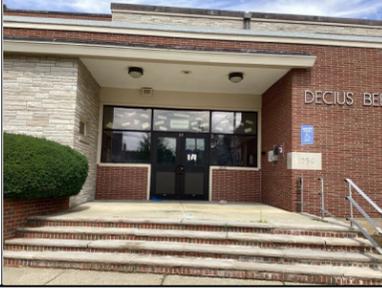
ID	Location	Floor	Room	Element	Type	Photo	Issues	Current Measure	Recommendations	Quantity	Price	Cost Estimation
11	Egress Door 1, Main Entrance	Ext.		Exterior Stair	N/A

Handrails do not extend 12" from stair Handrail not provided on both sides	- -	Bottom: Ensure that the sloped bottom extension extends one tread depth min. beyond last riser nosing in same direction as stair flight. Provide a handrail on one side.	1	-	\$0
<b>Access to Goods and Services</b>												
<b>Means of Egress</b>												
12	Accessible Entry and Egress Door at West Parking Lot	1		Means of Egress	N/A

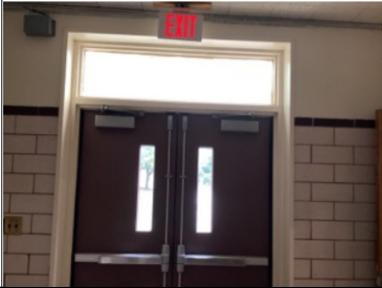
Tactile exit sign not provided Illuminated ISA symbol not provided (MAAB)	- -	Ensure tactile exit signs with raised characters and braille are provided at exit doors. Mount signs between 48"- 60" above the finished floor located on the latch side of the door. When the illuminated exit sign is replaced or repaired, provide an illuminated sign with the International Symbol of Accessibility (ISA).	1	232	\$232

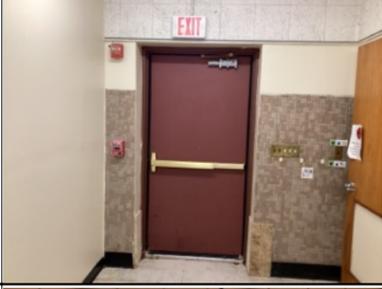
13	Egress Door 5	1		Means of Egress	N/A

Tactile exit sign not provided Directional sign to accessible emergency exit not provided	- -	Ensure tactile exit signs with raised characters and braille are provided at exit doors. Mount signs between 48"- 60" above the finished floor located on the latch side of the door. Provide a directional sign indicating the location of the nearest accessible emergency exit.	2	232	\$464
14	Egress Door 3	1		Means of Egress	N/A

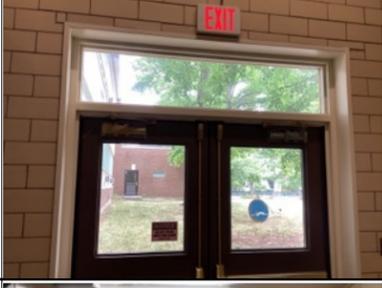
Tactile exit sign not provided Directional sign to accessible emergency exit not provided	- -	Ensure tactile exit signs with raised characters and braille are provided at exit doors. Mount signs between 48"- 60" above the finished floor located on the latch side of the door. Provide a directional sign indicating the location of the nearest accessible emergency exit.	2	232	\$464
15	Egress Door 7 to Loading Dock on West Side	1.5		Means of Egress	N/A

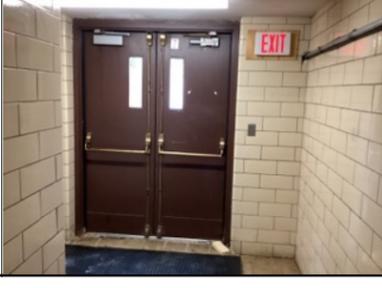
Tactile exit sign not provided Directional sign to accessible emergency exit not provided	- -	Ensure tactile exit signs with raised characters and braille are provided at exit doors. Mount signs between 48"- 60" above the finished floor located on the latch side of the door. Provide a directional sign indicating the location of the nearest accessible emergency exit.	2	232	\$464

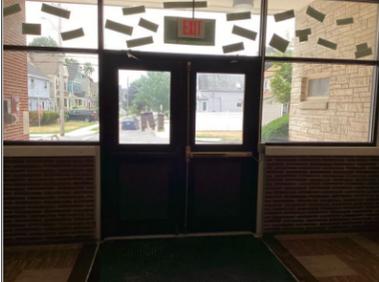
ID	Location	Floor	Room	Element	Type	Photo	Issues	Current Measure	Recommendations	Quantity	Price	Cost Estimation
16	Main Entrance and Egress Door 1 to Stairs at West Foster Street	1.5		Means of Egress	N/A

Tactile exit sign not provided Directional sign to accessible emergency exit not provided	- -	Ensure tactile exit signs with raised characters and braille are provided at exit doors. Mount signs between 48"- 60" above the finished floor located on the latch side of the door. Provide a directional sign indicating the location of the nearest accessible emergency exit.	2	232	\$464
17	Egress Door 9	1.5		Means of Egress	N/A

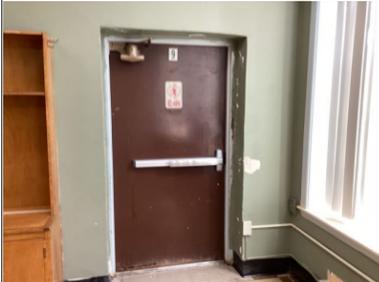
Tactile exit sign not provided Directional sign to accessible emergency exit not provided	- -	Ensure tactile exit signs with raised characters and braille are provided at exit doors. Mount signs between 48"- 60" above the finished floor located on the latch side of the door. Provide a directional sign indicating the location of the nearest accessible emergency exit.	2	232	\$464

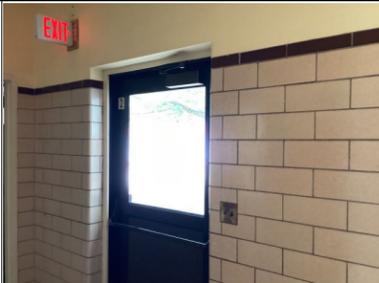
18	Egress Door 2	1.5		Means of Egress	N/A

Tactile exit sign not provided Directional sign to accessible emergency exit not provided	- -	Ensure tactile exit signs with raised characters and braille are provided at exit doors. Mount signs between 48"- 60" above the finished floor located on the latch side of the door. Provide a directional sign indicating the location of the nearest accessible emergency exit.	2	232	\$464
<b>Doors, Doorways, &amp; Gates</b>												
19	Classroom 11 to Girls' and Boys' Toilet Rooms	2		Doors, Doorways, & Gates	Circulation

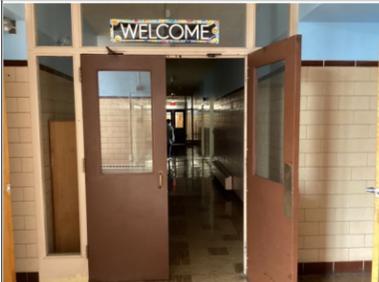
Clear width at door < 32"	27"	Ensure that both door leaves are opened simultaneously to maintain at least 32" min. clear width.	1	Labor	\$0
20	Nurse's Office, Single-User Toilet Room	1.5		Doors, Doorways, & Gates	Toilet Room

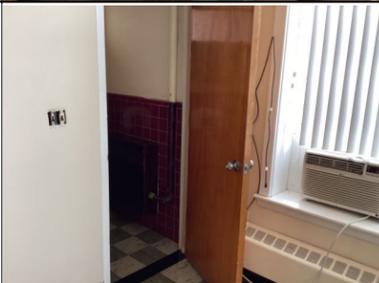
Clear width at door < 32" Hardware not operable with a closed fist	27" -	Widen the door so that there is 32" min. clear width. Provide hardware that can be operable with one hand and not require tight grasping, pinching, or twisting of the wrist. (Note: Cost to provide accessible door hardware and an accessible toilet room entry door is included in cost to provide an accessible single user toilet room in the nurse's office.)	1	-	\$0

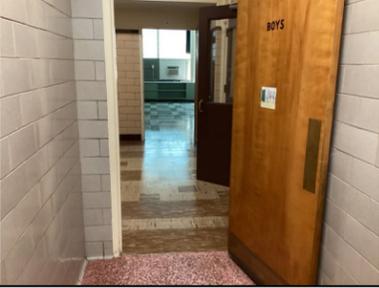
ID	Location	Floor	Room	Element	Type	Photo	Issues	Current Measure	Recommendations	Quantity	Price	Cost Estimation
21	Boys' Toilet Room	1.5		Doors, Doorways, & Gates	Toilet Room

Maneuvering clearance(s) not provided	10"	Provide an automatic door opener.	1	3060	\$3060
22	Girls' Toilet Room	1.5		Doors, Doorways, & Gates	Toilet Room

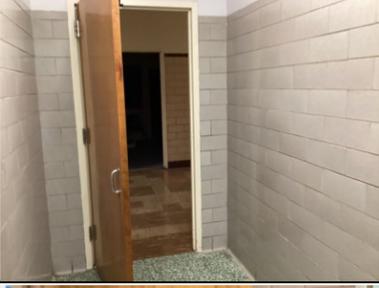
Maneuvering clearance(s) not provided	10"	Provide an automatic door opener.	1	3060	\$3060
23	Back of Stage	1.5		Doors, Doorways, & Gates	Assembly Space

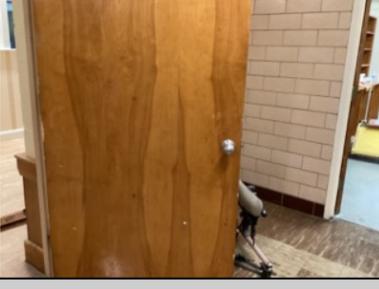
Hardware not operable with a closed fist	-	Provide hardware that can be operable with one hand and not require tight grasping, pinching, or twisting of the wrist.	1	484	\$484
<b>Ramps</b>												
24	Ramp From Former Stage Area at Floor 1.5 to Auditorium at Floor 1	1		Ramps	Interior

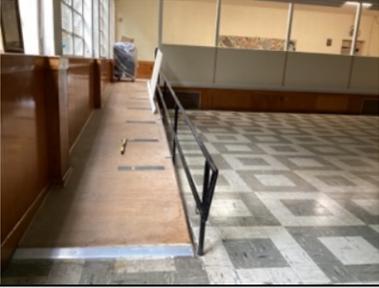
Handrails not provided at both sides if rise is > 6" Handrails do not extend 12" past top & bottom	- -	Provide handrails on both sides. Alter handrails to extend horizontally above the landing for 12" min. beyond the top and bottom of ramp runs.	1	-	\$0

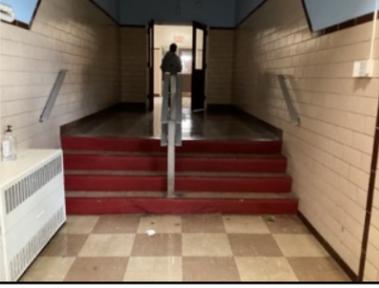
<b>Stairways</b>												
25	Hallway Stairs	1.5		Stairways	Other

Handrails do not extend 12" from stairs Handrails have non-compliant cross section	- -	Top: Ensure handrails extend horizontally above the landing for 12" min. beginning above the first riser nosing. Bottom: Ensure handrails extend to one tread depth beyond the last riser. Provide handrails with 1 1/4" - 2" circular cross sections.	1	-	\$0

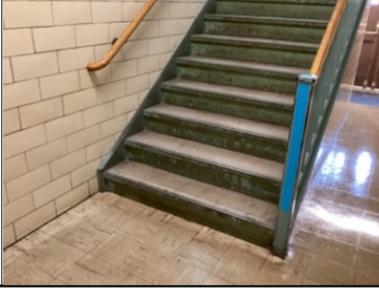
ID	Location	Floor	Room	Element	Type	Photo	Issues	Current Measure	Recommendations	Quantity	Price	Cost Estimation
26	Stair by Egress Door 7	1.5		Stairways	Egress

Handrails do not extend 12" from stairs Handrails not continuous where required	- -	Top: Ensure handrails extend horizontally above the landing for 12" min. beginning above the first riser nosing. Bottom: Ensure handrails extend to one tread depth beyond the last riser. Provide continuous handrails.	1	-	\$0
<b>Signage</b>												
27	Music Therapy	1	10A	Signage	Designation

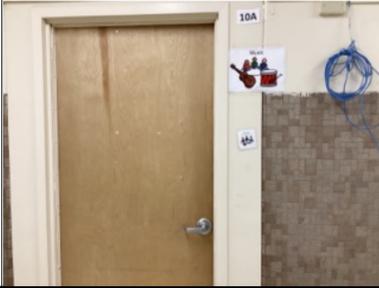
Raised characters not provided on sign Braille not provided on sign	- -	Provide text with raised characters duplicated in braille on sign.	1	232	\$232
28	Toilet Room by 10A	1		Signage	Designation

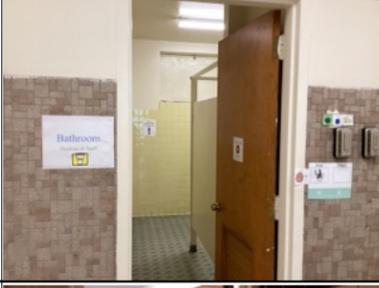
Raised characters not provided on sign Braille not provided on sign Sign to accessible toilet not provided	- -	If this toilet room is used by members of the public, provide a directional sign indicating the location of the nearest accessible toilet room.	2	232	\$464

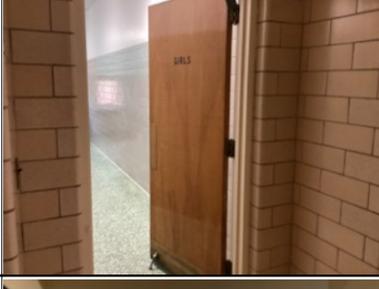
29	Girls' Toilet Room	1.5		Signage	Designation

Raised characters not provided on sign Braille not provided on sign Visual characters < 40" above ground Sign not located on the latch side of the door	- - 66" -	Provide text with raised characters duplicated in braille on sign. Mount the sign so that the baseline of the lowest visual character is 40" min. above the finished floor or ground. Locate the sign at permanent rooms alongside the door on the latch side.	1	232	\$232
30	Boys' Toilet Room	1.5		Signage	Designation

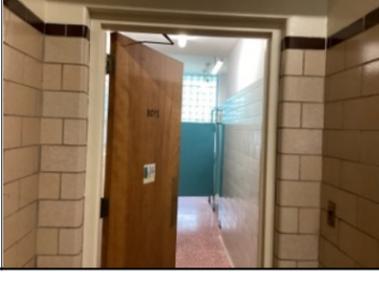
Raised characters not provided on sign Braille not provided on sign Visual characters < 40" above ground Sign not located on the latch side of the door	- - 66" -	Provide text with raised characters duplicated in braille on sign. Mount the sign so that the baseline of the lowest visual character is 40" min. above the finished floor or ground. Locate the sign at permanent rooms alongside the door on the latch side.	1	232	\$232

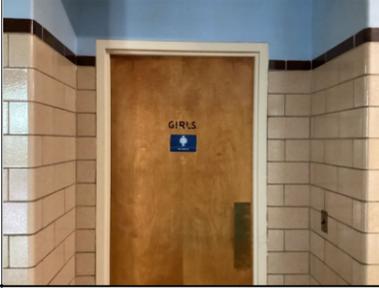
ID	Location	Floor	Room	Element	Type	Photo	Issues	Current Measure	Recommendations	Quantity	Price	Cost Estimation
31	Girls' Toilet Room	2		Signage	Designation

Raised characters not provided on sign Braille not provided on sign Sign not located on the latch side of the door Visual characters < 40" above ground	- - 60" -	Provide text with raised characters duplicated in braille on sign. Mount the sign so that the baseline of the lowest visual character is 40" min. above the finished floor or ground. Locate the sign at permanent rooms alongside the door on the latch side.	1	232	\$232
32	Boys' Toilet Room	2		Signage	Designation

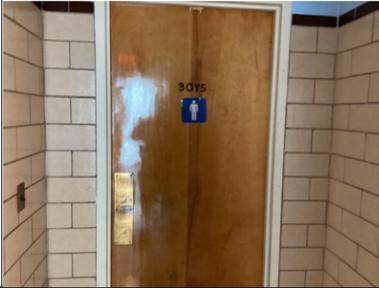
Raised characters not provided on sign Braille not provided on sign Sign not located on the latch side of the door Visual characters < 40" above ground	- - 60" -	Provide text with raised characters duplicated in braille on sign. Mount the sign so that the baseline of the lowest visual character is 40" min. above the finished floor or ground. Locate the sign at permanent rooms alongside the door on the latch side.	1	232	\$232

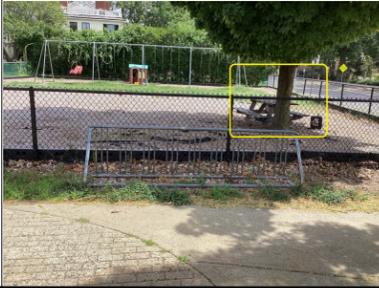
<b>Picnic Tables</b>												
33	Picnic Table	Ext.		Picnic Tables	N/A

At least 5% accessible spaces not provided	-	Ensure that at least 5% (minimum one) of picnic tables are accessible.	1	-	\$0
<b>Toilet Rooms for Children</b>												
<b>Toilet Compartment (Children)</b>												
34	Girls' Toilet Room	1.5		Toilet Compartment (Children)	Accessible Compartment

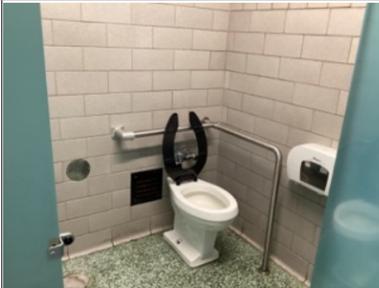
Door with non-compliant hardware Door with malfunctioning self-closing hinge Clearance at toilet 72" clear depth	- - 56"	Provide hardware that can be operable with one hand and that does not require tight grasping, pinching, or twisting of the wrist. Repair self-closing hinge. Provide a wheelchair accessible compartment that is 60" wide min. and 72" deep min.	1	6182	\$6182
35	Boys' Toilet Room	1.5		Toilet Compartment (Children)	Accessible Compartment

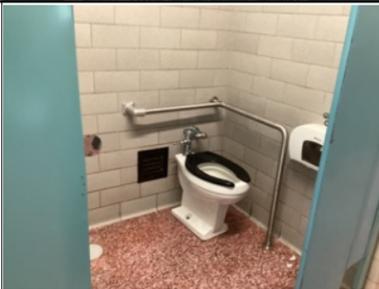
Door with non-compliant hardware Door with malfunctioning self-closing hinge Clearance at toilet 72" clear depth	- - 54"	Provide hardware that can be operable with one hand and that does not require tight grasping, pinching, or twisting of the wrist. Repair self-closing hinge. Provide a wheelchair accessible compartment that is 60" wide min. and 72" deep min.	1	6182	\$6182

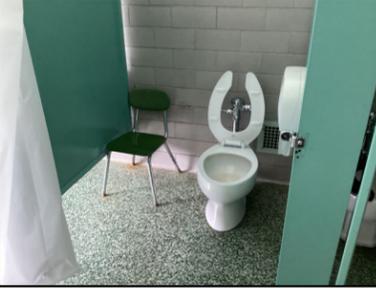
ID	Location	Floor	Room	Element	Type	Photo	Issues	Current Measure	Recommendations	Quantity	Price	Cost Estimation
36	Girls' Toilet Room	2		Toilet Compartment (Children)	Accessible Compartment

Clearance at toilet < 60" clear width Clearance at toilet 72" clear depth	50" 56"	Provide a wheelchair accessible compartment that is 60" wide min. and 72" deep min.	1	6182	\$6182
<b>Lavatory (Children)</b>												
37	Girls' Toilet Room	1.5		Lavatory (Children)	N/A

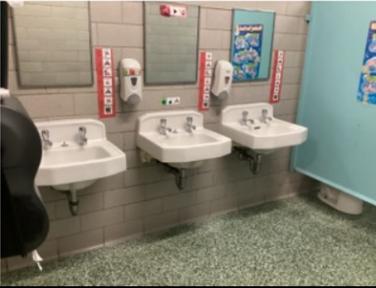
Exposed plumbing underneath Mirror above lavatory w/reflective surface > 31"	- 45"	Insulate or otherwise configure pipes to prevent contact, for at least one lavatory. Lower mirror so that the bottom surface is at 31" above the finished floor.	1	348	\$348
38	Boys' Toilet Room	1.5		Lavatory (Children)	N/A

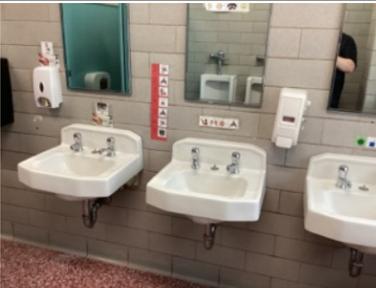
Exposed plumbing underneath Mirror above lavatory w/reflective surface > 31"	- 44"	Insulate or otherwise configure pipes to prevent contact, for at least one lavatory. Lower mirror so that the bottom surface is at 31" above the finished floor.	1	348	\$348

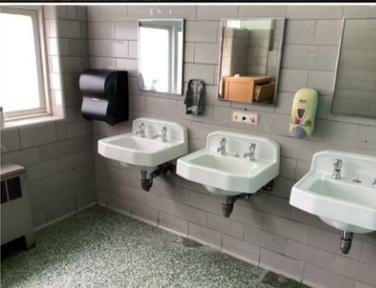
39	Girls' Toilet Room	2		Lavatory (Children)	N/A

Exposed plumbing underneath Mirror above lavatory w/reflective surface > 31"	- 44"	Insulate or otherwise configure pipes to prevent contact, for at least one lavatory. Lower mirror so that the bottom surface is at 31" above the finished floor.	1	348	\$348
40	Boys' Toilet Room	2		Lavatory (Children)	N/A

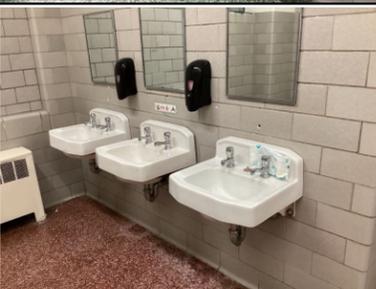
Exposed plumbing underneath Mirror above lavatory w/reflective surface > 31"	- 44"	Insulate or otherwise configure pipes to prevent contact, for at least one lavatory. Lower mirror so that the bottom surface is at 31" above the finished floor.	1	348	\$348

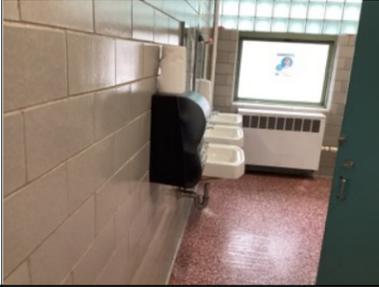
ID	Location	Floor	Room	Element	Type	Photo	Issues	Current Measure	Recommendations	Quantity	Price	Cost Estimation
<b>Dispensers (Children)</b>												
41	Boys' Toilet Room	1.5		Dispensers (Children)	Paper Towel Dispenser

Dispenser is a protruding object	12"	Relocate paper towel dispenser out of the circulation path or provide a cane-detectable barrier 27" max. above the ground below the dispenser.	1	306	\$306
42	Girls' Toilet Room	1.5		Dispensers (Children)	Paper Towel Dispenser

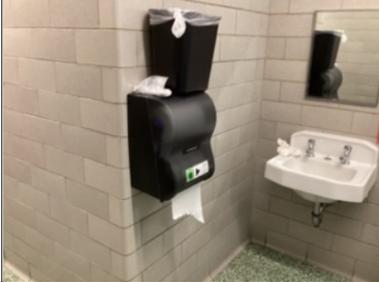
Dispenser is a protruding object	12"	Relocate paper towel dispenser out of the circulation path or provide a cane-detectable barrier 27" max. above the ground below the dispenser.	1	306	\$306
<b>Overall Access (Children)</b>												
43	Nurse's Office, Single-User Toilet Room	1.5		Overall Access (Children)	Toilet Room

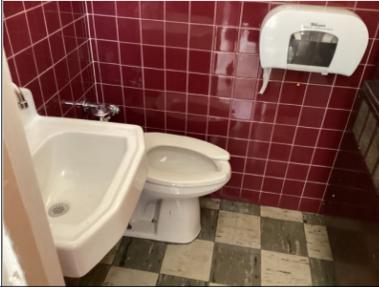
Turning space is not provided	53"	Provide an accessible single-user toilet room in the nurse's office.	1	24604	\$24604

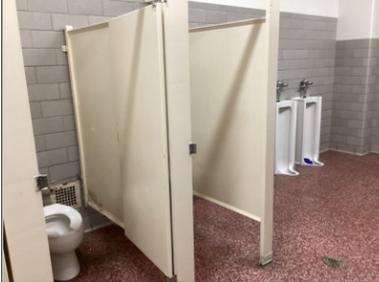
44	Boys' Toilet Room	2		Overall Access (Children)	Toilet Room

Turning space is not provided Accessible fixtures or stalls not provided	- -	Provide one accessible wheelchair compartment.	1	6182	\$6182
<b>Additional Access</b>

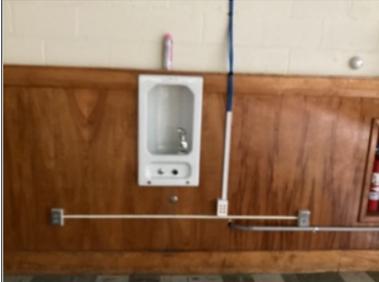
ID	Location	Floor	Room	Element	Type	Photo	Issues	Current Measure	Recommendations	Quantity	Price	Cost Estimation
<b>Drinking Fountains</b>												
45	Auditorium	1		Drinking Fountains	Low

No drinking fountain provided for standing users Knee or toe clearance not provided	- -	Provide a drinking fountain for standing users. Provide knee and toe clearance, 27" min. high at drinking fountain for seated users.  (Cost based on the provision of a new Hi-Lo drinking fountain.)	1	4216	\$4216
46	Near Classroom 3	1.5		Drinking Fountains	Low

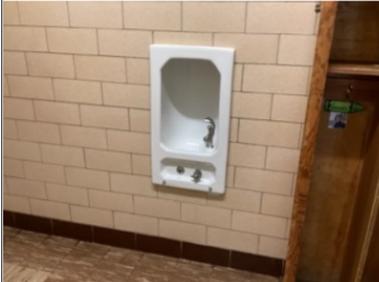
No drinking fountain provided for standing users Knee or toe clearance not provided		Provide a drinking fountain for standing users. Provide knee and toe clearance, 27" min. high at drinking fountain for seated users.  (Cost based on the provision of a new Hi-Lo drinking fountain.)	1	4216	\$4216
<b>Sink</b>												
47	Nurse's Office	1.5		Sink	Other

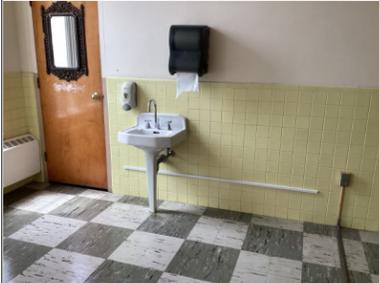
Toe and knee clearances not provided Exposed plumbing underneath sink	- -	Ensure there is a 27" min. knee clearance positioned for a forward approach. Insulate or otherwise configure pipes at sink.	1	1778	\$1778

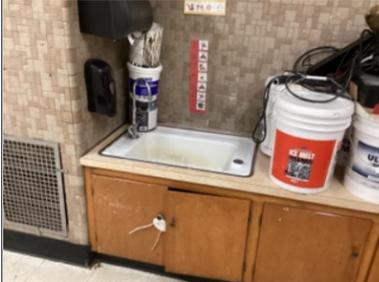
<b>Sinks for Children's Use</b>												
48	By Single-User Toilet Room	1		Sinks for Children's Use	Classroom

Exposed plumbing underneath Knee/toe clearance <27" at sink > 31" high	- -	Insulate or otherwise configure pipes to prevent contact, for at least one sink. Provide at least one sink with 27" high knee and toe clearance positioned for a forward approach (per 521 CMR 12.2.2.c).	1	1778	\$1778
49	Classroom 4	1.5		Sinks for Children's Use	Classroom

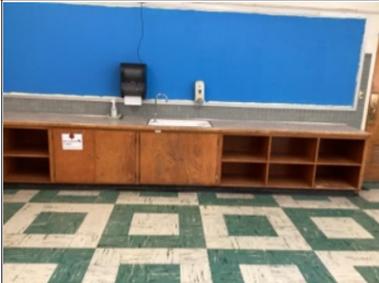
Exposed plumbing underneath Knee/toe clearance <27" at sink > 31" high	32"	Insulate or otherwise configure pipes to prevent contact, for at least one sink. Provide at least one sink with 27" high knee and toe clearance positioned for a forward approach (per 521 CMR 12.2.2.c).	1	1778	\$1778

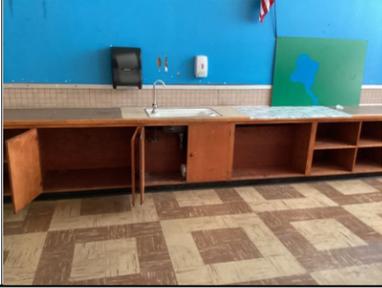
ID	Location	Floor	Room	Element	Type	Photo	Issues	Current Measure	Recommendations	Quantity	Price	Cost Estimation
50	Classroom 11	2		Sinks for Children's Use	Classroom

Exposed plumbing underneath Knee/toe clearance <27" at sink > 31" high		Insulate or otherwise configure pipes to prevent contact, for at least one sink. Provide at least one sink with 27" high knee and toe clearance positioned for a forward approach (per 521 CMR 12.2.2.c).	1	1778	\$1778
<b>Play and Sport Areas</b>												
<b>Play Areas</b>												
51	Playground	Ext.		Play Areas	N/A

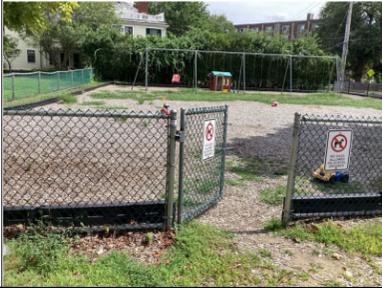
Accessible route not provided to playground Accessible route not provided to play components	- -	Install an accessible route to the playground. Provide a compliant impact-attenuating surface to and around the play components.	1	-	\$0
<b>Best Practice</b>												
<b>Lavatories</b>												
52	Girls' and Boys' Multi-User Toilet Rooms	1.5 and 2		Lavatories	N/A

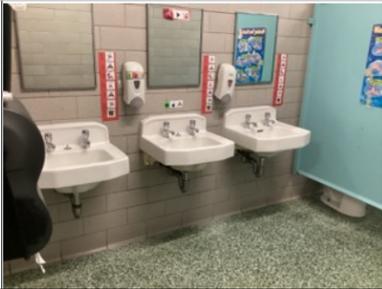
Recommend insulating the exposed plumbing under all three lavatories in the multi-user toilet rooms on the first and second floors so wheeled mobility device users can safely use all of the available lavatories.	1		\$0

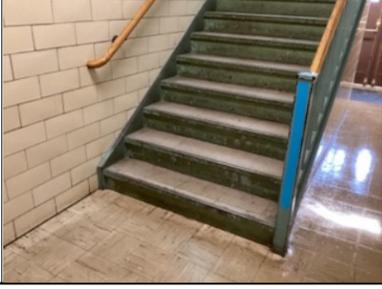
<b>Stairs</b>												
53	Interior and Exterior Stairs			Stairs	N/A

Recommend providing contrasting color strips on all exterior and interior stairs treads.	1		\$0

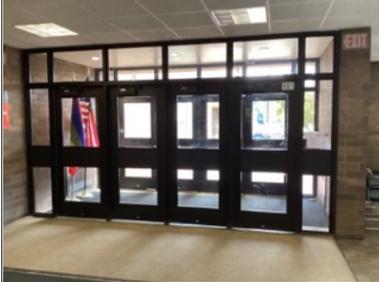
Tactile exit sign not provided	-	Ensure tactile exit signs with raised characters and braille are provided at exit doors. Mount signs between 48"- 60" above the finished floor located on the latch side of the door. <b>Note:</b> In this instance we are not recommending the inclusion of an illuminated sign with the International Symbol of Accessibility (ISA) because the exit sign is not illuminated.	1	232	\$232
2	Between Gym and Wrestling	2		Means of Egress	N/A

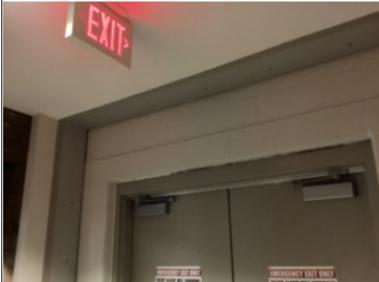
Tactile exit sign not provided	-	Ensure tactile exit signs with raised characters and braille are provided at exit doors. Mount signs between 48"- 60" above the finished floor located on the latch side of the door.	2	232	\$464

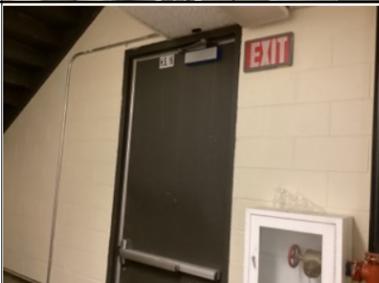
3	Door 16	1		Means of Egress	N/A

Tactile exit sign not provided Illuminated ISA symbol not provided (MAAB)	- -	Ensure tactile exit signs with raised characters and braille are provided at exit doors. Mount signs between 48"- 60" above the finished floor located on the latch side of the door. Provide an illuminated sign with the International Symbol of Accessibility (ISA). <b>Note:</b> This recommendation applies to accessible egress Doors 4, 12 (by interior Door 133) , 15 and 18 (by physics), 21 and 24.	9	432	\$3888
<b>Interior Access Route</b>												
4	By Guidance	1		Interior Access Route	N/A

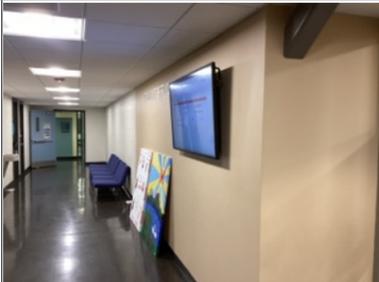
Obstructed by protruding objects	5.5"	Reposition screen so it does not protrude more than 4" or provide a cane-detectable barrier 27" max. above the finished floor.	1	306	\$306
5	By Locker Rooms	1		Interior Access Route	N/A

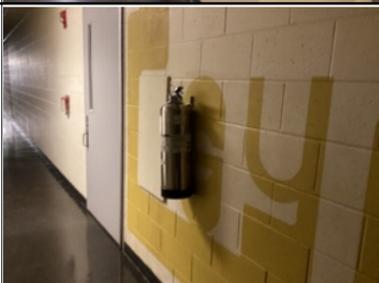
Obstructed by protruding objects	34"	Relocate extinguisher or provide a cane-detectable barrier 27" max. above the finished floor.	1	306	\$306

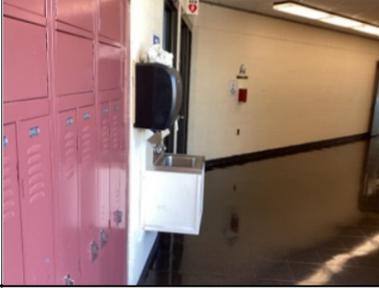
Obstructed by protruding objects	12"	Relocate paper towel dispenser or provide a cane-detectable barrier 27" max. above the finished floor.	1	306	\$306
7	Hallway All Floors	2		Interior Access Route	N/A

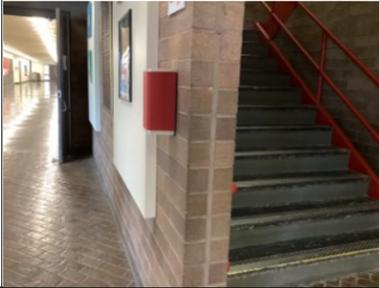
Obstructed by protruding objects	5"	Relocate sanitizer dispenser or provide a cane-detectable barrier 27" max. above the finished floor below the dispenser. Alternately, install a dispenser that protrudes 4" or less. This remedy applies to all identical hand sanitizer dispensers in the school.	1	Labor	\$0
8	Wrestling	2	242	Interior Access Route	N/A

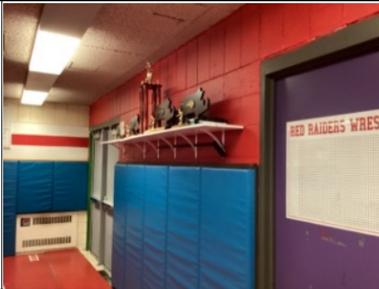
Obstructed by protruding objects	74"	Relocate shelf to at least 80" above the finished floor.	1	256	\$256
9	Art	1	112	Interior Access Route	N/A

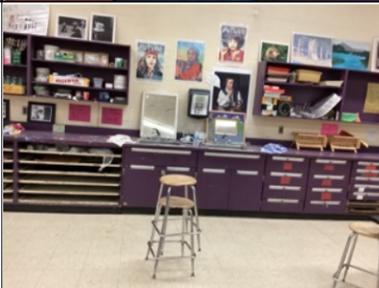
Accessible route not provided	-	Provide an accessible route or consider relocating the program. <b>Note:</b> The only interior route into this art room (112) had a staircase. If there are unique programs in this room that are not provided in the accessible art room (Room 113 which has a ramped entry), either provide an accessible route to this art room or relocate the unique programs to an accessible location such as Art Room 113.	1	-	\$0

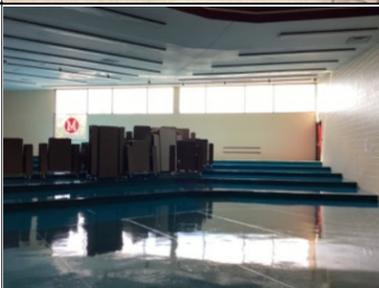
10	Cafeteria/Performance	2		Interior Access Route	N/A

Accessible route not provided	-	Provide an accessible route up the risers.	1	-	\$0

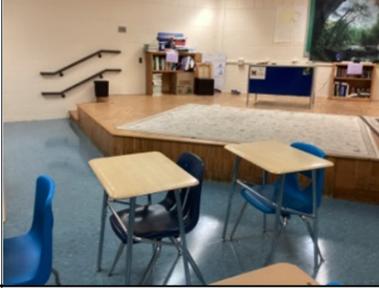
Accessible route not provided	-	Provide an accessible route to the stage if the stage area is accessed by students or other members of the public. (If needed, cost for an accessible route to stage will depend on method chosen.)	1	-	\$0
12	AP Literature	3	334	Interior Access Route	N/A

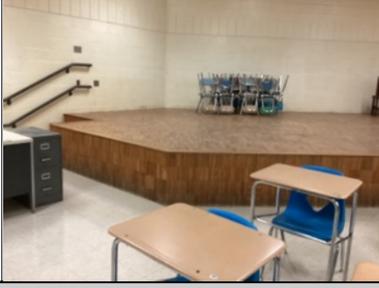
Accessible route not provided	-	Provide an accessible route to the stage if the stage area is accessed by students or other members of the public. (If needed, cost for an accessible route to stage will depend on method chosen.)	1	-	\$0
<b>Doors, Doorways, &amp; Gates</b>												
13	Single-User Toilet Room Across From Administration	1		Doors, Doorways, & Gates	Toilet Room

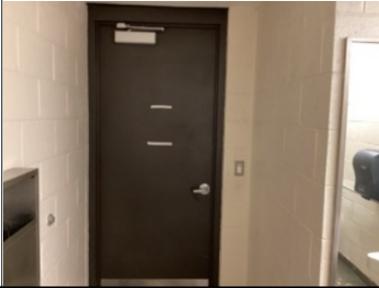
Maneuvering clearance(s) not provided	10"	Provide an automatic door opener.	1	3060	\$3060

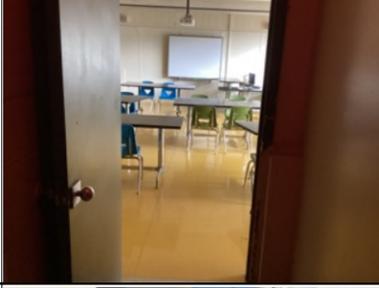
14	Photography Classroom	1	114	Doors, Doorways, & Gates	Circulation

Maneuvering clearance(s) not provided Hardware not operable with a closed fist	8" -	Provide an automatic door opener or keep the door propped open. Provide hardware that can be operable with one hand and not require tight grasping, pinching, or twisting of the wrist.	1	3060	\$3060
15	CAD Classroom	3	338	Doors, Doorways, & Gates	Classroom

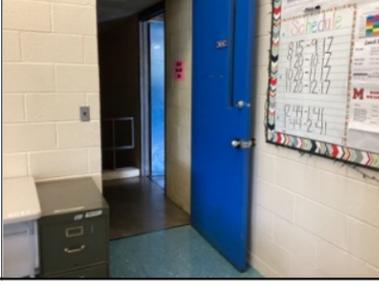
Maneuvering clearance(s) not provided Hardware not operable with a closed fist	- -	Relocate file cabinets to provide 18" min. pull-side maneuvering clearance at the door. Provide hardware that can be operable with one hand and not require tight grasping, pinching, or twisting of the wrist.	1	484	\$484

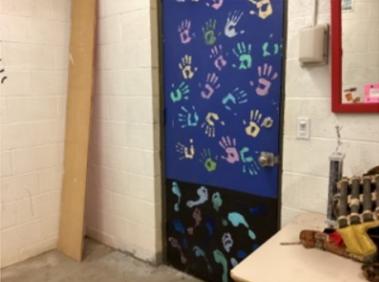
Maneuvering clearance(s) not provided Hardware not operable with a closed fist Door requires > 5 lbs. of force to open	- - -	Relocate the desk to provide maneuvering clearance. Provide hardware that can be operable with one hand and not require tight grasping, pinching, or twisting of the wrist. Adjust closers so doors do not require more than 5 pounds of force to open.	1	484	\$484
17	All Gender Toilet Room Across From Library	2		Doors, Doorways, & Gates	Toilet Room

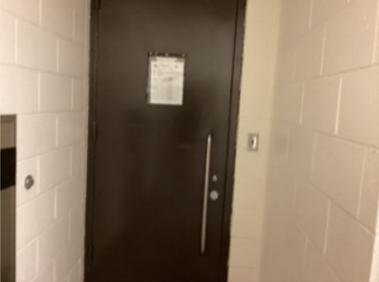
Maneuvering clearance not provided at recess > 6"	8"	Install an automatic door opener.	1	3060	\$3060
18	Single-User Toilet Room	3		Doors, Doorways, & Gates	Toilet Room

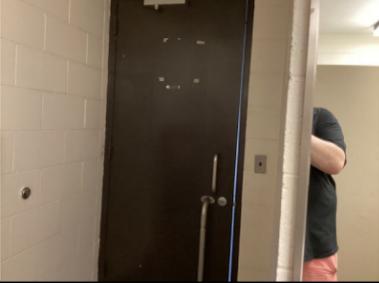
Maneuvering clearance not provided at recess > 6"	8"	Install an automatic door opener.	1	3060	\$3060

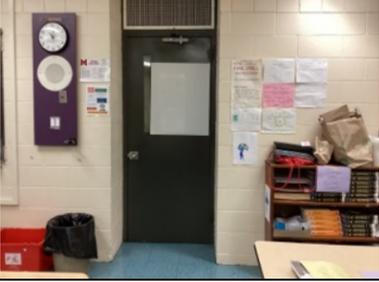
19	Math	2	234	Doors, Doorways, & Gates	Classroom

Maneuvering clearance not provided at recess > 6" Hardware not operable with a closed fist	- -	Install an automatic door opener. Provide hardware that can be operable with one hand and not require tight grasping, pinching, or twisting of the wrist.	1	3060	\$3060
20	SPED	3	337	Doors, Doorways, & Gates	Classroom

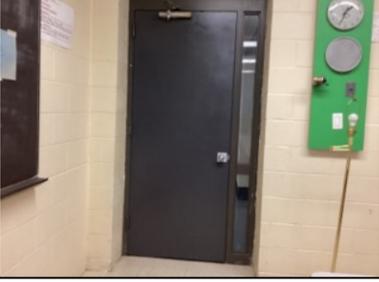
Maneuvering clearance not provided at recess > 6" Hardware not operable with a closed fist	10" -	Install an automatic door opener./Reverse the swing of the door to provide maneuvering clearance. Provide hardware that can be operable with one hand and not require tight grasping, pinching, or twisting of the wrist.	1	3060	\$3060

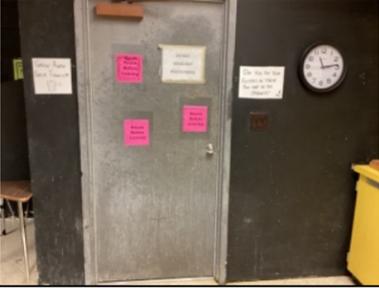
Hardware not operable with a closed fist	-	Provide hardware that can be operable with one hand and not require tight grasping, pinching, or twisting of the wrist.	1	484	\$484
22	Near Nurses Office	2		Doors, Doorways, & Gates	Other

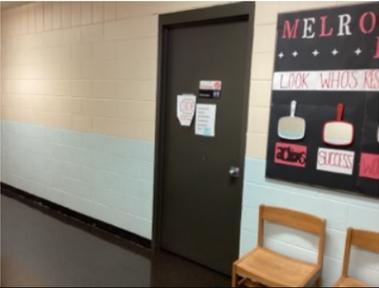
Hardware not operable with a closed fist	-	Provide hardware that can be operable with one hand and not require tight grasping, pinching, or twisting of the wrist.	2	484	\$968
23	By Nurse	2		Doors, Doorways, & Gates	Other

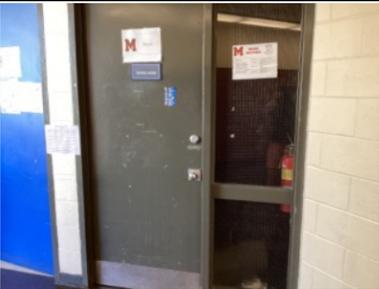
Hardware not operable with a closed fist	-	Provide hardware that can be operable with one hand and not require tight grasping, pinching, or twisting of the wrist.	1	484	\$484
24	Football and Nurse's Office	2	238	Doors, Doorways, & Gates	Office

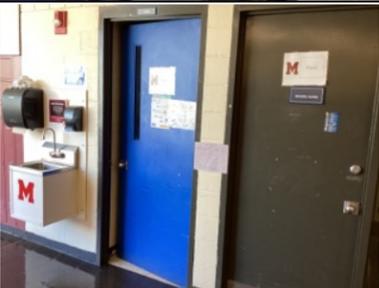
Hardware not operable with a closed fist	-	Provide hardware that can be operable with one hand and not require tight grasping, pinching, or twisting of the wrist.	2	484	\$968

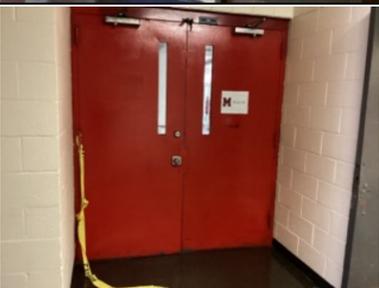
25	Weight Room	2	240	Doors, Doorways, & Gates	Classroom

Hardware not operable with a closed fist	-	Provide hardware that can be operable with one hand and not require tight grasping, pinching, or twisting of the wrist.	1	484	\$484

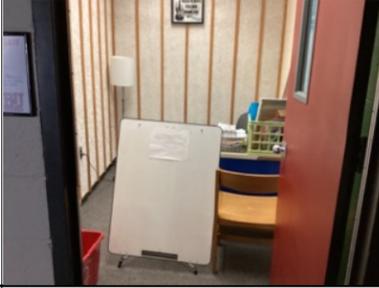
Hardware not operable with a closed fist	-	Provide hardware that can be operable with one hand and not require tight grasping, pinching, or twisting of the wrist.	1	484	\$484
27	Social Studies	3	317	Doors, Doorways, & Gates	Classroom

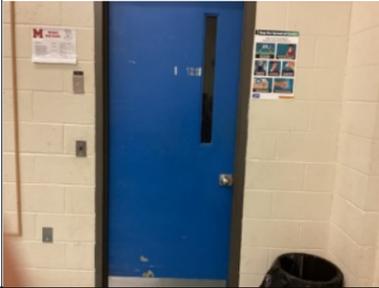
Hardware not operable with a closed fist	-	Provide hardware that can be operable with one hand and not require tight grasping, pinching, or twisting of the wrist.	1	484	\$484
28	Boys' and Girls' Multi-User Toilet Rooms Near Gym	2		Doors, Doorways, & Gates	Toilet Room
