# ADA Self-Evaluation and Transition Plan for the City of Melrose

Part 2 of 2

## Part 2: Reports:

January, 2023

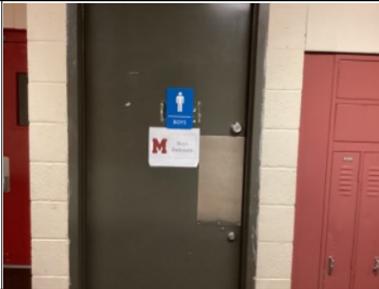
Door requires > 5 lbs. of force to open	20 Lbs.	Adjust closers so doors do not require more than 5 pounds of force to open.	2	Labor	\$0
29	Heritage Room Language Learning	2		Doors, Doorways, & Gates	Other

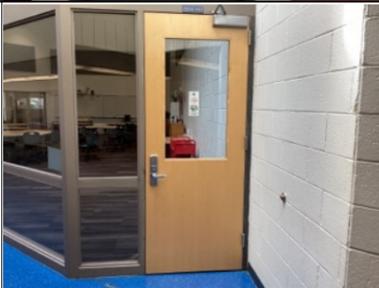
Door requires > 5 lbs. of force to open	28 lbs.	Adjust closers so doors do not require more than 5 pounds of force to open.	1	Labor	\$0

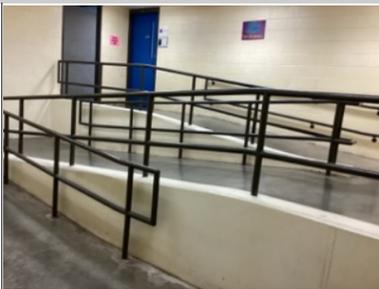
<b>Ramps</b>												
30	Ramp Near Room 338B	3	338B	Ramps	Interior

Running slope >1:12 (8.33%)	11%	Further study will be needed to determine whether it is technically feasible to bring this ramp into full compliance with the ADA Standards. (Cost to renovate interior ramp not included.)	1	-	\$0

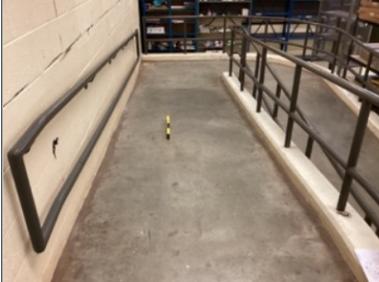
Running slope >1:12 (8.33%) Handrails < 34" or > 38" above ramp surface	10.2% 32"	Further study will be needed to determine whether it is technically feasible to bring this ramp into full compliance with the ADA Standards. Alter so the handrails are 34"- 38" high above the floor. (Cost to renovate interior ramp not included.)	1	-	\$0
32	Ramp to Floor 3 in Library	2		Ramps	Interior

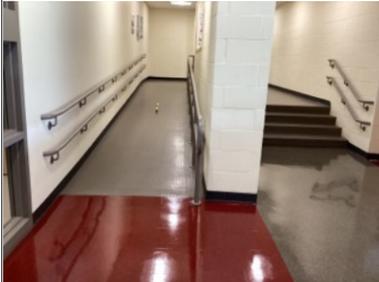
Running slope >1:12 (8.33%) Handrails < 34" or > 38" above ramp surface	11% 33"	Further study will be needed to determine whether it is technically feasible to bring this ramp into full compliance with the ADA Standards. Alter so the handrails are 34"- 38" high above the floor. (Cost to renovate interior ramp not included.)	1	-	\$0
<b>Stairways</b>

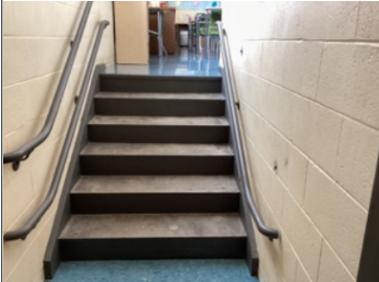
33	From 322 to 339	3		Stairways	Other

Handrail not provided on both sides	-	Provide top handrail on one side positioned between 34" and 38" above the ground on the right side.	1	-	\$0
<b>Elevator</b>												
34	Lobby Student Elevator	1		Elevator	Interior

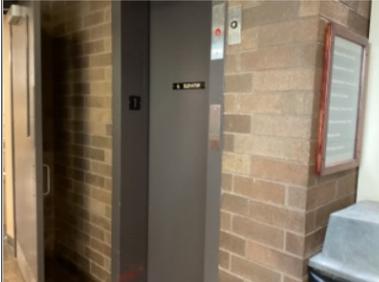
Elevator not in operable working condition.		The student elevator doors could not be opened on the day of the survey, so the elevator could not be surveyed. Ensure the student elevator is maintained in operable working condition.	1	-	\$0
<b>Signage</b>												
35	Single-User Toilet Room	3		Signage	Designation

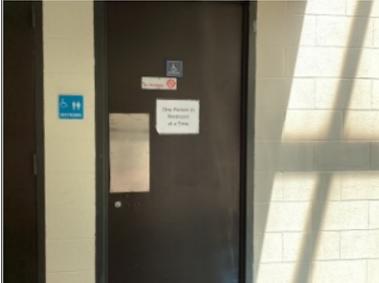
Raised characters not provided on sign Braille not provided on sign	- -	Provide text with raised characters duplicated in braille on sign.	1	232	\$232

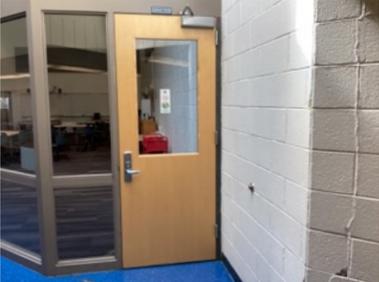
Raised characters not provided on sign Braille not provided on sign Visual characters < 40" above ground	- - -	Provide text with raised characters duplicated in braille on sign. Mount the sign so that the baseline of the lowest visual character is 40" min. above the finished floor or ground. <b>Note:</b> This signage issue also applies to doors to the gym and to the press box.	3	232	\$696
37	CAD	3	338	Signage	Designation

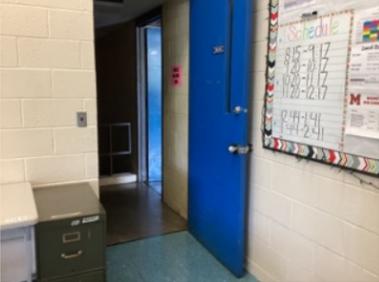
Raised characters not provided on sign Braille not provided on sign Visual characters < 40" above ground Sign not located on the latch side of the door	- - - -	Provide text with raised characters duplicated in braille on sign. Mount the sign so that the baseline of the lowest visual character is 40" min. above the finished floor or ground. Locate the sign at permanent rooms alongside the door on the latch side.	1	232	\$232

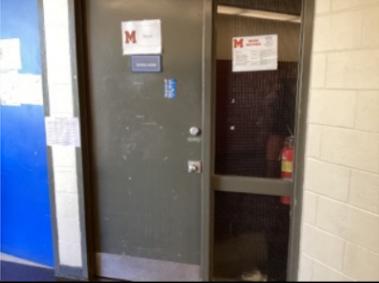
38	Nurse's Office Two Single-User Toilet Rooms	2		Signage	Designation

Raised characters not provided on sign Braille not provided on sign Sign not located on the latch side of the door	- - -	Provide text with raised characters duplicated in braille on sign. Locate the sign at permanent rooms alongside the door on the latch side.	2	232	\$464
39	Wrestling	2	242	Signage	Designation

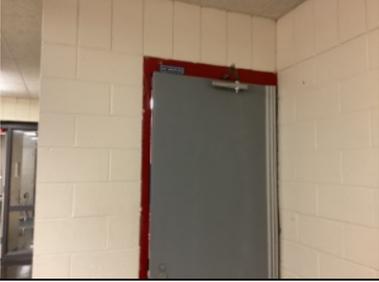
Raised characters < 48" or > 60" above ground Braille misplaced on sign Visual characters < 40" above ground	- - 85"	Mount signs so that the baseline of the lowest tactile character is 48" min. above finished floor and the baseline of the highest tactile character is 60" max. above the finished floor. Position the braille below the corresponding text. If text is multi-lined place braille below the entire text.	1	232	\$232
40	Single-User Toilet Room Across From Administration	1		Signage	Designation

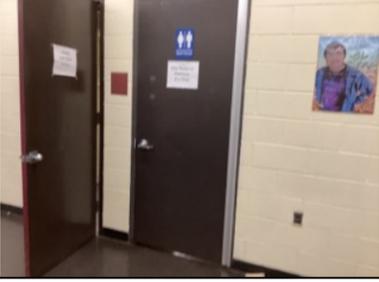
Visual characters < 40" above ground Sign not located on the latch side of the door	70" -	Mount the sign so that the baseline of the lowest visual character is 40" min. above the finished floor or ground. Locate the sign at permanent rooms alongside the door on the latch side.	2	Labor	\$0

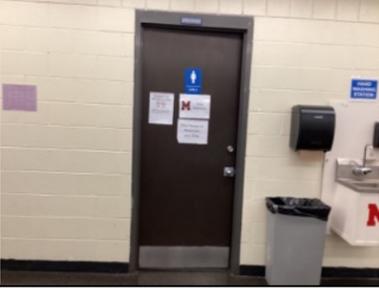
Visual characters < 40" above ground Sign not located on the latch side of the door Directional sign to access. toilet not provided	- - -	Mount the sign so that the baseline of the lowest visual character is 40" min. above the finished floor or ground. Locate the sign at permanent rooms alongside the door on the latch side. Install a sign indicating the location of the nearest accessible toilet room.	2	232	\$464
42	Girls' Toilet Room by Library	2		Signage	Designation

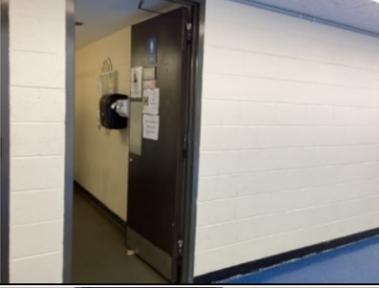
Visual characters < 40" above ground Sign not located on the latch side of the door Directional sign to access. toilet not provided	- - -	Mount the sign so that the baseline of the lowest visual character is 40" min. above the finished floor or ground. Locate the sign at permanent rooms alongside the door on the latch side. Install a sign indicating the location of the nearest accessible toilet room.	1	232	\$232

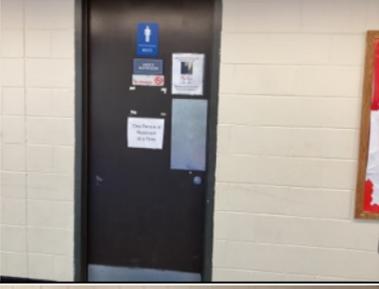
43	Boys' Toilet Room by Library	2		Signage	Designation

Visual characters < 40" above ground Sign not located on the latch side of the door Directional sign to access. toilet not provided	- - -	Mount the sign so that the baseline of the lowest visual character is 40" min. above the finished floor or ground. Locate the sign at permanent rooms alongside the door on the latch side. Install a sign indicating the location of the nearest accessible toilet room.	2	232	\$464
44	Boys' Toilet Room	1		Signage	Designation

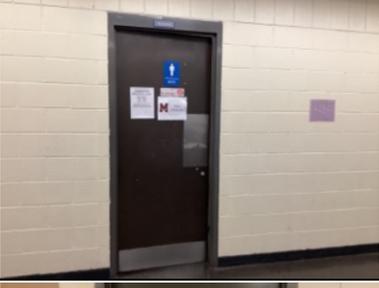
Sign not located on the latch side of the door Directional sign to access. toilet not provided Signage not located on an accessible route	- - -	Locate the sign at permanent rooms alongside the door on the latch side. Install a sign indicating the location of the nearest accessible toilet room. Relocate sign to an accessible route./Provide an accessible route to the sign.	1	232	\$232

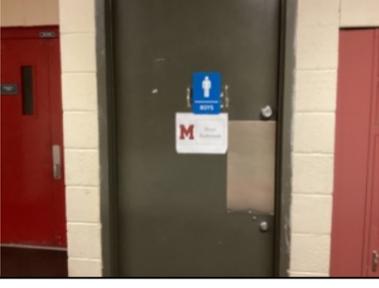
45	Boys' Toilet Room Near Gym	2		Signage	Designation

Sign not located on the latch side of the door Directional sign to access. toilet not provided	- -	Locate the sign at permanent rooms alongside the door on the latch side. Install a sign indicating the location of the nearest accessible toilet room.	2	232	\$464

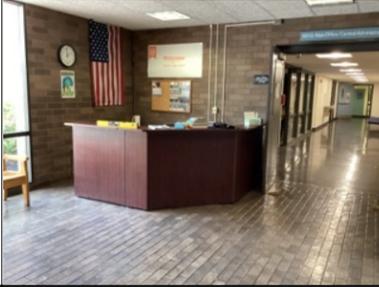
Counter > 36" high	42"	Provide a counter that is 36" max. above the ground or finished floor.	1	880	\$880
47	Administration	1		Service Counter	N/A

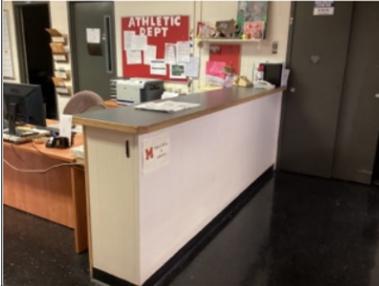
Counter > 36" high	44"	Provide a counter that is 36" max. above the ground or finished floor.	1	880	\$880
48	School Store	2		Service Counter	N/A

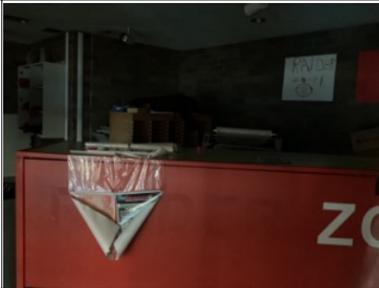
Counter > 36" high	-	Provide a counter that is 36" max. above the ground or finished floor. <b>Note:</b> On day of survey this room was locked, but the counter appeared to be more than 36" of the finished floor.	1	880	\$880
<b>Operable Parts</b>												
49	Hallway by Stair 2	2		Operable Parts	Other

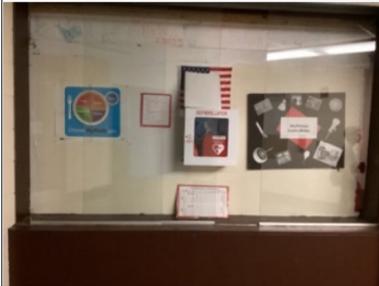
Element not on an accessible route	-	Ensure the defibrillator is located on an accessible route and that it has opening hardware that can be used without requiring tight grasping, pinching or twisting of the wrist. <b>Note:</b> On the day of the survey the glass case could not be opened in order to provide access to the defibrillator.	1	256	\$256

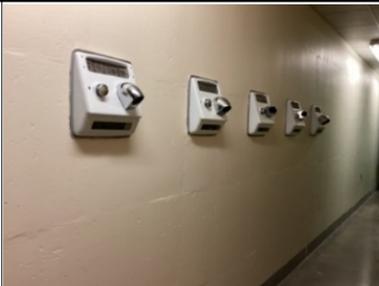
50	Girls' Locker Room	1		Operable Parts	Other

Side reach > 54"	62"	Relocate at least one hand dryer so that controls are between 15" - 48" above the finished floor.	1	256	\$256

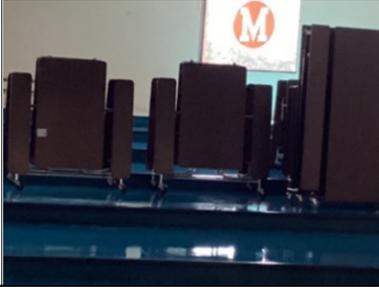
At least one or 5% accessible tables not provided	-	Ensure that at least one dining surface is accessible. <b>Note:</b> The dining tables were not set up so the required accessibility could not be determined.	1	-	\$0
<b>Assembly Area</b>												
52	Heritage Room Language Learning	2		Assembly Area	N/A

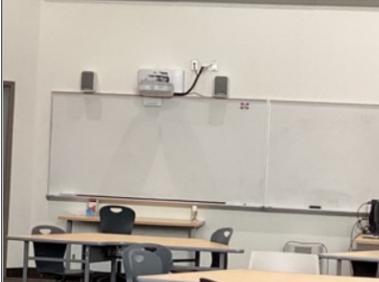
Assistive listening devices not provided	-	If audible communication is integral to the use of the space, provide an assistive listening system.	1	1214	\$1214
<b>Locker Room</b>												
53	Boys' Team Room	1		Locker Room	Boys

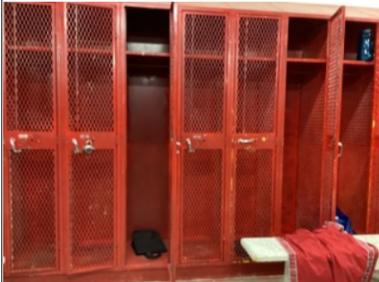
5% of lockers are not accessible Storage > 48" high	- 64"	Provide at least one accessible locker (or ensure 5% of all lockers are accessible) with at least one shelf no higher than 48 inches above the ground if a shelf is provided.	1	-	\$0

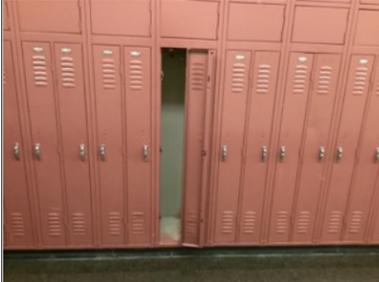
54	Lockers Near Room 240	2		Locker Room	Other

5% of lockers are not accessible Hook > 48" high	- 55"	Ensure 5% of all lockers are accessible (at least one) in each area of the school where lockers are provided. Locate hook no higher than 48" above the finished floor.	1	-	\$0
55	Girls' Locker Room	1		Locker Room	Girls

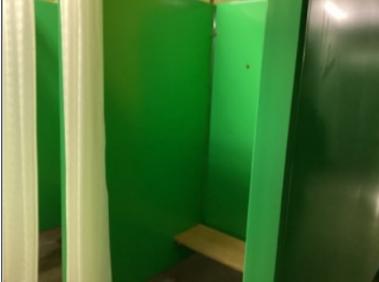
Turning space not provided 5% of changing rooms are not accessible	35" -	Provide turning space. Ensure that 5% of changing rooms (at least one) are accessible.	1	5866	\$5866

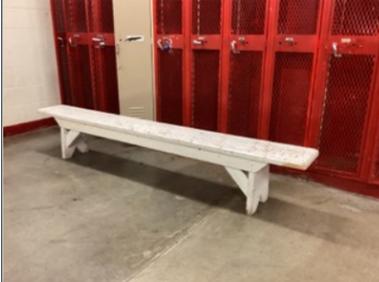
Back support not provided at bench Bench < 48" long	- -	Provide at least one bench with back support or that is affixed to a wall with room on the side to transfer. Provide a bench that is 48" long.	1	200	\$200
57	Men's Locker Room	1		Locker Room	Men's

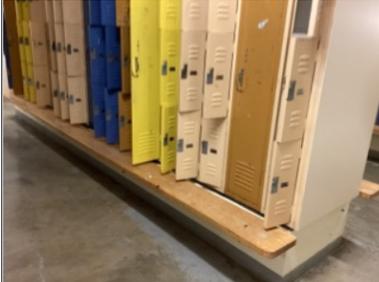
Bench < 24" deep	8"	Provide a bench that is 24" deep.	1	200	\$200
58	Girls' Locker Room	1		Locker Room	Girls

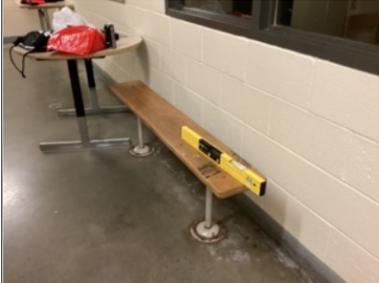
Bench < 24" deep	-	Provide a bench that is 24" deep.	1	200	\$200
<b>Toilet &amp; Bathing Rooms</b>												
<b>Overall Access</b>												
59	One of Two Nurse's Office Single-User Toilet Rooms	2	238	Overall Access	Toilet Room

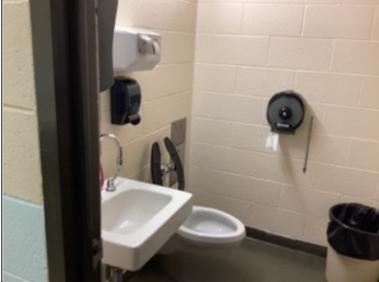
Turning space not provided Accessible plumbing fixtures or stalls not provided	- -	Add an accessible single-user toilet room.	1	24604	\$24604

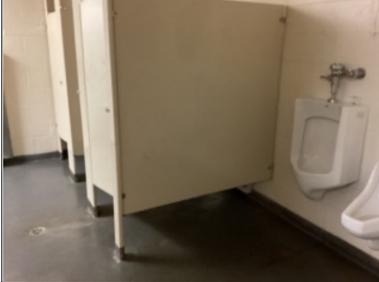
60	Men's Locker Room Toilet Room	1		Overall Access	Toilet Room

Accessible plumbing fixtures or stalls not provided	-	Provide one accessible wheelchair compartment.	1	6182	\$6182

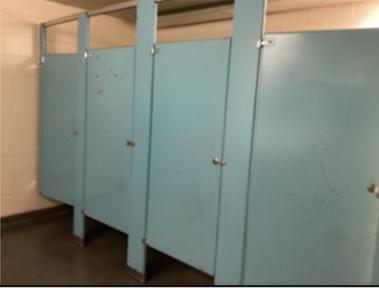
Accessible plumbing fixtures or stalls not provided	-	Provide one accessible wheelchair compartment.	1	6182	\$6182
62	Girls' Toilet Room	1		Overall Access	Toilet Room

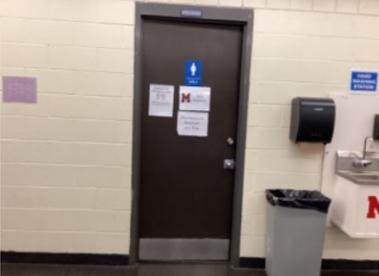
Accessible plumbing fixtures or stalls not provided	-	Provide one accessible wheelchair compartment.	1	6182	\$6182
63	Boys' Toilet Room	1		Overall Access	Toilet Room

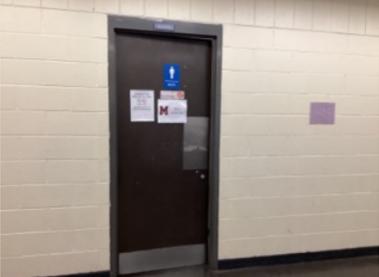
Accessible plumbing fixtures or stalls not provided	-	Provide one accessible wheelchair compartment.	1	6182	\$6182
64	Boys' Toilet Room Near Gym	2		Overall Access	Toilet Room

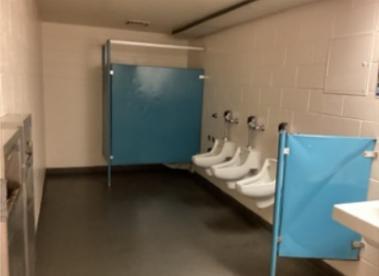
Accessible plumbing fixtures or stalls not provided	-	Provide one accessible wheelchair compartment.	1	6182	\$6182
65	Girls' Toilet Room by Library	2		Overall Access	Toilet Room

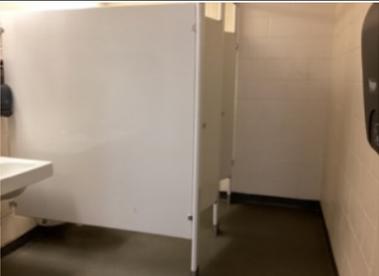
Accessible plumbing fixtures or stalls not provided	-	Provide one accessible wheelchair compartment.	1	6182	\$6182

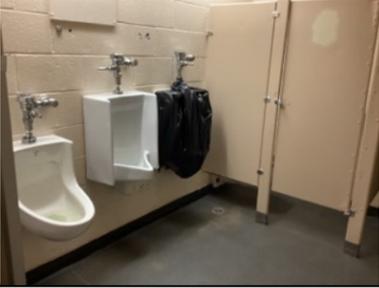
Accessible plumbing fixtures or stalls not provided	-	Provide one accessible wheelchair compartment.	1	6182	\$6182
67	Girls' Toilet Room	2	241	Overall Access	Toilet Room

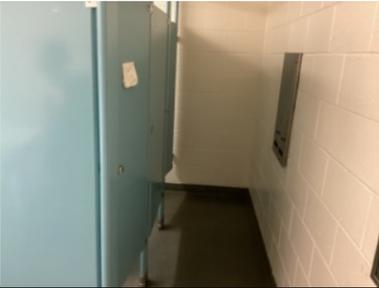
Accessible plumbing fixtures or stalls not provided	-	Provide one accessible wheelchair compartment.	1	6182	\$6182
68	Boys' Toilet Room	3		Overall Access	Toilet Room

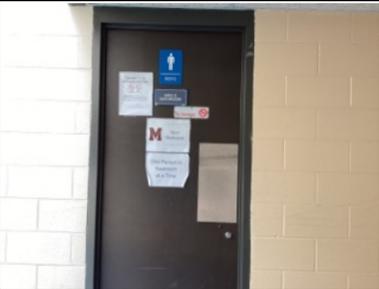
Accessible plumbing fixtures or stalls not provided	-	Provide one accessible wheelchair compartment.	1	6182	\$6182
69	Girls' Toilet Room	2		Overall Access	Toilet Room

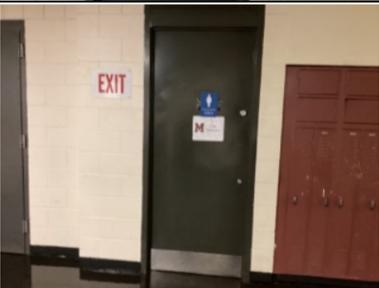
Sign to accessible toilet not provided	-	Provide a directional sign indicating the location of the nearest accessible toilet or bathing room.	1	232	\$232
<b>Lavatory</b>												
70	Girls' Locker Room Toilet Room	1		Lavatory	N/A

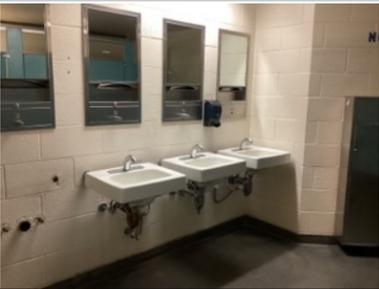
Plumbing underneath is exposed	-	Insulate or otherwise configure pipes to prevent contact for at least one lavatory.	1	92	\$92

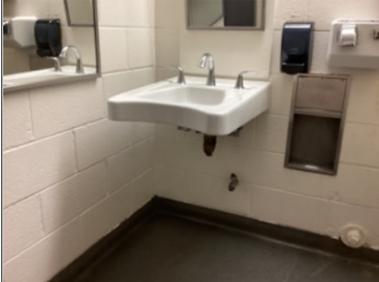
Plumbing underneath is exposed	-	Insulate or otherwise configure pipes to prevent contact for at least one lavatory.	1	92	\$92
72	Accessible Single-User Toilet Room	3		Lavatory	N/A

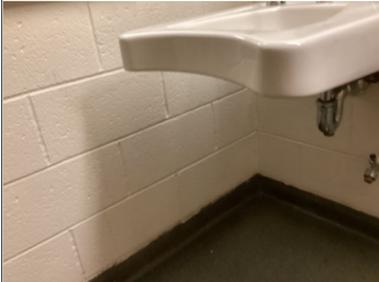
Plumbing underneath is exposed	-	Insulate or otherwise configure pipes to prevent contact for at least one lavatory.	1	92	\$92
73	Men's Locker Room Toilet Room	1		Lavatory	N/A

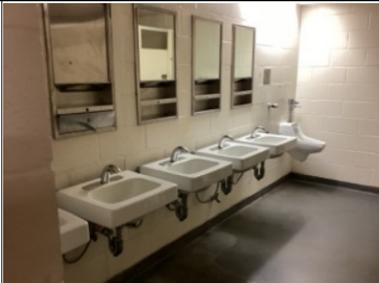
Plumbing underneath is exposed Mirror above lavatory w/reflective surface > 40"	- 56"	Insulate or otherwise configure pipes to prevent contact for at least one lavatory. Lower mirror at the accessible lavatory so that the bottom surface is at 40" max. above the finished floor.	1	348	\$348
<b>Single-User Toilet</b>												
74	Single-User Toilet Room	3		Single-User Toilet	N/A

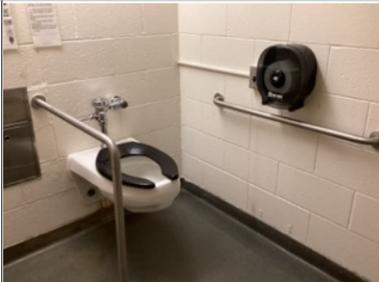
Grab bar not provided Clearance at toilet < 60" clear width Toilet paper dispenser is not compliant	- - -	Provide a rear grab bar. Remove grab bar on left side of toilet (if seated on toilet) to provide clear floor space at the toilet Relocate toilet paper so that it is 24" min. high, located under the grab bar, and between 7" and 9" from the front of the toilet.	1	1198	\$1198

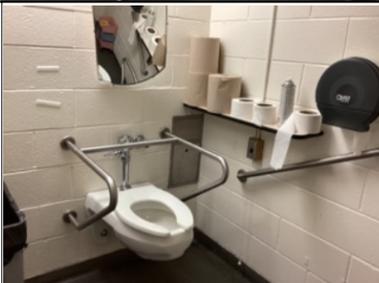
75	All Gender Toilet Room Across From Library	2		Single-User Toilet	N/A

Side or rear grab bar < 33" or > 36" high Clearance at toilet < 60" clear width Toilet paper dispenser is not compliant	- - 43"	Mount grab bars 33"- 36" above the finished floor. Renovate the toilet room to ensure that there is 60" wide min. clear floor space at the toilet (remove existing grab bars.) Relocate toilet paper so that it is 24" min. high, located under the grab bar, and between 7" and 9" from the front of the toilet. <b>Note:</b> Fixtures may not be located above the grab bar.	1	1647	\$1647

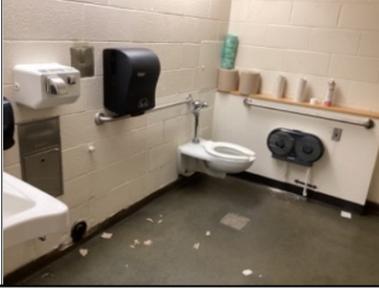
Paper towel dispenser is not compliant	-	Relocate paper towel dispenser so it is not above the grab bar.	1	353	\$353
<b>Dispensers</b>												
77	Girls' Locker Room Toilet Room	1		Dispensers	Paper Towel Dispenser

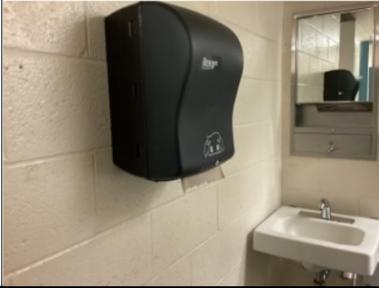
Dispenser acts as a protruding object	10"	Relocate paper towel dispenser out of the circulation path.	1	353	\$353
<b>Shower Compartment</b>												
78	Men's Locker Room Shower Area	1		Shower Compartment	N/A

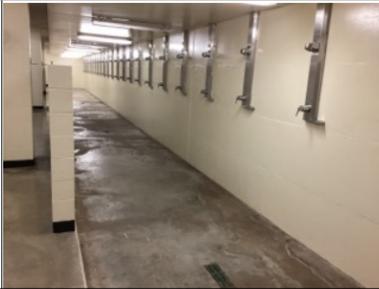
Shower not on an accessible route Accessible shower not provided	4" -	Remove curb. Provide at least one compliant accessible shower. (Reduce level change to 1/2" max., provide grab bars and accessible controls.)	1	9832	\$9832
79	Girls' Locker Room Shower Area	1		Shower Compartment	N/A

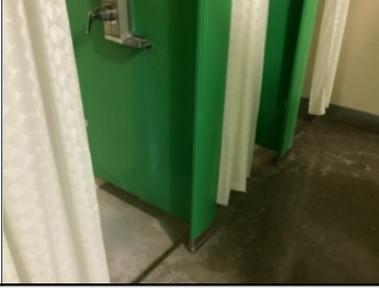
Accessible shower on an accessible route not provided.	3"	Provide at least one compliant accessible shower located on an accessible route.	1	6072	\$6072

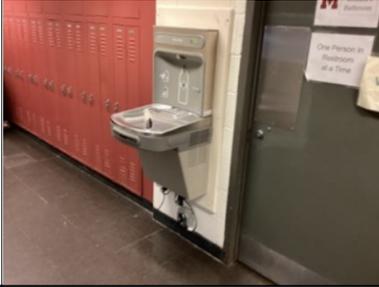
No drinking fountain provided for standing users	-	Provide an additional drinking fountain for standing users or install a Hi-Lo drinking fountain.	1	4028	\$4028
81	Near Exit 4	1		Drinking Fountains	Low

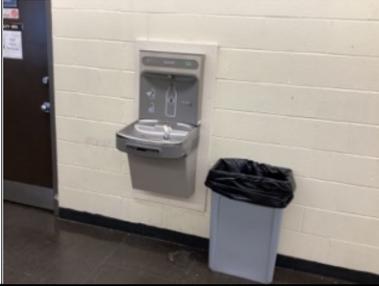
No drinking fountain provided for standing users	-	Provide an additional drinking fountain for standing users or install a Hi-Lo drinking fountain.	1	4028	\$4028
82	By Administration	1		Drinking Fountains	Low

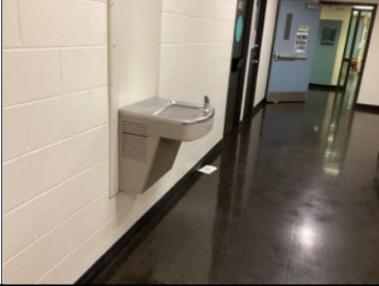
No drinking fountain provided for standing users	-	Provide an additional drinking fountain for standing users or install a Hi-Lo drinking fountain.	1	4028	\$4028
83	Gym	2		Drinking Fountains	Low

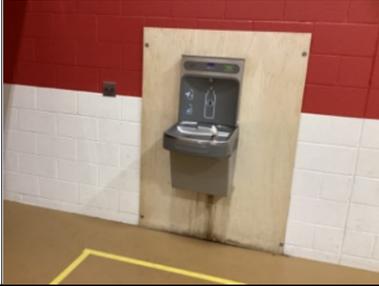
No drinking fountain provided for standing users	-	Provide an additional drinking fountain for standing users or install a Hi-Lo drinking fountain.	1	4028	\$4028

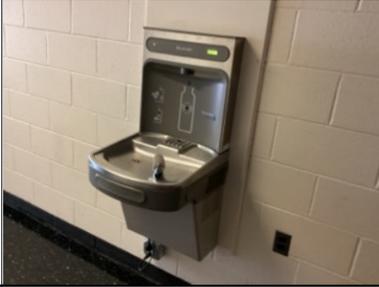
84	Near Trainers Office	2		Drinking Fountains	Low

No drinking fountain provided for standing users	-	Provide an additional drinking fountain for standing users or install a Hi-Lo drinking fountain.	1	4028	\$4028

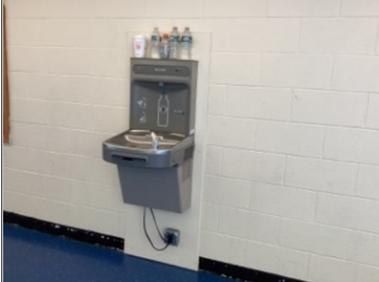
No drinking fountain provided for standing users	-	Provide an additional drinking fountain for standing users or install a Hi-Lo drinking fountain.	1	4028	\$4028
86	By Girls' Toilet Room	3		Drinking Fountains	Low

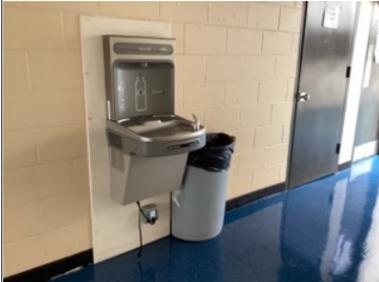
No drinking fountain provided for standing users	-	Provide an additional drinking fountain for standing users or install a Hi-Lo drinking fountain.	1	4028	\$4028
87	By Freight Elevator	3		Drinking Fountains	Low

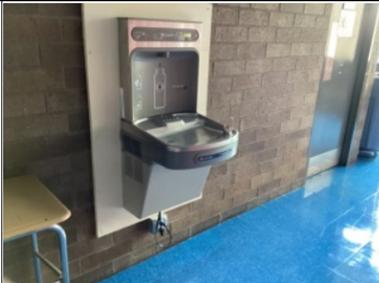
No drinking fountain provided for standing users	-	Provide an additional drinking fountain for standing users or install a Hi-Lo drinking fountain.	1	4028	\$4028
88	Men's Locker	1		Drinking Fountains	High

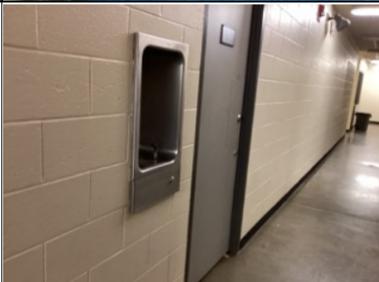
No drinking fountain provided for seated users Knee or toe clearance not provided	- -	Provide an additional drinking fountain for seated and standing users or install a Hi-Lo drinking fountain. Provide knee and toe clearance, 27" min. high at drinking fountain for seated users. (Cost based on a new Hi-Lo drinking fountain.)	1	4216	\$4216

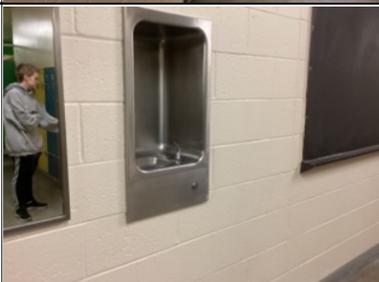
89	Girls' Locker Room	1		Drinking Fountains	High

No drinking fountain provided for seated users Knee or toe clearance not provided	- -	Provide an additional drinking fountain for seated and standing users or install a Hi-Lo drinking fountain. Provide knee and toe clearance, 27" min. high at drinking fountain for seated users. (Cost based on a new Hi-Lo drinking fountain.)	1	4216	\$4216

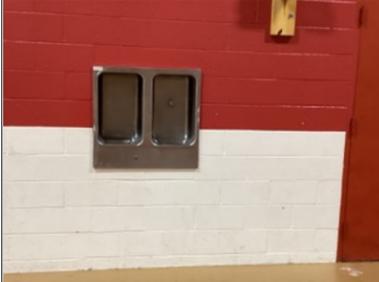
No drinking fountain provided for seated users Knee or toe clearance not provided	- -	Provide an additional drinking fountain for seated and standing users or install a Hi-Lo drinking fountain. Provide knee and toe clearance, 27" min. high at drinking fountain for seated users. (Cost based on a new Hi-Lo drinking fountain.)	1	4216	\$4216
91	Library	2		Drinking Fountains	Hi-Lo

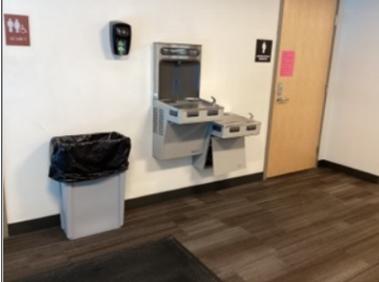
Standing height fountain does not have cane protection	-	Provide a cane-detectable barrier skirt under the high unit.	1	890	\$890
<b>Sink</b>												
92	Photography	1	139A	Sink	Lab

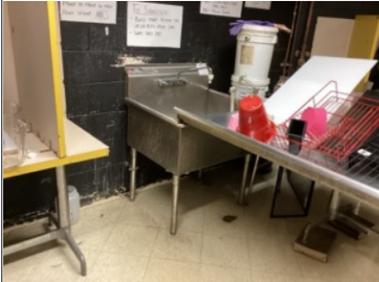
Toe and knee clearances not provided	8"	Ensure there is a 27" min. knee clearance positioned for a forward approach.	1	1686	\$1686
93	By Nurse	2		Sink	N/A

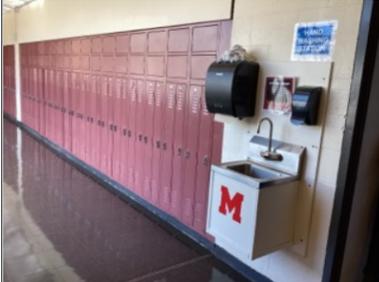
Toe and knee clearances not provided	18"	Ensure there is a 27" min. knee clearance positioned for a forward approach.	4	1686	\$6744

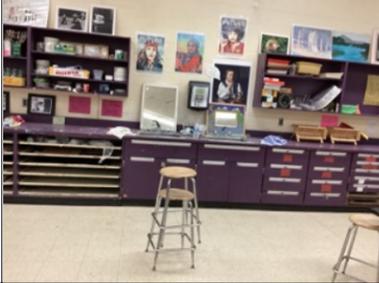
94	Art	1	112	Sink	Classroom

Toe and knee clearances not provided Rim or counter > 34"	- 36	Ensure there is a 27" min. knee clearance positioned for a forward approach. Relocate sink with the front of the rim or counter no higher than 34" above the finished floor.	1	3094	\$3094

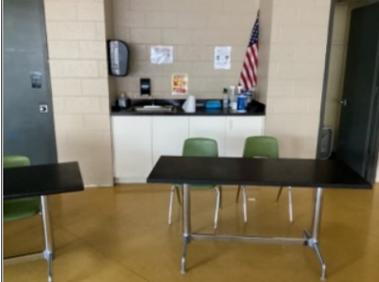
Toe and knee clearances not provided Rim or counter > 34"	36"	Ensure there is a 27" min. knee clearance positioned for a forward approach. Relocate sink with the front of the rim or counter no higher than 34" above the finished floor.	1	3094	\$3094
96	Science	1	120	Sink	Classroom

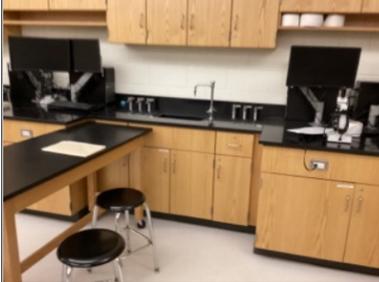
Toe and knee clearances not provided Rim or counter > 34"	- 36"	Ensure there is a 27" min. knee clearance positioned for a forward approach. Relocate sink with the front of the rim or counter no higher than 34" above the finished floor.	1	3094	\$3094
97	Art	1	113	Sink	Classroom

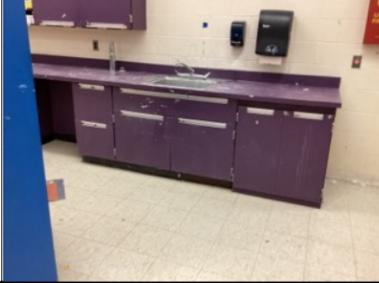
Toe and knee clearances not provided Rim or counter > 34" Exposed plumbing underneath sink	- 36" -	Ensure there is a 27" min. knee clearance positioned for a forward approach. Relocate sink with the front of the rim or counter no higher than 34" above the finished floor. Insulate or otherwise configure pipes at sink.	1	3094	\$3094

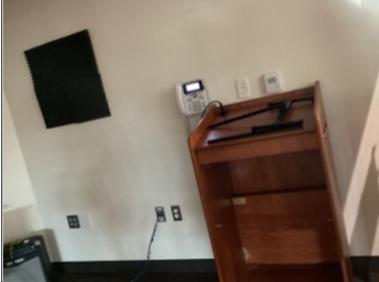
Recommend providing an accessible adjustable height podium with knee and toe clearance.	1	-	\$0

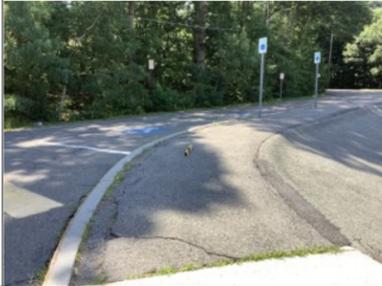
Cross slope > 1:50 (2.00%) Route not maintained in operable working condition	5% 9.2% -	Reduce cross slope to be no steeper than 1:50 (2.00%). Ensure the accessible route is maintained in operable working condition.	1	-	\$0
2	Route to Accessible Entrance, Door #5	Ext.		Exterior Access Route	4

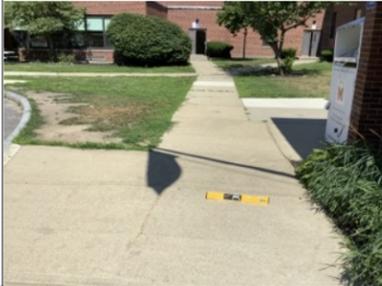
Cross slope > 1:50 (2.00%)	5%	Reduce the cross slope to be no steeper than 1:50 (2.00%).  Recommend placing additional directional signage along the walkway.	1	-	\$0
3	Route to Playground	Ext.		Exterior Access Route	4

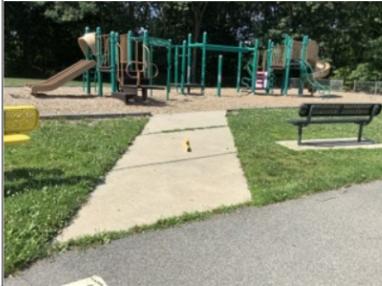
Cross slope > 1:50 (2.00%) Running slope > 1:20 (5.00%)	3.8% 8%	Reduce the cross slope to be no steeper than 1:50 (2.00%). Reduce the running slope to be no steeper than 1:20 (5.00%).	1	-	\$0

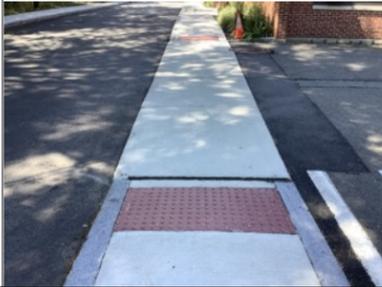
4	Southeast Parking to Main Entrance - Door #1	Ext.		Exterior Access Route	4

Level changes > 1/4"	0.5"	Alter the change in level to be 1/4" high max.	1	-	\$0
5	To Accessible Parking	Ext.		Exterior Access Route	Sidewalk

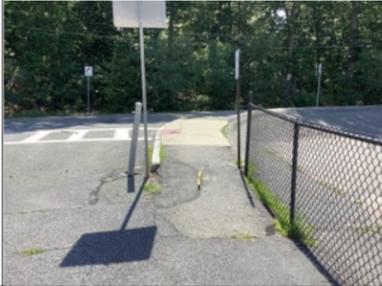
Cross slope > 1:50 (2.00%) Running slope > 1:20 (5.00%)	3% 13.2%	Reduce the cross slope to be no steeper than 1:50 (2.00%). Reduce the running slope to be no steeper than 1:20 (5.00%).	1	-	\$0

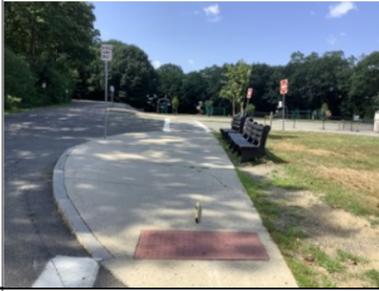
Cross slope > 1:50 (2.00%)	2.7%	Reduce the cross slope to be no steeper than 1:50 (2.00%).	1	-	\$0
7	To Playground	Ext.		Exterior Access Route	Sidewalk

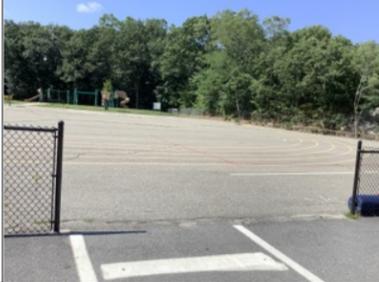
Surface openings > 1/2"	4"	Repair the surface openings to ensure that the accessible route is maintained in operable working condition.	1	-	\$0
8	Trail Outdoor Classroom	Ext.		Exterior Access Route	Walkway

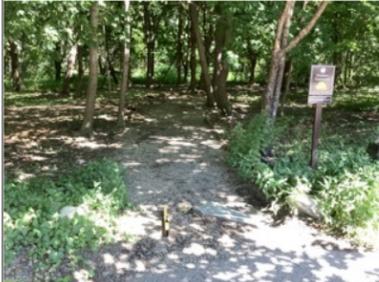
Exterior route < 36" wide Cross slope > 1:50 (2.00%) Running slope > 1:20 (5.00%)	28" 9.3% 5.7%	Ensure that a clear width of 36" min. is maintained at the accessible route. Reduce cross slope to be no steeper than 1:50 (2.00%). Reduce running slope to be no steeper than 1:20 (5.00%).	1	-	\$0
9	Trail to Outdoor Classroom	Ext.		Exterior Access Route	Walkway

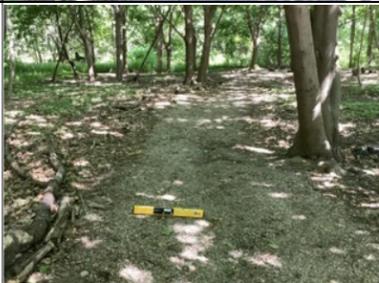
Cross slope > 1:50 (2.00%)	12%	Reduce the cross slope to be no steeper than 1:50 (2.00%).	1	-	\$0

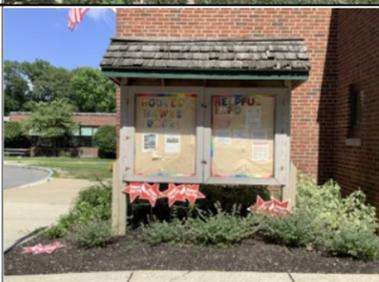
10	Wayside by Main Entrance - Door #1	Ext.		Exterior Access Route

Accessible route not provided	-	Ensure an accessible route is provided to the informational wayside.	1	-	\$0

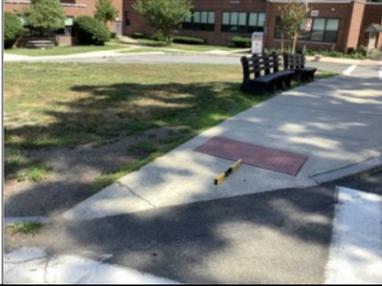
Transition from curb ramp to street not flush	-	Ensure transition from curb ramp to street is flush or free of changes in level.	1	-	\$0
<b>Curb Ramp</b>												
12	Across Main Entrance - Door #1	Ext.		Curb Ramp	60

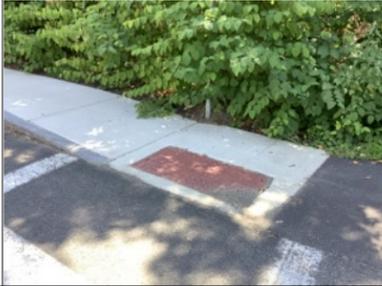
Transition from curb ramp to street not flush	-	Ensure transition from curb ramp to street is flush or free of changes in level.	1	-	\$0
13	Benches to Accessible Parking	Ext.		Curb Ramp	60

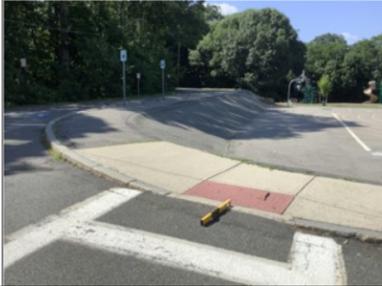
Transition from curb ramp to street not flush	-	Ensure transition from curb ramp to street is flush or free of changes in level.	1	-	\$0
14	Main Entrance, Egress Door 1 to Benches	Ext.		Curb Ramp	62

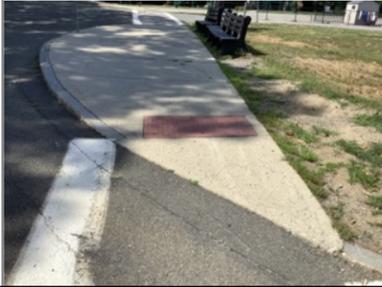
Transition from curb ramp to street not flush	-	Ensure transition from curb ramp to street is flush or free of changes in level.	1	-	\$0

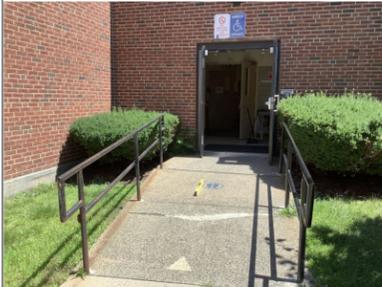
Handrails < 34" or > 38" above ramp surface	31"	Alter so the handrails are 34"- 38" high above the ground or finished floor.	1	-	\$0

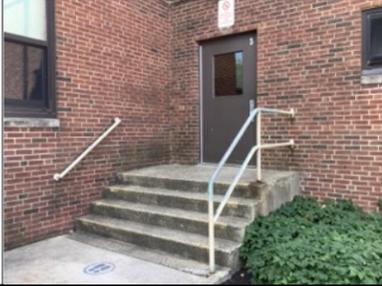
Handrails do not extend 12" from stair	-	Top: Ensure handrails extend horizontally above the landing for 12" min. beginning above the first riser nosing. Bottom: Ensure that the sloped bottom extension extends one tread depth min. beyond last riser nosing in same direction as stair flight.	1	-	\$0
<b>Entrance</b>												
17	Entrance - Door #3	Ext.		Entrance	Secondary Entrance

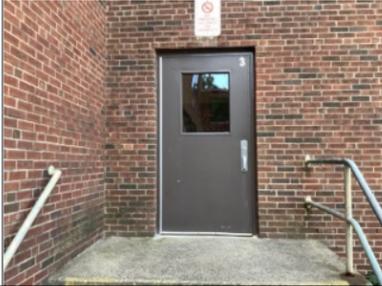
Entrance not on an accessible route Directional sign to accessible entrance not provided	- -	Provide a directional sign indicating the location of the nearest accessible entrance.	1	-	\$0
18	Entrance - Door #4	Ext.		Entrance	Secondary Entrance

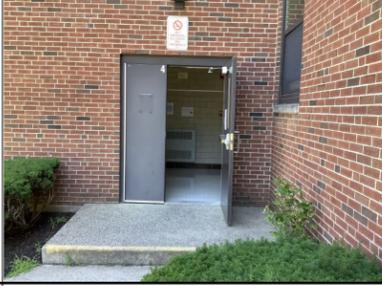
Entrance not on an accessible route Directional sign to accessible entrance not provided	- -	Provide a directional sign indicating the location of the nearest accessible entrance.	1	-	\$0

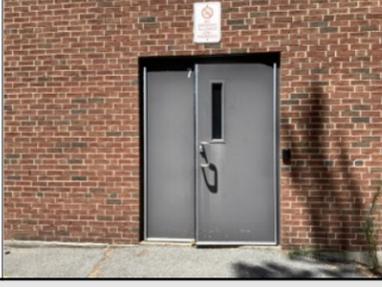
19	Entrance Door #7	Ext.		Entrance	Secondary Entrance

Entrance not on an accessible route Directional sign to accessible entrance not provided	- -	Provide a directional sign indicating the location of the nearest accessible entrance.	1	-	\$0
<b>Access to Goods and Services</b>												
<b>Means of Egress</b>												
20	Egress Door #2	1		Means of Egress	N/A

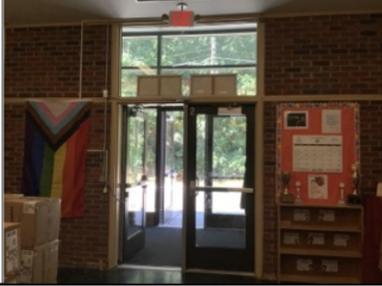
Tactile exit sign not provided Illuminated ISA symbol not provided (MAAB)	- -	Ensure tactile exit signs with raised characters and braille are provided at exit doors. Mount signs between 48"- 60" above the finished floor located on the latch side of the door. Provide an illuminated sign with the International Symbol of Accessibility (ISA).	1	432	\$432

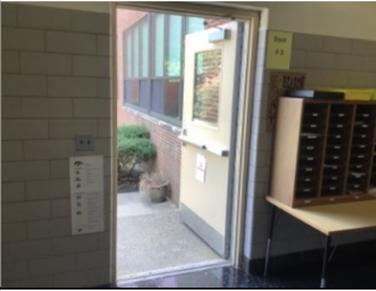
ID	Location	Floor	Room	Element	Type	Photo	Issues	Current Measure	Recommendations	Quantity	Price	Cost Estimation
21	Egress Door #3	1		Means of Egress	N/A

Tactile exit sign not provided Directional sign to accessible emergency exit not provided	- -	Ensure tactile exit signs with raised characters and braille are provided at exit doors. Mount signs between 48"- 60" above the finished floor located on the latch side of the door. Provide a directional sign indicating the location of the nearest accessible emergency exit.	1	464	\$464
22	Egress Door #4	1		Means of Egress	N/A

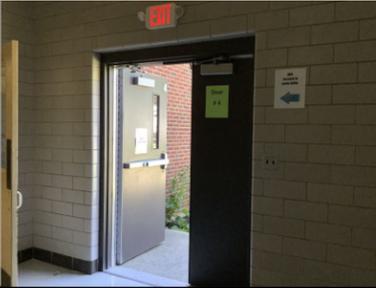
Tactile exit sign not provided Directional sign to accessible emergency exit not provided	- -	Ensure tactile exit signs with raised characters and braille are provided at exit doors. Mount signs between 48"- 60" above the finished floor located on the latch side of the door. Provide a directional sign indicating the location of the nearest accessible emergency exit.	1	464	\$464

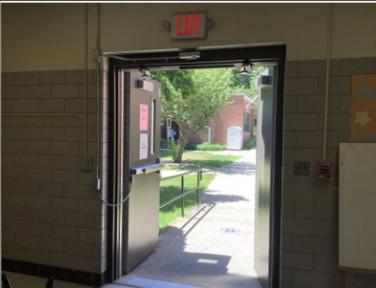
23	Egress Door #5	1		Means of Egress	N/A

Tactile exit sign not provided Illuminated ISA symbol not provided (MAAB)	- -	Ensure tactile exit signs with raised characters and braille are provided at exit doors. Mount signs between 48"- 60" above the finished floor located on the latch side of the door. Provide an illuminated sign with the International Symbol of Accessibility (ISA).	1	432	\$432
24	Egress Door #7	1		Means of Egress	N/A

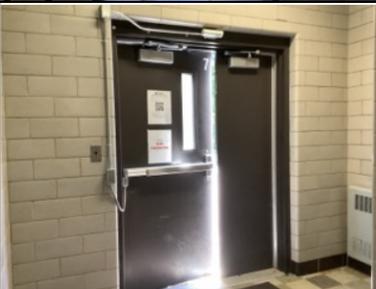
Tactile exit sign not provided Directional sign to accessible emergency exit not provided	- -	Ensure tactile exit signs with raised characters and braille are provided at exit doors. Mount signs between 48"- 60" above the finished floor located on the latch side of the door. Provide a directional sign indicating the location of the nearest accessible emergency exit.	1	464	\$464
25	Egress to Staircase #1	2		Means of Egress	N/A

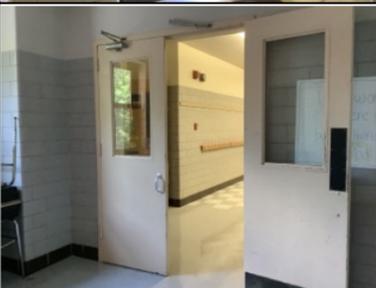
Tactile exit sign not provided	-	Ensure tactile exit signs with raised characters and braille are provided at exit doors. Mount signs between 48"- 60" above the finished floor located on the latch side of the door.	1	232	\$232

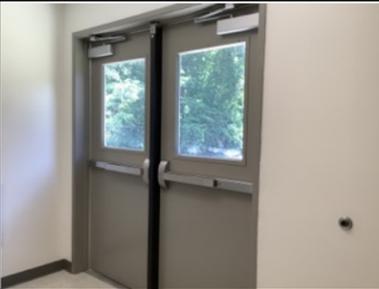
ID	Location	Floor	Room	Element	Type	Photo	Issues	Current Measure	Recommendations	Quantity	Price	Cost Estimation
26	South Egress Door From Kindergarten Classroom	1		Means of Egress	N/A

Tactile exit sign not provided Illuminated ISA symbol not provided (MAAB)	- -	Ensure tactile exit signs with raised characters and braille are provided at exit doors. Mount signs between 48"- 60" above the finished floor located on the latch side of the door. Provide an illuminated sign with the International Symbol of Accessibility (ISA).	1	432	\$432
27	Staircase #3 Egress	2		Means of Egress	N/A

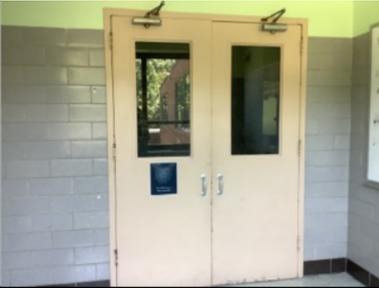
Tactile exit sign not provided	-	Ensure tactile exit signs with raised characters and braille are provided at exit doors. Mount signs between 48"- 60" above the finished floor located on the latch side of the door.	1	232	\$232
28	West Egress From Kindergarten Classroom	1		Means of Egress	N/A

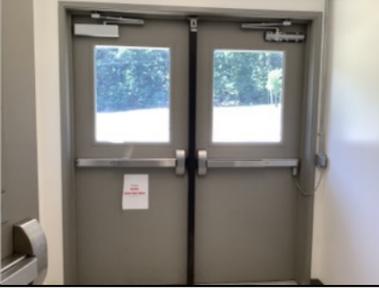
Tactile exit sign not provided Illuminated ISA symbol not provided (MAAB)	- -	Ensure tactile exit signs with raised characters and braille are provided at exit doors. Mount signs between 48"- 60" above the finished floor located on the latch side of the door. Provide an illuminated sign with the International Symbol of Accessibility (ISA).	1	432	\$432

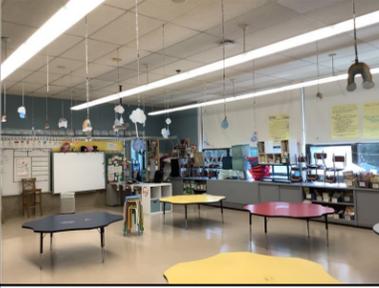
<b>Interior Access Route</b>												
29	Second Grade Classroom	1		Interior Access Route	N/A

Obstructed by protruding objects Vertical clearance < 80" above finished floor	- 63"	Ensure the object hanging from the ceiling are mounted 80" min. above the finished floor.	1	Labor	\$0
30	To Principal's Office	1		Interior Access Route	N/A

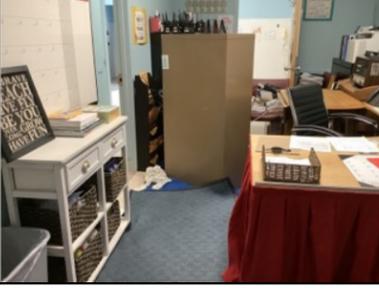
Route < 36" wide	30"	Ensure that a clear width of 36" min. is maintained at the accessible route.	1	Labor	\$0

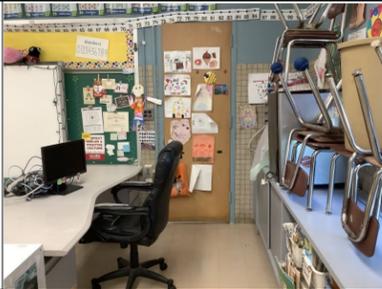
ID	Location	Floor	Room	Element	Type	Photo	Issues	Current Measure	Recommendations	Quantity	Price	Cost Estimation
31	To Toilet Room - Second Grade Classroom,	1		Interior Access Route	N/A

Route < 36" wide	22"	Ensure that a clear width of 36" min. is maintained at the accessible route.	1	Labor	\$0
<b>Doors, Doorways, &amp; Gates</b>												
32	Accessible Route to Stage	1		Doors, Doorways, & Gates	Other

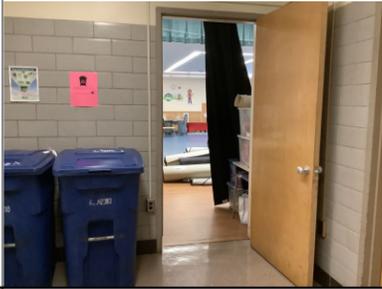
Maneuvering clearance(s) not provided Hardware not operable with a closed fist	11" -	Relocate the recycling bin to maintain the required 18" min. maneuvering clearance. Provide hardware that can be operable with one hand and not require tight grasping, pinching, or twisting of the wrist.	1	484	\$484
33	Boys' Toilet Room Across Reading Room	1		Doors, Doorways, & Gates	Circulation

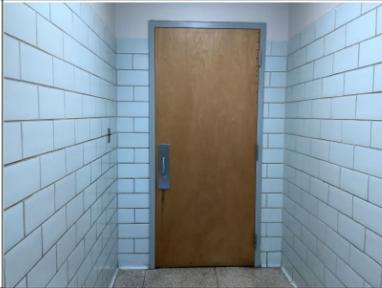
Door requires > 5 lbs. of force to open	15 lbs	Adjust closers so doors do not require more than 5 pounds of force to open.	1	Labor	\$0

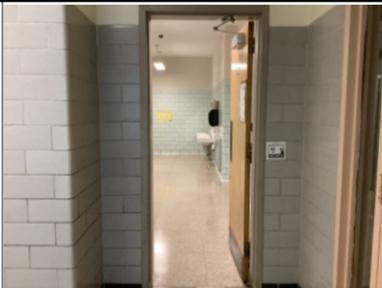
34	Boys' Toilet Room Across Speech Room	2		Doors, Doorways, & Gates	Toilet Room

Door requires > 5 lbs. of force to open	17 lbs	Adjust closers so doors do not require more than 5 pounds of force to open.	1	Labor	\$0
35	Fifth Grade Classroom	2		Doors, Doorways, & Gates	Classroom

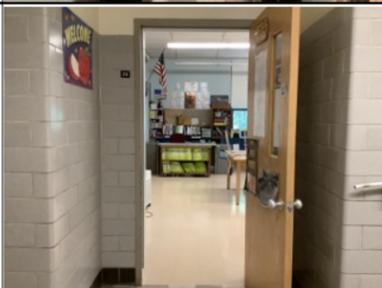
Maneuvering clearance(s) not provided Hardware not operable with a closed fist	13" -	Provide an automatic door opener. Provide hardware that can be operable with one hand and not require tight grasping, pinching, or twisting of the wrist.	1	3060	\$3060

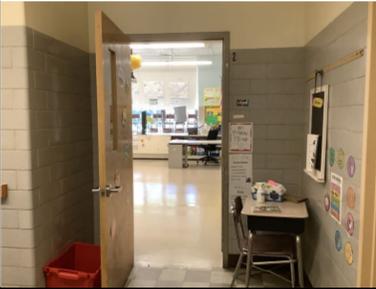
ID	Location	Floor	Room	Element	Type	Photo	Issues	Current Measure	Recommendations	Quantity	Price	Cost Estimation
36	First Grade Classroom	1		Doors, Doorways, & Gates	Classroom

Maneuvering clearance(s) not provided	9"	Remove the desk to maintain the required 18" min. maneuvering clearance.	1	Labor	\$0
37	Fourth Grade Classroom	1		Doors, Doorways, & Gates	Classroom

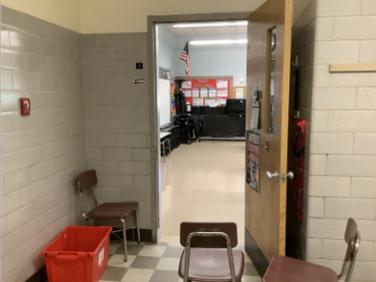
Maneuvering clearance(s) not provided Hardware not operable with a closed fist	7" -	Remove the chair to maintain the required 18" min. maneuvering clearance. Provide hardware that can be operable with one hand and not require tight grasping, pinching, or twisting of the wrist.	1	484	\$484
39	Girls' Toilet Room - Across Reading Room	1		Doors, Doorways, & Gates	Toilet Room

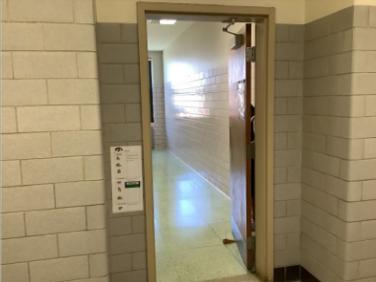
Door requires > 5 lbs. of force to open	20 lbs	Adjust closers so doors do not require more than 5 pounds of force to open.	1	Labor	\$0
38	Girls' Toilet Room - Across Reading Room	1		Doors, Doorways, & Gates	Toilet Room

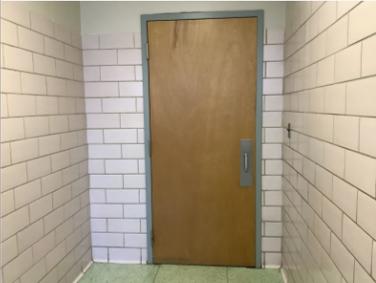
Maneuvering clearance(s) not provided	8"	Reverse the swing of the door to provide maneuvering clearance.	1	1884	\$1884

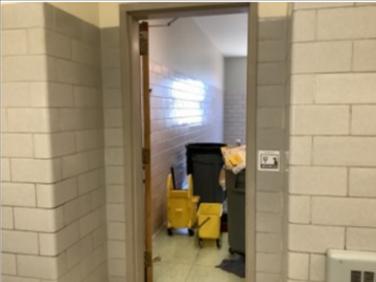
40	Girls' Toilet Room Across Speech Room	2		Doors, Doorways, & Gates	Toilet Room

Door requires > 5 lbs. of force to open	18 lbs	Adjust closers so doors do not require more than 5 pounds of force to open.	1	Labor	\$0

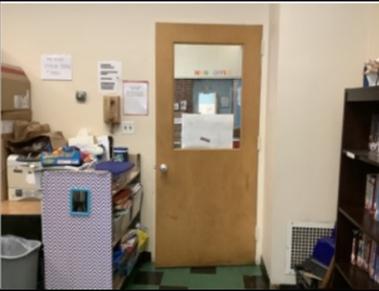
ID	Location	Floor	Room	Element	Type	Photo	Issues	Current Measure	Recommendations	Quantity	Price	Cost Estimation
41	Library	1		Doors, Doorways, & Gates	Circulation

Maneuvering clearance(s) not provided Hardware not operable with a closed fist	6" -	Remove the cabinet to maintain the required 18" min. maneuvering clearance. Provide hardware that can be operable with one hand and not require tight grasping, pinching, or twisting of the wrist.	1	484	\$484
42	Main Office	1		Doors, Doorways, & Gates	Office

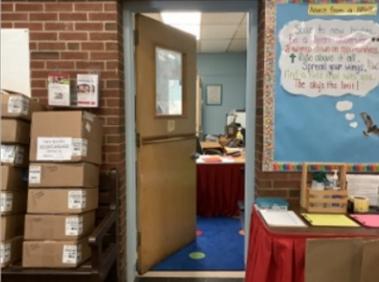
Hardware not operable with a closed fist	-	Provide hardware that can be operable with one hand and not require tight grasping, pinching, or twisting of the wrist.	1	484	\$484
43	Men's Multi-User Toilet Room by Mindfulness Room	1		Doors, Doorways, & Gates	Toilet Room

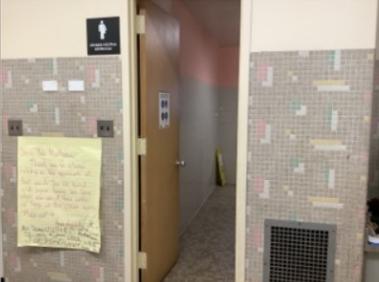
Clear width at door < 32" Hardware not operable with a closed fist	25" -	Widen the door so that there is 32" min. clear width. Provide hardware that can be operable with one hand and not require tight grasping, pinching, or twisting of the wrist.  See ID #85 for additional recommendations.	1	-	\$0

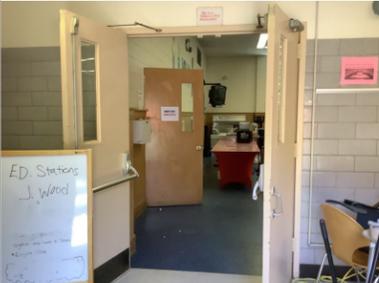
44	Multi-Purpose Room	1		Doors, Doorways, & Gates	Other

If double-leaf door, neither compliant	27"	Keep both doors open during business hours.	1	Labor	\$0
45	Multi-Purpose Room, Stage Side	1		Doors, Doorways, & Gates	Assembly Space

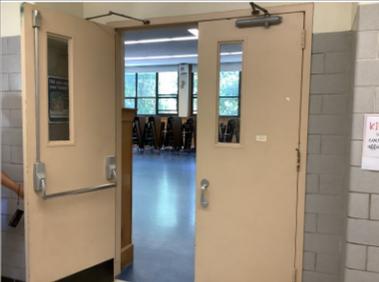
If double-leaf door, neither compliant Door requires > 5 lbs. of force to open	27" 19 lbs	Keep both doors open during business hours. Adjust closers so doors do not require more than 5 pounds of force to open.	1	Labor	\$0

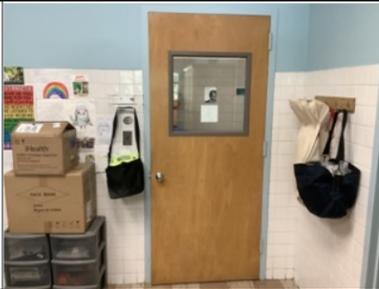
ID	Location	Floor	Room	Element	Type	Photo	Issues	Current Measure	Recommendations	Quantity	Price	Cost Estimation
46	Nurse's Office	1		Doors, Doorways, & Gates	Office

Maneuvering clearance(s) not provided Hardware not operable with a closed fist	- -	Remove carton box and plastic beans to maintain the 18" min. maneuvering clearance at the door. Provide hardware that can be operable with one hand and not require tight grasping, pinching, or twisting of the wrist.	1	484	\$484
47	PT/OT/ Speech Room	1		Doors, Doorways, & Gates	Office

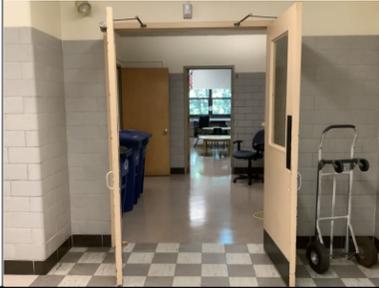
Clear width at door < 32"	27"	Keep both doors open during business hours.	1	Labor	\$0
48	PT/OT/ Speech Room	1		Doors, Doorways, & Gates	Office

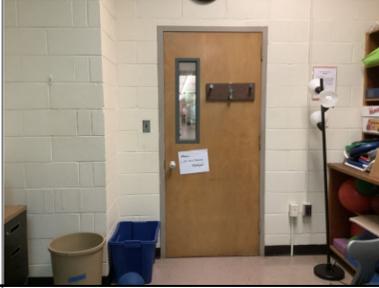
Maneuvering clearance(s) not provided Hardware not operable with a closed fist	- -	Relocate the trash bin to provide the required 18" min. maneuvering clearance. Provide hardware that can be operable with one hand and not require tight grasping, pinching, or twisting of the wrist.	1	484	\$484

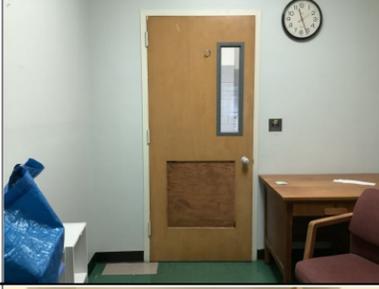
49	Reading Room	1		Doors, Doorways, & Gates	Circulation

Maneuvering clearance(s) not provided Hardware not operable with a closed fist	- -	Relocate the desk to maintain the required 18" min. maneuvering clearance. Provide hardware that can be operable with one hand and not require tight grasping, pinching, or twisting of the wrist.	1	484	\$484
50	Second Grade Classroom	1		Doors, Doorways, & Gates	Classroom

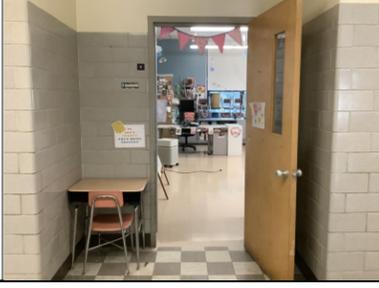
Maneuvering clearance(s) not provided Hardware not operable with a closed fist	- -	Remove the desk to maintain the required 18" maneuvering clearance. Provide hardware that can be operable with one hand and not require tight grasping, pinching, or twisting of the wrist.	1	484	\$484

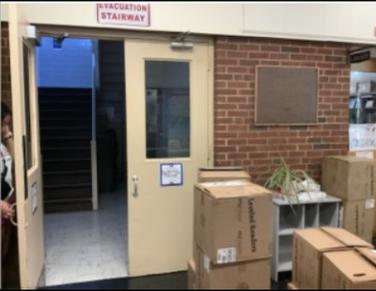
ID	Location	Floor	Room	Element	Type	Photo	Issues	Current Measure	Recommendations	Quantity	Price	Cost Estimation
51	Staircase #1	1		Doors, Doorways, & Gates	Circulation

If double-leaf door, neither compliant	27"	Keep both doors open during business hours.	1	Labor	\$0
52	Staircase #2	2		Doors, Doorways, & Gates	Circulation
