# ADA Self-Evaluation and Transition Plan for the City of Melrose

Part 2 of 2

## Part 2: Reports:

January, 2023

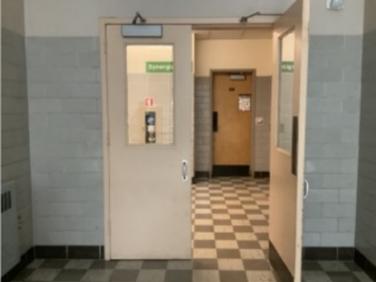
If double-leaf door, neither compliant	27"	Ensure that both doors remain open during school hours.	1	Labor	\$0
53	Staircase #3 Egress	2		Doors, Doorways, & Gates	Circulation

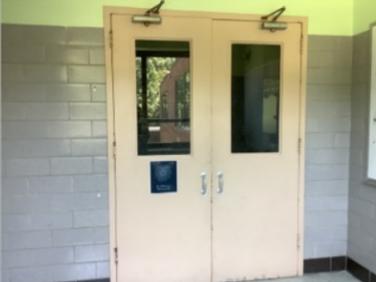
If double-leaf door, neither compliant Door requires > 5 lbs. of force to open	27" 18 lbs	Ensure that at least one of the active leaves is at least 32" min. wide. Adjust closers so doors do not require more than 5 pounds of force to open.	1	Labor	\$0
54	Third Grade Classroom	1		Doors, Doorways, & Gates	Classroom

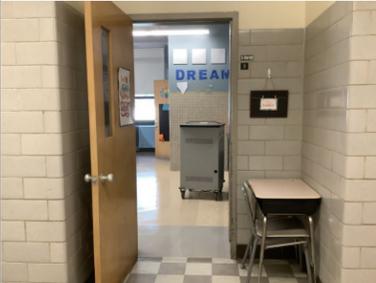
Maneuvering clearance(s) not provided Hardware not operable with a closed fist	6" -	Remove the desk to maintain the required 18" maneuvering clearance. Provide hardware that can be operable with one hand and not require tight grasping, pinching, or twisting of the wrist.	1	484	\$484

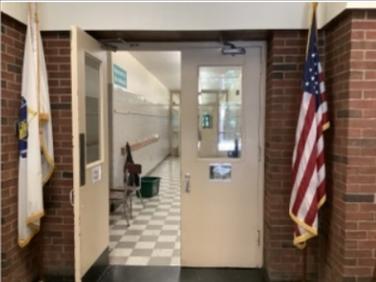
55	To Classrooms	1		Doors, Doorways, & Gates	Circulation

If double-leaf door, neither compliant	27"	Keep both doors open during business hours.	1	Labor	\$0

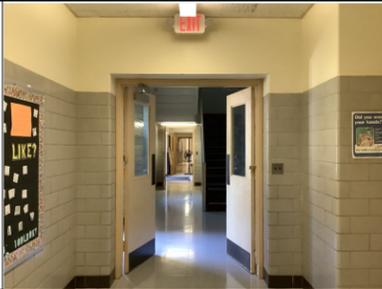
ID	Location	Floor	Room	Element	Type	Photo	Issues	Current Measure	Recommendations	Quantity	Price	Cost Estimation
56	To Egress Door #4	1		Doors, Doorways, & Gates	Circulation

If double-leaf door, neither compliant	27"	Keep both doors open during business hours.	1	Labor	\$0
57	To Second and Third Grade Classrooms	1		Doors, Doorways, & Gates	Circulation

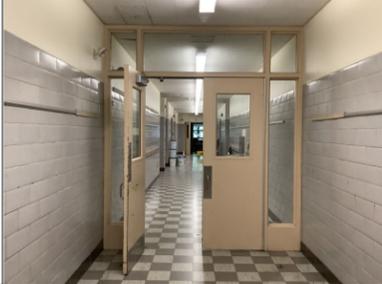
Clear width at door < 32"	27"	Keep both doors open during business hours.	1	Labor	\$0
58	Toilet Room - Kindergarten Classroom	1		Doors, Doorways, & Gates	Toilet Room

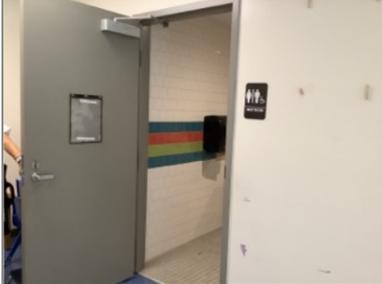
Door requires > 5 lbs. of force to open	16 lbs	Adjust closers so doors do not require more than 5 pounds of force to open.	1	Labor	\$0
59	Toilet Room - Third Grade Classroom	1		Doors, Doorways, & Gates	Toilet Room

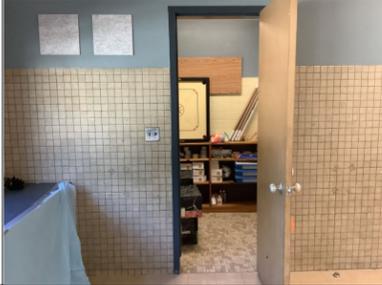
Clear width at door < 32" Hardware not operable with a closed fist	25" -	Widen the door so that there is 32" min. clear width. Provide hardware that can be operable with one hand and not require tight grasping, pinching, or twisting of the wrist.  See ID #89 for additional recommendation.	1	-	\$0

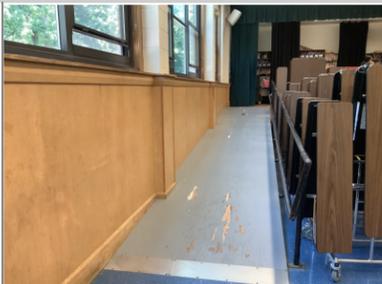
<b>Ramps</b>												
60	Multi-Purpose Room	1		Ramps	Interior

Handrails not provided at both sides if rise is > 6" Edge protection < 4" high	- -	Provide handrails on both sides. Provide edge protection that prevents the passage of a 4" diameter sphere, where any portion of the sphere is within 4" of the finished floor or ground surface. Ensure the 36" min. accessible route is maintained at the top of the ramp.	1	-	\$0

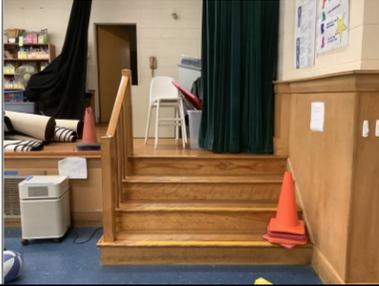
ID	Location	Floor	Room	Element	Type	Photo	Issues	Current Measure	Recommendations	Quantity	Price	Cost Estimation
<b>Stairways</b>												
61	Multi-Purpose Room	1		Stairways	Other

Handrail height < 34" or > 38" Handrail not provided on both sides Handrails do not extend 12" from stairs Handrails have non-compliant cross section	31" - - -	Alter so the handrails are 34"- 38" high above the floor. Provide handrail on one side. Top: Ensure handrails extend horizontally above the landing for 12" min. beginning above the first riser nosing. Bottom: Ensure handrails extend to one tread depth beyond the last riser. Provide handrails with 1 1/4" - 2" circular cross sections.	1	-	\$0
62	Staircase #1	1		Stairways	Egress

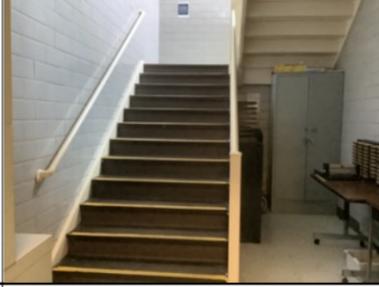
Handrails do not extend 12" from stairs Handrails have non-compliant cross section	- -	Top: Ensure handrails extend horizontally above the landing for 12" min. beginning above the first riser nosing. Bottom: Ensure handrails extend to one tread depth beyond the last riser. Provide handrails with 1 1/4" - 2" circular cross sections. Note: Recommendation applies to the whole staircase.	1	-	\$0

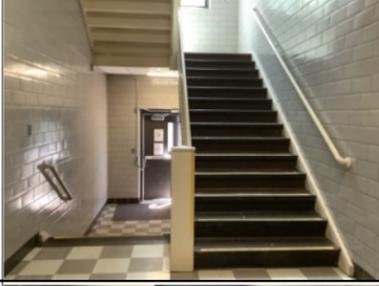
63	Staircase #2	1		Stairways	Egress

Handrails do not extend 12" from stairs Handrails have non-compliant cross section	- -	Top: Ensure handrails extend horizontally above the landing for 12" min. beginning above the first riser nosing. Bottom: Ensure handrails extend to one tread depth beyond the last riser. Provide handrails with 1 1/4" - 2" circular cross sections. Note: Recommendation applies to the whole staircase.	1	-	\$0
64	Staircase #3	1		Stairways	Egress

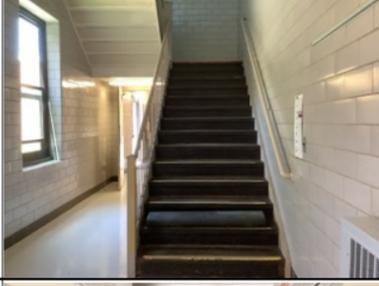
Handrails do not extend 12" from stairs Handrails have non-compliant cross section	- -	Top: Ensure handrails extend horizontally above the landing for 12" min. beginning above the first riser nosing. Bottom: Ensure handrails extend to one tread depth beyond the last riser. Provide handrails with 1 1/4" - 2" circular cross sections. Note: Recommendation applies to the whole staircase.	1	-	\$0
65	To Staircase #2	1		Stairways	Other

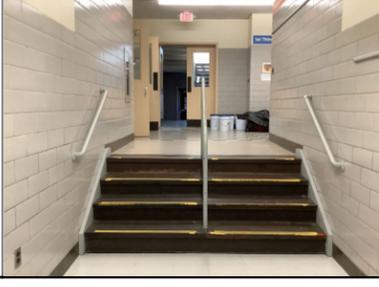
Handrails do not extend 12" from stairs Handrails have non-compliant cross section	- -	Top: Ensure handrails extend horizontally above the landing for 12" min. beginning above the first riser nosing. Bottom: Ensure handrails extend to one tread depth beyond the last riser. Provide handrails with 1 1/4" - 2" circular cross sections.	1	-	\$0

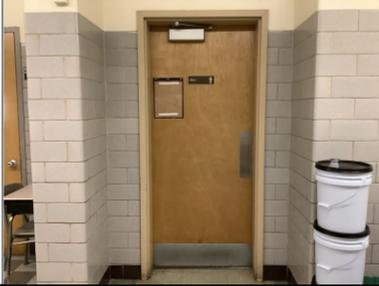
ID	Location	Floor	Room	Element	Type	Photo	Issues	Current Measure	Recommendations	Quantity	Price	Cost Estimation
<b>Signage</b>												
66	Boys' Toilet Room Across Reading Room	1		Signage	Designation

Raised characters not provided on sign Braille not provided on sign Sign not located on the latch side of the door	- - -	Provide text with raised characters duplicated in braille on sign. Locate the sign at permanent rooms alongside the door on the latch side.	1	232	\$232
67	Boys' Toilet Room Across Speech Room	2		Signage	Designation

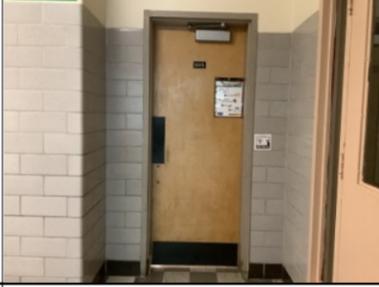
Raised characters not provided on sign Braille not provided on sign Sign not located on the latch side of the door	- - -	Provide text with raised characters duplicated in braille on sign. Locate the sign at permanent rooms alongside the door on the latch side.	1	232	\$232
68	First Grade Classroom	1		Signage	Designation

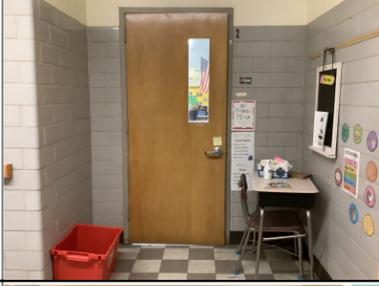
Raised characters not provided on sign Braille not provided on sign	- -	Provide text with raised characters duplicated in braille on sign.	1	232	\$232

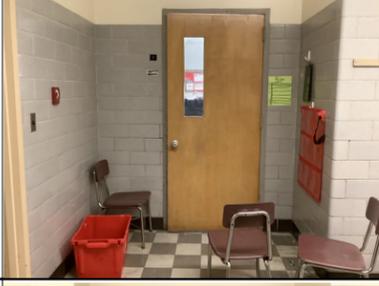
69	Fourth Grade Classroom	1		Signage	Designation

Raised characters not provided on sign Braille not provided on sign	- -	Provide text with raised characters duplicated in braille on sign.	1	232	\$232
70	Girls' Toilet Room - Across Reading Room	1		Signage	Designation

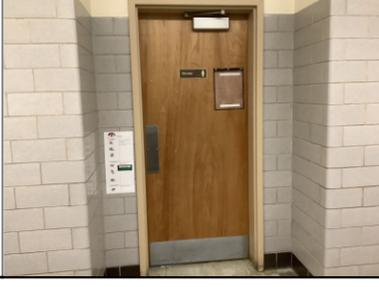
Raised characters not provided on sign Braille not provided on sign Sign not located on the latch side of the door	- - -	Provide text with raised characters duplicated in braille on sign. Locate the sign at permanent rooms alongside the door on the latch side.	1	232	\$232

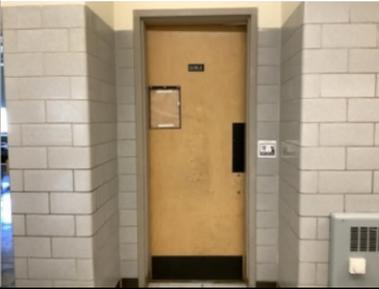
ID	Location	Floor	Room	Element	Type	Photo	Issues	Current Measure	Recommendations	Quantity	Price	Cost Estimation
71	Girls' Toilet Room Across Speech Room	2		Signage	Designation

<ul style="list-style-type: none"> <li>Raised characters not provided on sign</li> <li>Braille not provided on sign</li> <li>Sign not located on the latch side of the door</li> </ul>	<ul style="list-style-type: none"> <li>-</li> <li>-</li> <li>-</li> </ul>	<ul style="list-style-type: none"> <li>Provide text with raised characters duplicated in braille on sign.</li> <li>Locate the sign at permanent rooms alongside the door on the latch side.</li> </ul>	1	232	\$232
72	Library	1		Signage	Designation

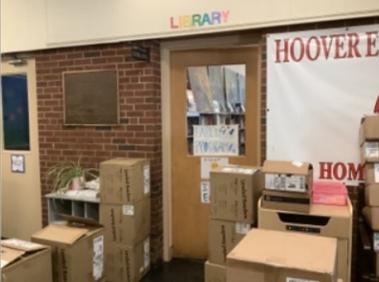
<ul style="list-style-type: none"> <li>Raised characters not provided on sign</li> <li>Braille not provided on sign</li> <li>Sign not located on the latch side of the door</li> </ul>	<ul style="list-style-type: none"> <li>-</li> <li>-</li> <li>-</li> </ul>	<ul style="list-style-type: none"> <li>Provide text with raised characters duplicated in braille on sign.</li> <li>Locate the sign at permanent rooms alongside the door on the latch side.</li> </ul>	1	232	\$232

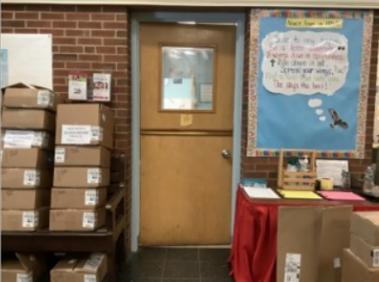
73	Main Office	1		Signage	Designation

<ul style="list-style-type: none"> <li>Raised characters not provided on sign</li> <li>Braille not provided on sign</li> <li>Sign not located on the latch side of the door</li> </ul>	<ul style="list-style-type: none"> <li>-</li> <li>-</li> <li>-</li> </ul>	<ul style="list-style-type: none"> <li>Provide text with raised characters duplicated in braille on sign.</li> <li>Locate the sign at permanent rooms alongside the door on the latch side.</li> </ul>	1	232	\$232
74	Men's Multi-User Toilet Room by Mindfulness Room	1		Signage	Designation

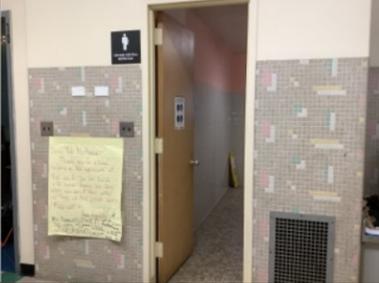
<ul style="list-style-type: none"> <li>Raised characters &lt; 48" or &gt; 60" above ground</li> <li>Sign not located on the latch side of the door</li> <li>Directional sign to access. toilet not provided</li> </ul>	<ul style="list-style-type: none"> <li>70"</li> <li>-</li> <li>-</li> </ul>	<ul style="list-style-type: none"> <li>Mount signs so that the baseline of the lowest tactile character is 48" min. above finished floor and the baseline of the highest tactile character is 60" max. above the finished floor.</li> <li>Locate the sign at permanent rooms alongside the door on the latch side.</li> <li>Until toilet room is made accessible, provide a sign indicating the location of the nearest accessible toilet room.</li> </ul>	1	232	\$232

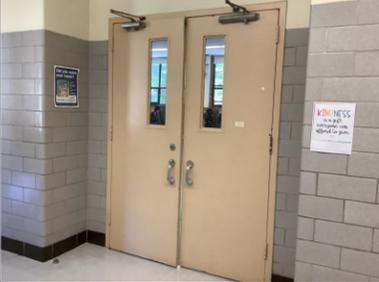
75	Multi-Purpose Room	1		Signage	Designation

<ul style="list-style-type: none"> <li>Raised characters not provided on sign</li> <li>Braille not provided on sign</li> <li>Sign not located on the latch side of the door</li> </ul>	<ul style="list-style-type: none"> <li>-</li> <li>-</li> <li>-</li> </ul>	<ul style="list-style-type: none"> <li>Provide text with raised characters duplicated in braille on sign.</li> <li>Locate the sign at permanent rooms alongside the door on the latch side.</li> </ul>	1	232	\$232

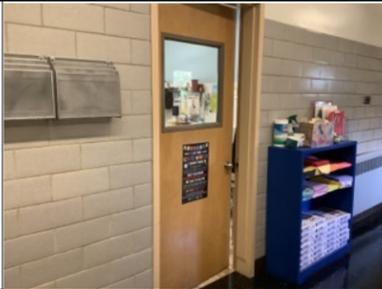
ID	Location	Floor	Room	Element	Type	Photo	Issues	Current Measure	Recommendations	Quantity	Price	Cost Estimation
76	Nurse's Office	1		Signage	Designation

Raised characters not provided on sign Braille not provided on sign Sign not located on the latch side of the door	- - -	Provide text with raised characters duplicated in braille on sign. Locate the sign at permanent rooms alongside the door on the latch side.	1	232	\$232
77	Second Grade Classroom	1		Signage	Designation

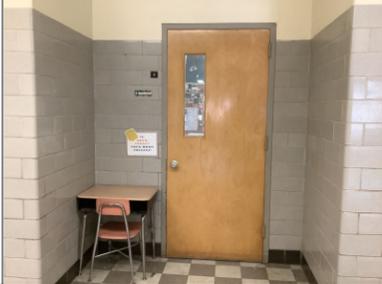
Raised characters not provided on sign Braille not provided on sign	- -	Provide text with raised characters duplicated in braille on sign. Ensure a 18" min. by 18" min. clear floor space is provided in front of the sign.	1	232	\$232
78	Single-User Toilet Room by Entrance - Door #3	1		Signage	Designation

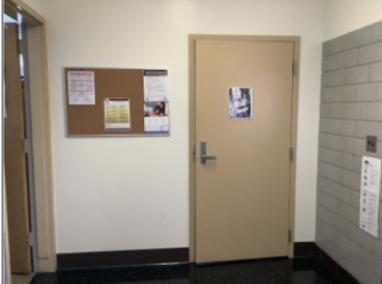
Signage is not provided International Symbol of Acc. not provided	- -	Locate compliant signage alongside the door on the latch side. Provide a sign containing the International Symbol of Accessibility (ISA).	1	232	\$232

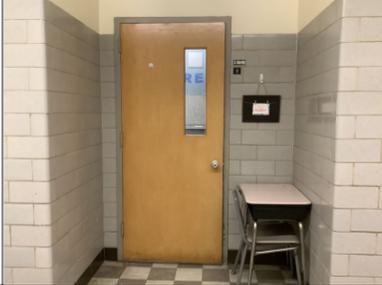
79	Third Grade Classroom	1		Signage	Designation

Raised characters not provided on sign Braille not provided on sign	- -	Provide text with raised characters duplicated in braille on sign.	1	232	\$232
<b>Operable Parts</b>												
80	Nurse's Office	1		Operable Parts	Clothes Rod/Hooks

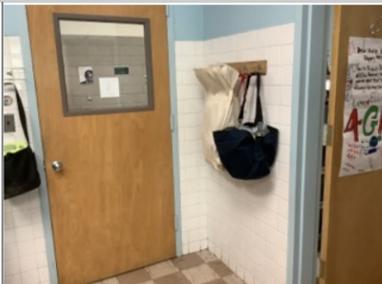
Side reach > 54"	57"	Provide an additional coat hook mounted 48" max. above the finished floor.	1	256	\$256

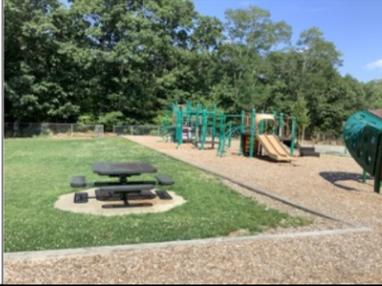
ID	Location	Floor	Room	Element	Type	Photo	Issues	Current Measure	Recommendations	Quantity	Price	Cost Estimation
<b>Picnic Tables</b>												
81	By Playground	Ext.		Picnic Tables	N/A

At least 5% accessible spaces not provided Picnic table not on an accessible route	- -	Provide an accessible picnic table. Ensure that the picnic table is connected to an accessible route.	1	-	\$0
<b>Exterior Benches</b>												
82	By Playground	Ext.		Exterior Benches	N/A

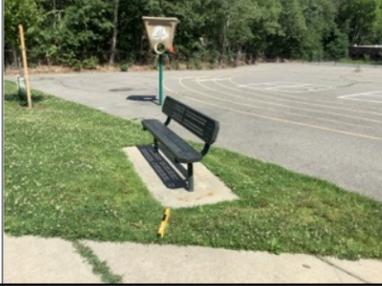
No accessible route to one bench in area	-	Relocate bench to an accessible route.	1	-	\$0
<b>Toilet &amp; Bathing Rooms</b>												
<b>Overall Access</b>												
83	Boys' Toilet Room Across Reading Room	1		Overall Access	Toilet Room

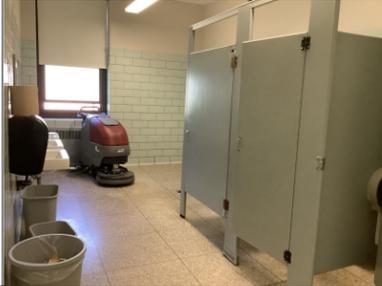
Audible and visible alarms not provided	-	When fire system is updated, ensure that a visible and audible fire alarm is installed.	1	-	\$0
84	Girls' Toilet Room - Across Reading Room	1		Overall Access	Toilet Room

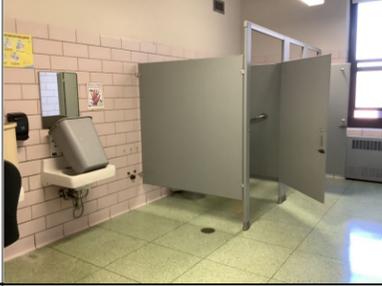
Audible and visible alarms not provided	-	When fire system is updated, ensure that a visible and audible fire alarm is installed.	1	-	\$0

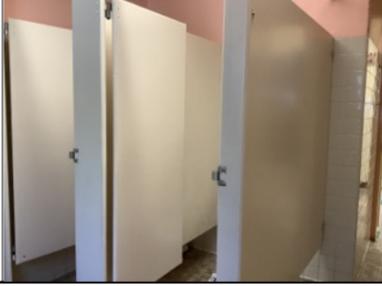
85	Men's Multi-User Toilet Room by Mindfulness Room	1		Overall Access	Toilet Room

Turning space not provided Accessible plumbing fixtures or stalls not provided Audible and visible alarms not provided	- - -	Renovate toilet room to provide turning space. Provide an accessible single-user toilet room. When fire system is updated, ensure that a visible and audible fire alarm is installed.	1	24604	\$24604

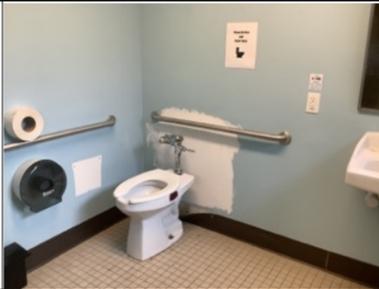
ID	Location	Floor	Room	Element	Type	Photo	Issues	Current Measure	Recommendations	Quantity	Price	Cost Estimation
86	Single-User Toilet Room by Entrance - Door #3	1		Overall Access	Toilet Room

Audible and visible alarms not provided	-	When fire system is updated, ensure that a visible and audible fire alarm is installed.	1	-	\$0
87	Toilet Room - Nurse's Office	1		Overall Access	Toilet Room

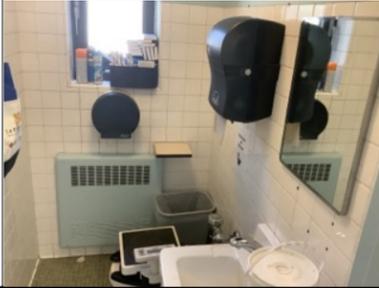
Turning space not provided	-	Provide a directional sign to the accessible toilet.	1	232	\$232
88	Toilet Room - Second Grade Classroom	1		Overall Access	Toilet Room

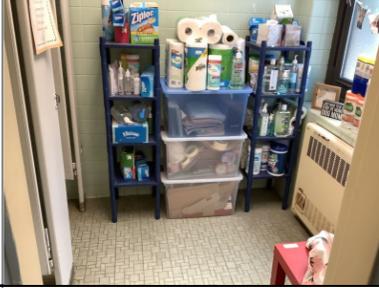
Accessible plumbing fixtures or stalls not provided	-	Provide one accessible wheelchair compartment.	1	6182	\$6182
89	Toilet Room - Third Grade Classroom	1		Overall Access	Toilet Room

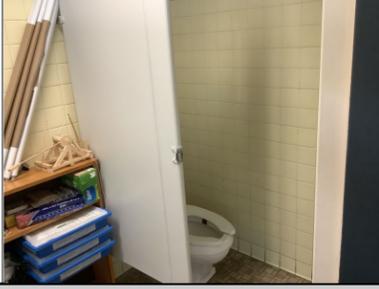
Accessible plumbing fixtures or stalls not provided Audible and visible alarms not provided	- -	Add an accessible single-user toilet room. When fire system is updated, ensure that a visible and audible fire alarm is installed.	1	24604	\$24604

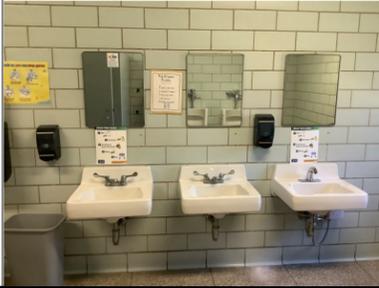
<b>Lavatory</b>												
90	Boys' Toilet Room - Across Reading Room	1		Lavatory	N/A

Toe or knee clearances not provided Plumbing underneath is exposed Mirror above lavatory w/reflective surface > 40"	24" - 44"	Provide at least one lavatory with knee and toe clearance positioned for a forward approach. Insulate or otherwise configure pipes to prevent contact for at least one lavatory. Lower mirror so that the bottom surface is at 40" max. above the finished floor.	1	2034	\$2034

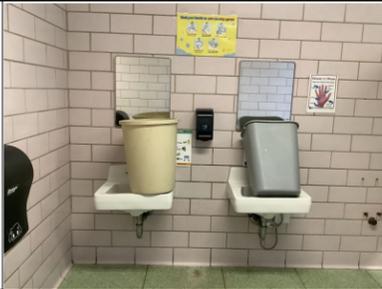
ID	Location	Floor	Room	Element	Type	Photo	Issues	Current Measure	Recommendations	Quantity	Price	Cost Estimation
91	Girls' Toilet Room - Across Reading Room	1		Lavatory	N/A

Toe or knee clearances not provided Plumbing underneath is exposed Mirror above lavatory w/reflective surface > 40"	- - 44"	Provide at least one lavatory with knee and toe clearance positioned for a forward approach. Insulate or otherwise configure pipes to prevent contact for at least one lavatory. Lower mirror so that the bottom surface is at 40" max. above the finished floor.	1	2034	\$2034
92	Single-User Toilet Room by Entrance - Door #3	1		Lavatory	N/A

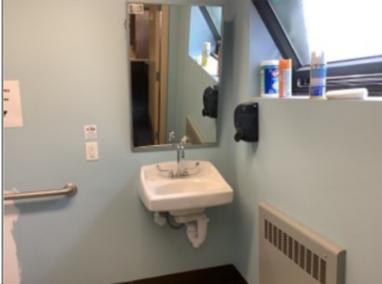
Mirror above lavatory w/reflective surface > 40"	42"	Lower mirror so that the bottom surface is at 40" max. above the finished floor.	1	256	\$256
<b>Toilet Compartment</b>												
93	Boys' Toilet Room - Across Reading Room	1		Toilet Compartment	Accessible Compartment

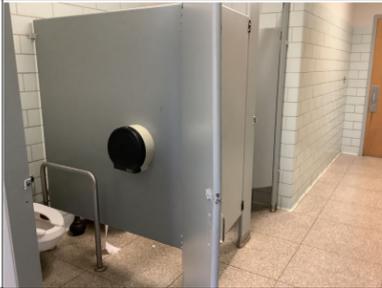
Door has malfunctioning self-closing hinge	-	Repair hinge.	1	Labor	\$0

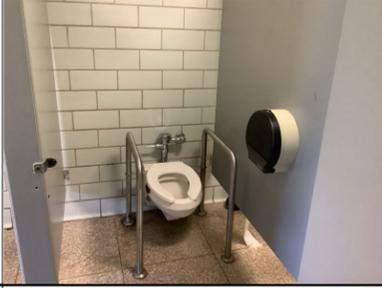
94	Boys' Toilet Room - Across Reading Room	1		Toilet Compartment	Accessible Compartment

Grab bars not compliant Clearance at toilet < 60" clear width Clearance at toilet < 72" clear depth (MAAB) Centerline < or > 18" (MAAB)	- 43" 56" 15"	Provide one grab bar on the side wall of the toilet and one on the rear wall. Ensure toilet paper is 24" min. high, located under the grab bar, and between 7" and 9" from the front of the toilet. Provide a wheelchair accessible compartment that is 60" wide and 72" deep. Relocate toilet so the centerline is 18" from the side wall.	1	6182	\$6182
95	Girls' Toilet Room - Across Reading Room	1		Toilet Compartment	Accessible Compartment

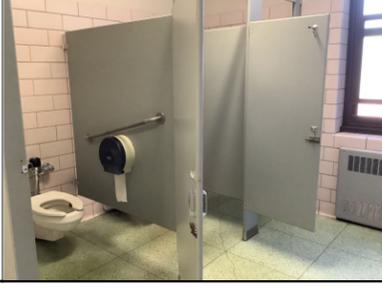
Door has malfunctioning self-closing hinge	-	Repair hinge.	1	Labor	\$0

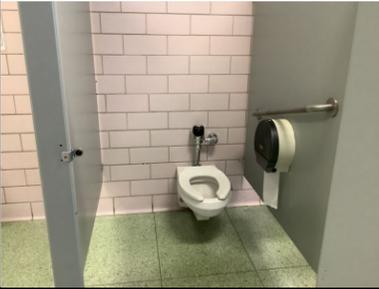
ID	Location	Floor	Room	Element	Type	Photo	Issues	Current Measure	Recommendations	Quantity	Price	Cost Estimation
96	Girls' Toilet Room - Across Reading Room	1		Toilet Compartment	Accessible Compartment

Grab bars not compliant Clearance at toilet < 60" clear width Clearance at toilet < 72" clear depth (MAAB) Centerline < or > 18" (MAAB)	- 43" 56" 15"	Provide one grab bar on the side wall of the toilet and one on the rear wall. Ensure toilet paper is 24" min. high, located under the grab bar, and between 7" and 9" from the front of the toilet. Provide a wheelchair accessible compartment that is 60" wide and 72" deep. Relocate toilet so the centerline is 18" from the side wall.	1	6182	\$6182
<b>Dispensers</b>												
97	Boys' Toilet Room - Across Reading Room	1		Dispensers	Paper Towel Dispenser

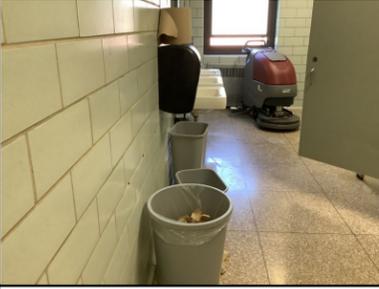
Dispenser acts as a protruding object	9"	Relocate dispenser out of the circulation path.	1	256	\$256

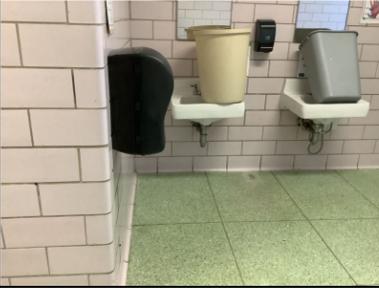
98	Girls' Toilet Room - Across Reading Room	1		Dispensers	Paper Towel Dispenser

Dispenser acts as a protruding object	9"	Relocate dispenser out of the circulation path.	1	256	\$256
99	Single-User Toilet Room - Near Kindergarten Classrooms	1		Dispensers	Paper Towel Dispenser

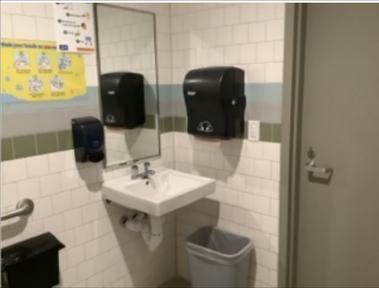
Dispenser acts as a protruding object	9"	Relocate dispenser out of the circulation path.	1	256	\$256
100	Single-User Toilet Room by Entrance - Door #3	1		Dispensers	Paper Towel Dispenser

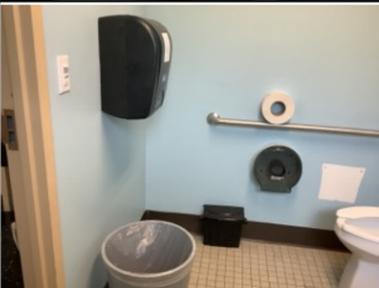
Dispenser acts as a protruding object	- 9"	Relocate dispenser out of the circulation path.	1	256	\$256

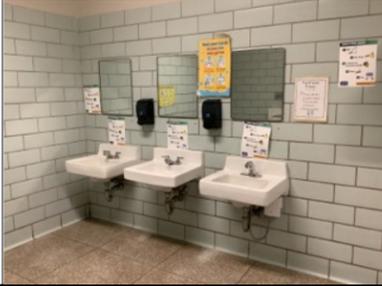
Toe or knee clearances not provided Exposed plumbing underneath Mirror above lavatory w/reflective surface > 31"	23" - 43"	Provide at least one lavatory with 25" min. knee clearance positioned for a forward approach. Ensure toe clearance is also provided. Insulate or otherwise configure pipes to prevent contact, for at least one lavatory. Lower mirror so that the bottom surface is at 31" above the finished floor.	1	2034	\$2034
102	Girls' Toilet Room - Across Speech Room	2		Lavatory (Children)	N/A

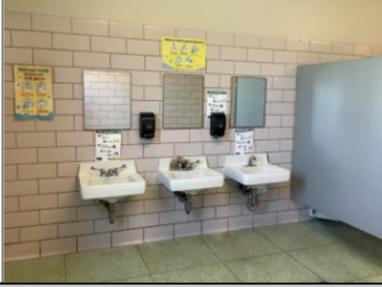
Toe or knee clearances not provided Exposed plumbing underneath Mirror above lavatory w/reflective surface > 31"	23" - 43"	Provide at least one lavatory with 25" min. knee clearance positioned for a forward approach. Ensure toe clearance is also provided. Insulate or otherwise configure pipes to prevent contact, for at least one lavatory. Lower mirror so that the bottom surface is at 31" above the finished floor.	1	2034	\$2034

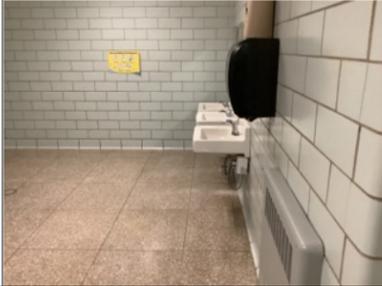
<b>Dispensers (Children)</b>												
103	Boys' Toilet Room - Across Speech Room	2		Dispensers (Children)	Paper Towel Dispenser

Dispenser is a protruding object	9"	Relocate dispenser out of the circulation path.	1	256	\$256
104	Girls' Toilet Room - Across Speech Room	2		Dispensers (Children)	Paper Towel Dispenser

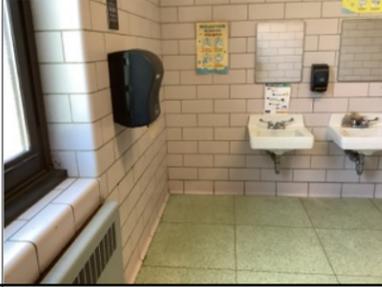
Dispenser is a protruding object	9"	Relocate dispenser out of the circulation path.	1	Labor	\$0
105	Toilet Room - Kindergarten Classroom	1		Dispensers (Children)	Paper Towel Dispenser

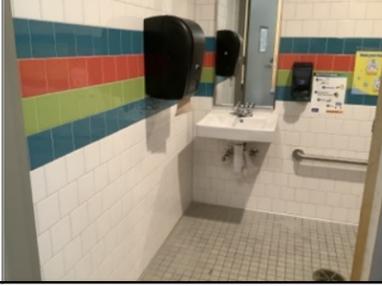
Dispenser is a protruding object	9"	Relocate dispenser out of the circulation path.	1	256	\$256

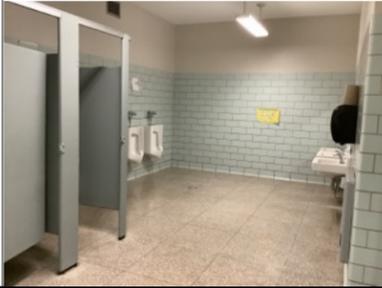
Accessible fixtures or stalls not provided	-	Provide one accessible wheelchair compartment.	1	6182	\$6182
107	Girls' Toilet Room - Across Speech Room	2		Overall Access (Children)	Toilet Room

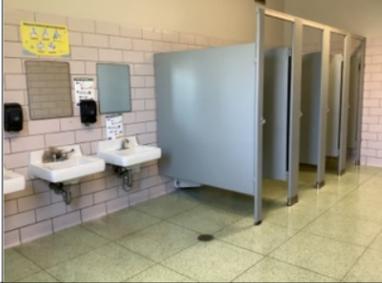
Accessible fixtures or stalls not provided	-	Provide one accessible wheelchair compartment.	1	6182	\$6182
<b>Additional Access</b>												
<b>Drinking Fountains</b>												
108	By Girls' Toilet Room Across Speech Room	2		Drinking Fountains	Low

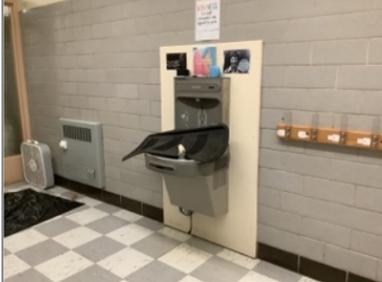
No drinking fountain provided for standing users	-	Provide an additional drinking fountain for standing users or install a Hi-Lo drinking fountain.	1	4028	\$4028
109	By Second Grade Classroom	1		Drinking Fountains	Low

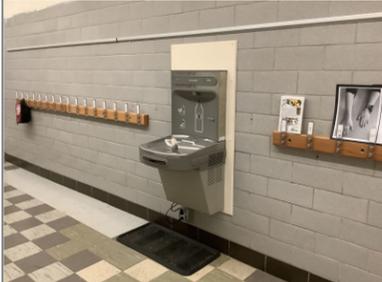
No drinking fountain provided for standing users	-	Provide an additional drinking fountain for standing users.	1	4028	\$4028

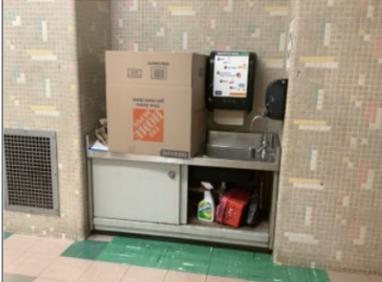
<b>Sink</b>												
110	By Multi-User Toilet Room by Mindfulness Room	1		Sink	Other

Toe and knee clearances not provided Exposed plumbing underneath sink	- -	Ensure there is a 27" min. knee clearance positioned for a forward approach. Insulate or otherwise configure pipes at sink.	1	1686	\$1686

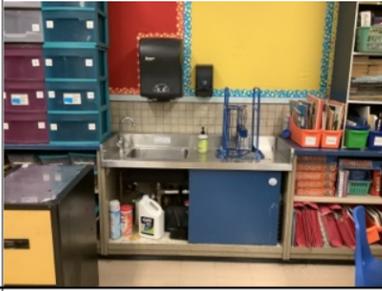
Exposed plumbing underneath Knee/toe clearance <27" at sink > 31" high	- -	Insulate or otherwise configure pipes to prevent contact, for at least one sink. Provide at least one sink with 27" high knee and toe clearance positioned for a forward approach (per 521 CMR 12.2.2.c).	1	1686	\$1686
113	First Grade Classroom	1		Sinks for Children's Use	Classroom

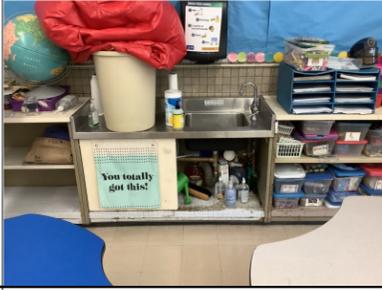
Exposed plumbing underneath Knee/toe clearance <27" at sink > 31" high	- -	Insulate or otherwise configure pipes to prevent contact, for at least one sink. Provide at least one sink with 27" high knee and toe clearance positioned for a forward approach (per 521 CMR 12.2.2.c).	1	1686	\$1686

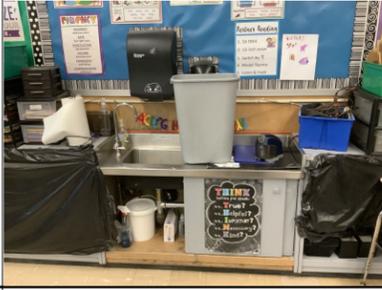
114	Fourth Grade Classroom	1		Sinks for Children's Use	Classroom

Exposed plumbing underneath Knee/toe clearance <27" at sink > 31" high	- -	Insulate or otherwise configure pipes to prevent contact, for at least one sink. Provide at least one sink with 27" high knee and toe clearance positioned for a forward approach (per 521 CMR 12.2.2.c).	1	1686	\$1686
115	Second Grade Classroom	1		Sinks for Children's Use	Classroom

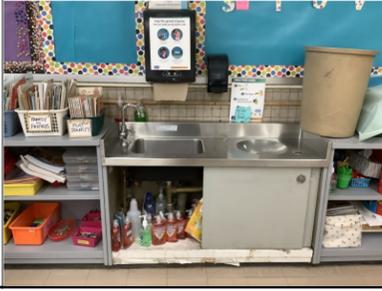
Exposed plumbing underneath Knee/toe clearance <27" at sink > 31" high	- -	Insulate or otherwise configure pipes to prevent contact, for at least one sink. Provide at least one sink with 27" high knee and toe clearance positioned for a forward approach (per 521 CMR 12.2.2.c).	1	1686	\$1686

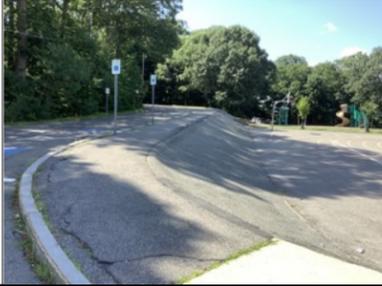
Recommend providing a barrier or railing along steep drop-off.	1	-	\$0
<b>Signage</b>												
121		Ext.		Signage	N/A

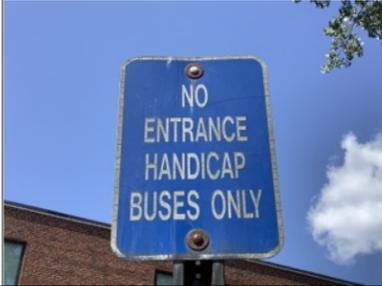
Recommend replacing sign with one that reads "Accessible Entrance."	1	-	\$0
122	Entrance - Door #5	1		Signage	N/A

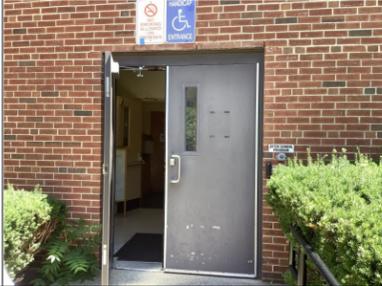
Recommend replacing sign with one that reads "Accessible Entrance."	1	-	\$0
<b>Stairs</b>												
123	Entrance - Door #3	Ext.		Stairs	N/A

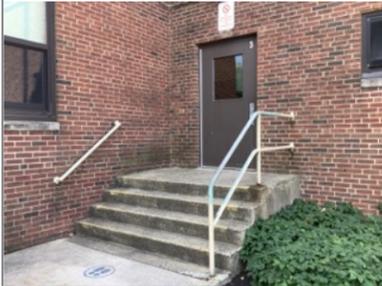
-	Recommend providing contrasting color strips at the edge of each step at the exterior and interior stairs.	1	-	\$0
<b>Accessible Space</b>												
124	Parking Lot - South Side	Ext.		Accessible Space	N/A

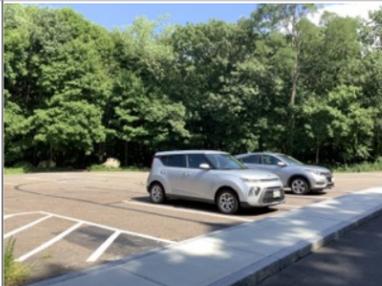
Recommend providing an accessible parking space here.	1	-	\$0

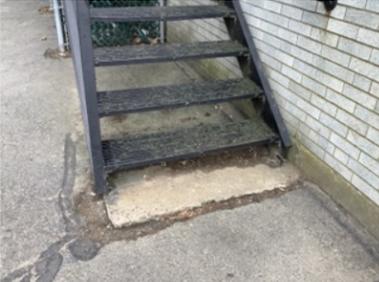
Surface openings > 1/2" Level changes > 1/4"	3" 0.5"	Repair crack in asphalt at fire escape stair base. Alter change in level to be 1/4" high max.	1	-	\$0
2	Ruggles Street Walkway	Ext.		Exterior Access Route	Walkway

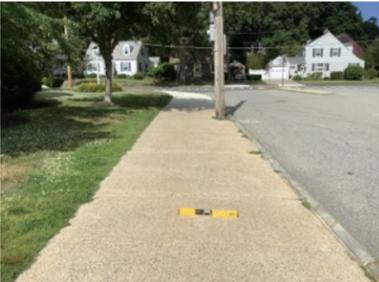
Cross slope > 1:50 (2.00%)	4.3%	Reduce cross slope to be no steeper than 1:50 (2.00%).	1	-	\$0
3	Route to Egress Door 4	Ext.		Exterior Access Route	Walkway

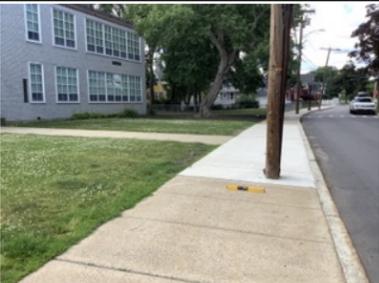
Cross slope > 1:50 (2.00%)	4.6%	Reduce cross slope to be no steeper than 1:50 (2.00%).	1	-	\$0
4	Route to Egress Door 4	Ext.		Exterior Access Route	Sidewalk

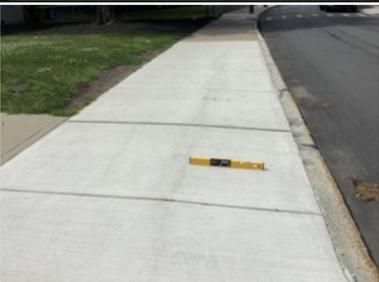
Cross slope > 1:50 (2.00%)	5.2%	Reduce cross slope to be no steeper than 1:50 (2.00%).	1	-	\$0
5	Route to Playground by Egress Door 2	Ext.		Exterior Access Route	Walkway

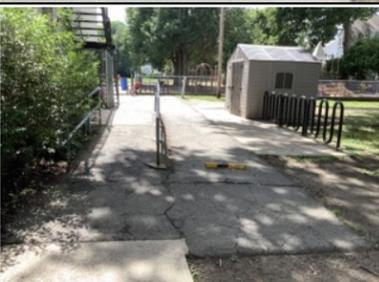
Cross slope > 1:50 (2.00%) Route not maintained in operable working condition	3.5% -	Reduce cross slope to be no steeper than 1:50 (2.00%). Ensure the accessible route is maintained in operable working condition.	1	-	\$0

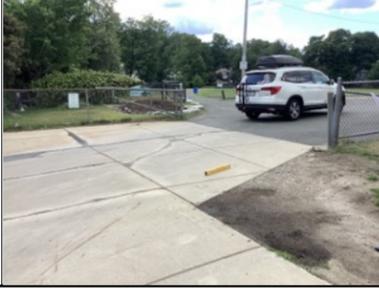
Route not maintained in operable working condition	-	Ensure the accessible route is maintained in operable working condition by repairing surface.	1	-	\$0
<b>Curb Ramp</b>												
7	Walkway to Egress Door 1, Drop-Off Entrance	Ext.		Curb Ramp	Parallel

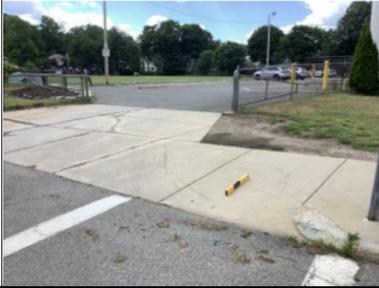
Running slope > 1:12 (8.33%)	9.3%	Reduce running slope to be no steeper than 1:12 (8.33%).	1	-	\$0
8	Egress Door 1, Drop-Off Entrance	Ext.		Curb Ramp	Parallel

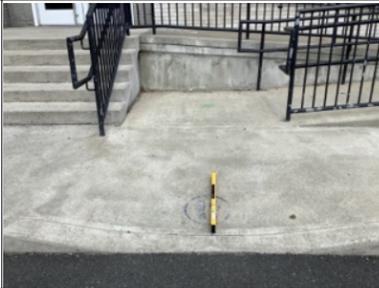
Running slope > 1:12 (8.33%) Curb ramp flares > 1:10 (10%)	10.7% 16%	Reduce running slope to be no steeper than 1:12 (8.33%). Reduce slope at curb ramp flares to be no steeper than 1:10 (10%).	1	-	\$0
<b>Exterior Ramp</b>												
9	Ramp to Egress Door 1, Drop-Off Entrance	Ext.		Exterior Ramp	N/A

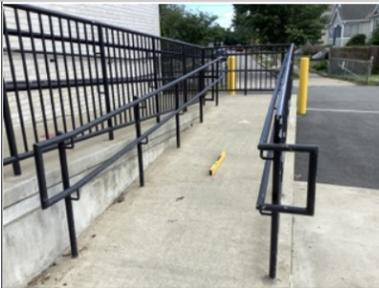
No lower handrail 18"-20" high provided Ramp < 48" wide	22" 46.6"	Provide a lower handrail between 18" to 20" high above the ground. Widen ramp so that the clear width is 48" min.	1	-	\$0

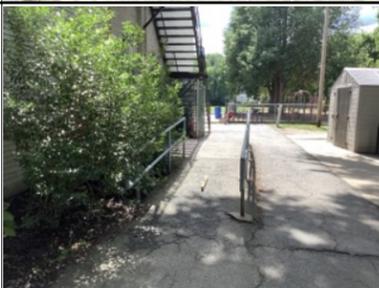
10	Ramp to Secondary Entrance, Egress Door 2	Ext.		Exterior Ramp	N/A

Ramp < 48" wide Handrails < 34" or > 38" above ramp surface Handrails do not extend 12" past top & bottom	44.9" 29.6" -	Widen ramp so that the clear width is 48" min. Alter so the handrails are 34"- 38" high above the ground or finished floor. Alter handrails to extend horizontally above the landing for 12" min. beyond the top and bottom of ramp runs.	1	-	\$0

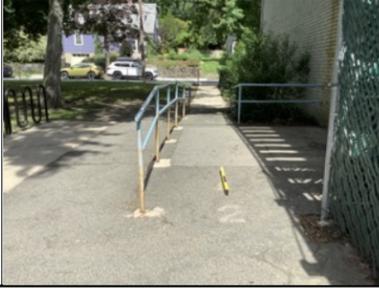
Handrails not provided at both sides if rise is > 6" Handrails do not extend 12" past top & bottom	- -	Provide handrails on both sides. Alter handrails to extend horizontally above the landing for 12" min. beyond the top and bottom of ramp runs.	1	-	\$0
<b>Exterior Stair</b>												
12	Fire Escape, Egress Door 3	Ext.		Exterior Stair	N/A

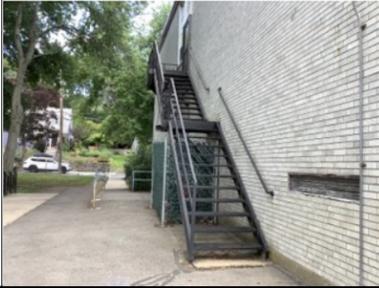
Handrails do not extend 12" from stair Cross section of handrail is not compliant	- -	Top: Ensure handrails extend horizontally above the landing for 12" min. beginning above the first riser nosing. Bottom: Ensure that the sloped bottom extension extends one tread depth min. beyond last riser nosing in same direction as stair flight. Provide handrails with 1 1/4" - 2" circular cross sections or 4"- 6 1/4" non-circular cross sections.	1	-	\$0

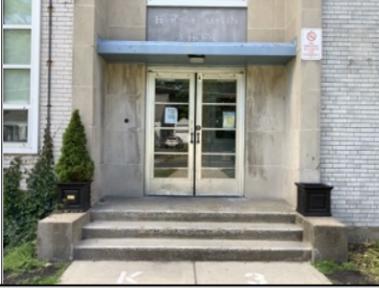
13	Egress Door 4	Ext.		Exterior Stair	N/A

Handrails not provided	-	Provide handrail on both sides.	1	-	\$0
<b>Entrance</b>												
14	Egress Door 4	Ext.		Entrance	Other

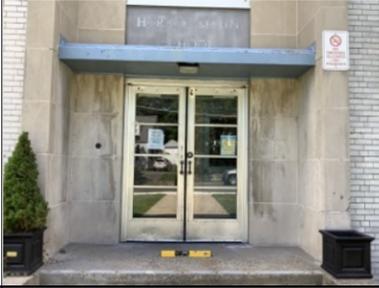
Entrance not on an accessible route Directional sign to accessible entrance not provided	- -	Provide a directional sign indicating the location of the nearest accessible entrance.	1	-	\$0
<b>Access to Goods and Services</b>

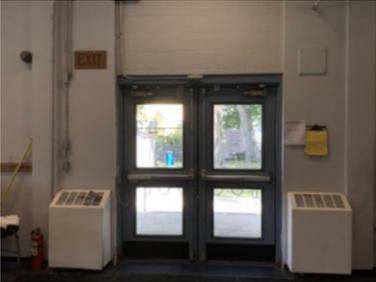
Tactile exit sign not provided	-	Ensure tactile exit signs with raised characters and braille are provided at exit doors. Mount signs between 48"- 60" above the finished floor located on the latch side of the door.	1	232	\$232
16	Egress Door 1, Drop-Off Entrance	1		Means of Egress	N/A

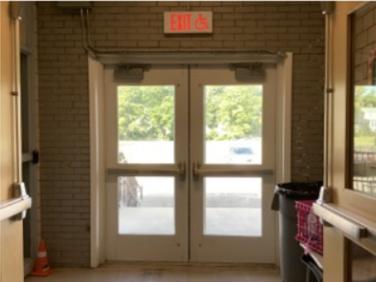
Tactile exit sign not provided	-	Ensure tactile exit signs with raised characters and braille are provided at exit doors. Mount signs between 48"- 60" above the finished floor located on the latch side of the door.	1	232	\$232
17	Main Entrance, Egress Door 5	1		Means of Egress	N/A

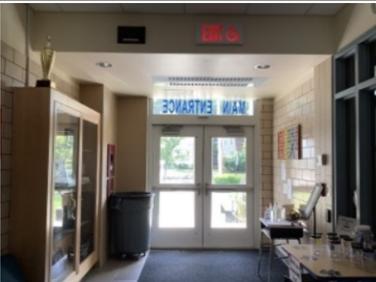
Tactile exit sign not provided	-	Ensure tactile exit signs with raised characters and braille are provided at exit doors. Mount signs between 48"- 60" above the finished floor located on the latch side of the door.	1	232	\$232

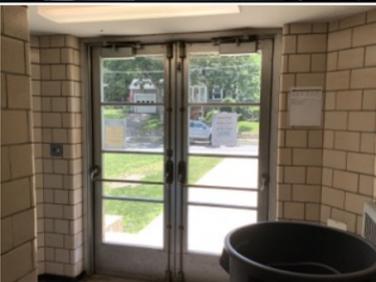
18	Egress Door 4	1		Means of Egress	N/A

Tactile exit sign not provided Directional sign to accessible emergency exit not provided	- -	Ensure tactile exit signs with raised characters and braille are provided at exit doors. Mount signs between 48"- 60" above the finished floor located on the latch side of the door. Provide a directional sign indicating the location of the nearest accessible emergency exit.	1	464	\$464
19	Fire Escape, Egress Door 3	2		Means of Egress	N/A

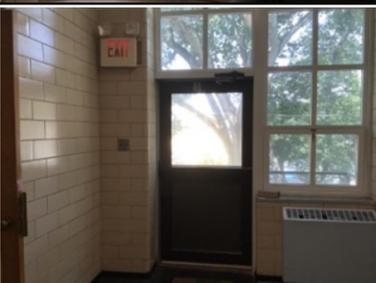
Tactile exit sign not provided Directional sign to accessible emergency exit not provided	- -	Ensure tactile exit signs with raised characters and braille are provided at exit doors. Mount signs between 48"- 60" above the finished floor located on the latch side of the door. Provide a directional sign indicating the location of the nearest accessible emergency exit.	1	464	\$464

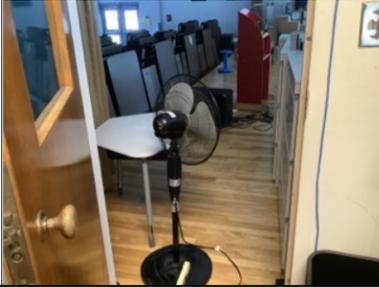
Route < 36" wide	30"	Relocate desk to ensure that a clear width of 36" min. is maintained at the accessible route.	1	Labor	\$0
21	Social Worker Office	1	110	Interior Access Route	N/A

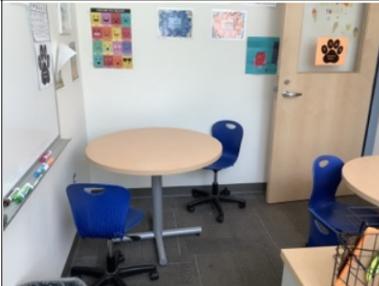
Route < 36" wide	24"	Ensure that a clear width of 36" min. is maintained at the accessible route.	1	Labor	\$0
22	Boys' Multi-User Toilet Room	1		Interior Access Route	N/A

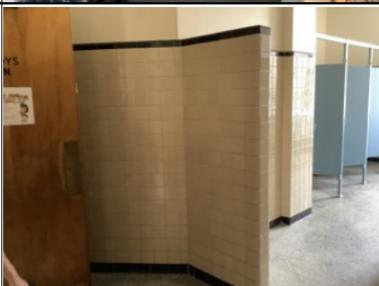
Route < 36" wide	15"	Ensure that a clear width of 36" min. is maintained at the accessible route.	1	Labor	\$0
23	Nurse's Office	1	114	Interior Access Route	N/A

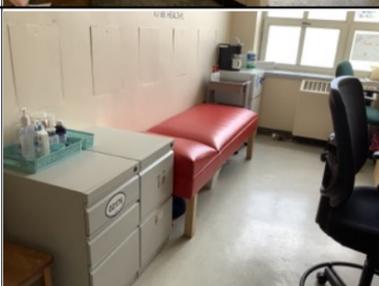
Route < 36" wide	30"	Ensure that a clear width of 36" min. is maintained at the accessible route.	1	Labor	\$0
24	Library	1	111	Interior Access Route	N/A

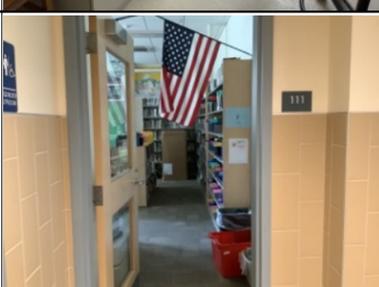
Obstructed by protruding objects	39"	Relocate flag to be lower than 80" above the finished floor.	1	256	\$256

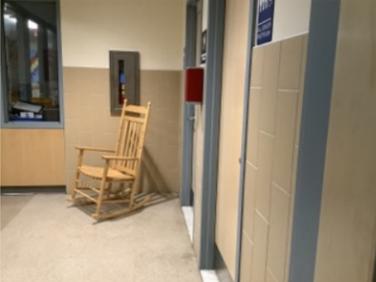
Obstructed by protruding objects	5"	Provide a cane-detectable barrier 27" max. above the finished floor underneath the hand sanitizer dispenser or relocate it out of the accessible route.	1	306	\$306
26	By Nurses	1		Interior Access Route	N/A

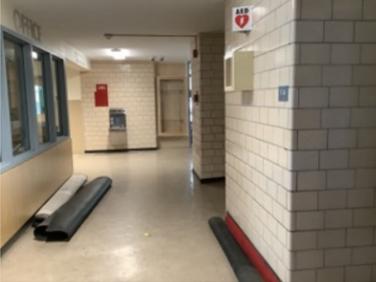
Obstructed by protruding objects	7.5"	Relocate defibrillator out of the accessible route or provide a cane-detectable barrier 27" max. above the ground below the defibrillator.	1	306	\$306
27	To Principal's Office	1		Interior Access Route	N/A

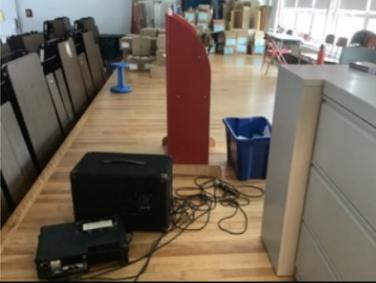
Accessible route not provided	-	Relocate stored objects to provide a 36" min. wide accessible route.	1	Labor	\$0
28	Speech Therapist	2	207B	Interior Access Route	N/A

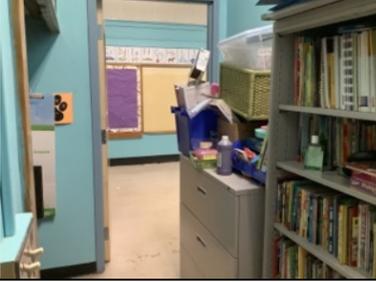
Route < 36" wide	25"	Relocate cabinet to ensure that a clear width of 36" min. is maintained at the accessible route.	1	Labor	\$0

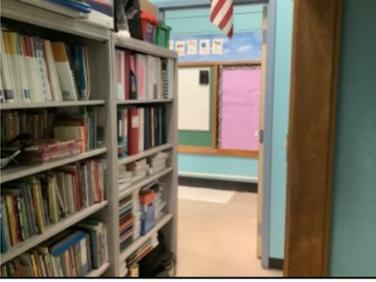
29	Reading Room	2	207A	Interior Access Route	N/A

Route < 36" wide	27"	Relocate cabinet to ensure that a clear width of 36" min. is maintained at the accessible route.	1	Labor	\$0

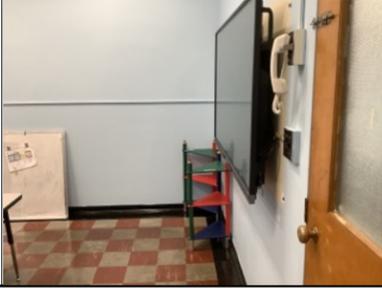
Obstructed by protruding objects	6"	Provide a cane-detectable barrier 27" min. above the finish floor underneath the TV monitor or adjust the monitor so it does not protrude more than 4" into the accessible route.	1	306	\$306
<b>Doors, Doorways, &amp; Gates</b>												
31	Art Room	1	112	Doors, Doorways, & Gates	Classroom

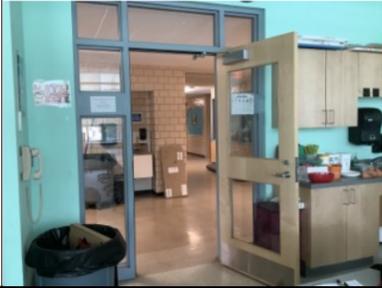
Maneuvering clearance(s) not provided	14" -	Remove the trash can to provide 18" min. pull side maneuvering clearance on the latch side of the door.	1	Labor	\$0
32	Single-User Toilet Room	1		Doors, Doorways, & Gates	Toilet Room

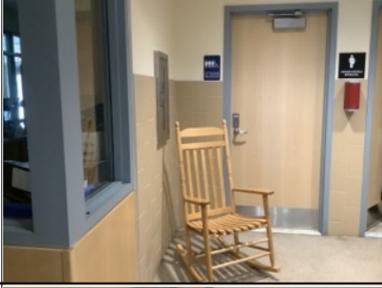
Maneuvering clearance(s) not provided	-	Remove the rocking chair to provide 18" min. pull side maneuvering clearance on the latch side of the door.	1	Labor	\$0

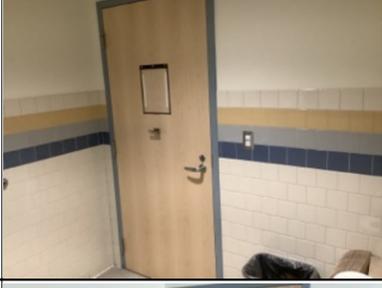
33	Single-User Toilet Room	1		Doors, Doorways, & Gates	Toilet Room

Maneuvering clearance(s) not provided	13"	Remove the trash can to provide 18" min. pull side maneuvering clearance on the latch side of the door.	1	Labor	\$0
34	Social Worker Office	1	110	Doors, Doorways, & Gates	Circulation

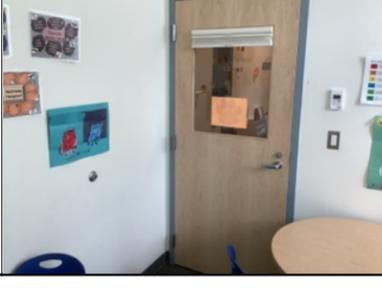
Maneuvering clearance(s) not provided	-	Relocate table to provide 18" min. pull side maneuvering clearance on the latch side of the door.	1	Labor	\$0

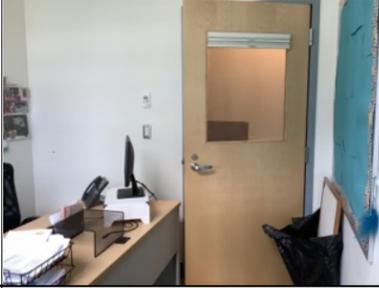
Maneuvering clearance(s) not provided	-	Relocate the desk to provide 18" min. pull side maneuvering clearance at the latch side of the door. Consider leaving door permanently open or open door as needed to provide access.	1	Labor	\$0
36	Kindergarten Classroom, Single-User Toilet Room	1	105	Doors, Doorways, & Gates	Toilet Room

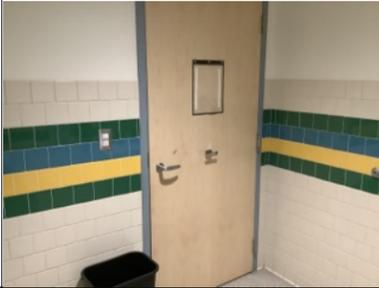
Maneuvering clearance(s) not provided	-	Remove the trash can to provide 18" min. pull side maneuvering clearance on the latch side of the door.	1	Labor	\$0
37	To Principal's Office	1		Doors, Doorways, & Gates	Circulation

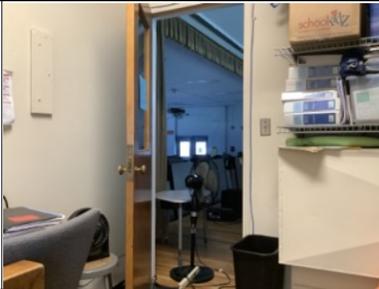
Maneuvering clearance(s) not provided Hardware not operable with a closed fist	- -	Remove the trash can to provide 18" min. pull side maneuvering clearance on the latch side of the door. Provide hardware that can be operable with one hand and not require tight grasping, pinching, or twisting of the wrist.	1	484	\$484

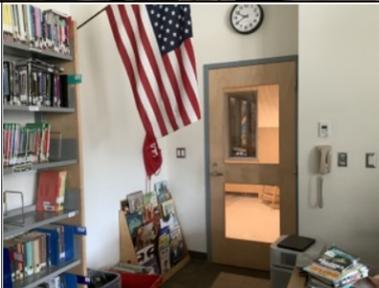
38	Library	1	111	Doors, Doorways, & Gates	Other

Maneuvering clearance(s) not provided Door requires > 5 lbs. of force to open	10" 10 lbs	Relocate shelves with stored items to provide 18" min. pull side maneuvering clearance on the latch side of the door. Adjust closers so doors do not require more than 5 pounds of force to open.	1	Labor	\$0
39	Nurse's Office	1	114	Doors, Doorways, & Gates	Office

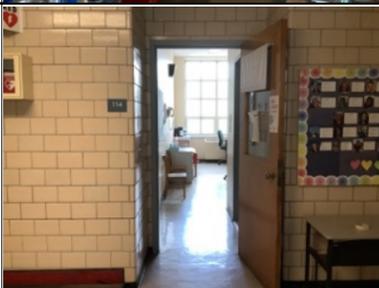
Maneuvering clearance not provided at recess > 6" Hardware not operable with a closed fist	- -	Install an automatic door opener. Provide hardware that can be operable with one hand and not require tight grasping, pinching, or twisting of the wrist.	1	3060	\$3060

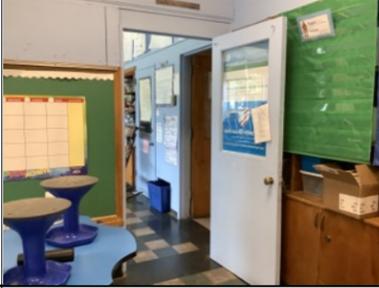
Hardware not operable with a closed fist	-	Provide hardware that can be operable with one hand and not require tight grasping, pinching, or twisting of the wrist.	1	484	\$484
41	Egress To Kindergarten and Fifth Grade	1	106	Doors, Doorways, & Gates	Circulation

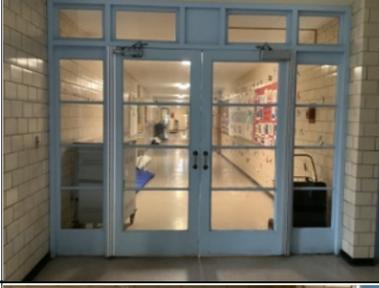
Hardware not operable with a closed fist	-	Provide hardware that can be operable with one hand and not require tight grasping, pinching, or twisting of the wrist.	1	484	\$484
42	Fifth Grade Classroom	1	106	Doors, Doorways, & Gates	Classroom

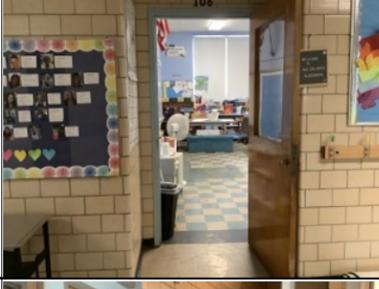
Hardware not operable with a closed fist	-	Provide hardware that can be operable with one hand and not require tight grasping, pinching, or twisting of the wrist.	1	484	\$484
43	South Staircase Egress	1		Doors, Doorways, & Gates	Circulation

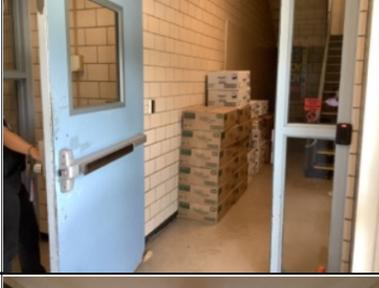
Door requires > 5 lbs. of force to open	10 lbs	Adjust closers so doors do not require more than 5 pounds of force to open.	1	Labor	\$0

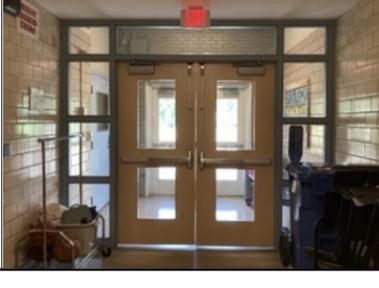
44	Egress Door 1, Drop-Off Entrance	1		Doors, Doorways, & Gates	Emergency Egress

Door requires > 5 lbs. of force to open	12 lbs	Adjust closers so doors do not require more than 5 pounds of force to open.	1	Labor	\$0

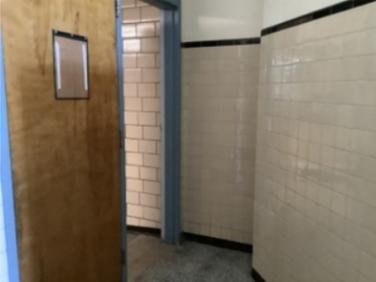
Door requires > 5 lbs. of force to open	17 lbs	Adjust closers so doors do not require more than 5 pounds of force to open.	1	Labor	\$0
46	Main Office	1		Doors, Doorways, & Gates	Office

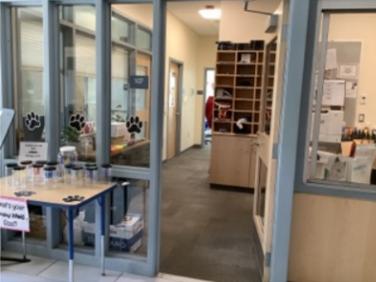
Door requires > 5 lbs. of force to open	10 lbs	Adjust closers so doors do not require more than 5 pounds of force to open.	1	Labor	\$0
47	Kindergarten Classroom	1	105	Doors, Doorways, & Gates	Classroom

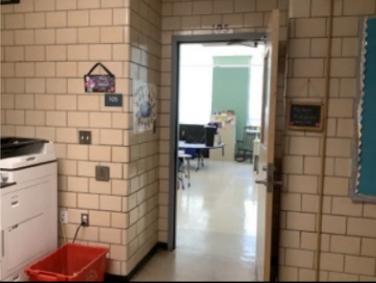
Not maintained in operable working condition		Repair door, automatic door opener failed to open door.	1	Labor	\$0
48	To Boys' Multi-User Toilet Room	2		Doors, Doorways, & Gates	Circulation

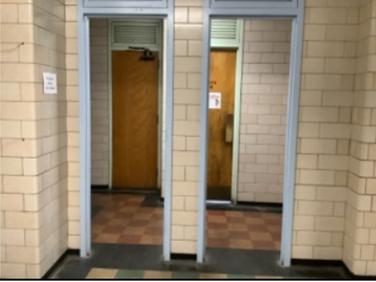
Clear width at door < 32"	26"	Widen the door so that there is 32" min. clear width.	1	3366	\$3366
49	Boys' Multi-User Toilet Room	2		Doors, Doorways, & Gates	Toilet Room

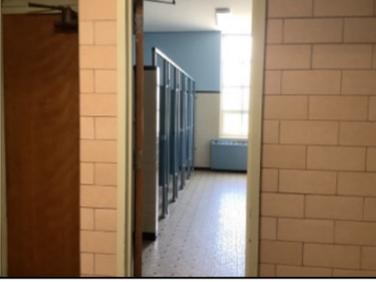
Clear width at door < 32" Door requires > 5 lbs. of force to open	26" 10 lbs	Widen the door so that there is 32" min. clear width. Adjust closers so doors do not require more than 5 pounds of force to open.	1	3366	\$3366

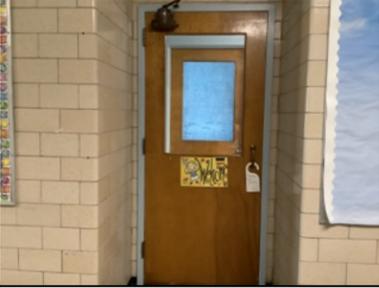
Maneuvering clearance not provided at recess > 6"	-	Install an automatic door opener./Reverse the swing of the door to provide maneuvering clearance.	1	3060	\$3060
51	Third Grade Classroom	2	202	Doors, Doorways, & Gates	Classroom
