# ADA Self-Evaluation and Transition Plan for the City of Melrose

Part 2 of 2

## Part 2: Reports:

January, 2023

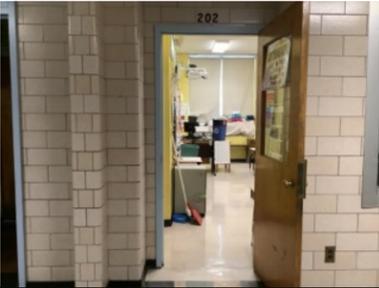
Maneuvering clearance not provided at recess > 6" Hardware not operable with a closed fist	6.5" -	Install an automatic door opener. Provide hardware that can be operable with one hand and not require tight grasping, pinching, or twisting of the wrist.	1	3060	\$3060
52	Fourth Grade Classroom	2	206	Doors, Doorways, & Gates	Classroom

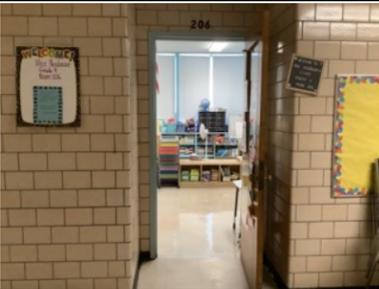
Maneuvering clearance not provided at recess > 6" Hardware not operable with a closed fist	- -	Install an automatic door opener. Provide hardware that can be operable with one hand and not require tight grasping, pinching, or twisting of the wrist.	1	3060	\$3060

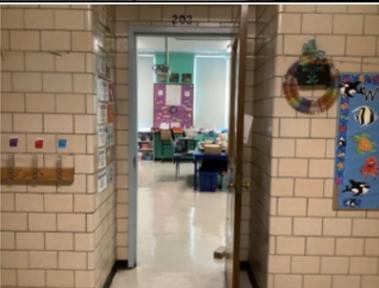
53	Second Grade Classroom	2	203	Doors, Doorways, & Gates	Classroom

Maneuvering clearance not provided at recess > 6" Hardware not operable with a closed fist	6" -	Install an automatic door opener. Provide hardware that can be operable with one hand and not require tight grasping, pinching, or twisting of the wrist.	1	3060	\$3060
54	First Grade Classroom	2	209	Doors, Doorways, & Gates	Classroom

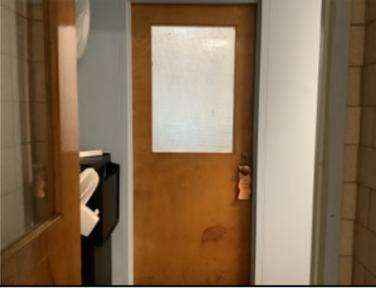
ID	Location	Floor	Room	Element	Type	Photo	Issues	Current Measure	Recommendations	Quantity	Price	Cost Estimation
55	Occupational Therapy/Physical Therapy	2		Doors, Doorways, & Gates	Occupational Therapy/Physical Therapy

Hardware not operable with a closed fist	-	Provide hardware that can be operable with one hand and not require tight grasping, pinching, or twisting of the wrist.	1	484	\$484
56	To Occupational Therapy/Physical Therapy	2		Doors, Doorways, & Gates	Circulation

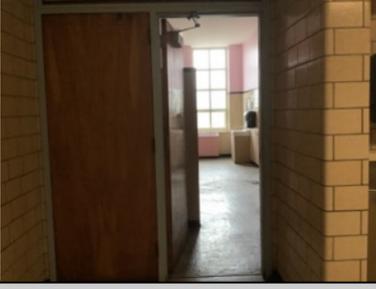
Door requires > 5 lbs. of force to open	10 lbs	Adjust closers so doors do not require more than 5 pounds of force to open.	1	Labor	\$0

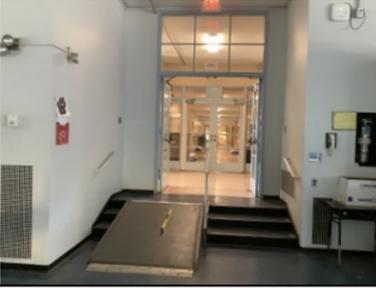
<b>Ramps</b>												
58	Ramp to Gymnasium/Cafeteria	1		Ramps	Interior

Running slope >1:12 (8.33%) Handrails < 34" or > 38" above ramp surface Handrails do not extend 12" past top & bottom Handrails have non-compliant cross section	22% 32" - -	Reduce running slope to be no steeper than 1:12 (8.33%). Alter so the handrails are 34"- 38" high above the floor. Alter handrails to extend horizontally above the landing for 12" min. beyond the top and bottom of ramp runs. Provide handrails with 1 1/4" - 1 1/2" circular cross section.	1	-	\$0
<b>Stairways</b>												
59	South Staircase	1		Stairways	Egress

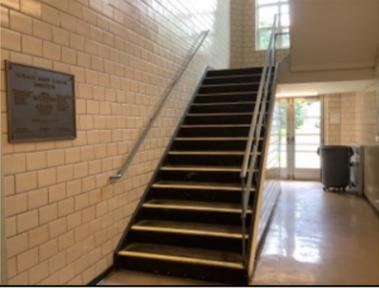
ID	Location	Floor	Room	Element	Type	Photo	Issues	Current Measure	Recommendations	Quantity	Price	Cost Estimation
60	North Staircase	1		Stairways	Egress

Handrail height < 34" or > 38" Handrails do not extend 12" from stairs Handrails have non-compliant cross section	31" - -	Alter so the handrails are 34"- 38" high above the floor. Top: Ensure handrails extend horizontally above the landing for 12" min. beginning above the first riser nosing. Bottom: Ensure handrails extend to one tread depth beyond the last riser. Provide handrails with 1 1/4" - 2" circular cross sections.	1	-	\$0
61	To Principal's Office	1		Stairways	Other

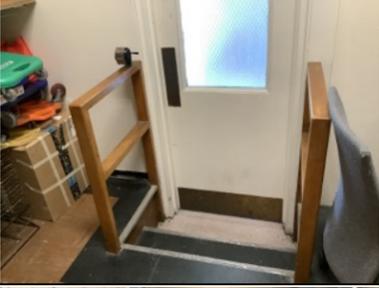
Handrails do not extend 12" from stairs Handrails have non-compliant cross section	- -	Top: Ensure handrails extend horizontally above the landing for 12" min. beginning above the first riser nosing. Provide handrails with 1 1/4" - 2" circular cross sections.	1	-	\$0

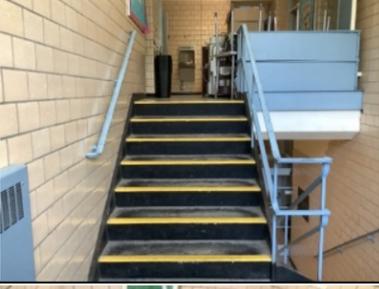
62	North Staircase	2		Stairways	Egress

Handrail height < 34" or > 38" Handrails do not extend 12" from stairs Handrails have non-compliant cross section	31" - -	Alter so the handrails are 34"- 38" high above the floor. Top: Ensure handrails extend horizontally above the landing for 12" min. beginning above the first riser nosing. Bottom: Ensure handrails extend to one tread depth beyond the last riser. Provide handrails with 1 1/4" - 2" circular cross sections.	1	-	\$0
63	South Staircase	2		Stairways	Egress

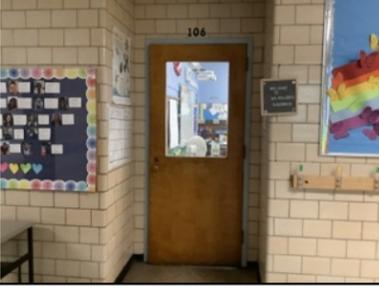
<b>Signage</b>												
64	Fifth Grade Classroom	1	106	Signage	Designation

Raised characters not provided on sign Braille not provided on sign Visual characters < 40" above ground	- - -	Provide text with raised characters duplicated in braille on sign. Mount the sign so that the baseline of the lowest visual character is 40" min. above the finished floor or ground.	1	232	\$232

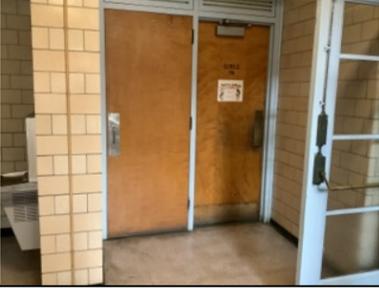
ID	Location	Floor	Room	Element	Type	Photo	Issues	Current Measure	Recommendations	Quantity	Price	Cost Estimation
65	Girls' Multi-User Toilet Room	1		Signage	Designation

Raised characters not provided on sign Braille not provided on sign Sign not located on the latch side of the door	- - -	Provide text with raised characters duplicated in braille on sign. Locate the sign at permanent rooms alongside the door on the latch side.	1	232	\$232
66	Library	1	111	Signage	Designation

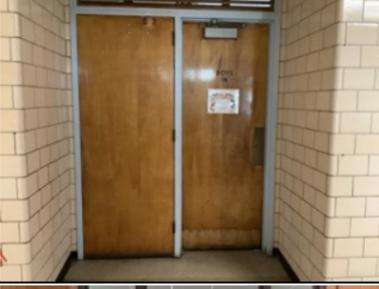
Raised characters not provided on sign Braille not provided on sign Sign not located on the latch side of the door	- - -	Locate compliant room designation signage alongside the door on the latch side with corresponding braille and raised characters.	1	232	\$232

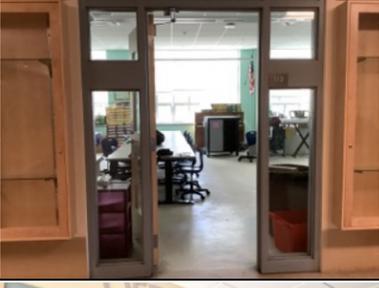
68	Art Room	1	112	Signage	Designation

Non-glare finish and contrast not provided on sign	-	Install a designation sign with a non-glare finish with characters that have a high contrast to the background.	1	232	\$232
69	Main Office	1		Signage	Designation

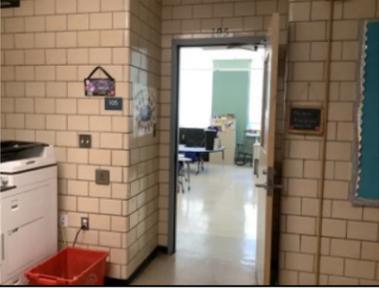
ID	Location	Floor	Room	Element	Type	Photo	Issues	Current Measure	Recommendations	Quantity	Price	Cost Estimation
70	Kindergarten Classroom	1	105	Signage	Designation

Signage lacks 18" by 18" clear floor space		Relocate the trash can to provide a clear floor space of 18" min. by 18" min. at the sign.	1	Labor	\$0
71	Third Grade Classroom	2	202	Signage	Designation

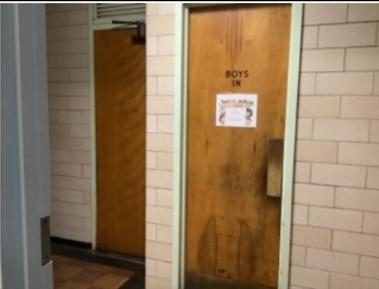
Raised characters not provided on sign Braille not provided on sign Sign not located on the latch side of the door	- - -	Provide text with raised characters duplicated in braille on sign. Locate the sign at permanent rooms alongside the door on the latch side.	1	232 Labor	\$232

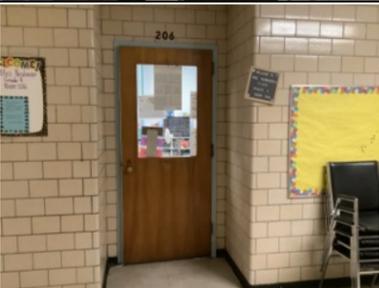
73	Fourth Grade Classroom	2	206	Signage	Designation

Raised characters not provided on sign Braille not provided on sign Sign not located on the latch side of the door	- - -	Provide text with raised characters duplicated in braille on sign. Locate the sign at permanent rooms alongside the door on the latch side.	1	232	\$232
74	Second Grade Classroom	2	203	Signage	Designation

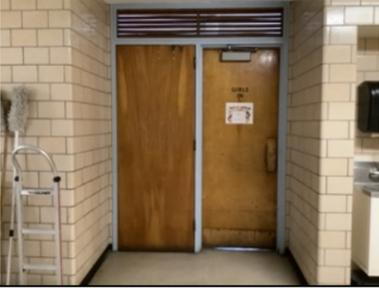
ID	Location	Floor	Room	Element	Type	Photo	Issues	Current Measure	Recommendations	Quantity	Price	Cost Estimation
75	Girls' Multi-User Toilet Room	2		Signage	Designation

Raised characters not provided on sign Braille not provided on sign Sign not located on the latch side of the door	- - -	Provide text with raised characters duplicated in braille on sign. Locate the sign at permanent rooms alongside the door on the latch side.	1	232	\$232
76	First Grade Classroom	2	209	Signage	Designation

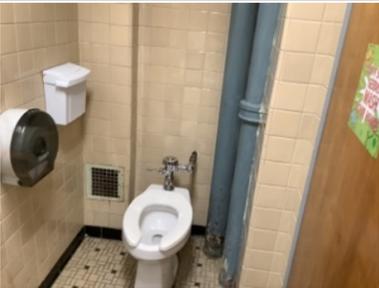
<b>Toilet &amp; Bathing Rooms</b>												
<b>Overall Access</b>												
78	Nurse's Office, Single-User Toilet Room	1	114	Overall Access	Toilet Room

Not on an accessible route Turning space not provided Accessible plumbing fixtures or stalls not provided	10% - -	Provide an accessible single-user toilet room.	1	24604	\$24604
79	Boys' Multi-User Toilet Room	1		Overall Access	Toilet Room

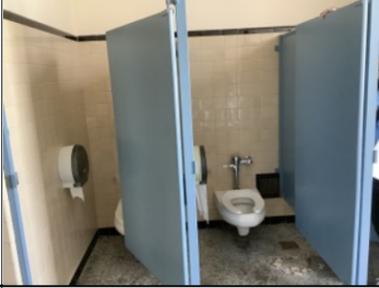
ID	Location	Floor	Room	Element	Type	Photo	Issues	Current Measure	Recommendations	Quantity	Price	Cost Estimation
80	Boys' Multi-User Toilet Room	1		Overall Access	Toilet Room

Accessible plumbing fixtures or stalls not provided	-	Provide one accessible wheelchair compartment.	1	6182	\$6182
81	Girls' Multi-User Toilet Room	2		Overall Access	Toilet Room

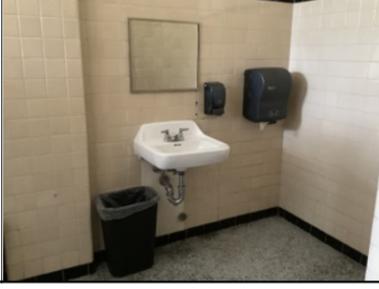
84	Boys' Multi-User Toilet Room	1		Lavatory	N/A

Clear floor space not provided at lavatory Plumbing underneath is exposed Mirror above lavatory w/reflective surface > 40"	- - 46"	Relocate trash bin to provide the lavatory with a 30" min. by 48" min. clear floor space positioned for a forward approach at the lavatory. Insulate or otherwise configure pipes to prevent contact for at least one lavatory. Lower mirror so that the bottom surface is at 40" max. above the finished floor.	1	348	\$348

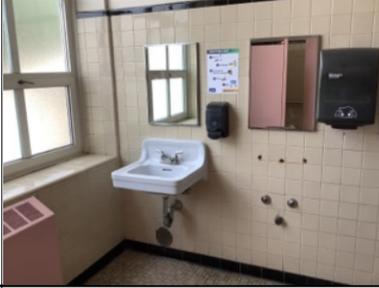
ID	Location	Floor	Room	Element	Type	Photo	Issues	Current Measure	Recommendations	Quantity	Price	Cost Estimation
85	Girls' Multi-User Toilet Room	1		Lavatory	N/A

Plumbing underneath is exposed	-	Insulate or otherwise configure pipes to prevent contact for at least one lavatory.	1	92	\$92
86	Boys' Multi-User Toilet Room	2		Lavatory	N/A

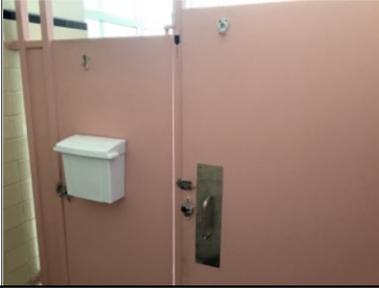
88	Girls' Multi-User Toilet Room	1		Toilet Compartment	Accessible Compartment

Door has malfunctioning self-closing hinge Coat hook > 48" (2010 ADA)	- 68"	Repair hinge. Locate the coat hook no higher than 48" above the finished floor.	1	150	\$150
89	Girls' Multi-User Toilet Room	1		Toilet Compartment	Accessible Compartment

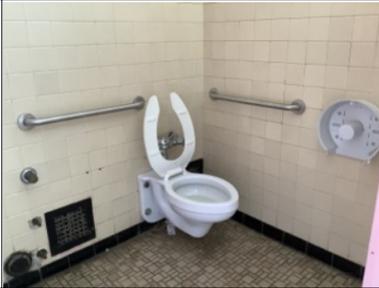
Side grab bar < 42" long Non-compliant toilet paper dispenser Clearance at toilet < 72" clear depth (MAAB)	- - 56"	Provide a side wall grab bar that is 42" long min. located 12" max. from the rear wall. Relocate toilet paper so that it is located under the grab bar. Provide a wheelchair accessible compartment that is 60" wide and 72" deep.	1	6182	\$6182

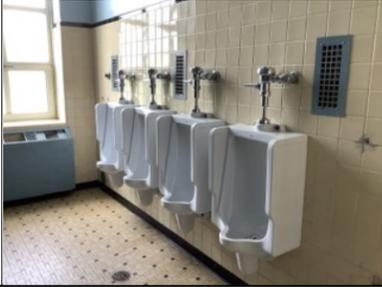
ID	Location	Floor	Room	Element	Type	Photo	Issues	Current Measure	Recommendations	Quantity	Price	Cost Estimation
<b>Urinal</b>												
90	Boys' Multi-User Toilet Room	2		Urinal	N/A

Rim > 17" high Clear floor space not provided at urinal	22" -	Provide at least one urinal with the rim no higher than 17" above the finished floor.	1	3248	\$3248
<b>Dispensers</b>												
91	Girls' Multi-User Toilet Room	1		Dispensers	Paper Towel Dispenser

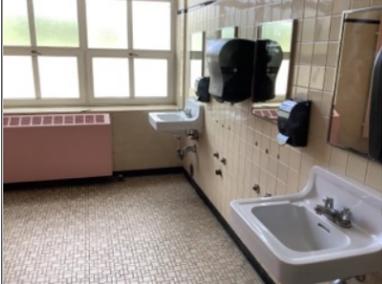
Dispenser acts as a protruding object	9"	Relocate paper towel dispenser out of the circulation path.	1	256	\$256
<b>Toilet Rooms for Children</b>												
<b>Lavatory (Children)</b>												
92	Girls' Multi-User Toilet Room	2		Lavatory (Children)	N/A

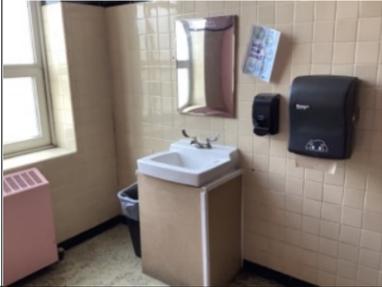
Toe or knee clearances not provided Lavatory rim or counter > 30" Mirror above lavatory w/reflective surface > 31"	- 32" 41"	Provide at least one lavatory with 25" min. knee clearance positioned for a forward approach. Ensure toe clearance is also provided. Relocate lavatory with the front of the rim or counter no higher than 30" above the finished floor. Lower mirror so that the bottom surface is at 31" above the finished floor.	1	1942	\$1942

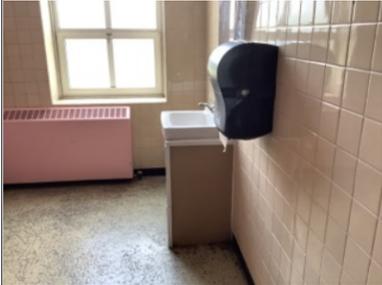
<b>Dispensers (Children)</b>												
93	Girls' Multi-User Toilet Room	2		Dispensers (Children)	Paper Towel Dispenser

Dispenser is a protruding object	9"	Relocate dispenser out of the circulation path.	1	256	\$256

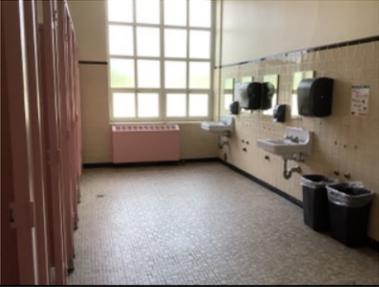
ID	Location	Floor	Room	Element	Type	Photo	Issues	Current Measure	Recommendations	Quantity	Price	Cost Estimation
<b>Overall Access (Children)</b>												
94	Girls' Multi-User Toilet Room	1		Overall Access (Children)	Toilet Room

6 fixtures, no ambulatory compartment provided Audible and visible alarms are not provided	-	Provide one ambulatory accessible compartment. When fire system is updated, ensure that a visible and audible fire alarm is installed.	1	3012	\$3012
95	Boys' Multi-User Toilet Room	2		Overall Access (Children)	Toilet Room

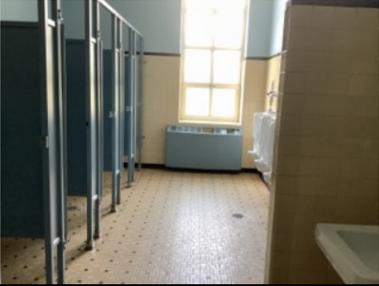
Accessible fixtures or stalls not provided 6 fixtures, no ambulatory compartment provided Audible and visible alarms are not provided	- - -	Provide one accessible wheelchair compartment. Provide one ambulatory accessible compartment. When fire system is updated, ensure that a visible and audible fire alarm is installed.	1	9194	\$9194
96	Girls' Multi-User Toilet Room	2		Overall Access (Children)	Toilet Room

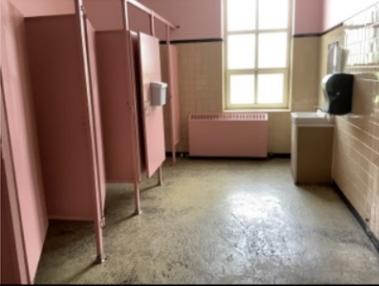
Accessible fixtures or stalls not provided 6 fixtures, no ambulatory compartment provided Audible and visible alarms are not provided	- - -	Provide one accessible wheelchair compartment. Provide one ambulatory accessible compartment. When fire system is updated, ensure that a visible and audible fire alarm is installed.	1	9194	\$9194

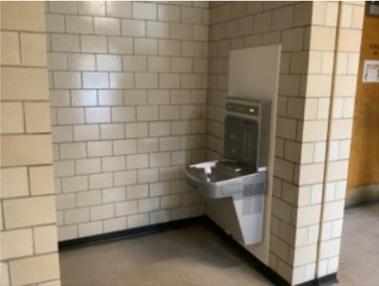
<b>Additional Access</b>												
<b>Drinking Fountains</b>												
97	By Girls' Multi-User Toilet Room	1		Drinking Fountains	Low

No drinking fountain provided for standing users	-	Provide an additional drinking fountain for standing users or install a Hi-Lo drinking fountain.	1	4028	\$4028
98	Near Library	1		Drinking Fountains	Low

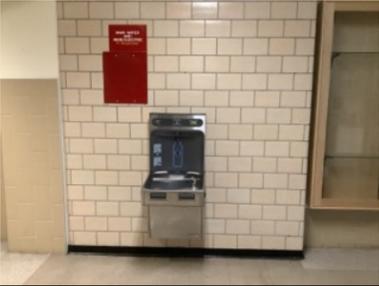
No drinking fountain provided for standing users Knee or toe clearance not provided	- 23"	Provide an additional drinking fountain for standing users. Provide knee and toe clearance, 27" min. high at drinking fountain for seated users.	1	6056	\$6056

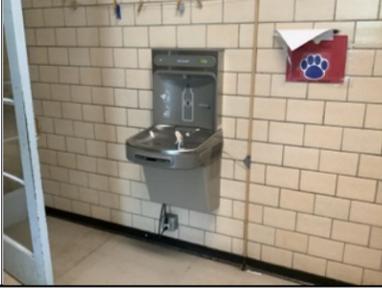
ID	Location	Floor	Room	Element	Type	Photo	Issues	Current Measure	Recommendations	Quantity	Price	Cost Estimation
99	By Teacher's Lounge	2		Drinking Fountains	Low

No drinking fountain provided for standing users	-	Provide an additional drinking fountain for standing users or install a Hi-Lo drinking fountain.	1	4028	\$4028
<b>Sink</b>												
100	Near Art Room	1		Sink	Other

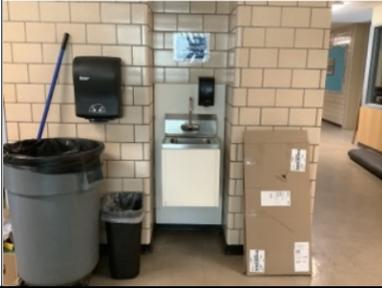
Clear floor space not provided at sink Toe and knee clearances not provided	- 3"	At the sink provide a 30" by 48" clear floor space positioned for a forward approach. At the sink ensure there is a 27" min. knee clearance positioned for a forward approach.	1	1686	\$1686
101	Third Grade Classroom	2	202	Sink	Classroom

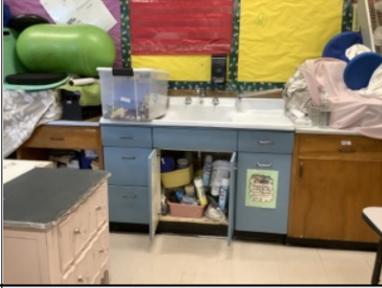
Clear floor space not provided at sink Toe and knee clearances not provided Exposed plumbing underneath sink	- - -	Provide a 30" by 48" clear floor space positioned for a forward approach. Ensure there is a 27" min. knee clearance positioned for a forward approach. Insulate or otherwise configure pipes at sink.	1	1778	\$1778

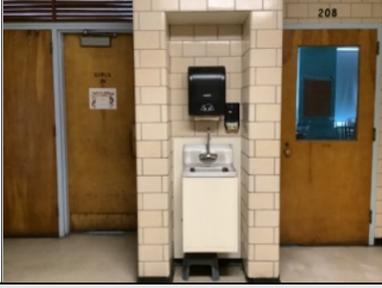
102	By Girls' Multi-User Toilet Room	2		Sink	Classroom

Toe and knee clearances not provided	3"	Provide a sink with 27" min. knee and toe clearance positioned for a forward approach.	1	1686	\$1686
<b>Best Practice</b>												
103	Girls' Multi-User Toilet Room	2			563

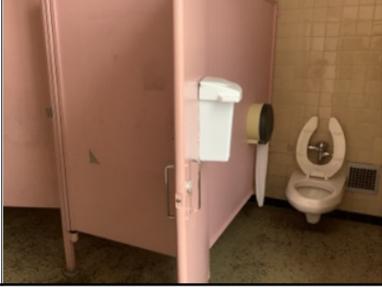
-	Recommend relocating sanitary napkin disposal bin in the women's accessible toilet compartment to be on the side wall. However, the disposal bin should not be mounted above the grab bar per 521 CMR, the regulations of the Massachusetts Architectural Access Board (MAAB).	1	-	\$0

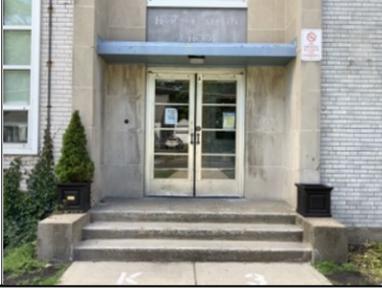
ID	Location	Floor	Room	Element	Type	Photo	Issues	Current Measure	Recommendations	Quantity	Price	Cost Estimation
104	Egress Door 4	Ext.

Recommend providing color contrast striping on stair treads.	1	-	\$0
<b>American Flag</b>												
105	Second Grade Classroom	2	203	American Flag	N/A

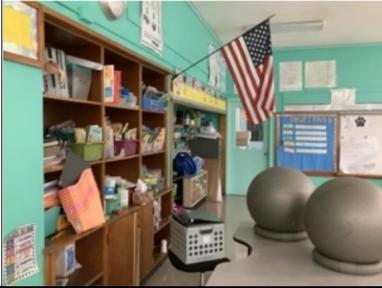
Recommend relocating flag so that the bottom of the flag is located 80" min. above the finished floor.	1	-	\$0
<b>Detectable Warning</b>												
106	Walkway to Egress Door 1, Drop-Off Entrance	Ext.		Detectable Warning

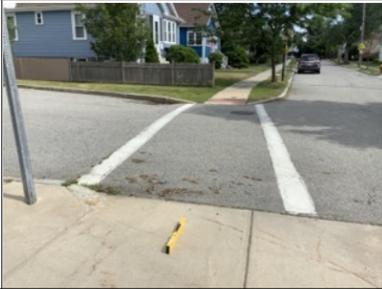
Recommend providing detectable warning at both sides of crosswalk.	1	-	\$0
<b>Signage</b>												
107	Principal's Office	1		Signage	N/A

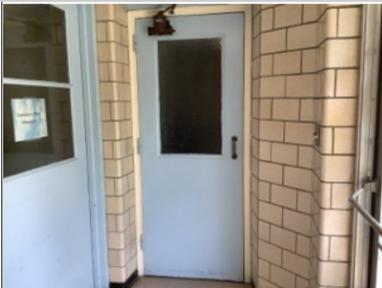
Recommend providing designation signage with raised characters and braille on the latch side of the door to all permanent rooms that lack designation signage.	1	-	\$0
108	Nurse's Office	1	114	Signage	Designation

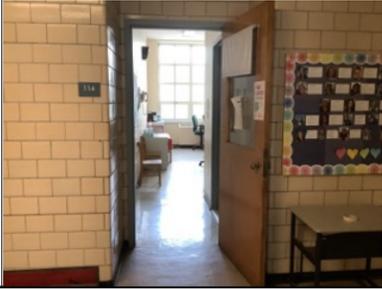
Recommend providing designation sign on the latch side of the door.	1	-	\$0

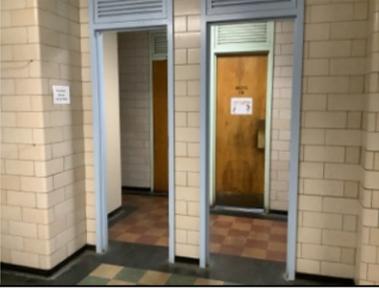
ID	Location	Floor	Room	Element	Type	Photo	Issues	Current Measure	Recommendations	Quantity	Price	Cost Estimation
109	To Boys' Multi-User Toilet Room	2		Signage	Designation

Recommend providing a directional sign to the toilet room.	1	-	\$0
110	Main Entrance, Egress Door 5	Ext.		Signage	Directional

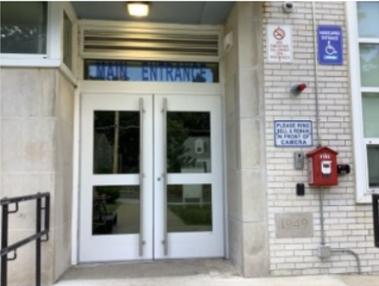
Recommend providing an additional International Symbol of Accessibility (ISA) sign at a more visible location such as at the start of the walkway since the existing sign is not visible from the sidewalk or street.	1	-	\$0

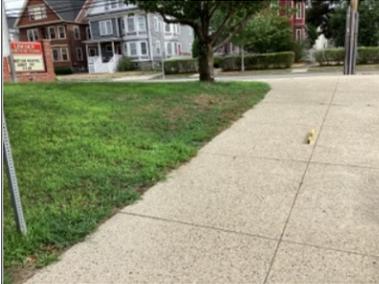
ID	Location	Floor	Room	Element	Type	Photo	Issues	Current Measure	Recommendations	Quantity	Price	Cost Estimation
<b>Approach and Entrance</b>												
<b>Exterior Access Route</b>												
1	Walkway by Front of School	Ext.		Exterior Access Route	Sidewalk

Running slope > 1:20 (5.00%)	6.5%	Reduce running slope to be no steeper than 1:20 (5.00%).	1	-	\$0
2	Route From School to Garden	Ext.		Exterior Access Route	Walkway

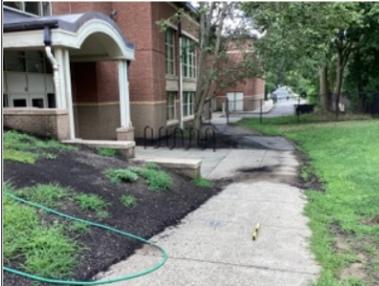
Running slope > 1:20 (5.00%)	9%	Reduce running slope to be no steeper than 1:20 (5.00%).	1	-	\$0
3	Route From Back of School by Garden	Ext.		Exterior Access Route	Exterior

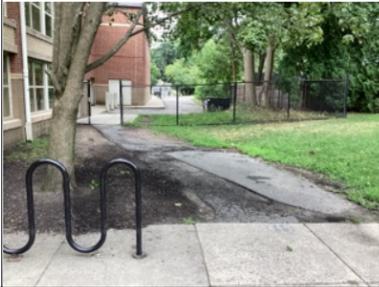
Level changes > 1/4" Surface is not stable, firm, and slip-resistant Route not maintained in operable working condition	1" - -	Alter change in level to be 1/4" high max. Repair surface.	1	-	\$0
4	Northwest Playground by Cottage Street	Ext.		Exterior Access Route	Walkway

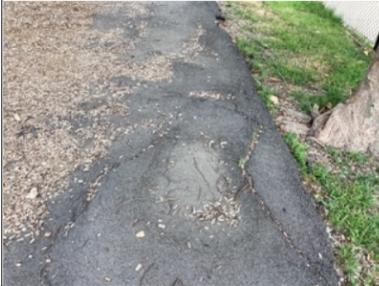
Surface is not stable, firm, and slip-resistant Route not maintained in operable working condition	-	Repair surface.	1	-	\$0

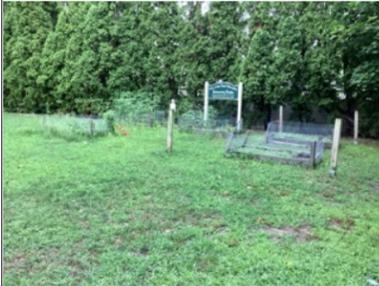
5	Garden	Ext.		Exterior Access Route	Exterior

Accessible route not provided		Ensure an accessible route is provided to and within the garden.	1	-	\$0

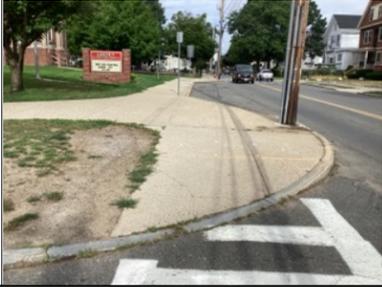
ID	Location	Floor	Room	Element	Type	Photo	Issues	Current Measure	Recommendations	Quantity	Price	Cost Estimation
<b>Curb Ramp</b>												
6	Curb Ramp at Front of School	Ext.		Curb Ramp	Perpendicular

Transition from curb ramp to street not flush	-	Ensure transition from curb ramp to street is flush or free of changes in level.	1	-	\$0
<b>Off-Street Parking Lot or Garage</b>												
7	Car Accessible Space by Door 2	Ext.		Off-Street Parking Lot or Garage	Visitor

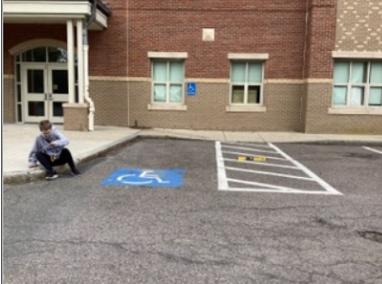
Sign bottom < 60" above finished grade	49"	Locate sign with the bottom of the sign 60" above the ground.	1	-	\$0
<b>Passenger Loading Zones</b>												
8	Van and Car Spaces by Door 1 Main Entrance	Ext.		Passenger Loading Zones	N/A

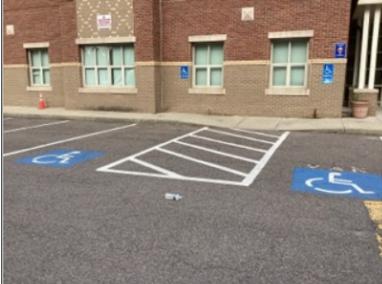
Sign bottom < 60" above finished grade	50"	Provide a sign with the bottom of the sign 60" above the ground. Recommend replacing fading sign.	1	-	\$0
<b>Access to Goods and Services</b>

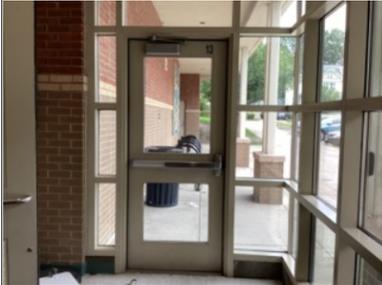
<b>Means of Egress</b>												
9	Door 13	1		Means of Egress	N/A

Tactile exit sign not provided	-	Ensure tactile exit signs with raised characters and braille are provided at exit doors. Mount signs between 48"- 60" above the finished floor located on the latch side of the door.	1	232	\$232

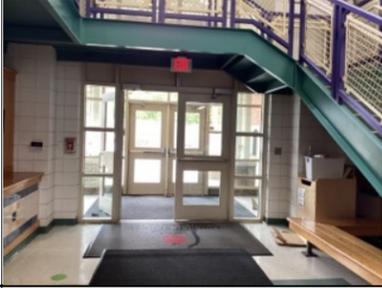
ID	Location	Floor	Room	Element	Type	Photo	Issues	Current Measure	Recommendations	Quantity	Price	Cost Estimation
10	Door 10	1	138	Means of Egress	N/A

Tactile exit sign not provided Illuminated ISA symbol not provided (MAAB)	- -	Ensure tactile exit signs with raised characters and braille are provided at exit doors. Mount signs between 48"- 60" above the finished floor located on the latch side of the door. When the illuminated exit sign is repaired or replaced provide an illuminated sign with the International Symbol of Accessibility (ISA).	1	232	\$232
11	Door 9	1		Means of Egress

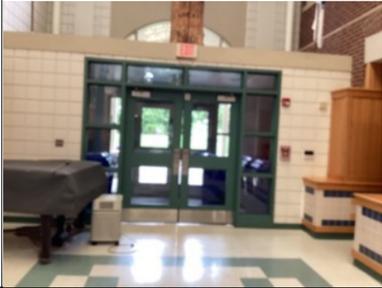
Tactile exit sign not provided Illuminated ISA symbol not provided (MAAB)		Ensure tactile exit signs with raised characters and braille are provided at exit doors. Mount signs between 48"- 60" above the finished floor located on the latch side of the door. When the illuminated exit sign is repaired or replaced provide an illuminated sign with the International Symbol of Accessibility (ISA).	1	232	\$232

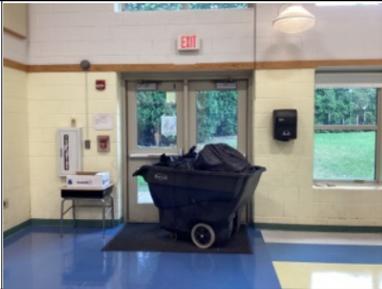
12	Door 8 in Cafeteria	1		Means of Egress	N/A

Tactile exit sign not provided Illuminated ISA symbol not provided (MAAB)		Ensure tactile exit signs with raised characters and braille are provided at exit doors. Mount signs between 48"- 60" above the finished floor located on the latch side of the door. When the illuminated exit sign is repaired or replaced provide an illuminated sign with the International Symbol of Accessibility (ISA).	1	232	\$232
13	Door 12	1		Means of Egress	N/A

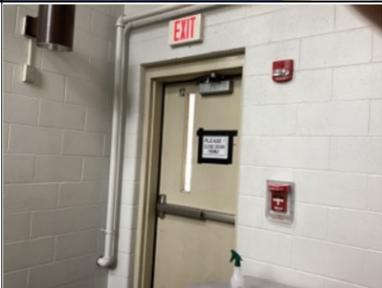
Tactile exit sign not provided Illuminated ISA symbol not provided (MAAB)		Ensure tactile exit signs with raised characters and braille are provided at exit doors. Mount signs between 48"- 60" above the finished floor located on the latch side of the door. When the illuminated exit sign is repaired or replaced provide an illuminated sign with the International Symbol of Accessibility (ISA).	1	232	\$232

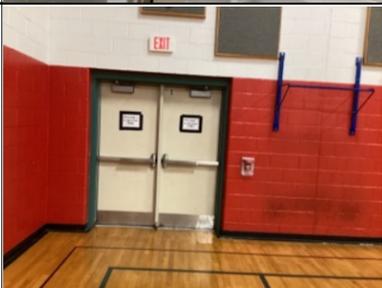
14	Gym	1		Means of Egress	N/A

Tactile exit sign not provided Illuminated ISA symbol not provided (MAAB)		Ensure tactile exit signs with raised characters and braille are provided at exit doors. Mount signs between 48"- 60" above the finished floor located on the latch side of the door. When the illuminated exit sign is repaired or replaced provide an illuminated sign with the International Symbol of Accessibility (ISA).	1	232	\$232

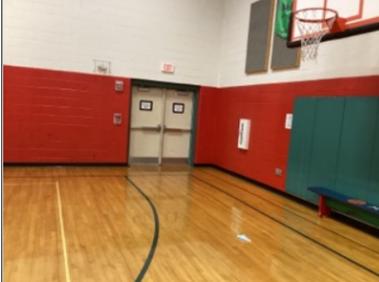
ID	Location	Floor	Room	Element	Type	Photo	Issues	Current Measure	Recommendations	Quantity	Price	Cost Estimation
15	Gym Towards Playground	1		Means of Egress	N/A

Tactile exit sign not provided Illuminated ISA symbol not provided (MAAB)		Ensure tactile exit signs with raised characters and braille are provided at exit doors. Mount signs between 48"- 60" above the finished floor located on the latch side of the door. When the illuminated exit sign is repaired or replaced provide an illuminated sign with the International Symbol of Accessibility (ISA).	1	232	\$232
16	Door 10	1		Means of Egress	N/A

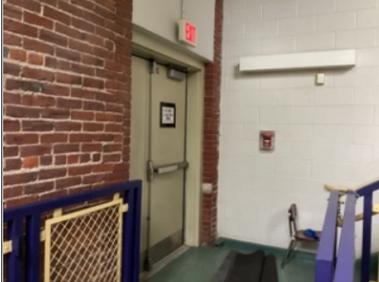
Tactile exit sign not provided Directional sign to accessible emergency exit not provided	-	Ensure tactile exit signs with raised characters and braille are provided at exit doors. Mount signs between 48"- 60" above the finished floor located on the latch side of the door. Provide a directional sign indicating the location of the nearest accessible emergency exit.	2	232	\$464

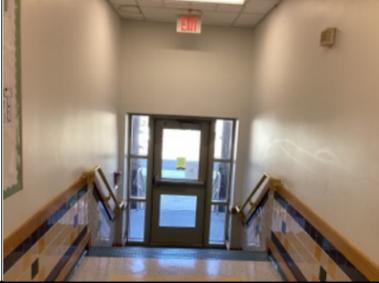
17	Towards Main Street Door 11	2		Means of Egress	N/A

Tactile exit sign not provided Directional sign to accessible emergency exit not provided	-	Ensure tactile exit signs with raised characters and braille are provided at exit doors. Mount signs between 48"- 60" above the finished floor located on the latch side of the door. Provide a directional sign indicating the location of the nearest accessible emergency exit.	2	232	\$464
<b>Interior Access Route</b>												
18	Office Hand Sanitizer	1	138	Interior Access Route	N/A

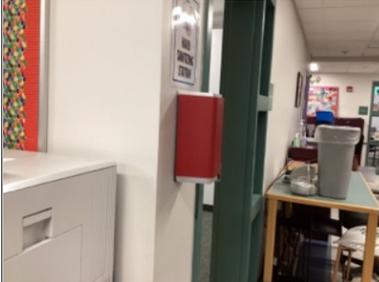
Obstructed by protruding objects	5"	Provide a cane-detectable barrier below dispenser or relocate dispenser out of the interior accessible route.	1	306	\$306
19	Cafeteria by Door 8	1		Interior Access Route	N/A

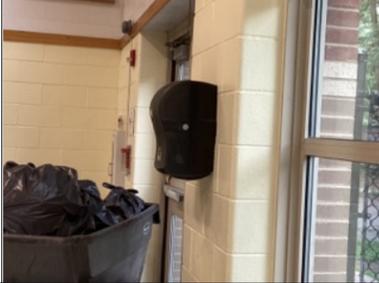
Obstructed by protruding objects	12"	Relocate paper towel dispenser out of the circulation path or provide a cane-detectable barrier.	1	306	\$306

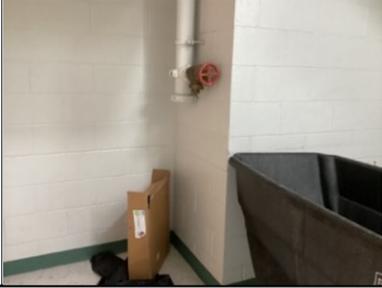
ID	Location	Floor	Room	Element	Type	Photo	Issues	Current Measure	Recommendations	Quantity	Price	Cost Estimation
20	Stairwell B by Door 12	3		Interior Access Route	N/A

Obstructed by protruding objects	-	Provide a cane-detectable barrier 27" max. above the finished floor under the pipe.	1	306	\$306
<b>Doors, Doorways, &amp; Gates</b>												
21	Resource Room A	2		Doors, Doorways, & Gates	Other

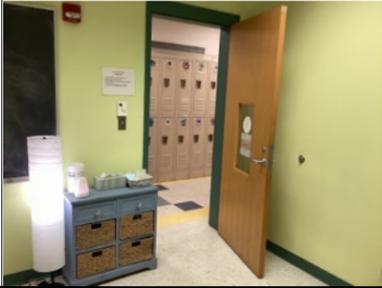
Maneuvering clearance(s) not provided	-	Relocate furniture to provide 18" min. pull-side maneuvering clearance at the door.	1	Labor	\$0
22	Single-User Toilet Room by Office	1		Doors, Doorways, & Gates	N/A

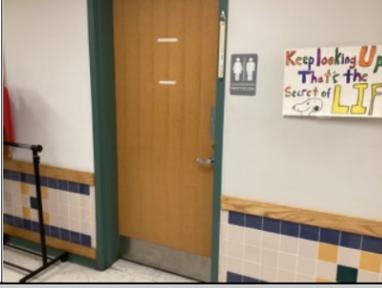
Door requires > 5 lbs. of force to open	11 lbs	Adjust closers so doors do not require more than 5 pounds of force to open.	1	Labor	\$0
<b>Signage</b>												
23	Gym	1		Signage	Designation

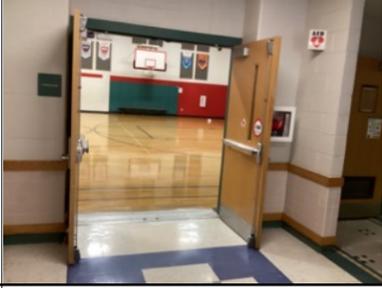
For double-leaf doors when each door is active, the sign must be located to the right of the door. Ensure also that there is clear floor space at the sign.	1	Labor	\$0

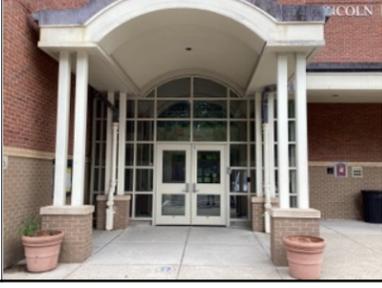
24	Main Entrance Door 1	Ext.		Signage	Informational

Signage is not provided	-	Provide accessible signage with raised characters and braille duplicating the Lincoln Elementary School wording above the main entrance. Locate the accessible sign alongside the main entry doors on the right side.	1	-	\$0

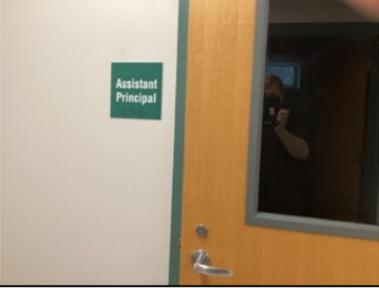
ID	Location	Floor	Room	Element	Type	Photo	Issues	Current Measure	Recommendations	Quantity	Price	Cost Estimation
25	Special Education Coordinator's Office	1	138	Signage	Designation

Raised characters not provided on sign Braille not provided on sign		Provide text with raised characters duplicated in braille on sign.	1	232	\$232
26	Social Worker's Office	1	138	Signage

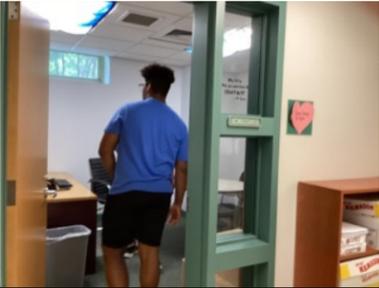
Raised characters not provided on sign Braille not provided on sign		Provide text with raised characters duplicated in braille on sign. Provide braille on the sign.	1	232	\$232
27	Psychologist Office	1	138	Signage	Designation

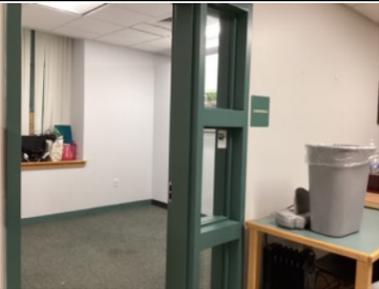
Raised characters not provided on sign Braille not provided on sign Sign not located on the latch side of the door	-	Provide text with raised characters duplicated in braille on sign. Locate the sign at permanent rooms alongside the door on the latch side. (Recommend mounting sign on glass closer to the door's latch.) Sign at psychologist office reads "Conference Room" Update designation sign to correct room name.	1	Labor	\$0

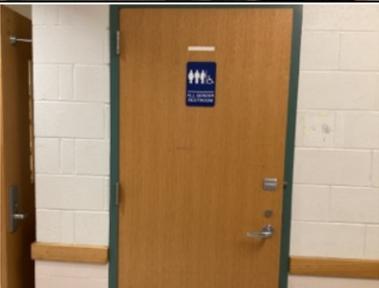
28	Single-User All Gender Toilet Room by Gym	1		Signage	Designation

Visual characters < 40" above ground Sign not located on the latch side of the door	64" -	Mount the sign so that the baseline of the lowest visual character is 40" min. above the finished floor or ground. Locate the sign at permanent rooms alongside the door on the latch side.	1	Labor	\$0
29	Main Office	1		Signage	Designation

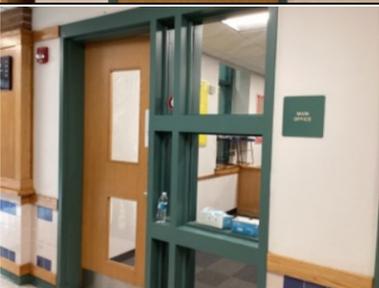
Sign not located on the latch side of the door	-	Locate the sign at permanent rooms alongside the door on the latch side. (Recommend mounting sign on glass closer to the door's latch.)	1	Labor	\$0

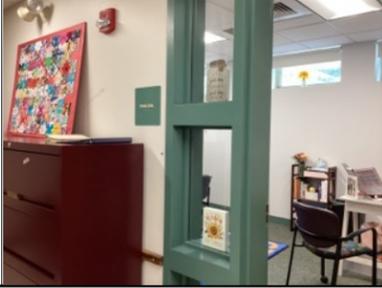
ID	Location	Floor	Room	Element	Type	Photo	Issues	Current Measure	Recommendations	Quantity	Price	Cost Estimation
30	Principal's Office	1		Signage	Designation

Sign not located on the latch side of the door	-	Locate the sign at permanent rooms alongside the door on the latch side. (Recommend mounting sign on glass closer to the door's latch.)	1	Labor	\$0
<b>Service Counter</b>												
31	Main Office	1		Service Counter	N/A

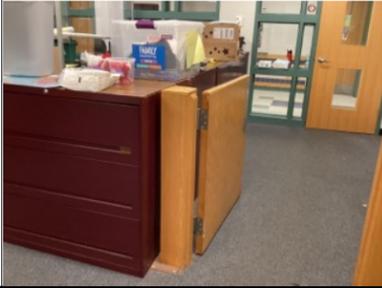
Counter > 36" high	40"	Provide a counter that is 36" max. above the ground or finished floor.	1	880	\$880
<b>Assembly Area</b>												
32	Cafeteria	1		Assembly Area	N/A

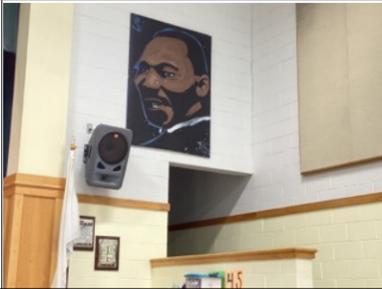
Assistive listening devices not provided		If audible communication is integral to the use of the space, provide an assistive listening system.	1	1214	\$1214
<b>Exterior Benches</b>												
33	South Playground by School	Ext.		Exterior Benches	N/A

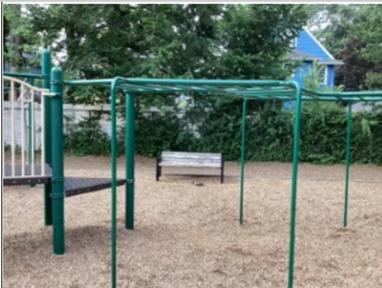
No accessible route to one bench in area	-	Provide an accessible route to one bench in this area or relocate bench to an accessible route.	1	-	\$0

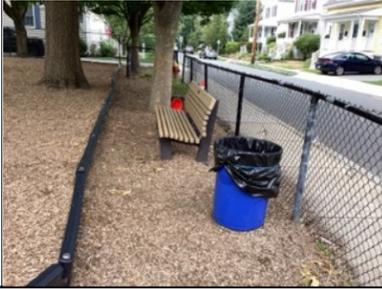
34	Northwest Playground by Cottage Street	Ext.		Exterior Benches	N/A

No accessible route to one bench in area	-	Provide an accessible route to one bench in this area or relocate bench to an accessible route.	1	-	\$0

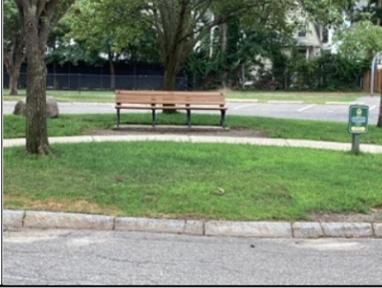
ID	Location	Floor	Room	Element	Type	Photo	Issues	Current Measure	Recommendations	Quantity	Price	Cost Estimation
35	Bench by Parking	Ext.		Exterior Benches	N/A

No accessible route to one bench in area	-	Provide an accessible route to one bench in this area or relocate bench to an accessible route.	1	-	\$0
<b>Toilet &amp; Bathing Rooms</b>												
<b>Lavatory</b>												
36	Boys' Multi-User Toilet Room by Reading	2		Lavatory	N/A

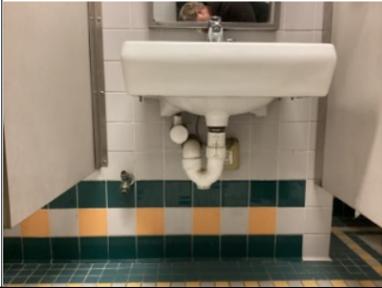
Toe or knee clearances not provided	23"	Provide at least one lavatory with knee and toe clearance positioned for a forward approach.	1	1686	\$1686
<b>Single-User Toilet</b>												
37	Women's Single-User Toilet Room by Gym	1		Single-User Toilet	N/A

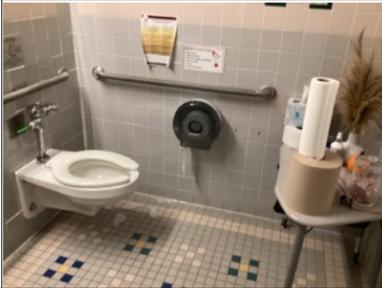
Clearance at toilet < 60" clear width	19.5"	Relocate table and stored items.	1	Labor	\$0
38	Single-User Toilet Room by Office	1		Single-User Toilet	N/A

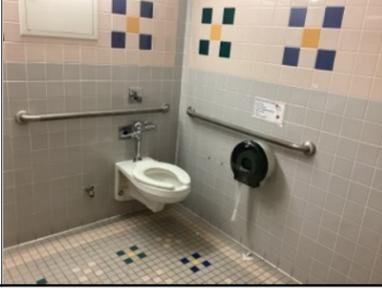
Toilet paper dispenser is not compliant	.5"	Relocate toilet paper so that it has a clearance of 1 1/2 inches (38 mm) minimum below the grab bar.	1	353	\$353

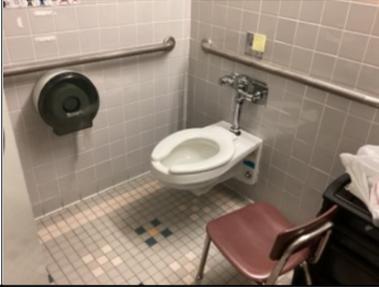
ID	Location	Floor	Room	Element	Type	Photo	Issues	Current Measure	Recommendations	Quantity	Price	Cost Estimation
<b>Toilet Compartment</b>												
39	Single-User All Gender Toilet Room by Gym	1		Toilet Compartment

Door has incorrect swing Clearance at toilet < 60" clear width Centerline < or > 18" (MAAB) Non-compliant toilet paper dispenser	.5" 20"	Reverse swing at door so the door swings out. Relocate toilet paper so that it has a clearance of 1 1/2 inches (38 mm) minimum below the grab bar. Relocate toilet so the centerline is 18" from the side wall.	1	353	\$353
40	Single-User All Gender Toilet Room by Gym	1		Toilet Compartment

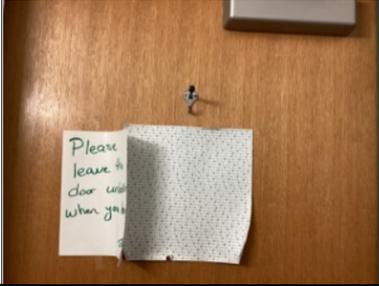
Coat hook > 48" (2010 ADA)	70"	Locate the coat hook no higher than 48" above the finished floor.	1	150	\$150
<b>Dispensers</b>												
41	Boys' Multi-User Toilet Room by Gym	1		Dispensers	Paper Towel Dispenser

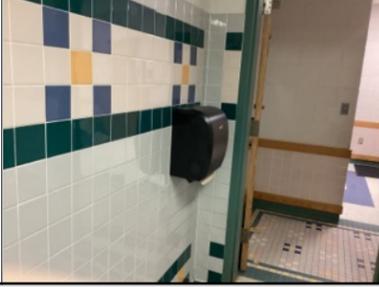
Dispenser acts as a protruding object		Relocate the paper towel dispenser out of the circulation path or provide a cane-detectable barrier under the dispenser.	1	306	\$306

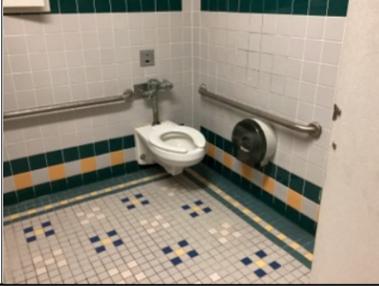
<b>Toilet Rooms for Children</b>												
<b>Toilet Compartment (Children)</b>												
42	Boys' Multi-User Toilet Room	3		Toilet Compartment (Children)	Accessible Compartment

Door with non-compliant hardware		Provide hardware that can be operable with one hand and not require tight grasping, pinching, or twisting of the wrist.	1	70	\$70

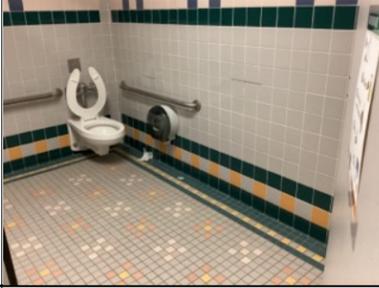
ID	Location	Floor	Room	Element	Type	Photo	Issues	Current Measure	Recommendations	Quantity	Price	Cost Estimation
43	Girls' Multi-User Toilet Room	1		Toilet Compartment (Children)	Accessible Compartment

Door with non-compliant hardware Door with malfunctioning self-closing hinge		Provide hardware that can be operable with one hand and not require tight grasping, pinching, or twisting of the wrist. Provide a door pull on each side of the door Repair self-closing hinge.	1	70 Labor	\$70
44	Boys' Multi-User Toilet Room by Gym	1		Toilet Compartment (Children)	Accessible Compartment

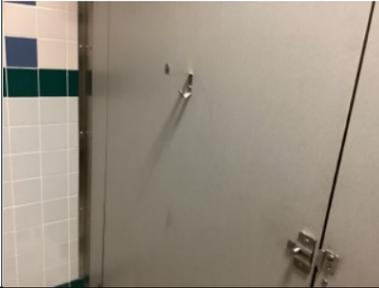
Door with non-compliant hardware Door pull not provided		Provide hardware that can be operable with one hand and not require tight grasping, pinching, or twisting of the wrist. Provide a door pull on each side of the door between 34" to 48" above the finished floor that does not require tight grasping, pinching or twisting of the wrist.	1	140	\$140

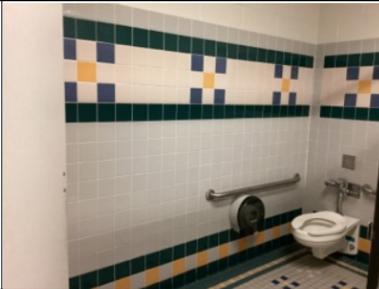
45	Boys' Multi-User Toilet Room	1		Toilet Compartment (Children)

Door with malfunctioning self-closing hinge Door with non-compliant hardware		Provide hardware that can be operable with one hand and not require tight grasping, pinching, or twisting of the wrist. Provide a door pull on each side of the door Repair self-closing hinge.	1	70 Labor	\$70
46	Girls' Multi-User Toilet Room	3	307	Toilet Compartment (Children)	Accessible Compartment

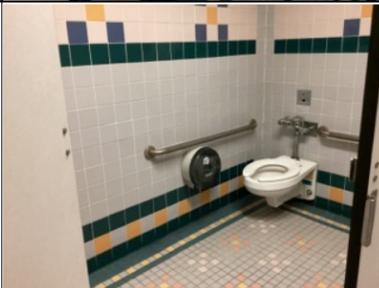
Door with malfunctioning self-closing hinge Door with non-compliant hardware		Provide hardware that can be operable with one hand and not require tight grasping, pinching, or twisting of the wrist. Provide a door pull on each side of the door Repair self-closing hinge.	1	70 Labor	\$70
47	All Gender Single-User Toilet Room	2		Toilet Compartment (Children)	Accessible Compartment

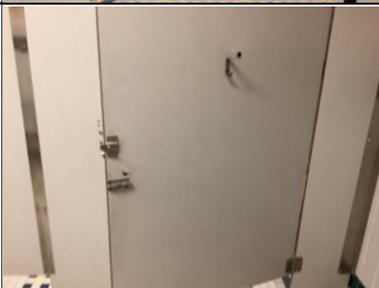
Door with malfunctioning self-closing hinge Door pull not provided		Repair self-closing hinge. Provide a door pull on each side of the door between 34" to 48" above the finished floor that does not require tight grasping, pinching or twisting of the wrist.	1	Labor 70	\$70

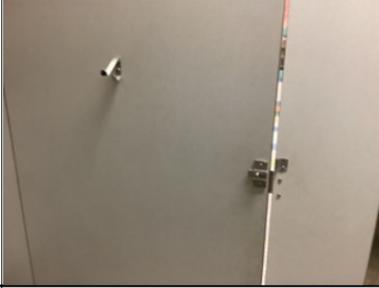
ID	Location	Floor	Room	Element	Type	Photo	Issues	Current Measure	Recommendations	Quantity	Price	Cost Estimation
48	Girls' Multi-User Toilet Room by Stairs and Media Center	2		Toilet Compartment (Children)

Door with malfunctioning self-closing hinge Door pull not provided		Repair self-closing hinge. Provide a door pull on each side of the door between 34" to 48" above the finished floor that does not require tight grasping, pinching or twisting of the wrist.	1	Labor 70	\$70
49	Girls' Multi-User Toilet Room by Reading	2		Toilet Compartment (Children)

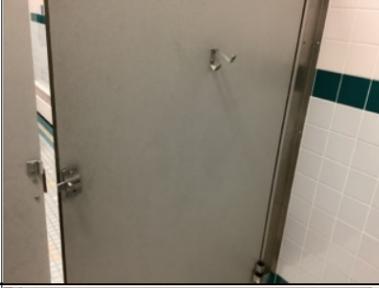
Door with malfunctioning self-closing hinge Door pull not provided		Repair self-closing hinge. Provide a door pull on each side of the door between 34" to 48" above the finished floor that does not require tight grasping, pinching or twisting of the wrist.	1	Labor 70	\$70
50	Boys' Multi-User Toilet Room by Reading	2		Toilet Compartment (Children)	Accessible Compartment

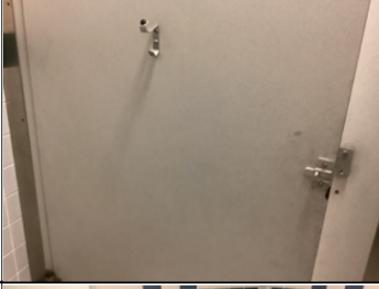
Door with malfunctioning self-closing hinge Door pull not provided		Repair self-closing hinge. Provide a door pull on each side of the door between 34" to 48" above the finished floor that does not require tight grasping, pinching or twisting of the wrist.	1	Labor 70	\$70

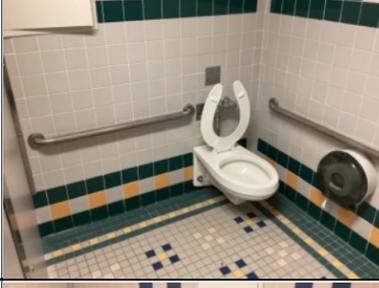
51	Boys' Multi-User Toilet Room by Gym	1		Toilet Compartment (Children)	Accessible Compartment

Non-compliant toilet paper dispenser	-	Relocate toilet paper so that it has a clearance of 1 1/2 inches (38 mm) minimum below the grab bar.	1	353	\$353
52	All Gender Single-User Toilet Room	2		Toilet Compartment (Children)	Accessible Compartment

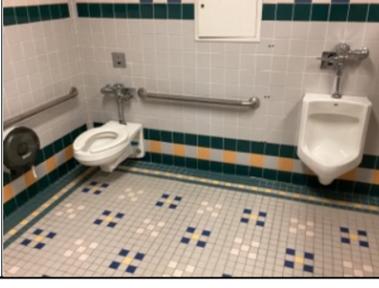
Non-compliant toilet paper dispenser		Relocate toilet paper so that it has a clearance of 1 1/2 inches (38 mm) minimum below the grab bar.	1	353	\$353

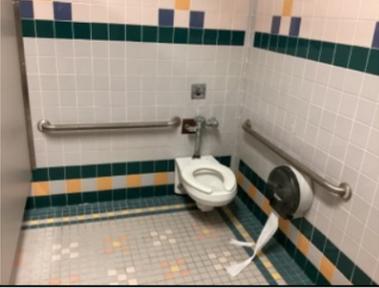
ID	Location	Floor	Room	Element	Type	Photo	Issues	Current Measure	Recommendations	Quantity	Price	Cost Estimation
53	Girls' Multi-User Toilet Room by Stairs and Media Center	2		Toilet Compartment (Children)	Accessible Compartment

Non-compliant toilet paper dispenser		Relocate toilet paper so that it has a clearance of 1 1/2 inches (38 mm) minimum below the grab bar.	1	353	\$353
54	Girls' Multi-User Toilet Room by Reading	2		Toilet Compartment (Children)	Accessible Compartment

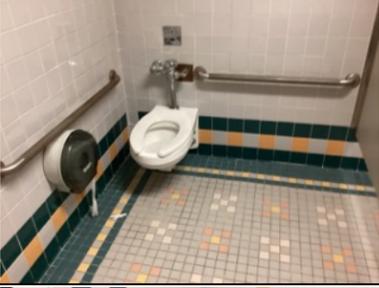
Non-compliant toilet paper dispenser	.5"	Relocate toilet paper so that it has a clearance of 1 1/2 inches (38 mm) minimum below the grab bar.	1	353	\$353
55	Boys' Multi-User Toilet Room by Reading	2		Toilet Compartment (Children)	Accessible Compartment

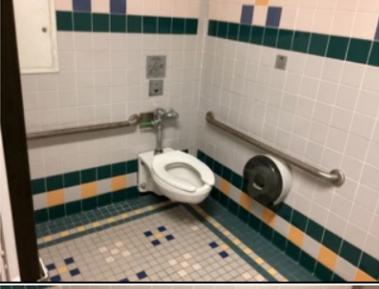
Non-compliant toilet paper dispenser	.5"	Relocate toilet paper so that it has a clearance of 1 1/2 inches (38 mm) minimum below the grab bar.	1	353	\$353

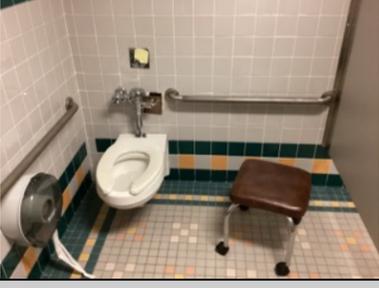
56	Girls' Multi-User Toilet Room by Gym	1		Toilet Compartment (Children)	Accessible Compartment

Non-compliant toilet paper dispenser Clearance at toilet < 60" clear width	- -	Provide a wheelchair accessible compartment that is 60" wide min. and 72" deep min. (Relocate stored items.) Relocate toilet paper so that it has a clearance of 1 1/2 inches (38 mm) minimum below the grab bar.	1	353	\$353
<b>Lavatory (Children)</b>												
57	Boys' Multi-User Toilet Room by Gym	1		Lavatory (Children)	N/A

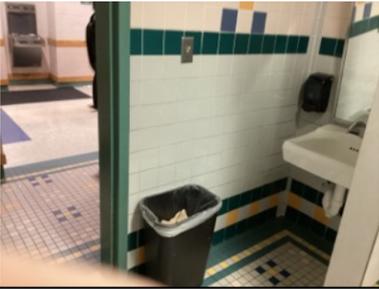
Toe or knee clearances not provided	23"	Provide at least one lavatory with 25" min. knee clearance positioned for a forward approach. Ensure toe clearance is also provided.	1	1686	\$1686

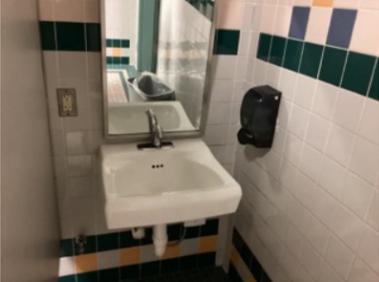
ID	Location	Floor	Room	Element	Type	Photo	Issues	Current Measure	Recommendations	Quantity	Price	Cost Estimation
58	Girls' Multi-User Toilet Room by Gym	1		Lavatory (Children)	N/A

Toe or knee clearances not provided	23"	Provide at least one lavatory with 25" min. knee clearance positioned for a forward approach. Ensure toe clearance is also provided.	1	1686	\$1686
59	All Gender Single-User Toilet Room	2		Lavatory (Children)	N/A

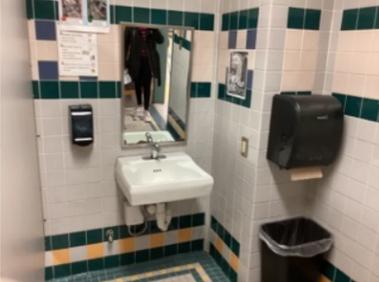
Toe or knee clearances not provided	23.6"	Provide at least one lavatory with 25" min. knee clearance positioned for a forward approach. Ensure toe clearance is also provided.	1	1686	\$1686
60	Girls' Multi-User Toilet Room by Stairs and Media Center	2		Lavatory (Children)	N/A

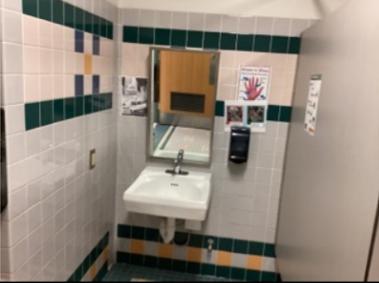
Toe or knee clearances not provided	22.5"	Provide at least one lavatory with 25" min. knee clearance positioned for a forward approach. Ensure toe clearance is also provided. Ensure toe clearance is also provided. (Relocate paper towel dispenser and trash container.)	1	1686	\$1686

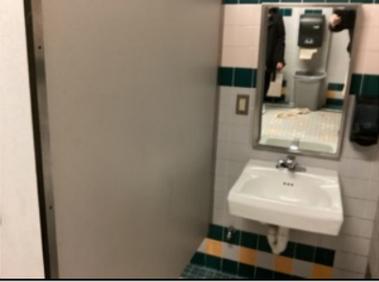
61	Girls' Multi-User Toilet Room by Reading	2		Lavatory (Children)	N/A

Toe or knee clearances not provided	22.5"	Provide at least one lavatory with 25" min. knee clearance positioned for a forward approach. Ensure toe clearance is also provided.	1	1686	\$1686
<b>Dispensers (Children)</b>												
62	Girls' Multi-User Toilet Room	3		Dispensers (Children)	Paper Towel Dispenser

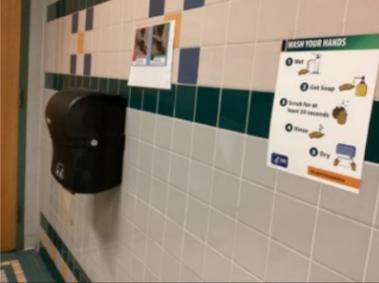
Dispenser is a protruding object		Relocate the paper towel dispenser out of the circulation path or provide a cane-detectable barrier under the dispenser.	1	306	\$306

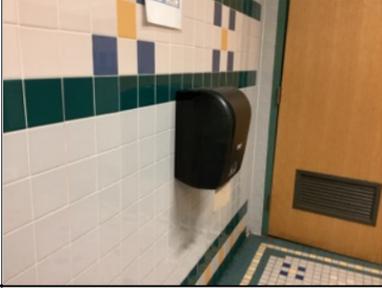
ID	Location	Floor	Room	Element	Type	Photo	Issues	Current Measure	Recommendations	Quantity	Price	Cost Estimation
63	Boys' Multi-User Toilet Room	3		Dispensers (Children)	Paper Towel Dispenser

Dispenser is a protruding object		Relocate the paper towel dispenser out of the circulation path or provide a cane-detectable barrier under the dispenser.	1	306	\$306
64	Girls' Multi-User Toilet Room by Gym	1		Dispensers (Children)	Paper Towel Dispenser

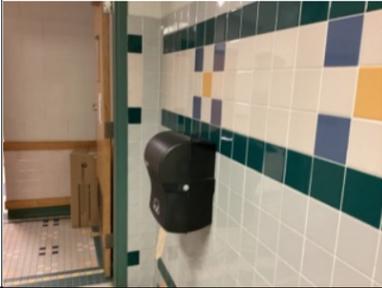
Dispenser is a protruding object	-	Relocate the paper towel dispenser out of the circulation path or provide a cane-detectable barrier under the dispenser.	1	306	\$306
65	Nurse's Office Single-User Toilet Room	1		Dispensers (Children)	Paper Towel Dispenser

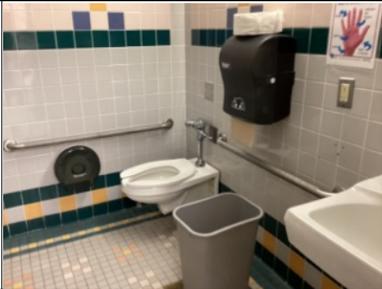
Paper towel dispenser located above grab bar.		Relocate paper towel dispenser so it is not above the grab bar.	1	353	\$353
<b>Overall Access (Children)</b>												
66	Girls' Multi-User Toilet Room by Reading	2		Overall Access (Children)	Toilet Room

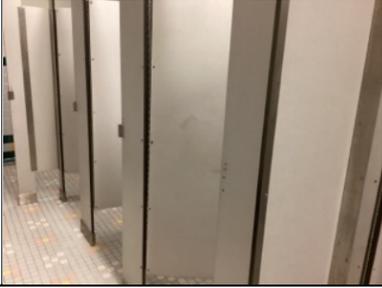
6 fixtures, no ambulatory compartment provided	-	Provide one ambulatory accessible compartment.	1	3012	\$3012
