# ADA Self-Evaluation and Transition Plan for the City of Melrose

Part 2 of 2

## Part 2: Reports:

January, 2023

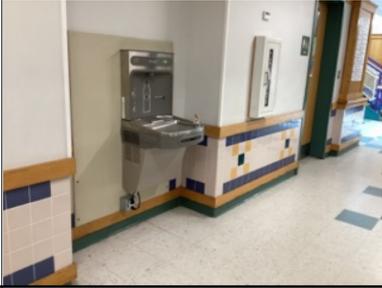
No drinking fountain provided for standing users	-	Provide an additional drinking fountain for standing users or install a Hi-Lo drinking fountain.	1	4028	\$4028

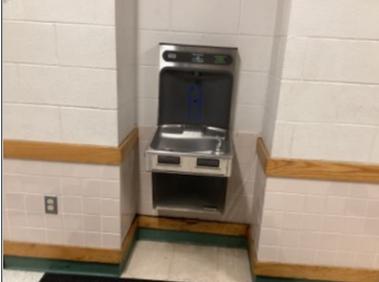
ID	Location	Floor	Room	Element	Type	Photo	Issues	Current Measure	Recommendations	Quantity	Price	Cost Estimation
68	Drinking Fountain by Gym	1		Drinking Fountains	Low

No drinking fountain provided for standing users		Provide an additional drinking fountain for standing users or install a Hi-Lo drinking fountain.	1	4028	\$4028
69	Drinking Fountain by Stairs and Toilet Rooms	2		Drinking Fountains	Low

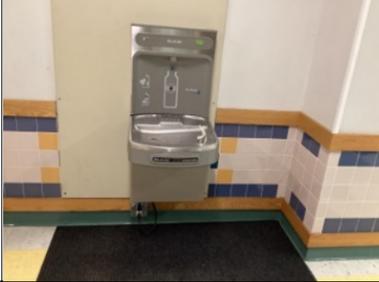
No drinking fountain provided for standing users		Provide an additional drinking fountain for standing users or install a Hi-Lo drinking fountain.	1	4028	\$4028
70	Drinking Fountain by Classroom 209	2		Drinking Fountains	Low

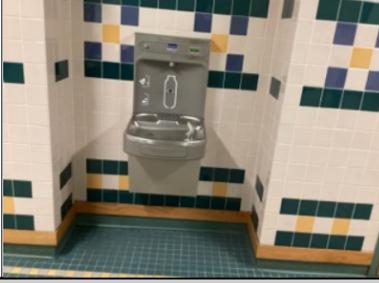
No drinking fountain provided for standing users		Provide an additional drinking fountain for standing users or install a Hi-Lo drinking fountain.	1	4028	\$4028
<b>Sink</b>												
71	Hallway Sink By Gym	1		Sink	Other

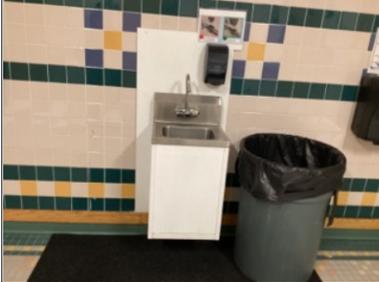
Toe and knee clearances not provided	9.4"	Ensure there is a 27" min. knee clearance positioned for a forward approach.	1	1686	\$1686

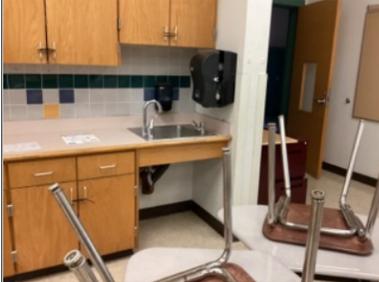
<b>Sinks for Children's Use</b>												
72	Classroom	3	307	Sinks for Children's Use	Classroom

Exposed plumbing underneath	-	Insulate or otherwise configure pipes to prevent contact, for at least one sink.	1	92	\$92

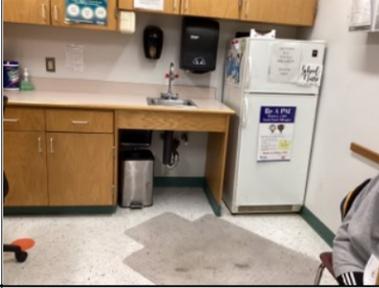
ID	Location	Floor	Room	Element	Type	Photo	Issues	Current Measure	Recommendations	Quantity	Price	Cost Estimation
73	Nurse's Office	1		Sinks for Children's Use	Other

Exposed plumbing underneath Knee/toe clearance <27" at sink > 31" high		Insulate or otherwise configure pipes to prevent contact, for at least one sink. Provide at least one sink with 27" high knee and toe clearance positioned for a forward approach (per 521 CMR 12.2.2.c). (Relocate trash can.)	1	92	\$92
74	By Toilet Rooms	3	307	Sinks for Children's Use	N/A

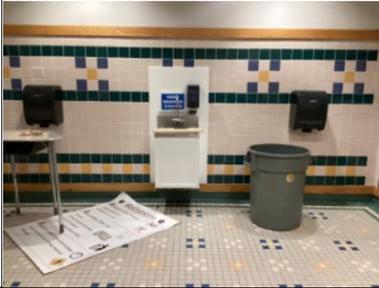
Knee/toe clearance <24" at sink 31" high	12"	Provide at least one sink with 27" high knee and toe clearance positioned for a forward approach (per 521 CMR 12.2.2.c).	1	1686	\$1686
<b>Play and Sport Areas</b>												
<b>Play Areas</b>												
75	Northwest Playground by Cottage Street	Ext.		Play Areas	N/A

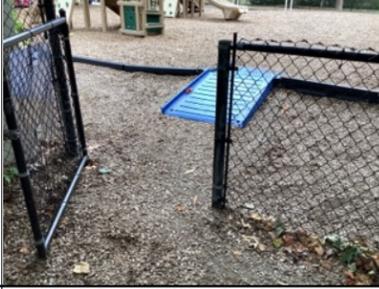
Accessible route not provided to playground	-	Install an accessible route to the playground.	1	-	\$0

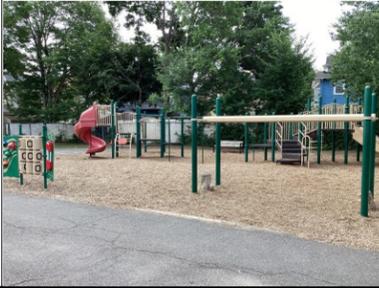
76	South Playground by School	Ext.		Play Areas	N/A

Accessible route not provided to playground Accessible route not provided to play components		Install an accessible route to the playground. Provide a compliant impact-attenuating surface to and around the play components.	1	-	\$0
77	Northwest Playground by Cottage Street	Ext.		Play Areas	N/A

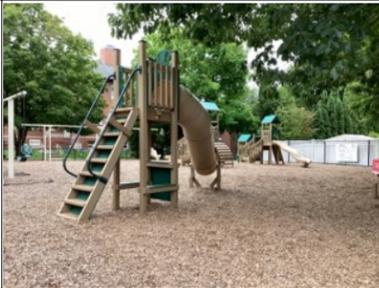
Accessible route not provided around playground Accessible route not provided to play components		Provide an accessible route around the play area. Provide a compliant impact-attenuating surface to and around the play components.	1	-	\$0

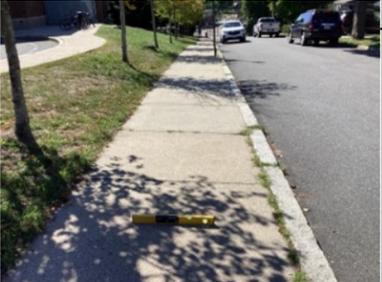
ID	Location	Floor	Room	Element	Type	Photo	Issues	Current Measure	Recommendations	Quantity	Price	Cost Estimation
<b>Approach and Entrance</b>												
<b>Exterior Access Route</b>												
1	Footbalk Parking To Football Main Entrance	Ext.		Exterior Access Route	Sidewalk

Cross slope > 1:50 (2.00%)	4.6%	Reduce cross slope to be no steeper than 1:50 (2.00%).	1	-	\$0
2	By North Football Parking	Ext.		Exterior Access Route	Sidewalk

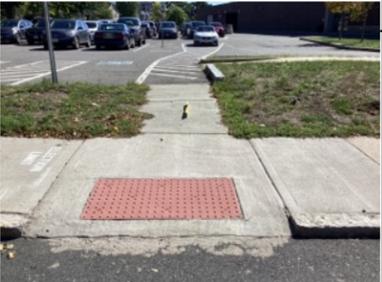
Cross slope > 1:50 (2.00%)	3.8%	Reduce cross slope to be no steeper than 1:50 (2.00%).	1	-	\$0
3	Union Street Sidewalk to Football Main Entrance	Ext.		Exterior Access Route	21

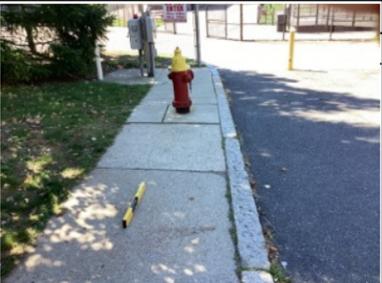
Cross slope > 1:50 (2.00%) Running slope > 1:20 (5.00%)	6.0% 10.0%	Reduce cross slope to be no steeper than 1:50 (2.00%). Reduce running slope to be no steeper than 1:20 (5.00%).	1	-	\$0
4	Middle School to Ramp and Main Entrance	Ext.		Exterior Access Route	Sidewalk

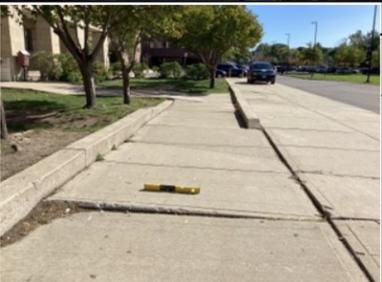
Cross slope > 1:50 (2.00%) Level changes > 1/4" Route not maintained in operable working condition	4.5% 2" -	Reduce cross slope to be no steeper than 1:50 (2.00%). Alter change in level to be 1/4" high max. Ensure the accessible route is maintained in operable working condition.	1	-	\$0

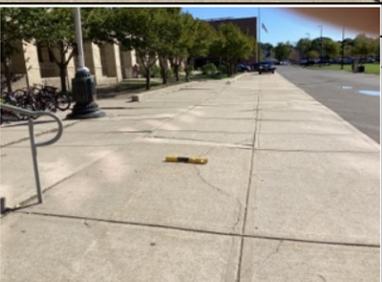
5	Middle School to Ramp and Main Entrance	Ext.		Exterior Access Route	Sidewalk

Cross slope > 1:50 (2.00%) Route not maintained in operable working condition	6.3% -	Reduce cross slope to be no steeper than 1:50 (2.00%). Ensure the accessible route is maintained in operable working condition.	1	-	\$0

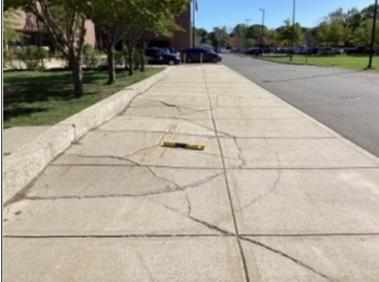
ID	Location	Floor	Room	Element	Type	Photo	Issues	Current Measure	Recommendations	Quantity	Price	Cost Estimation
6	Middle School to Ramp and Main Entrance	Ext.		Exterior Access Route	Sidewalk

Cross slope > 1:50 (2.00%) Route not maintained in operable working condition	10.8% -	Reduce cross slope to be no steeper than 1:50 (2.00%). Ensure the accessible route is maintained in operable working condition.	1	-	\$0
7	Middle School Chess Table	Ext.		Exterior Access Route	Exterior

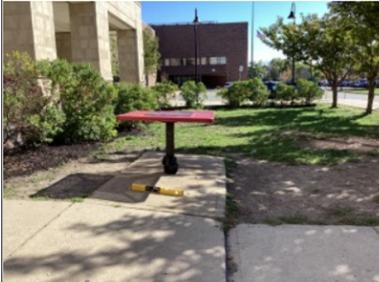
Cross slope > 1:50 (2.00%) Accessible route not provided	9.3% -	Reduce cross slope to be no steeper than 1:50 (2.00%). Ensure an accessible route is provided.	1	-	\$0
8	Football Secondary Entrance off Tremont Street	Ext.		Exterior Access Route	Exterior

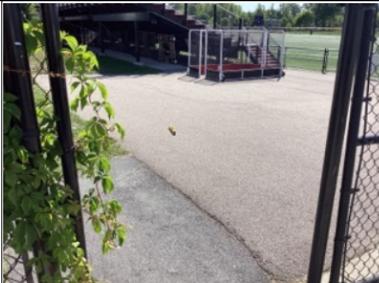
Running slope > 1:20 (5.00%)	7%	Reduce running slope to be no steeper than 1:20 (5.00%).	1	-	\$0
9	Football and Baseball Entry Off Tremont Street	Ext.		Exterior Access Route	Sidewalk

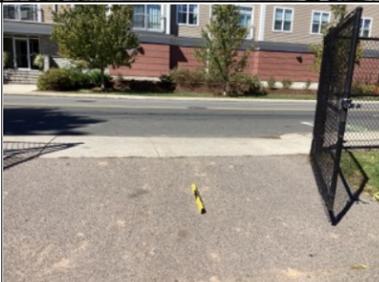
Running slope > 1:20 (5.00%)	13.2%	Reduce running slope to be no steeper than 1:20 (5.00%).	1	-	\$0

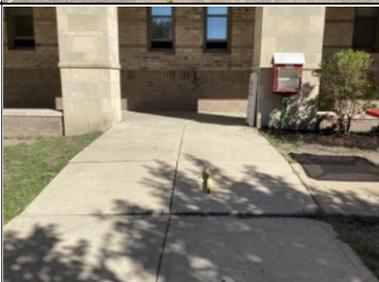
10	Middle School to Ramp and Main Entrance	Ext.		Exterior Access Route	Sidewalk

Running slope > 1:20 (5.00%) Level changes > 1/4"	13% 2"	Reduce running slope to be no steeper than 1:20 (5.00%). Alter change in level to be 1/4" high max.	1	-	\$0

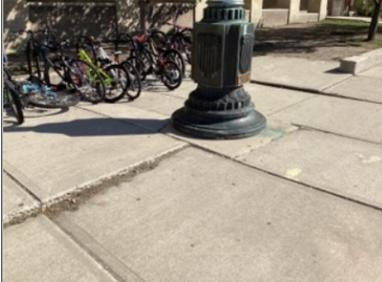
ID	Location	Floor	Room	Element	Type	Photo	Issues	Current Measure	Recommendations	Quantity	Price	Cost Estimation
11	By Middle School Main Entrance	Ext.		Exterior Access Route	Sidewalk

Level changes > 1/4"	2"	Alter change in level to be 1/4" high max.	1	-	\$0
12	Walkway at Tremont Street by End Zone	Ext.		Exterior Access Route	Sidewalk

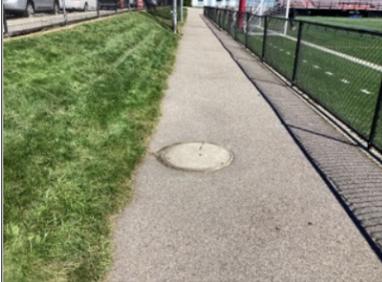
Level changes > 1/4"	1"	Alter change in level to be 1/4" high max.	1	-	\$0
13	Football Entry at Treemont and Lynn Fells Parkway	Ext.		Exterior Access Route	Exterior

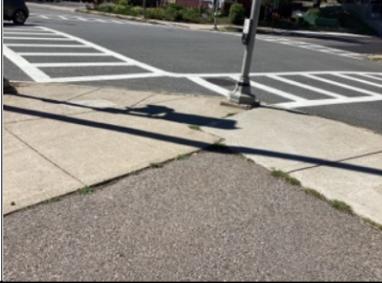
Level changes > 1/4"	1"	Alter change in level to be 1/4" high max.	1	-	\$0
14	Walkway Between Middle and High School	Ext.		Exterior Access Route	Sidewalk

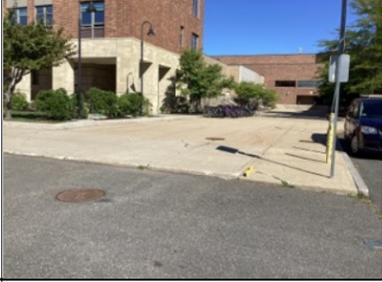
Route not maintained in operable working condition	-	Ensure the accessible route is maintained in operable working condition.	1	-	\$0
15	Football Entry at Treemont and Lynn Fells Parkway	Ext.		Exterior Access Route	Walkway

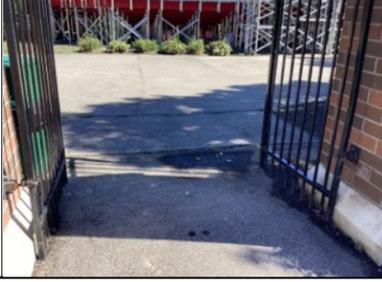
Route not maintained in operable working condition	-	Ensure the accessible route is maintained in operable working condition.	1	-	\$0

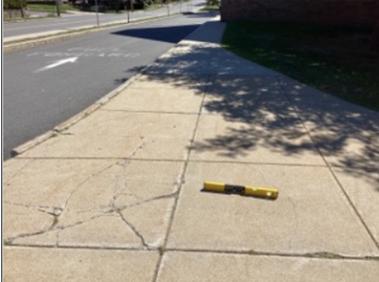
ID	Location	Floor	Room	Element	Type	Photo	Issues	Current Measure	Recommendations	Quantity	Price	Cost Estimation
16	Middle School to Drop off Near Door 14	Ext.		Exterior Access Route	Sidewalk

Route not maintained in operable working condition	-	Ensure the accessible route is maintained in operable working condition.	1	-	\$0
17	Front of High School	Ext.		Exterior Access Route	Sidewalk

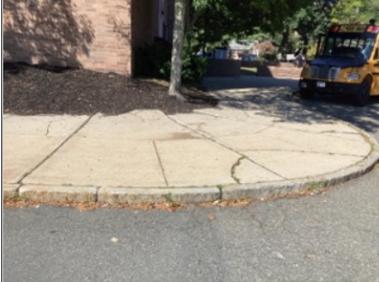
Route not maintained in operable working condition	-	Ensure the accessible route is maintained in operable working condition.	1	-	\$0
18	By Door 15	Ext.		Exterior Access Route	Exterior

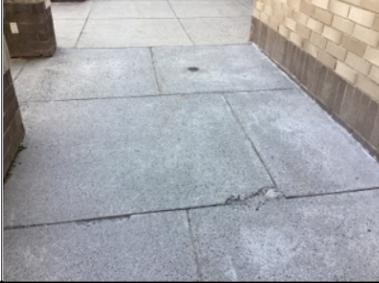
Route not maintained in operable working condition	-	Ensure the accessible route is maintained in operable working condition.	1	-	\$0
19	Front of High School	Ext.		Exterior Access Route	Exterior

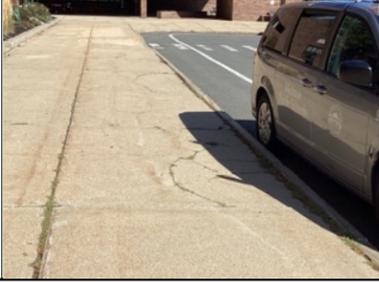
Route not maintained in operable working condition	-	Ensure the accessible route is maintained in operable working condition.	1	-	\$0

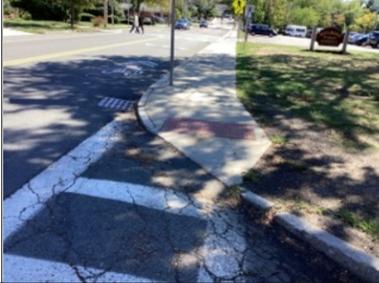
<b>Curb Ramp</b>												
20	By Melrose Street Parking	Ext.		Curb Ramp	N/A

Transition from curb ramp to street not flush	-	Ensure transition from curb ramp to street is flush or free of changes in level.	1	-	\$0

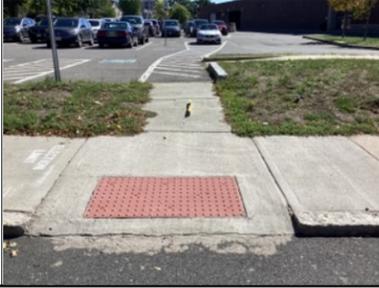
ID	Location	Floor	Room	Element	Type	Photo	Issues	Current Measure	Recommendations	Quantity	Price	Cost Estimation
21	By North Football Parking at Marcoux Memorial Gymnasium	Ext.		Curb Ramp	N/A

Landing not provided at top of curb ramp	7%	Provide landing at top of curb ramp or reconfigure ramp.	1	-	\$0
<b>Off-Street Parking Lot or Garage</b>												
22	Parking by Melrose Street	Ext.		Off-Street Parking Lot or Garage	Visitor

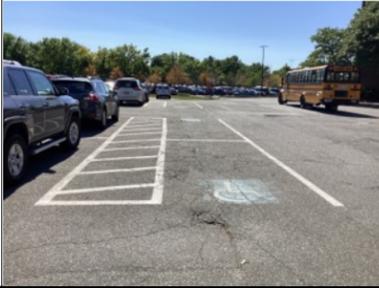
Total # of parking Total # of designated accessible parking spaces Total # of designated van accessible spaces Access aisle < 60" wide at car/van space Sign not provided	112 4 0 56" -	Provide 1 van accessible parking space 96" wide min. with a marked access aisle 96" wide min. with an identification sign with the International Symbol of Accessibility (ISA) and the designation "Van Accessible". Provide access aisles at the 4 car accessible parking spaces 60" wide min. Provide identification signs with the International Symbol of Accessibility (ISA) at the 4 car accessible parking spaces.	1	-	\$0

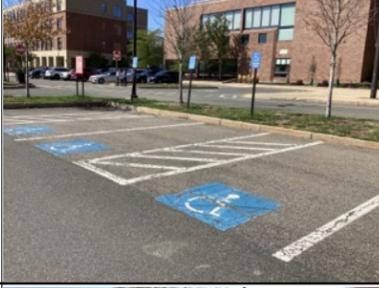
23	Parking at Front of High School	Ext.		Off-Street Parking Lot or Garage	Visitor

Total # of parking Total # of designated accessible parking spaces Total # of designated van accessible spaces Access aisle < 96" wide at van space Sign bottom < 60" above finished grade	72 1 3 59" 54"	Provide a marked access aisle that is at least 96" wide. Locate sign with the bottom of the sign 60" above the ground.	1	-	\$0
24	Middle School Parking Southwest Side	Ext.		Off-Street Parking Lot or Garage	N/A

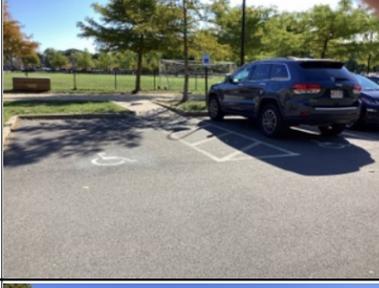
Sign not provided Sign does not have the designation "Van Accessible"	- -	Provide an identification sign with the International Symbol of Accessibility (ISA) and the designation "Van Accessible" at the van accessible space.	1	-	\$0
25	Parking North of the Middle School by the Gymnasium Entrance	Ext.		Off-Street Parking Lot or Garage	N/A

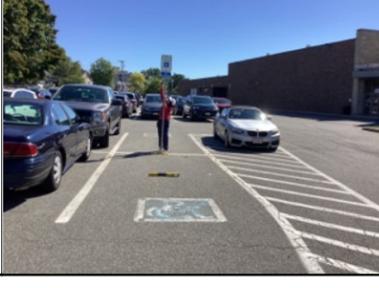
Sign top > 96" above finished grade	110"	Locate sign with the top of the sign 96" above the ground.	1	Labor	\$0

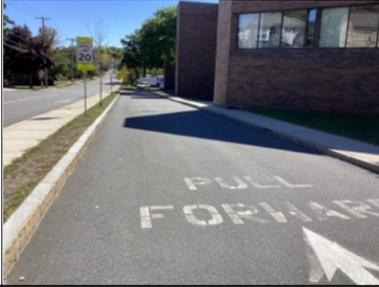
ID	Location	Floor	Room	Element	Type	Photo	Issues	Current Measure	Recommendations	Quantity	Price	Cost Estimation
<b>Passenger Loading Zones</b>												
26	Middle School Drop Off at Melrose Street	Ext.		Passenger Loading Zones	N/A

Access aisle not provided Sign with ISA not provided (MAAB)	- -	Provide a marked access aisle that is at least 60" wide and that extends the full length of the vehicle pull-up space. Provide a sign that includes the International Symbol of Accessibility (ISA) at the head of the space. Locate the sign so that the bottom is 60" min. above the ground and the top is 96" max. above the ground.	1	-	\$0
<b>Exterior Stair</b>												
27	Stairs Near Middle School Drop Off and Parking Between Middle and High School	Ext.		Exterior Stair	N/A

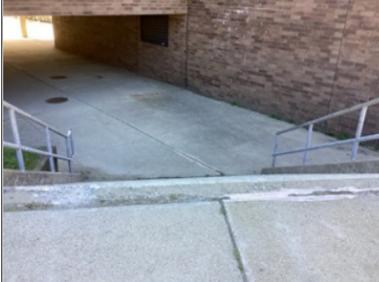
Not maintained in operable working condition	-	Ensure stairs are maintained in operable working condition.	1	-	\$0
<b>Entrance</b>

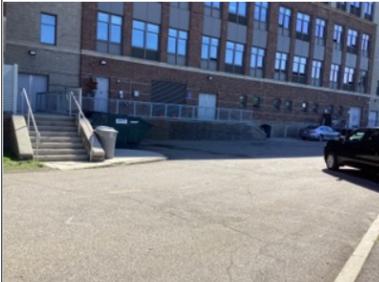
28	West Side of Middle School by Football	Ext.		Entrance	130

Entrance not on an accessible route	-	Provide a directional sign indicating the location of the nearest accessible entrance.	1	-	\$0
29	Near Door 22	Ext.		Entrance	N/A

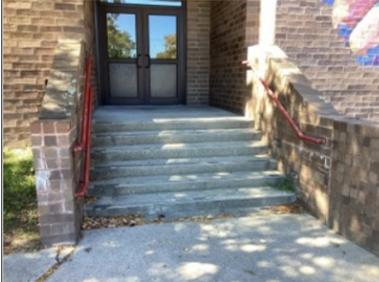
Entrance not on an accessible route	-	Provide a directional sign indicating the location of the nearest accessible entrance.	1	-	\$0
30	Doors 8, 9 and 12 by Football	Ext.		Entrance	Other

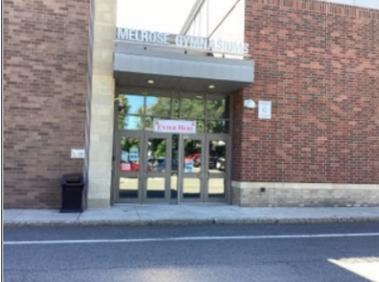
International Symbol of Accessibility not provided	-	Provide a sign with the International Symbol of Accessibility (ISA).	1	-	\$0

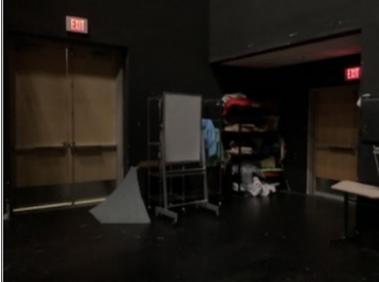
ID	Location	Floor	Room	Element	Type	Photo	Issues	Current Measure	Recommendations	Quantity	Price	Cost Estimation
<b>Access to Goods and Services</b>												
<b>Means of Egress</b>												
31	Auditorium	1		Means of Egress	N/A

Tactile exit sign not provided	-	Ensure tactile exit signs with raised characters and braille are provided at exit doors. Mount signs between 48"- 60" above the finished floor located on the latch side of the door.	1	232	\$232
32	Auditorium	1		Means of Egress	N/A

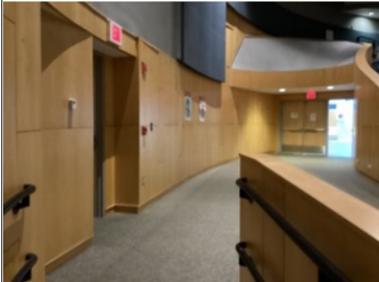
Tactile exit sign not provided	-	Ensure tactile exit signs with raised characters and braille are provided at exit doors. Mount signs between 48"- 60" above the finished floor located on the latch side of the door.	1	232	\$232
33	Auditorium	1		Means of Egress	N/A

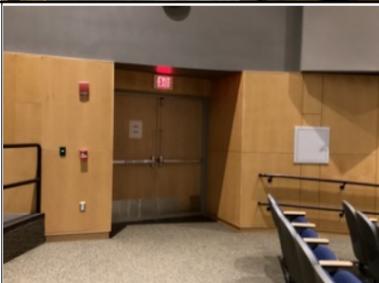
Tactile exit sign not provided	-	Ensure tactile exit signs with raised characters and braille are provided at exit doors. Mount signs between 48"- 60" above the finished floor located on the latch side of the door.	1	232	\$232

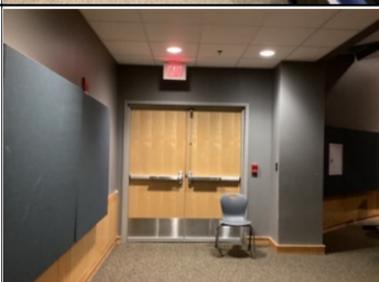
34	Auditorium Near Lighting Booth	2		Means of Egress	N/A

Tactile exit sign not provided	-	Ensure tactile exit signs with raised characters and braille are provided at exit doors. Mount signs between 48"- 60" above the finished floor located on the latch side of the door.	1	232	\$232
35	Auditorium	1		Means of Egress	N/A

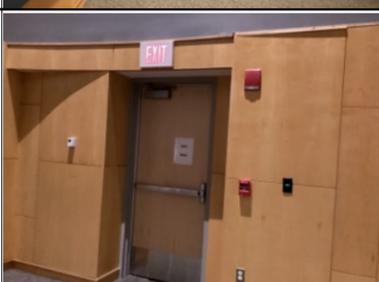
Tactile exit sign not provided	-	Ensure tactile exit signs with raised characters and braille are provided at exit doors. Mount signs between 48"- 60" above the finished floor located on the latch side of the door.	1	232	\$232

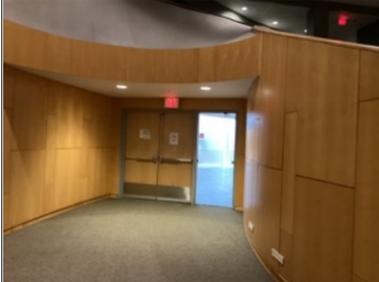
ID	Location	Floor	Room	Element	Type	Photo	Issues	Current Measure	Recommendations	Quantity	Price	Cost Estimation
36	Auditorium	1		Means of Egress	N/A

Tactile exit sign not provided	-	Ensure tactile exit signs with raised characters and braille are provided at exit doors. Mount signs between 48"- 60" above the finished floor located on the latch side of the door.	1	232	\$232
37	Cafeteria	1		Means of Egress	N/A

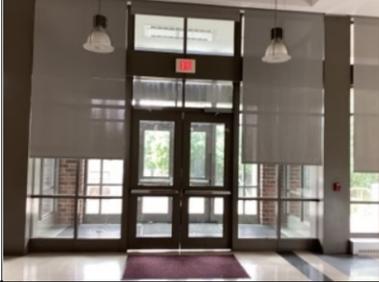
Tactile exit sign not provided Illuminated ISA symbol not provided (MAAB)	- -	Ensure tactile exit signs with raised characters and braille are provided at exit doors. Mount signs between 48"- 60" above the finished floor located on the latch side of the door. When the illuminated exit sign is repaired or replaced, provide an illuminated sign with the International Symbol of Accessibility (ISA).	1	232	\$232
38	Chorus	1		Means of Egress	N/A

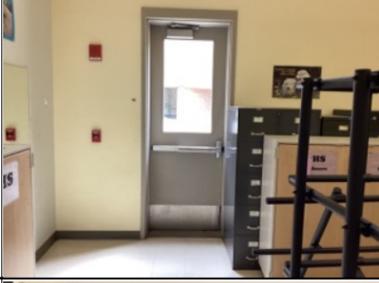
Tactile exit sign not provided Illuminated ISA symbol not provided (MAAB)	- -	Ensure tactile exit signs with raised characters and braille are provided at exit doors. Mount signs between 48"- 60" above the finished floor located on the latch side of the door. When the illuminated exit sign is repaired or replaced, provide an illuminated sign with the International Symbol of Accessibility (ISA).	1	232	\$232

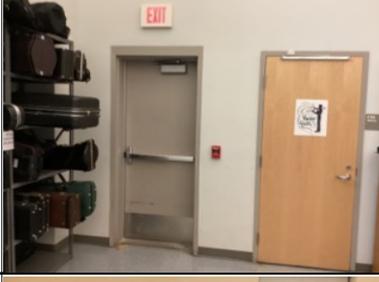
39	Orchestra and Band Door 15	1		Means of Egress	N/A

Tactile exit sign not provided Illuminated ISA symbol not provided (MAAB)	- -	Ensure tactile exit signs with raised characters and braille are provided at exit doors. Mount signs between 48"- 60" above the finished floor located on the latch side of the door. When the illuminated exit sign is repaired or replaced, provide an illuminated sign with the International Symbol of Accessibility (ISA).	1	232	\$232
40	Art Door 16	1		Means of Egress	N/A

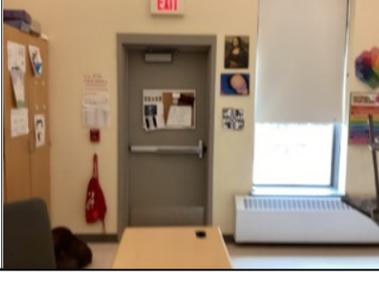
Tactile exit sign not provided Illuminated ISA symbol not provided (MAAB)	- -	Ensure tactile exit signs with raised characters and braille are provided at exit doors. Mount signs between 48"- 60" above the finished floor located on the latch side of the door. When the illuminated exit sign is repaired or replaced provide an illuminated sign with the International Symbol of Accessibility (ISA).	1	232	\$232

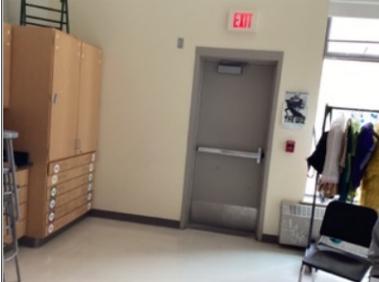
ID	Location	Floor	Room	Element	Type	Photo	Issues	Current Measure	Recommendations	Quantity	Price	Cost Estimation
41	Drama Door 17	1		Means of Egress	N/A

Tactile exit sign not provided Illuminated ISA symbol not provided (MAAB)	- -	Ensure tactile exit signs with raised characters and braille are provided at exit doors. Mount signs between 48"- 60" above the finished floor located on the latch side of the door. When the illuminated exit sign is repaired or replaced provide an illuminated sign with the International Symbol of Accessibility (ISA).	1	232	\$232
42	Door 18	1		Means of Egress	N/A

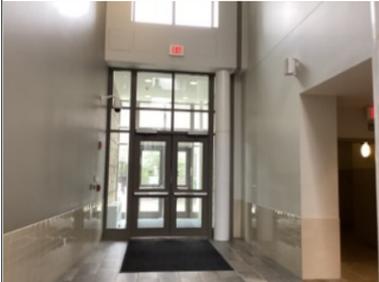
Tactile exit sign not provided Illuminated ISA symbol not provided (MAAB)	- -	Ensure tactile exit signs with raised characters and braille are provided at exit doors. Mount signs between 48"- 60" above the finished floor located on the latch side of the door. When the illuminated exit sign is repaired or replaced provide an illuminated sign with the International Symbol of Accessibility (ISA).	1	232	\$232

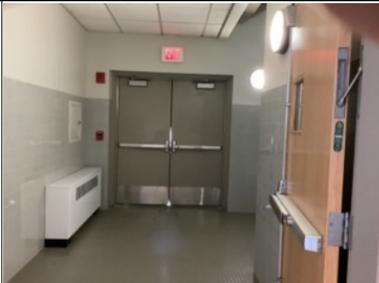
43	Door 19	1		Means of Egress	N/A

Tactile exit sign not provided Illuminated ISA symbol not provided (MAAB)	- -	Ensure tactile exit signs with raised characters and braille are provided at exit doors. Mount signs between 48"- 60" above the finished floor located on the latch side of the door. When the illuminated exit sign is repaired or replaced provide an illuminated sign with the International Symbol of Accessibility (ISA).	1	232	\$232
44	Door 9 to Football	1		Means of Egress	N/A

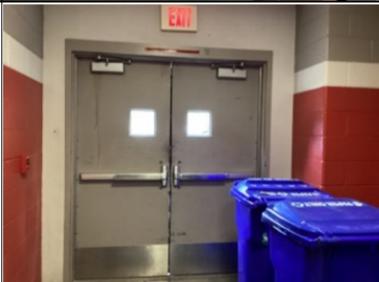
Tactile exit sign not provided Illuminated ISA symbol not provided (MAAB)	- -	Ensure tactile exit signs with raised characters and braille are provided at exit doors. Mount signs between 48"- 60" above the finished floor located on the latch side of the door. When the illuminated exit sign is repaired or replaced provide an illuminated sign with the International Symbol of Accessibility (ISA).	1	232	\$232

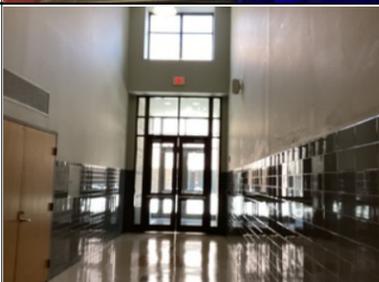
45	Door 13	1		Means of Egress	N/A

Tactile exit sign not provided Illuminated ISA symbol not provided (MAAB)	- -	Ensure tactile exit signs with raised characters and braille are provided at exit doors. Mount signs between 48"- 60" above the finished floor located on the latch side of the door. When the illuminated exit sign is repaired or replaced provide an illuminated sign with the International Symbol of Accessibility (ISA).	1	232	\$232

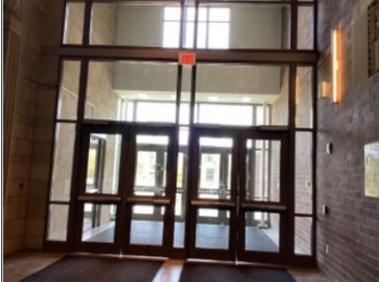
ID	Location	Floor	Room	Element	Type	Photo	Issues	Current Measure	Recommendations	Quantity	Price	Cost Estimation
46	Door 1 Main Entrance	1		Means of Egress	N/A

Tactile exit sign not provided Illuminated ISA symbol not provided (MAAB)	- -	Ensure tactile exit signs with raised characters and braille are provided at exit doors. Mount signs between 48"- 60" above the finished floor located on the latch side of the door. When the illuminated exit sign is repaired or replaced provide an illuminated sign with the International Symbol of Accessibility (ISA).	1	232	\$232
47	Door 6	1		Means of Egress	N/A

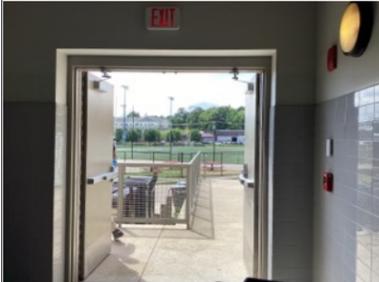
Tactile exit sign not provided Directional sign to accessible emergency exit not provided	- -	Ensure tactile exit signs with raised characters and braille are provided at exit doors. Mount signs between 48"- 60" above the finished floor located on the latch side of the door. Provide a directional sign indicating the location of the nearest accessible emergency exit.	2	232	\$464

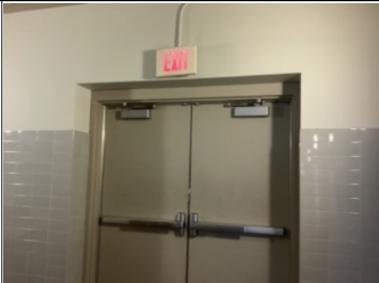
48	Stair 32	1		Means of Egress	N/A

Tactile exit sign not provided Directional sign to accessible emergency exit not provided	- -	Ensure tactile exit signs with raised characters and braille are provided at exit doors. Mount signs between 48"- 60" above the finished floor located on the latch side of the door. Provide a directional sign indicating the location of the nearest accessible emergency exit.	2	232	\$464
<b>Interior Access Route</b>												
49	Cafeteria	1		Interior Access Route	N/A

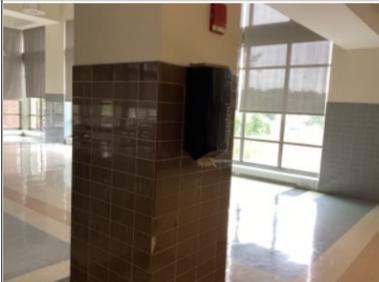
Obstructed by protruding objects	7"	Relocate napkin dispenser out of the accessible route or provide a cane-detectable barrier 27" max. above the finished floor.	1	306	\$306
50	Chorus	1		Interior Access Route	N/A

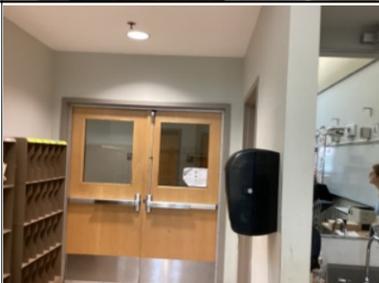
Obstructed by protruding objects	12"	Relocate paper towel dispenser out of the accessible route or provide a cane-detectable barrier 27" max. above the finished floor.	1	306	\$306

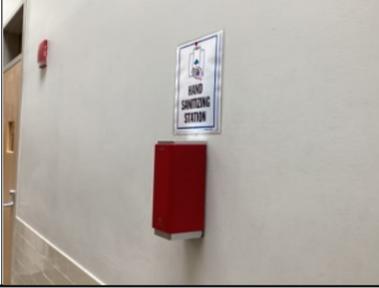
ID	Location	Floor	Room	Element	Type	Photo	Issues	Current Measure	Recommendations	Quantity	Price	Cost Estimation
51	Outside Auditorium	1		Interior Access Route	N/A

Obstructed by protruding objects	5"	Relocate sanitizer out of the accessible route or provide a cane-detectable barrier 27" max. above the finished floor positioned below the dispenser. (This recommendation applies to all similarly situation hand sanitizer dispensers that protrude more than 4" in to the accessible route.)	1	306	\$306
<b>Doors, Doorways, &amp; Gates</b>												
52	Life Skills	1	A121	Doors, Doorways, & Gates	Classroom

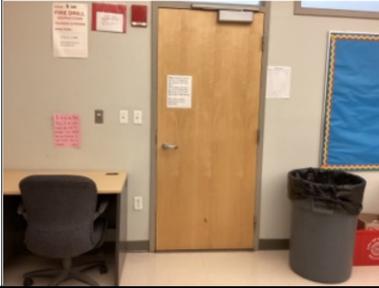
Maneuvering clearance(s) not provided	10"	Relocate the desk to provide 18" min. pull-side maneuvering clearance at the door.	1	Labor	\$0
53	SPED	1	111	Doors, Doorways, & Gates	Classroom

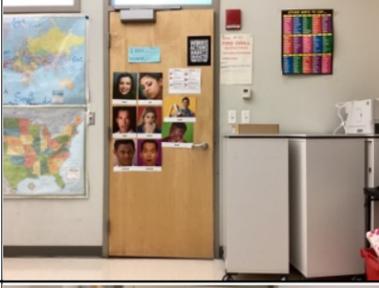
Maneuvering clearance(s) not provided	-	Relocate the cabinet to provide 18" min. pull-side maneuvering clearance at the door.	1	Labor	\$0

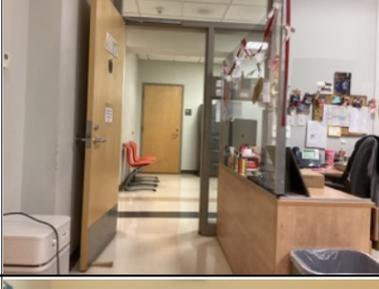
54	Nurse's Office	1		Doors, Doorways, & Gates	Office

Maneuvering clearance(s) not provided	4"	Relocate the desk to provide 18" min. pull-side maneuvering clearance at the door.	1	Labor	\$0
55	Chorus	1		Doors, Doorways, & Gates	Classroom

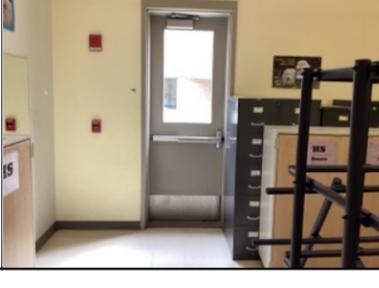
Maneuvering clearance(s) not provided	-	Relocate the cabinet to provide 12" min. push-side maneuvering clearance at the door.	1	Labor	\$0

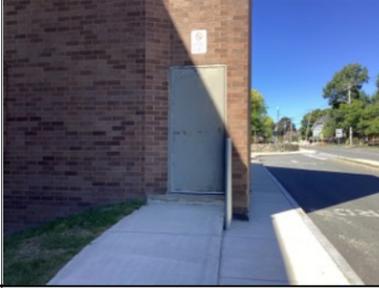
ID	Location	Floor	Room	Element	Type	Photo	Issues	Current Measure	Recommendations	Quantity	Price	Cost Estimation
56	Door 15	Ext.		Doors, Doorways, & Gates	Emergency Egress

Threshold > 1/2" high	-	Alter the threshold to be 1/2" high max.	1	-	\$0
57	Door 17	Ext.		Doors, Doorways, & Gates	Emergency Egress

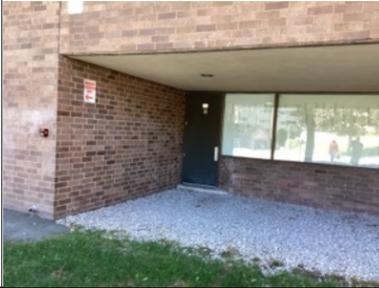
Threshold > 1/2" high	-	Alter the threshold to be 1/2" high max.	1	-	\$0
58	Nurse's Office Toilet Room	1		Doors, Doorways, & Gates	Other

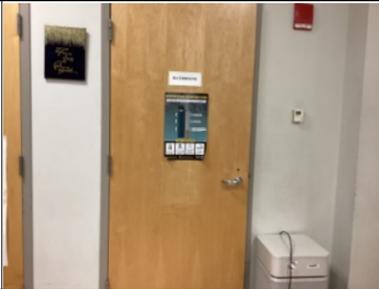
Door requires > 5 lbs. of force to open Maneuvering clearance(s) not provided	- 17 lbs	Remove the purifier to provide 18" min. pull-side maneuvering clearance at the door. Adjust closers so doors do not require more than 5 pounds of force to open.	1	Labor	\$0
<b>Ramps</b>												
59	Top of Ramp to Main High School Entrance	Ext.		Ramps	N/A

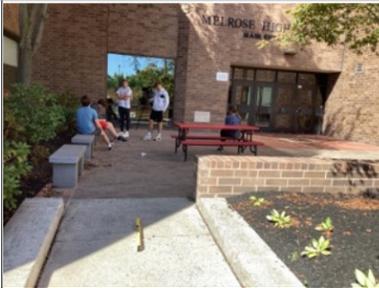
Handrails not provided at both sides if rise is > 6"	7.0%	Provide handrails on both sides. (The running slope of the accessible route in this area exceeds 5.0% (1:20) and therefore becomes a ramp.)	1	-	\$0

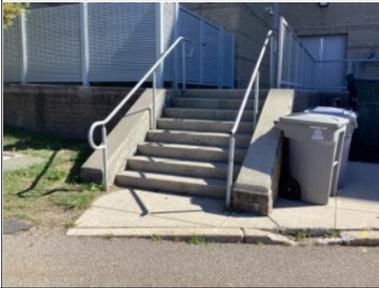
<b>Stairways</b>												
60	Stair at Door 7	Ext.		Stairways	Other

Handrails do not extend 12" from stairs	-	Top: Ensure handrails extend horizontally above the landing for 12" min. beginning above the first riser nosing. Bottom: Ensure handrails extend to one tread depth beyond the last riser.	1	-	\$0

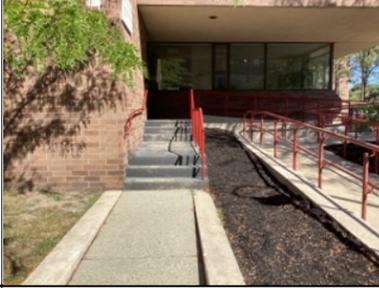
ID	Location	Floor	Room	Element	Type	Photo	Issues	Current Measure	Recommendations	Quantity	Price	Cost Estimation
61	Door 2	Ext.		Stairways	Egress

Handrails do not extend 12" from stairs	-	Top: Ensure handrails extend horizontally above the landing for 12" min. beginning above the first riser nosing. Bottom: Ensure handrails extend to one tread depth beyond the last riser.	1	-	\$0
62	By Middle School Main Entrance	Ext.		Stairways	Egress

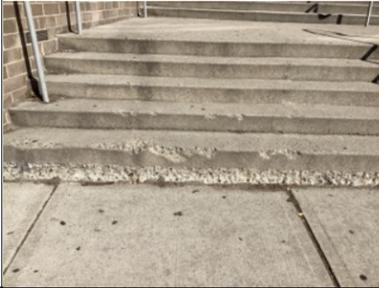
Not maintained in operable working condition	-	Ensure stairs are maintained in operable working condition.	1	-	\$0
<b>Elevator</b>												
63	Elevator 1	1		Elevator	Interior

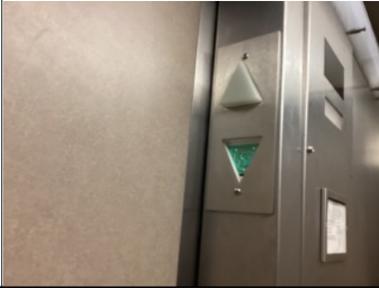
Elevator visual down arrow not in operable working condition		Repair or replace broken elevator direction of travel indicator.	1	Labor	\$0
<b>Signage</b>												
64	Satir 2	1		Signage	Designation

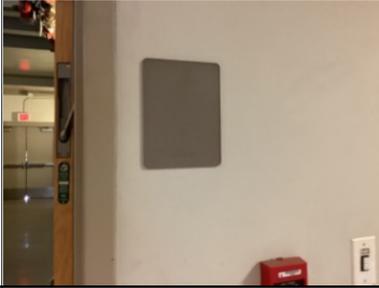
Raised characters not provided on sign Braille not provided on sign	- -	Provide text with raised characters duplicated in braille on sign.  Note: Sign is faded and needs to be replaced.	1	232	\$232

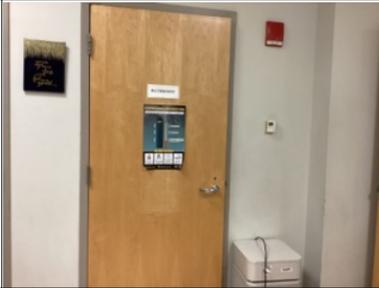
65	Nurse's Office Toilet Room	1		Signage	Designation

Raised characters not provided on sign Braille not provided on sign Visual characters < 40" above ground Sign not located on the latch side of the door	- - 63" -	Provide text with raised characters duplicated in braille on sign. Mount the sign so that the baseline of the lowest visual character is 40" min. above the finished floor or ground. Locate the sign at permanent rooms alongside the door on the latch side.	1	232	\$232

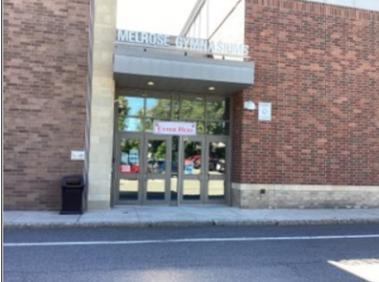
ID	Location	Floor	Room	Element	Type	Photo	Issues	Current Measure	Recommendations	Quantity	Price	Cost Estimation
66	Gymnasium Entrance by Parking on the North Side of the School	Ext.		Signage	Exterior

Raised characters not provided on sign Braille not provided on sign Sign not located on the latch side of the door	- - -	Provide text with raised characters duplicated in braille on sign with the braille reading, "Melrose Gymnasiums" like the large sign above the doors. For double-leaf doors with one active leaf, locate sign on the inactive leaf. If each door has an active leaf, locate sign to the right of the right hand door.	1	326	\$326
67	Main Office	1		Signage	Designation

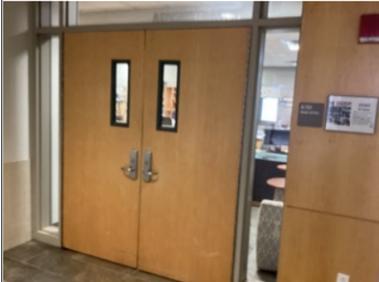
Sign not located on the latch side of the door	-	Relocate the sign to the glass area closer to the door.	1	Labor	\$0
68	Boys' Toilet Room by Locker Room	1		Signage	Designation

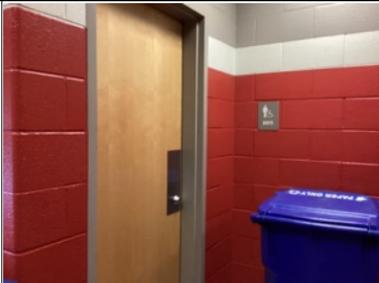
Sign not located on the latch side of the door	-	Locate the sign at permanent rooms alongside the door on the latch side.	1	Labor	\$0

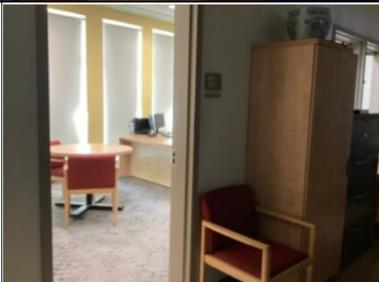
69	Principal's Office	4		Signage	Designation

Signage lacks 18" by 18" clear floor space	-	Relocate chair to provide a clear floor space of 18" min. by 18" min. at the sign.	1	Labor	\$0
<b>Operable Parts</b>												
70	Clothing Drop Off	Ext.		Operable Parts	Other

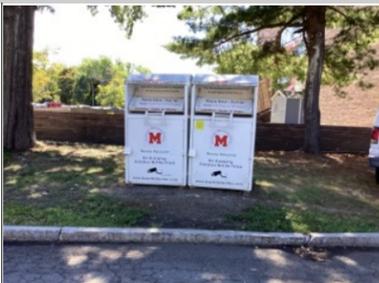
Element not on an accessible route	-	Ensure clothing drop off bins are located on an accessible route.	1	-	\$0

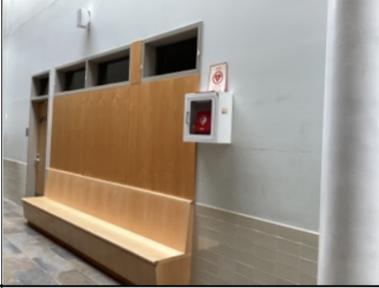
ID	Location	Floor	Room	Element	Type	Photo	Issues	Current Measure	Recommendations	Quantity	Price	Cost Estimation
71	Outside Auditorium	1		Operable Parts	Other

Side reach > 54"	-	Relocate defibrillator so that controls are between 15" - 48" above the finished floor. Ensure that if the defibrillator is relocate, it does not protrude into the accessible route.	1	256	\$256
72	SPED	1	A115	Operable Parts	Clothes Rod/Hooks

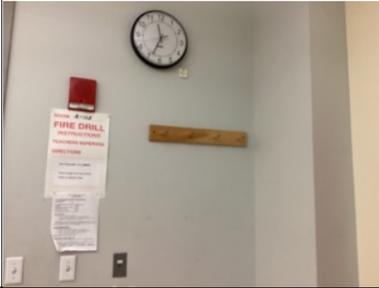
Side reach > 54"	70"	Provide at least one coat hook that is between 15" - 48" above the finished floor.	1	256	\$256
<b>Dining or Work Surfaces</b>												
73	Cafeteria	1		Dining or Work Surfaces	Dining Surface

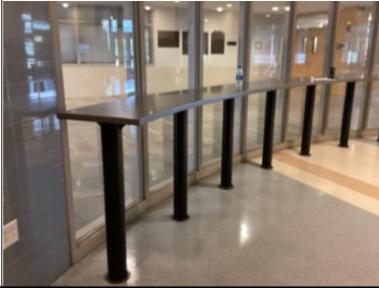
At least one or 5% accessible tables not provided Top of dining/work surface < 28" or > 34"	- 40"	Ensure that at least one dining or work surface is accessible. Provide at least one dining or work surface with tops between 28"- 34" above the floor and 27" clear height underneath.	1	1100	\$1100

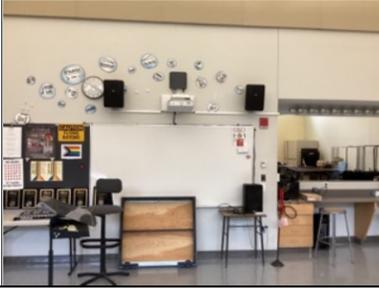
<b>Assembly Area</b>												
74	Orchestra and Band	1		Assembly Area	Assembly Area

Assistive listening devices not provided	-	If audible communication is integral to the use of the space, provide an assistive listening system.	1	1214	\$1214
<b>Locker Room</b>												
75	Boys' Locker Room	1		Locker Room	Boys

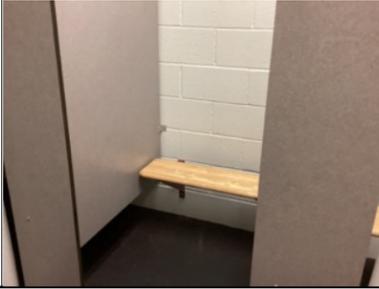
5% of lockers are not accessible	35"	Ensure that 5% of changing rooms (at least one) are accessible with a 60" diameter min. circular or compliant T-shaped turning space, a bench that is at least 24" deep and 48" long, and with 30" clear floor space alongside the bench to allow for transfer.	1	5866	\$5866

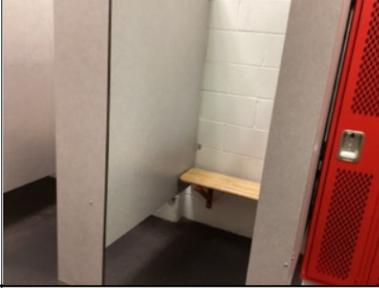
ID	Location	Floor	Room	Element	Type	Photo	Issues	Current Measure	Recommendations	Quantity	Price	Cost Estimation
76	Boys' Locker Room	1		Locker Room	Boys

5% of changing rooms are not accessible	43"	Ensure that 5% of changing rooms (at least one) are accessible with a 60" diameter min. circular or compliant T-shaped turning space, a bench that is at least 24" deep and 48" long, and with 30" clear floor space alongside the bench to allow for transfer.	1	5866	\$5866
77	Boys' Locker Rooms	1		Locker Room	Boys

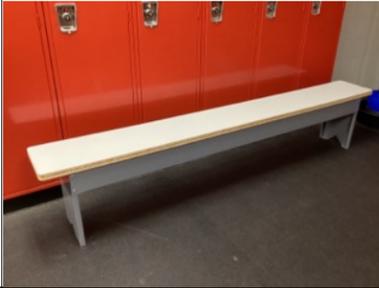
Back support not provided at bench Bench < 24" deep	- -	Provide at least one bench with back support or that is affixed to a wall with room on the side to transfer. Provide a bench that is 24" deep.	2	200	\$400
78	Boys' Team Room	1		Locker Room	Boys

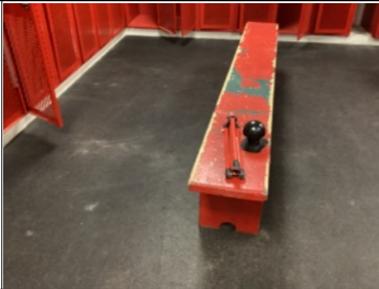
Back support not provided at bench Bench < 24" deep	- -	Provide at least one bench with back support or that is affixed to a wall with room on the side to transfer. Provide a bench that is 24" deep.	1	200	\$200

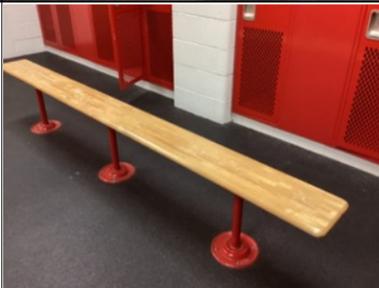
79	Girls' Team Room	1		Locker Room	Girls

Back support not provided at bench Bench < 24" deep	- -	Provide at least one bench with back support or that is affixed to a wall with room on the side to transfer. Provide a bench that is 24" deep.	1	200	\$200
<b>Kitchens and Kitchenettes</b>												
80	Life Skills	1		Kitchens and Kitchenettes	N/A

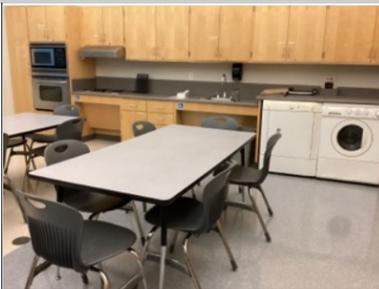
If a bottom hinged oven is provided		Provide a retractable bread board adjacent to the oven door.	1	412	\$412
<b>Toilet &amp; Bathing Rooms</b>

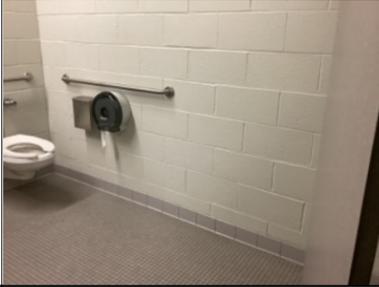
ID	Location	Floor	Room	Element	Type	Photo	Issues	Current Measure	Recommendations	Quantity	Price	Cost Estimation
<b>Overall Access</b>												
81	Girls' Team Room Multi-User Toilet Room	1		Overall Access	Toilet Room

6 fixtures, but no ambulatory compartment provided	-	Provide one ambulatory accessible compartment.	1	3012	\$3012
82	Girls' Multi-User Toilet Room	3		Overall Access	Toilet Room

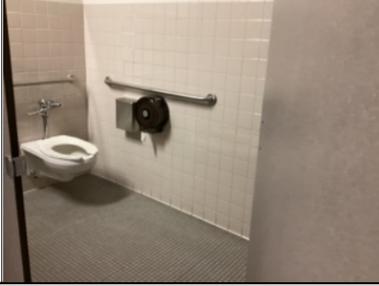
6 fixtures, but no ambulatory compartment provided	-	Provide one ambulatory accessible compartment.	1	3012	\$3012
<b>Toilet Compartment</b>												
83	Boys' Team Room Multi-User Toilet Room	1		Toilet Compartment	Accessible Compartment

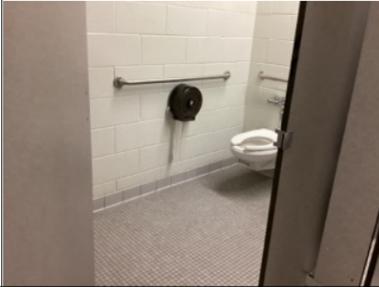
Door has non-compliant hardware	-	Provide hardware that can be operable with one hand and not require tight grasping, pinching, or twisting of the wrist.	1	70	\$70
84	Girls' Multi-User Toilet Room	3		Toilet Compartment	Accessible Compartment

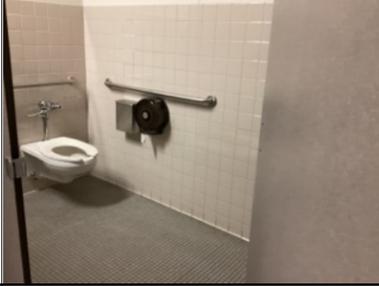
Door has non-compliant hardware	-	Provide hardware that can be operable with one hand and not require tight grasping, pinching, or twisting of the wrist.	1	70	\$70

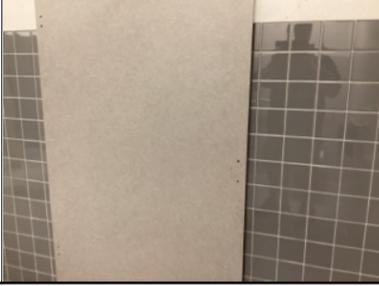
85	Women's Toilet Room by Auditorium	1		Toilet Compartment	Accessible Compartment

Door has non-compliant hardware Door has malfunctioning self-closing hinge	- -	Provide hardware that can be operable with one hand and not require tight grasping, pinching, or twisting of the wrist. Repair hinge.	1	70	\$70

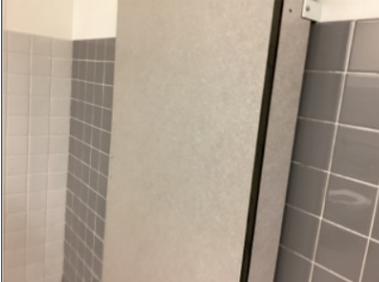
ID	Location	Floor	Room	Element	Type	Photo	Issues	Current Measure	Recommendations	Quantity	Price	Cost Estimation
86	Men's Toilet Room by Auditorium	1		Toilet Compartment	Accessible Compartment

Door has non-compliant hardware Door has malfunctioning self-closing hinge	- -	Provide hardware that can be operable with one hand and not require tight grasping, pinching, or twisting of the wrist. Repair hinge.	1	70	\$70
87	Boys' Locker Room Accessible Compartment	1		Toilet Compartment	Accessible Compartment

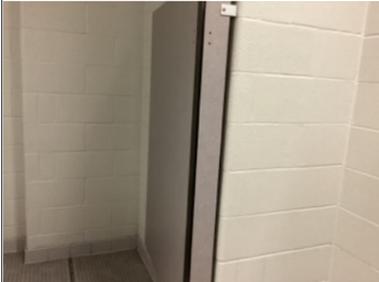
Door has non-compliant hardware Door has malfunctioning self-closing hinge	- -	Provide hardware that can be operable with one hand and not require tight grasping, pinching, or twisting of the wrist. Repair hinge.	1	70	\$70
88	Girls' Locker Room Accessible Compartment	1		Toilet Compartment	Accessible Compartment

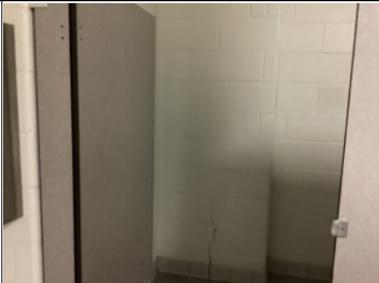
Door has non-compliant hardware Door has malfunctioning self-closing hinge	- -	Provide hardware that can be operable with one hand and not require tight grasping, pinching, or twisting of the wrist. Repair hinge.	1	70	\$70

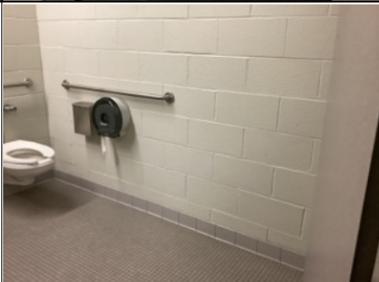
89	Girls' Team Room Accessible Compartment	1		Toilet Compartment	Accessible Compartment

Door has non-compliant hardware Door has malfunctioning self-closing hinge	- -	Provide hardware that can be operable with one hand and not require tight grasping, pinching, or twisting of the wrist. Repair hinge.	1	70	\$70
90	Girls' by Locker Room Accessible Compartment	1		Toilet Compartment	Accessible Compartment

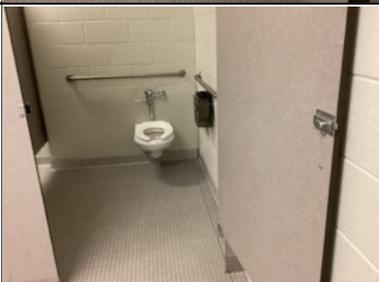
Door has malfunctioning self-closing hinge	-	Repair hinge.	1	Labor	\$0

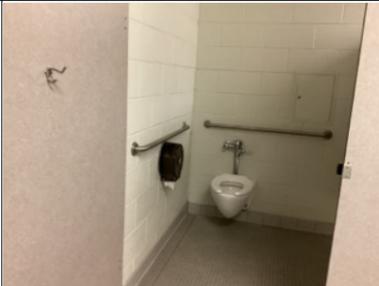
Door has malfunctioning self-closing hinge	-	Repair hinge.	1	Labor	\$0
92	Boys' Multi-User Toilet Room	3		Toilet Compartment	Accessible Compartment

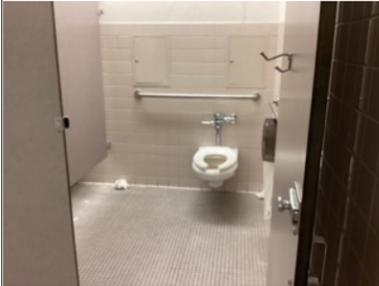
Door has malfunctioning self-closing hinge	-	Repair hinge.	1	Labor	\$0
93	Boys' Locker Room Accessible Compartment	1		Toilet Compartment	Accessible Compartment

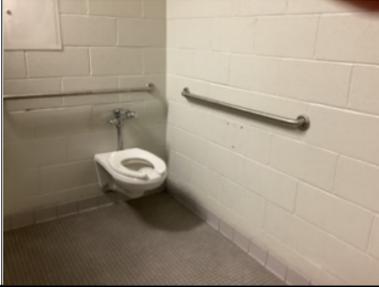
Non-compliant toilet paper dispenser	-	Provide a toilet paper dispenser located so that it is 24" min. high, located under the grab bar, and between 7" and 9" from the front of the toilet.	1	353	\$353
<b>Dispensers</b>												
94	Girls' Multi-User Toilet Room	3		Dispensers	Tampon Dispenser

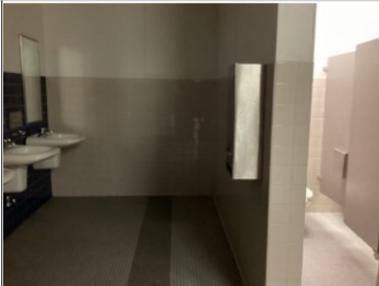
Dispenser acts as a protruding object	-	Relocate tampon dispenser out of the circulation path or provide a cane-detectable barrier 27" max. above the finished floor.	1	306	\$306

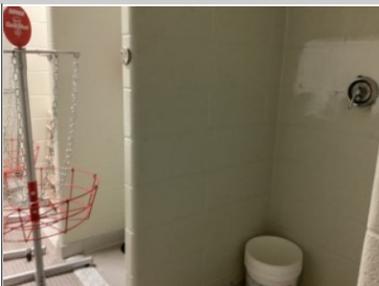
<b>Shower Compartment</b>												
95	Boys' Locker Room Shower Near Training Room	1		Shower Compartment	N/A

Grab bars not provided Seat not provided (transfer compartment) Accessible shower not provided	- - -	Provide at least one accessible shower.	1	6072	\$6072

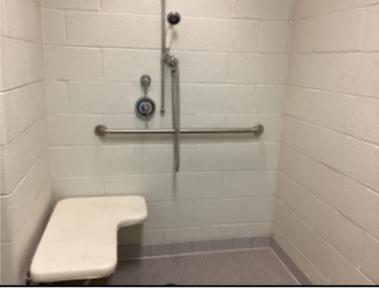
Grab bars mounted in wrong location	-	Provide compliant grab bar on the wall opposite the seat. Ensure grab bars are not provided over the seat (replace existing grab bar). For a roll-in shower with a seat, grab bars shall be provided on the back wall and side wall opposite the seat. Ensure seat is a folding seat.	1	2192	\$2192
97	Boys' Locker Room Shower	1		Shower Compartment	N/A

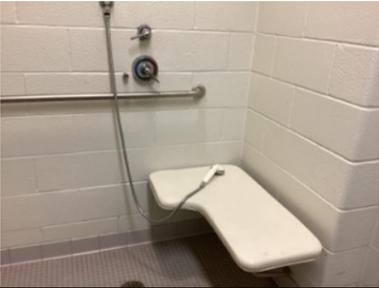
Grab bars mounted in wrong location	-	Ensure grab bars are not provided over the seat. (Replace existing grab bar.) For a roll-in shower with a seat, grab bars shall be provided on the back wall and side wall opposite the seat. Here a grab bar is missing on the side wall opposite the seat. Ensure seat is a folding seat.	1	2192	\$2192
<b>Additional Access</b>

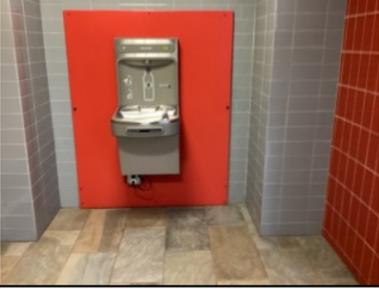
No drinking fountain provided for standing users	-	Provide an additional drinking fountain for standing users or install a Hi-Lo drinking fountain.	1	4028	\$4028
99	Drinking Fountain By Door 9	1		Drinking Fountains	Low

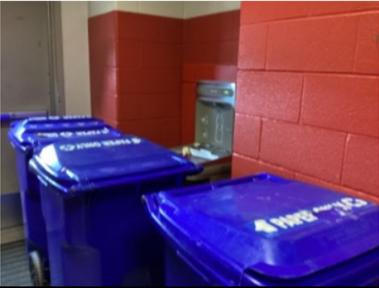
No drinking fountain provided for standing users	-	Provide an additional drinking fountain for standing users or install a Hi-Lo drinking fountain.	1	4028	\$4028
100	Drinking Fountain By Elevator	2		Drinking Fountains	Low

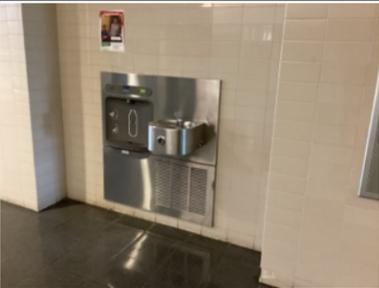
No drinking fountain provided for standing users	-	Provide an additional drinking fountain for standing users or install a Hi-Lo drinking fountain.	1	4028	\$4028

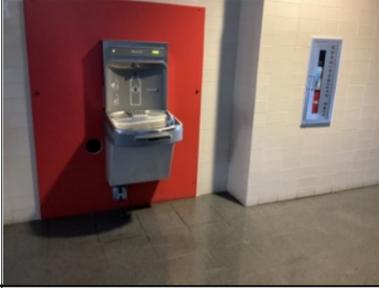
No drinking fountain provided for standing users	-	Provide an additional drinking fountain for standing users or install a Hi-Lo drinking fountain.	1	4028	\$4028
102	Drinking Fountain By Girls' Multi-User Toilet Room	4		Drinking Fountains	Low

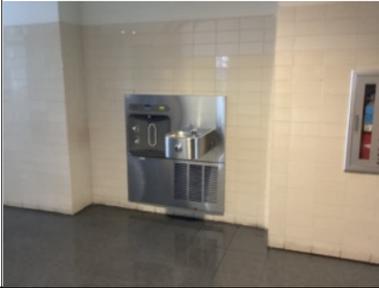
No drinking fountain provided for standing users	-	Provide an additional drinking fountain for standing users or install a Hi-Lo drinking fountain.	1	4028	\$4028
103	Drinking Fountain By Boys' Team Room	1		Drinking Fountains	Hi-Lo

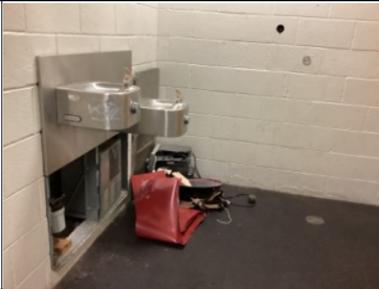
Standing height fountain does not have cane protection	-	Provide a cane-detectable barrier skirt under the high unit.	1	890	\$890
104	Drinking Fountain By Girls' Team Room	1		Drinking Fountains	Hi-Lo

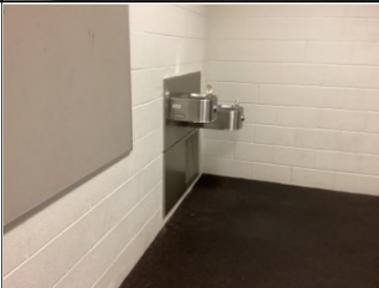
Standing height fountain does not have cane protection	-	Provide a cane-detectable barrier skirt under the high unit.	1	890	\$890

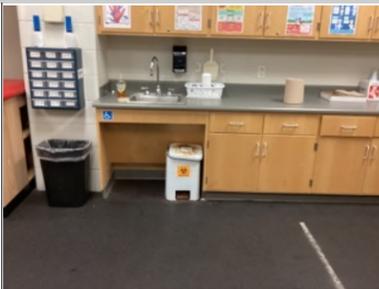
<b>Sink</b>												
105	Training Room	1		Sink	Other

Clear floor space not provided at sink	-	Provide a 30" by 48" clear floor space positioned for a forward approach. (Relocate disposal container that is under the sink.)	1		\$0

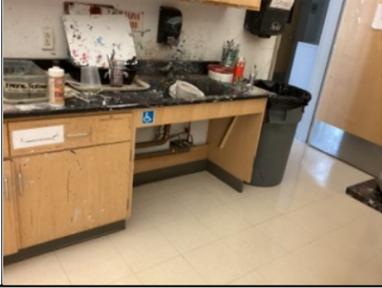
Exposed plumbing underneath sink	-	Insulate or otherwise configure pipes at sink.	1	92	\$92
<b>Play and Sport Areas</b>												
<b>Field</b>												
107	Middle School Practice Soccer Field	Ext.		Field	Soccer
