# ADA Self-Evaluation and Transition Plan for the City of Melrose

Part 2 of 2

## Part 2: Reports:

January, 2023

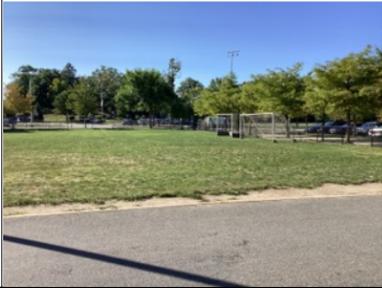
Field not connected to an accessible route	-	Provide a stable, firm and slip resistant accessible route to the boundary of sport activity at the soccer field.	1	-	\$0
<b>Best Practice</b>												
<b>Access Aisle</b>												
108	Parking North Side of Middle School by the Gymnasium Entrance	Ext.		Access Aisle	N/A

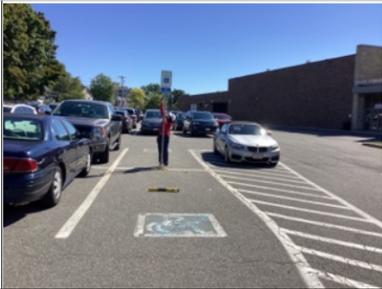
Recommend re-stripping access aisle. At present aisle width is a bit uneven and curved.	1	-	\$0
<b>Curb Ramp</b>												
109	Gymnasium Entrance by Parking on the North Side of the School	Ext.		Curb Ramp	Exterior

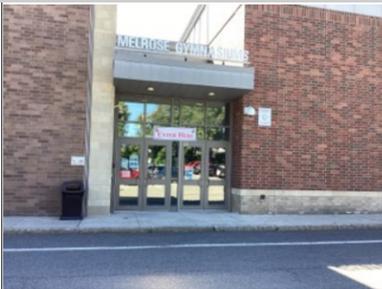
Recommend providing a curb ramp at the gymnasium entrance by the parking lot on the north side of the school.	1	-	\$0

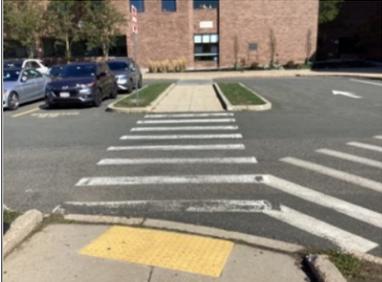
Recommend providing a detectable warning at the far side of the crosswalk.	1	-	\$0
111	By North Football Parking at Marcoux Memorial Gymnasium	Ext.		Detectible Warning	N/A

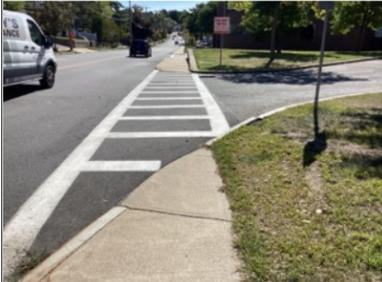
Recommend providing a detectable warning on both sides of the crosswalk.	1	-	\$0
<b>Exterior Access Route</b>												
112	Union Street Sidewalk to Football Main Entrance	Ext.		Exterior Access Route	Curb Ramp

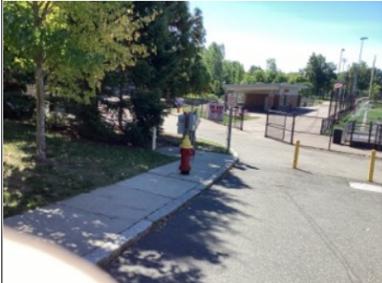
Recommend providing a curb ramp before the fire hydrant so visitors, including visitors with wheeled mobility devices, can exit the sidewalk at this point on route to football stadium rather than having to backtrack to exit the sidewalk.	1	-	\$0
113	Walkway Between Middle and High School	Ext.		Exterior Access Route	Sidewalk

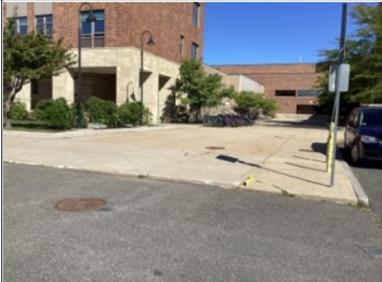
Recommend providing a curb ramp at the transition to the walkway between the middle school and high school.	1	-	\$0

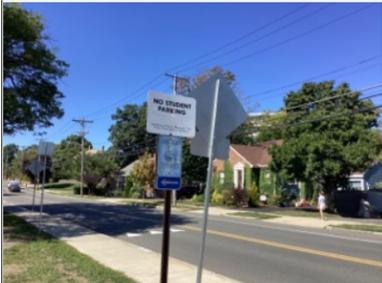
<b>Signage</b>												
114	Melrose Street Directional Accessibility Sign	Ext.		Signage	N/A

Recommend replacing faded directional International Symbol of Accessibility sign.	1	-	\$0

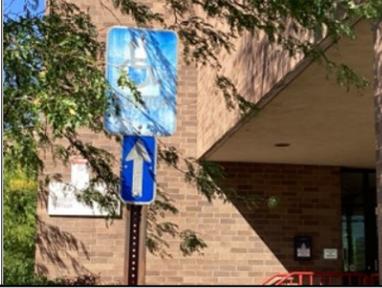
Recommend replacing faded directional International Symbol of Accessibility sign.	1	-	\$0

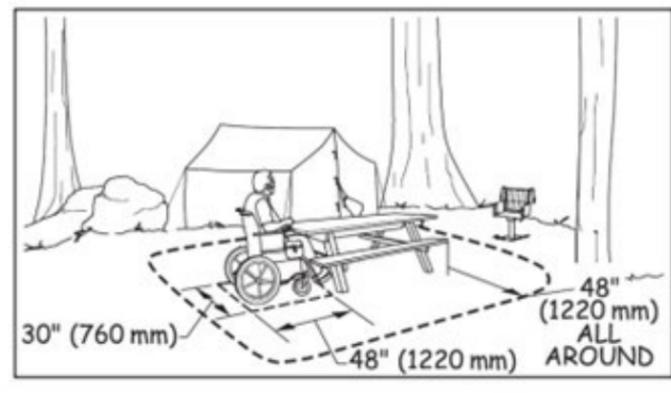
Fig. 2

**Figure 2:** Shows a stable, firm and slip-resistant surface around a picnic table to allow a person in a wheeled mobility device to maneuver around the picnic table.

- Recommend providing a 48" min. stable, firm, and slip-resistant surface around at least one (1) accessible picnic table at each location where picnic tables are provided in a manner that is substantially similar to what is shown in Figure 2.

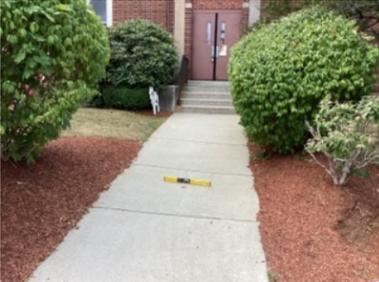
Cross slope > 1:50 (2.00%) Running slope > 1:20 (5.00%)	4.4% 12.2%	Reduce cross slope to be no steeper than 1:50 (2.00%). Reduce running slope to be no steeper than 1:20 (5.00%).	1	-	\$0
2	Forest Street Entrance	Ext.		Exterior Access Route	Exterior

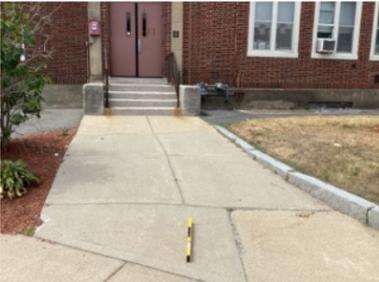
Running slope > 1:20 (5.00%)	13%	Reduce running slope to be no steeper than 1:20 (5.00%).	1	-	\$0
3	Entry to Paved Area by South Side Playground	Ext.		Exterior Access Route	Exterior

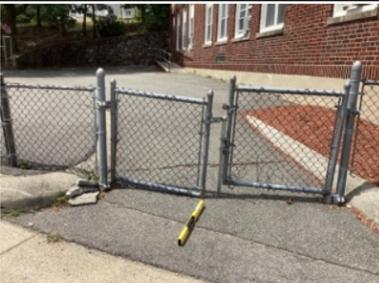
Running slope > 1:20 (5.00%)	18%	Reduce running slope to be no steeper than 1:20 (5.00%).	1	-	\$0
4	Northwest Playground Entry	Ext.		Exterior Access Route	Exterior

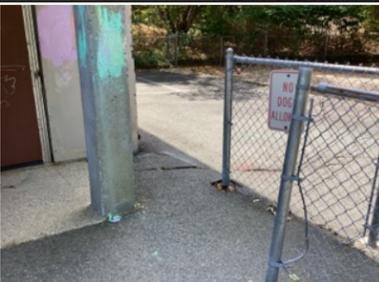
Route not maintained in operable working condition		Ensure the accessible route to the playground is maintained in operable working condition.	1	-	\$0

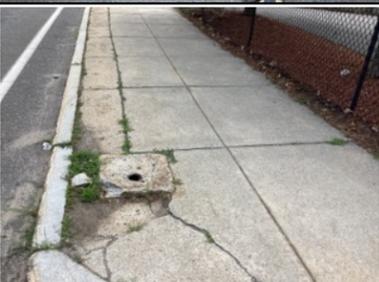
5	Walkway to Main Entrance	Ext.		Exterior Access Route	Sidewalk

Route not maintained in operable working condition		Ensure the accessible route is maintained in operable working condition.	1	-	\$0

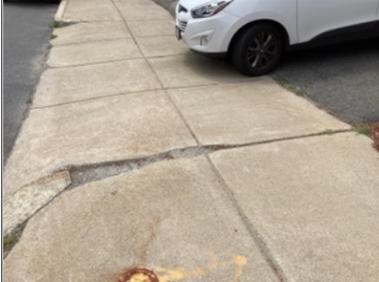
Route not maintained in operable working condition		Ensure the accessible route is maintained in operable working condition.	1	-	\$0
7	Garden Above Northwest Parking	Ext.		Exterior Access Route	Exterior

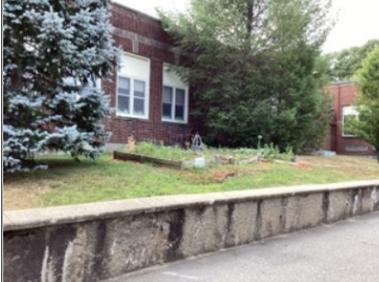
Accessible route not provided		Ensure an accessible route is provided. (Relocate the garden to an accessible location.)	1	-	\$0
<b>Off-Street Parking Lot or Garage</b>												
8	Main Parking Northwest of School	Ext.		Off-Street Parking Lot or Garage	N/A

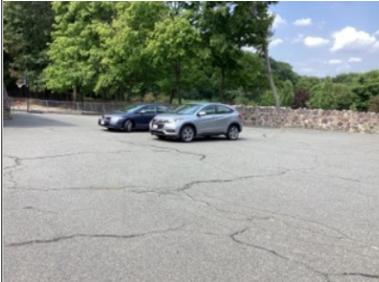
Total # of parking Total # of designated accessible parking spaces Total # of designated van accessible spaces Access aisle not provided Sign not provided Sign does not have the designation "Van Accessible"	25 - - - -	Provide a compliant van accessible parking space with both the space and a marked access aisle that are at least 96" wide. Provide a sign with the International Symbol of Accessibility (ISA) with bottom of the sign 60" min. above the ground and the top 96" max. above the ground. Add the designation "Van Accessible" to the sign located at the van accessible space.	1	-	\$0

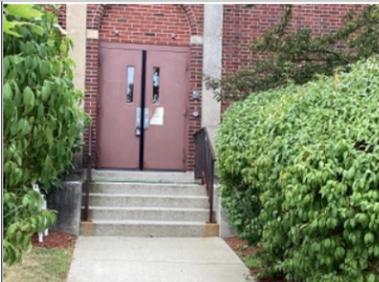
<b>Entrance</b>												
9	Main Entrance on Lebanon Street	Ext.		Entrance	Main Entrance

Entrance not on an accessible route Directional sign to accessible entrance not provided	- -	Provide a directional sign indicating the location of the nearest accessible entrance. Provide a directional sign indicating the location of the nearest accessible entrance.	1	-	\$0
10	Forest Street Entrance	Ext.		Entrance	Secondary Entrance

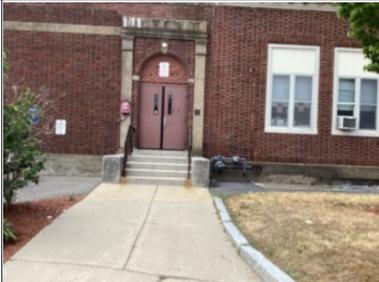
Entrance not on an accessible route Directional sign to accessible entrance not provided	- -	Provide a directional sign indicating the location of the nearest accessible entrance. Provide a directional sign indicating the location of the nearest accessible entrance.	1	-	\$0

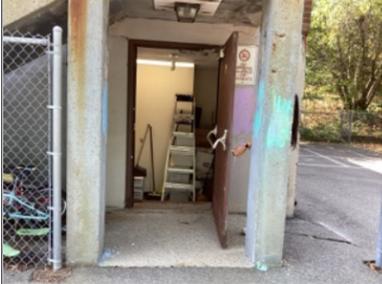
Directional sign to accessible entrance not provided	-	Provide a directional sign indicating the location of the nearest accessible entrance.	1	-	\$0
<b>Access to Goods and Services</b>												
<b>Means of Egress</b>												
12	Kindergarten Classroom	1		Means of Egress	N/A

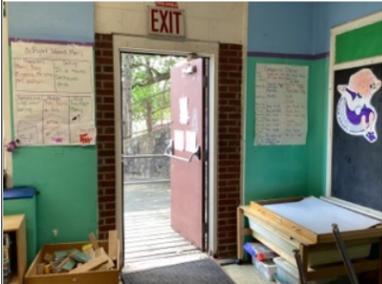
Tactile exit sign not provided		Ensure tactile exit signs with raised characters and braille are provided at exit doors. Mount signs between 48"- 60" above the finished floor located on the latch side of the door. <b>Note:</b> When the ramp at this egress is made fully compliant, an illuminated International Symbol of Accessibility (ISA) sign should be provided.	1	232	\$232
13	Basement Egress Near Playground and Parking Lot	B		Means of Egress	N/A

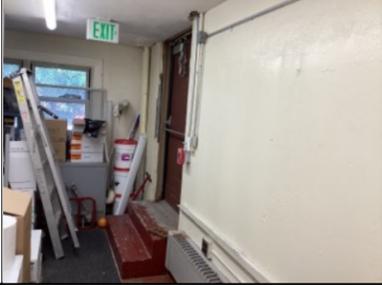
Tactile exit sign not provided Directional sign to accessible emergency exit not provided	- -	Ensure tactile exit signs with raised characters and braille are provided at exit doors. Mount signs between 48"- 60" above the finished floor located on the latch side of the door. Provide a directional sign indicating the location of the nearest accessible emergency exit.	1	232	\$232

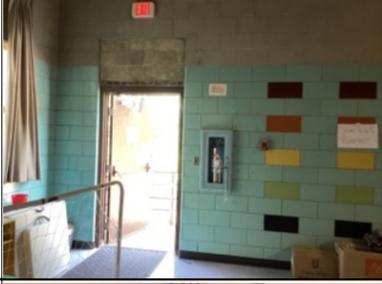
14	Auditorium	1		Means of Egress	N/A

Tactile exit sign not provided Directional sign to accessible emergency exit not provided	- -	Ensure tactile exit signs with raised characters and braille are provided at exit doors. Mount signs between 48"- 60" above the finished floor located on the latch side of the door. Provide a directional sign indicating the location of the nearest accessible emergency exit.	1	232	\$232
15	Fourth Grade Classroom Egress Door	1		Means of Egress	N/A

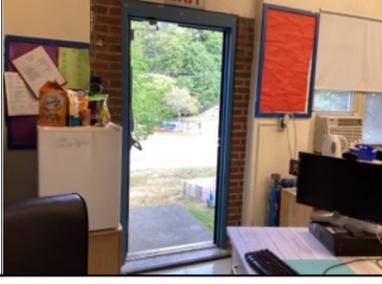
Tactile exit sign not provided Directional sign to accessible emergency exit not provided		Ensure tactile exit signs with raised characters and braille are provided at exit doors. Mount signs between 48"- 60" above the finished floor located on the latch side of the door. Provide a directional sign indicating the location of the nearest accessible emergency exit.	1	-	\$0

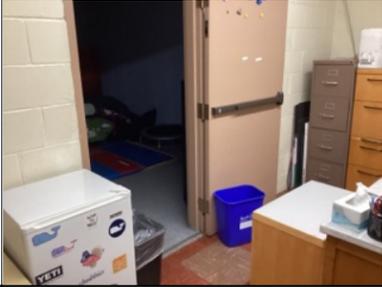
ID	Location	Floor	Room	Element	Type	Photo	Issues	Current Measure	Recommendations	Quantity	Price	Cost Estimation
<b>Interior Access Route</b>												
16	Occupational Therapy	B		Interior Access Route	N/A

Route < 36" wide	24"	Relocate stored items to ensure that a clear width of 36" min. is maintained at the accessible route.	1	-	\$0
17	Hallway to Principal's Office	1		Interior Access Route	N/A

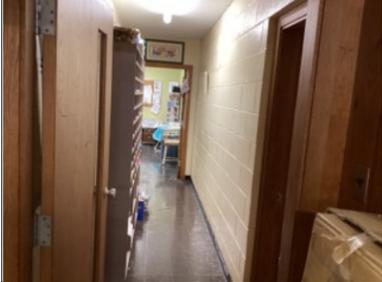
Route < 36" wide	33"	Ensure that a clear width of 36" min. is maintained at the accessible route.	1	Labor	\$0
18	Boys' Multi-User Toilet Room	1		Interior Access Route	N/A

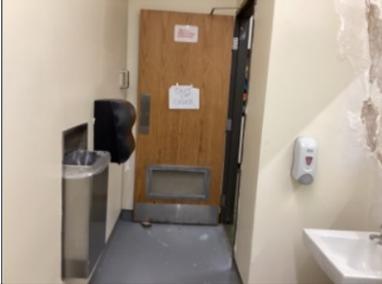
Route < 36" wide	32"	Ensure that a clear width of 36" min. is maintained at the accessible route.	1	Labor	\$0
19	Auditorium	1		Interior Access Route	N/A

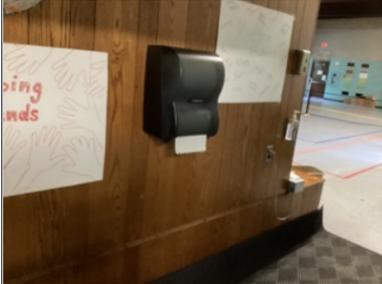
Obstructed by protruding objects	43"	Relocate object out of the circulation path or provide a cane-detectable barrier.	1	306	\$306
20	Hallway Near Behavioral Support	1		Interior Access Route	N/A

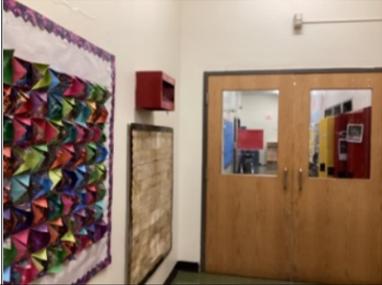
Obstructed by protruding objects	66"	Relocate object to at least 80" above the finished floor.	1	256	\$256

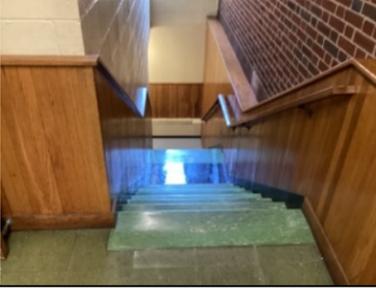
ID	Location	Floor	Room	Element	Type	Photo	Issues	Current Measure	Recommendations	Quantity	Price	Cost Estimation
21	Stairs to The Basement	1		Interior Access Route	N/A

Accessible route not provided	-	Provide an accessible route between the first floor and the basement. (Cost for a 2-stop limited-use/limited-application (LULA) elevator.)	1	90000	\$90000
22	Staircase to Back of Stage	1		Interior Access Route	N/A

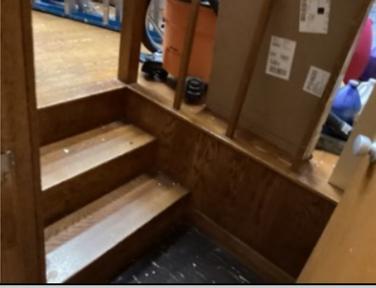
Accessible route not provided		Provide an accessible route to the stage. (Cost for a new interior unenclosed lift.) <b>Note:</b> Alternatively the option exists to provide an accessible route to the stage approaching from ground level of the main auditorium area.	1	21660	\$21660
<b>Doors, Doorways, &amp; Gates</b>												
23	Basement Single-User Toilet Room	B		Doors, Doorways, & Gates	Toilet Room

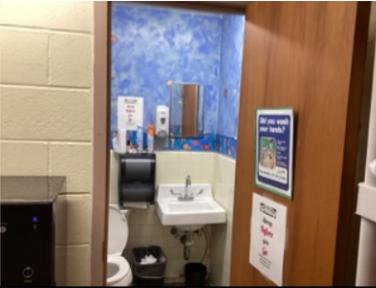
Clear width at door < 32"	21"	Widen the door so that there is 32" min. clear width. <b>Note:</b> Cost to widen the door is included in the cost to provide an accessible single-user toilet room at the basement level. See ID #54.	1	-	\$0

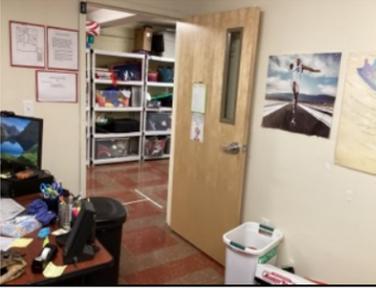
24	Counselor's Office	B		Doors, Doorways, & Gates	Office

Maneuvering clearance(s) not provided		Remove or relocate stored items and furniture to provide 18" min. pull side maneuvering clearance at the door.	1	-	\$0
25	Second Basement Office	B		Doors, Doorways, & Gates	Office

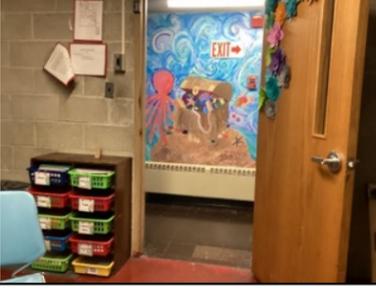
Maneuvering clearance(s) not provided		Relocate stored objects to provide 18" min. pull-side maneuvering clearance at the door.	1	-	\$0

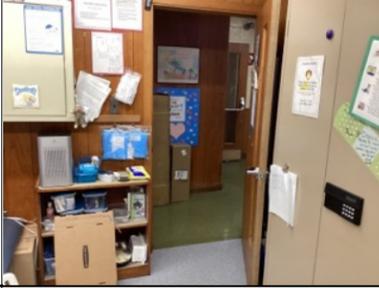
ID	Location	Floor	Room	Element	Type	Photo	Issues	Current Measure	Recommendations	Quantity	Price	Cost Estimation
26	Health Office	1		Doors, Doorways, & Gates	Office

Maneuvering clearance(s) not provided		Relocate stored objects to provide 18" min. pull-side maneuvering clearance at the door.	1	-	\$0
27	Administrator's Office	1		Doors, Doorways, & Gates	Office

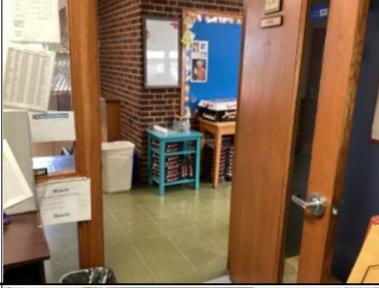
Maneuvering clearance(s) not provided		Relocate stored objects to provide 18" min. pull-side maneuvering clearance at the door.	1	-	\$0
28	Counselor's Office	1		Doors, Doorways, & Gates	Office

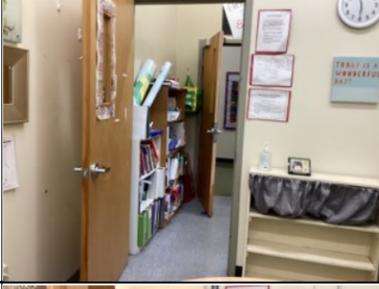
Maneuvering clearance(s) not provided	-	Relocate bookcase to provide 18" min. pull-side maneuvering clearance at the door.	1	-	\$0
29	Speech Room	1		Doors, Doorways, & Gates	Classroom

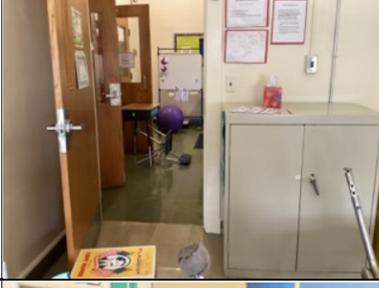
Maneuvering clearance(s) not provided		Relocate metal cabinet to provide 18" min. pull-side maneuvering clearance at the door.	1	-	\$0
30	Kindergarten Classroom	1		Doors, Doorways, & Gates	Classroom

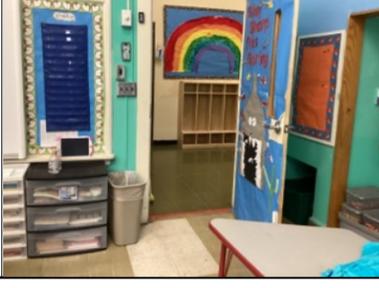
Maneuvering clearance(s) not provided		Relocate trash container and other items to provide 18" min. pull-side maneuvering clearance at the door.	1	-	\$0

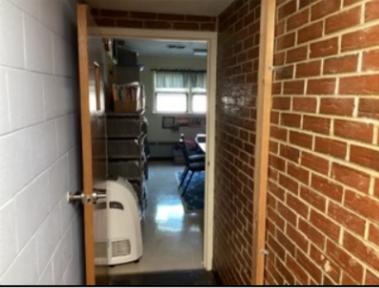
ID	Location	Floor	Room	Element	Type	Photo	Issues	Current Measure	Recommendations	Quantity	Price	Cost Estimation
31	Vice Principal's Office	B		Doors, Doorways, & Gates	Office

Maneuvering clearance not provided at recess > 6"	-	Install an automatic door opener.	1	3060	\$3060
32	Behavioral Supprt	1		Doors, Doorways, & Gates	Classroom

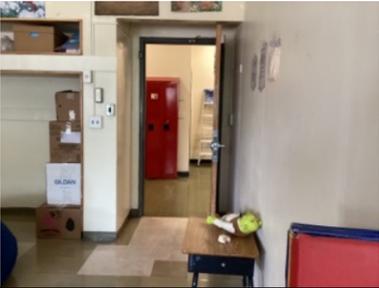
Maneuvering clearance not provided at recess > 6"	-	Install an automatic door opener.	1	3060	\$3060
33	Sixth Grade Classroom	1		Doors, Doorways, & Gates	Classroom

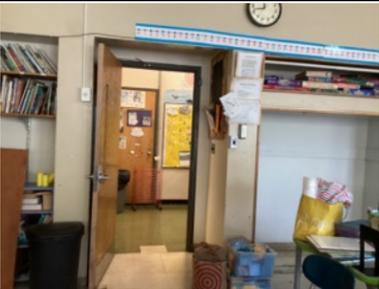
Maneuvering clearance not provided at recess > 6"	4"	Install an automatic door opener.	1	3060	\$3060
<b>Ramps</b>												
34	Accessible Entrance at Southwest Side of School	Ext.		Ramps	Other

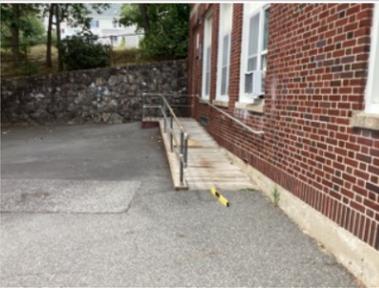
Ramp < 48" wide Handrails do not extend 12" past top & bottom Landing has a slope > 1:50 (2.00%) Edge protection < 4" high	41" 4.4%	Widen ramp so that the clear width is 48" min. (Repair to this ramp might be technically infeasible.) Alter handrail on one side to extend horizontally above the landing for 12" min. beyond the bottom ramp run. Rebuild the ramp to ensure that the slope of the landing does not exceed 1:50 (2.00%). Provide edge protection.	1	-	\$0

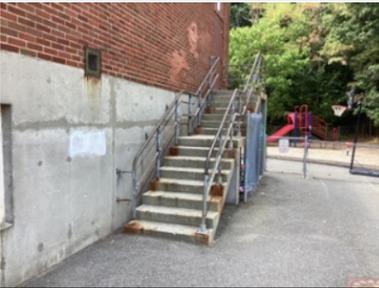
<b>Stairways</b>												
35	Egress Stairs to the Main Parking Lot by Northwest Playground	Ext.		Stairways	Egress

Handrails do not extend 12" from stairs		Top: Ensure handrails extend horizontally above the landing for 12" min. beginning above the first riser nosing. Bottom: Ensure handrails extend to one tread depth beyond the last riser.	1	-	\$0

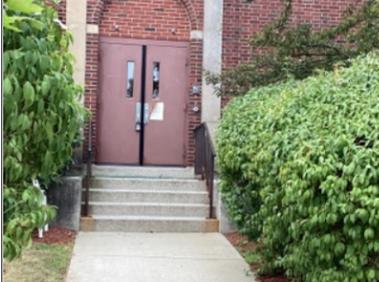
ID	Location	Floor	Room	Element	Type	Photo	Issues	Current Measure	Recommendations	Quantity	Price	Cost Estimation
36	Main Entrance on Lebanon Street	Ext.		Stairways	Other

Handrails do not extend 12" from stairs		Top: Ensure handrails extend horizontally above the landing for 12" min. beginning above the first riser nosing. Bottom: Ensure handrails extend to one tread depth beyond the last riser.	1	-	\$0
37	Forest Street Entrance	Ext.		Stairways	Other

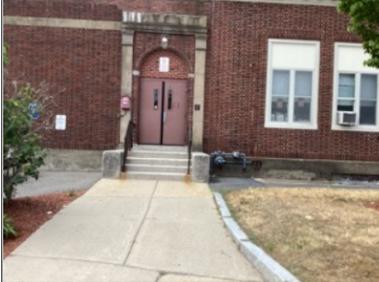
Handrails do not extend 12" from stairs		Top: Ensure handrails extend horizontally above the landing for 12" min. beginning above the first riser nosing. Bottom: Ensure handrails extend to one tread depth beyond the last riser.	1	-	\$0
<b>Signage</b>												
38	Boys' Multi-User Toilet Room	1		Signage	Designation

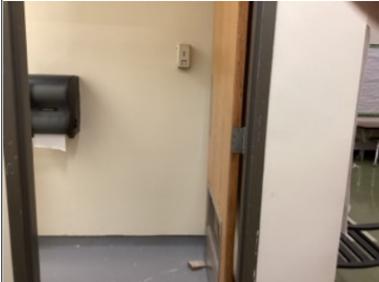
Signage is not provided		Locate compliant signage alongside the door on the latch side.	1	232	\$232
39	Girls' Multi-User Toilet Room	1		Signage	Designation

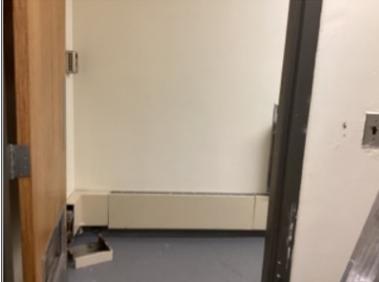
Signage is not provided		Locate compliant signage alongside the door on the latch side.	1	232	\$232

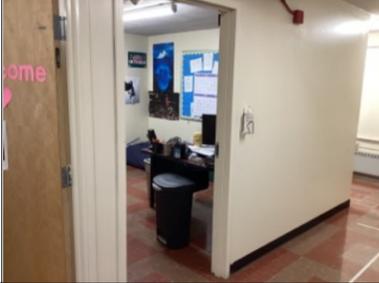
40	Counselor's Office	B		Signage	Designation

Raised characters not provided on sign Raised characters < 48" or > 60" above ground Sign not located on the latch side of the door	- - -	Provide text with raised characters duplicated in braille on sign. Mount signs so that the baseline of the lowest tactile character is 48" min. above finished floor and the baseline of the highest tactile character is 60" max. above the finished floor. Locate the sign at permanent rooms alongside the door on the latch side. <b>Note:</b> This same issue repeats throughout the school.	1	232	\$232

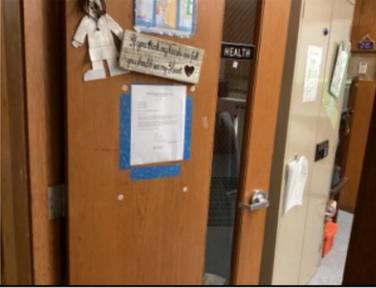
ID	Location	Floor	Room	Element	Type	Photo	Issues	Current Measure	Recommendations	Quantity	Price	Cost Estimation
41	Health Office	1		Signage	Designation

Raised characters not provided on sign Braille not provided on sign Visual characters < 40" above ground Sign not located on the latch side of the door	- - - 61"	Provide text with raised characters duplicated in braille on sign. Mount the sign so that the baseline of the lowest visual character is 40" min. above the finished floor or ground. Locate the sign at permanent rooms alongside the door on the latch side.	1	232	\$232
42	Basement Single-User Toilet Room	B		Signage	Designation

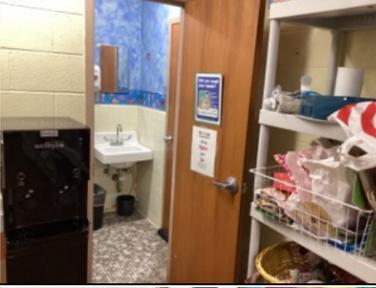
Raised characters not provided on sign Braille not provided on sign Sign not located on the latch side of the door International Symbol of Acc. not provided		Provide text with raised characters duplicated in braille on sign. Locate the sign at permanent rooms alongside the door on the latch side. Once the toilet room has been made accessible, provide a sign with the International Symbol of Accessibility (ISA).	1	232	\$232

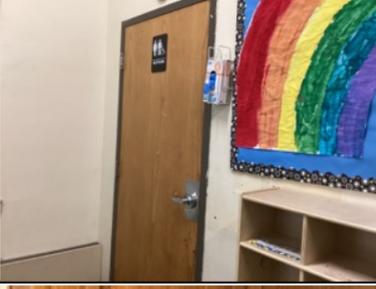
43	Single-User Toilet Room by E1	1		Signage	Designation

Visual characters < 40" above ground Sign not located on the latch side of the door	72"	Mount the sign so that the baseline of the lowest visual character is 40" min. above the finished floor or ground. Locate the sign at permanent rooms alongside the door on the latch side.	1	-	\$0
44	Principal's Office	1		Signage	Designation

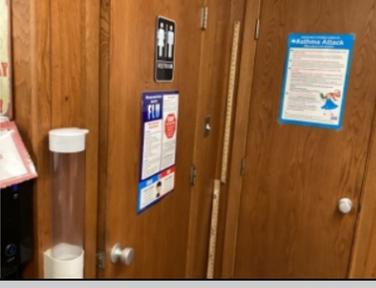
Sign not located on the latch side of the door Visual characters < 40" above ground	60"	Mount the sign so that the baseline of the lowest visual character is 40" min. above the finished floor or ground. Locate the sign at permanent rooms alongside the door on the latch side.	1	-	\$0
<b>Assembly Area</b>												
45	Auditorium	1		Assembly Area	N/A

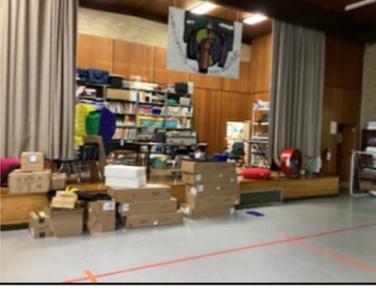
Assistive listening devices not provided	-	If audible communication is integral to the use of the space, provide an assistive listening system.	1	1214	\$1214

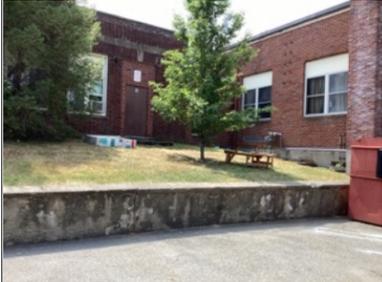
ID	Location	Floor	Room	Element	Type	Photo	Issues	Current Measure	Recommendations	Quantity	Price	Cost Estimation
<b>Picnic Tables</b>												
46	Above Northwest Parking	Ext.		Picnic Tables	N/A

Toe or knee clearance at tables not provided Picnic table not on an accessible route	- -	Provide at least 1 picnic table (or ensure that 5% of picnic tables) have toe and knee clearance. Ensure that the picnic table and the sandbox are connected to an accessible route. (Relocate sandbox and picnic table.)	1	-	\$0
47	Near Main Entrance	Ext.		Picnic Tables	N/A

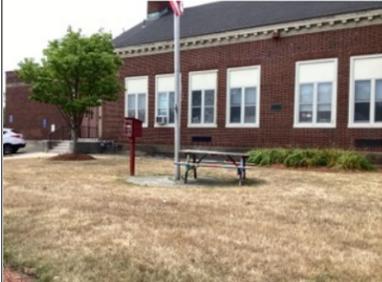
Toe or knee clearance at tables not provided Picnic table not on an accessible route	- -	Provide at least 1 picnic table (or ensure that 5% of picnic tables) have toe and knee clearance. Ensure that the picnic table is connected to an accessible route.	1	-	\$0
<b>Exterior Benches</b>												
48	Playground Near Southwest Ramp	Ext.		Exterior Benches	N/A

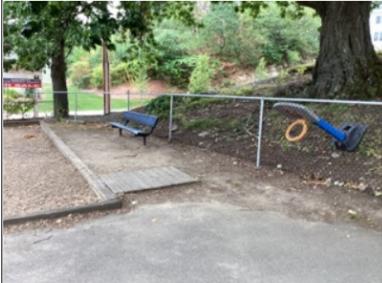
No accessible route to one bench in area	-	Provide an accessible route to one bench in this area.	1	-	\$0

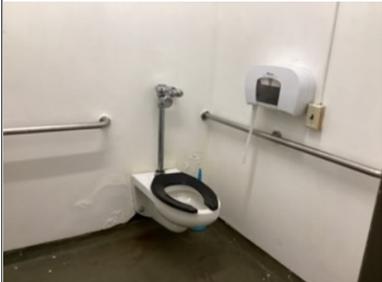
<b>Toilet Rooms for Children</b>												
<b>Single-User Toilet (Children)</b>												
49	Single-User Toilet Room by E1	1		Single-User Toilet (Children)	N/A

Non-compliant toilet paper dispenser	-	Relocate toilet paper dispenser so that it is between 14"- 19" above the floor and between 7"- 9" in front of the toilet. Ensure dispensers and other devices are not mounted above grab bars.	1	256	\$256

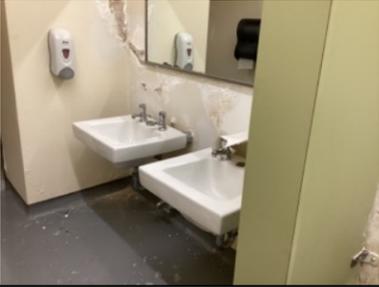
ID	Location	Floor	Room	Element	Type	Photo	Issues	Current Measure	Recommendations	Quantity	Price	Cost Estimation
<b>Lavatory (Children)</b>												
50	Boys' Multi-User Toilet Room	1		Lavatory (Children)	N/A

Toe or knee clearances not provided Exposed plumbing underneath	22" -	Provide at least one lavatory with 25" min. knee clearance positioned for a forward approach. Ensure toe clearance is also provided. Insulate or otherwise configure pipes to prevent contact, for at least one lavatory.	1	1778	\$1778
51	Girls' Multi-User Toilet Room	1		Lavatory (Children)	N/A

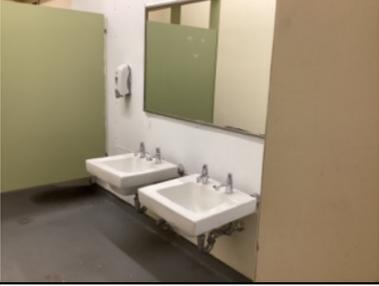
Toe or knee clearances not provided Mirror above lavatory w/reflective surface > 31"	21" 38"	Provide at least one lavatory with 25" min. knee clearance positioned for a forward approach. Ensure toe clearance is also provided.  Lower mirror so that the bottom surface is at 31" above the finished floor.	1	1942	\$1942
52	Single-User Toilet Room by E1	1		Lavatory (Children)	N/A

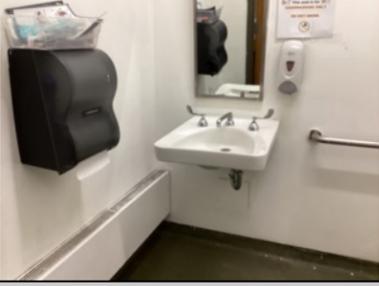
Exposed plumbing underneath		Insulate or otherwise configure pipes to prevent contact, for at least one lavatory.	1	92	\$92

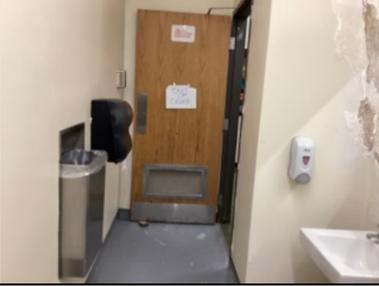
<b>Dispensers (Children)</b>												
53	Boys' Multi-User Toilet Room	1		Dispensers (Children)	Paper Towel Dispenser

Dispenser is a protruding object	-	Relocate paper towel dispenser out of the circulation path when entering the toilet room from the main entry door or provide a cane-detectible barrier under the paper towel dispenser.	1	306	\$306
<b>Overall Access (Children)</b>												
54	Basement Single-User Toilet Room	B		Overall Access (Children)	Toilet Room

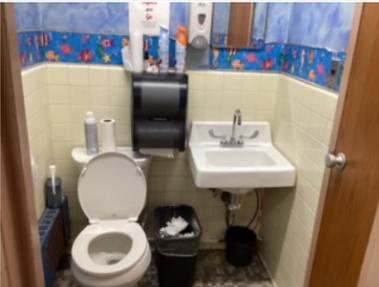
Accessible fixtures or stalls not provided	-	Provide an accessible single-user toilet room.	1	24604	\$24604

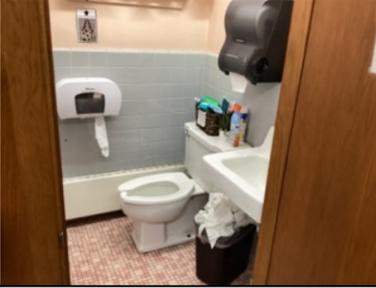
ID	Location	Floor	Room	Element	Type	Photo	Issues	Current Measure	Recommendations	Quantity	Price	Cost Estimation
55	Health Office	1		Overall Access (Children)	Toilet Room

Accessible fixtures or stalls not provided	-	Provide an accessible single-user toilet room.	1	24604	\$24604
56	Boys' Multi-User Toilet Room	1		Overall Access (Children)	Toilet Room

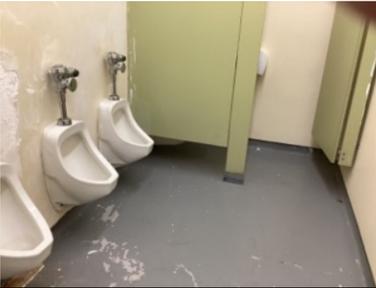
Accessible fixtures or stalls not provided	-	Provide one accessible wheelchair compartment.	1	6182	\$6182
57	Girls' Multi-User Toilet Room	1		Overall Access (Children)	Toilet Room

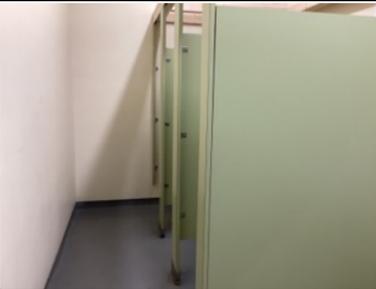
Accessible fixtures or stalls not provided	-	Provide one accessible wheelchair compartment.	1	6182	\$6182
<b>Additional Access</b>												
<b>Sink</b>												
58	Principal's Office	1		Sink	Other

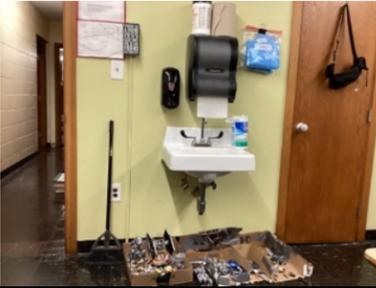
Exposed plumbing underneath sink Clear floor space not provided at sink	- -	If this sink is used by students or members of the public provide a 30" by 48" clear floor space positioned for a forward approach. Insulate or otherwise configure pipes at sink.	1	92	\$92

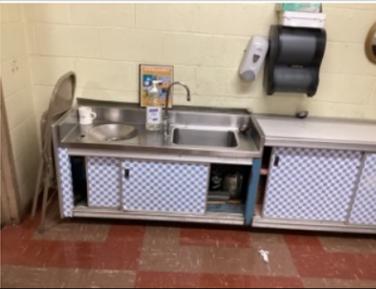
<b>Sinks for Children's Use</b>												
59	Near Occupational Therapy	B		Sinks for Children's Use	N/A

Exposed plumbing underneath Knee/toe clearance <27" at sink > 31" high		Insulate or otherwise configure pipes to prevent contact, for at least one sink. Provide at least one sink with 27" high knee and toe clearance positioned for a forward approach (per 521 CMR 12.2.2.c).	1	1778	\$1778

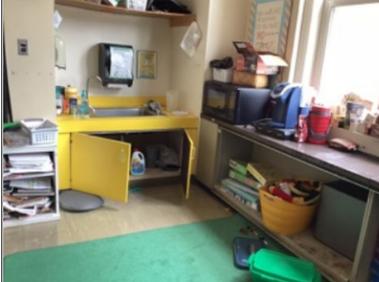
ID	Location	Floor	Room	Element	Type	Photo	Issues	Current Measure	Recommendations	Quantity	Price	Cost Estimation
60	Behavioral Support	1		Sinks for Children's Use	Other

Exposed plumbing underneath Knee/toe clearance <27" at sink > 31" high		Insulate or otherwise configure pipes to prevent contact, for at least one sink. Provide at least one sink with 27" high knee and toe clearance positioned for a forward approach (per 521 CMR 12.2.2.c).	1	1778	\$1778
61	Sixth Grade Classroom	1		Sinks for Children's Use	Classroom

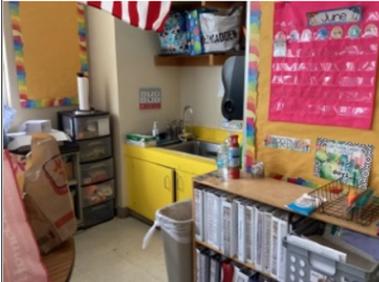
Exposed plumbing underneath Knee/toe clearance <27" at sink > 31" high	- -	Insulate or otherwise configure pipes to prevent contact, for at least one sink. Provide at least one sink with 27" high knee and toe clearance positioned for a forward approach (per 521 CMR 12.2.2.c).	1	1778	\$1778
62	Speech Room	1		Sinks for Children's Use	Other

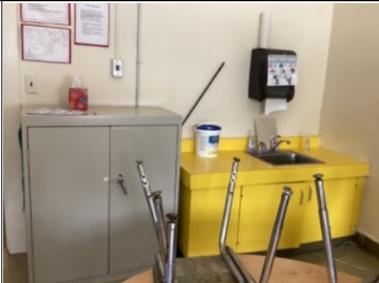
Exposed plumbing underneath Knee/toe clearance <27" at sink > 31" high	27"	Insulate or otherwise configure pipes to prevent contact, for at least one sink. Provide at least one sink with 27" high knee and toe clearance positioned for a forward approach (per 521 CMR 12.2.2.c).	1	1778	\$1778

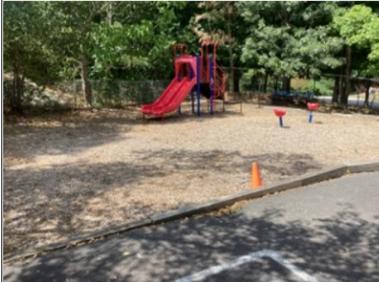
<b>Play and Sport Areas</b>												
<b>Play Areas</b>												
63	Northwest Playground	Ext.		Play Areas	N/A

Accessible route not provided to playground Accessible route not provided around playground Surface not stable, firm, and slip-resistant		Install a 48" wide min. stable, firm and slip resistant accessible route to and around the playground. Provide a compliant impact-attenuating accessible route around the play area to all unique play elements. Repair surface and ensure that surface is firm, stable and slip-resistant (to areas around play components).	1	-	\$0
64	Playground Near Southwest Ramp	Ext.		Play Areas	N/A

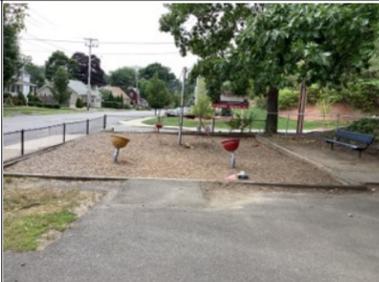
Accessible route not provided to playground Accessible route not provided around playground Surface not stable, firm, and slip-resistant		Install a 48" wide min. stable, firm and slip resistant accessible route to and around the playground. Provide a compliant impact-attenuating accessible route around the play area to all unique play elements. Repair surface and ensure that surface is firm, stable and slip-resistant (to areas around play components).	1	-	\$0

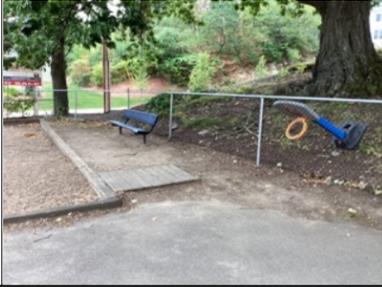
ID	Location	Floor	Room	Element	Type	Photo	Issues	Current Measure	Recommendations	Quantity	Price	Cost Estimation
<b>Bench</b>												
65	Playground at Southwest Side of School	Ext.		Bench	N/A

Recommend providing a stable, firm and slip resistant surface alongside the bench by the playground located at the southwest corner of the school so an individual using a wheeled mobility device could sit with his or her shoulders aligned with someone seated on the bench.	1	-	\$0
<b>Picnic Table</b>												
66	Near Main Entrance	Ext.		Picnic Table	N/A

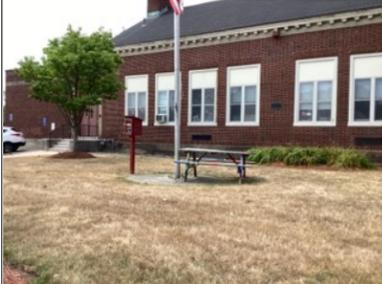
Recommend providing a 48" min. stable, firm, and slip-resistant surface around at least one (1) accessible picnic table at each location where picnic tables are provided.	1	-	\$0
<b>Sign</b>												
67	Entrance at Exterior Ramp	Ext.		Sign	N/A

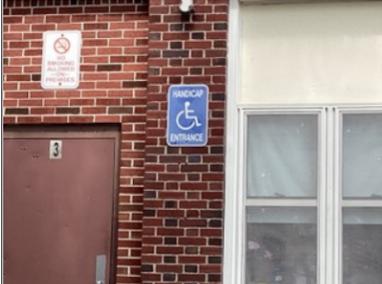
Recommend changing sign language from "Handicap" to "Accessible".	1	-	\$0
<b>Stairs</b>

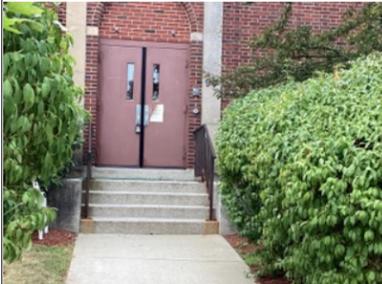
68	Main Entrance Stairs	Ext.		Stairs	N/A

Recommend providing contrasting color strips on the nosings of all stairs.	1	-	\$0

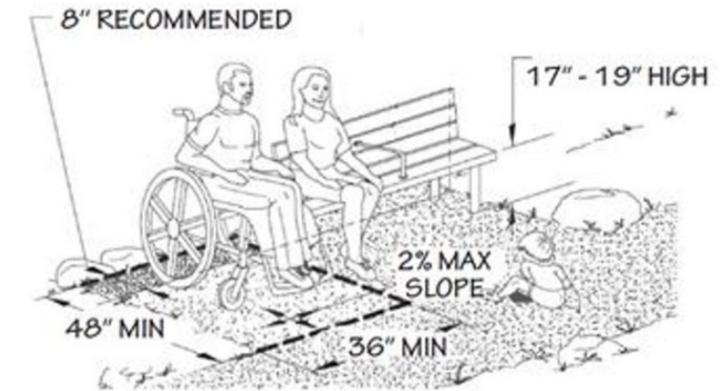
**Figure 1**

- Recommend providing a detectible warning at the Vinton Street crosswalk curb ramp that lacks a detectible warning.
- Recommend providing a 36" min. by 48" min. stable, firm and slip-resistant surface adjacent to at least one bench in each area where benches are provided positioned to allow a person in a wheeled mobility device and a person sitting on the bench to have their shoulders aligned in a manner that is substantially similar to what is shown in Figure 1.

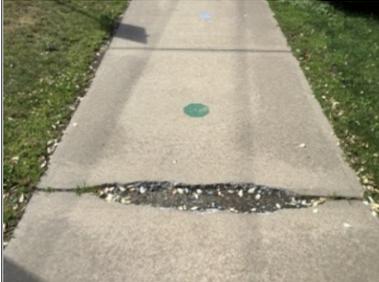
ID	Location	Floor	Room	Element	Type	Photo	Issues	Current Measure	Recommendations	Quantity	Price	Cost Estimation
<b>Approach and Entrance</b>												
<b>Exterior Access Route</b>												
1	Walkway to Secondary Entrance, Egress Door 5	Ext.		Exterior Access Route	Walkway

Surface openings > 1/2"	7"	Repair crack in walkway to ensure the accessible route is maintained in operable working condition.	1	-	\$0
2	Vinton Street Crosswalk	Ext.		Exterior Access Route	Walkway

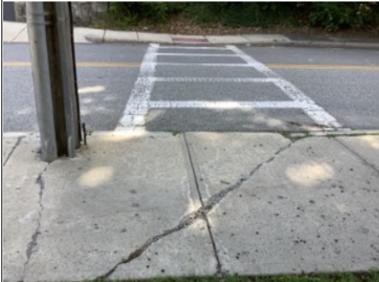
Surface openings > 1/2" Route not maintained in operable working condition	1.5" -	Repair crack in walkway to ensure the accessible route is maintained in operable working condition.	1	-	\$0
3	Route to Egress Door 3 and Egress Door 4	Ext.		Exterior Access Route	Exterior

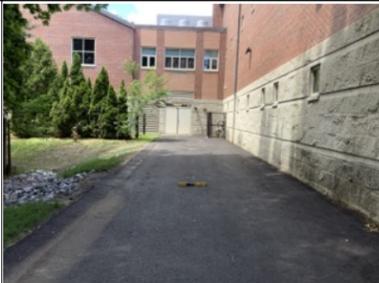
Cross slope > 1:50 (2.00%)	3.7%	Reduce cross slope to be no steeper than 1:50 (2.00%).	1	-	\$0
4	Stair to Secondary Entrance, Egress Door 5	Ext.		Exterior Access Route	Walkway

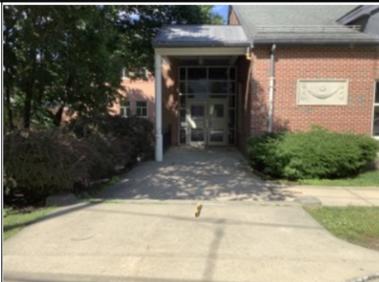
Running slope > 1:20 (5.00%)	7.3%	Reduce running slope to be no steeper than 1:20 (5.00%).	1	-	\$0

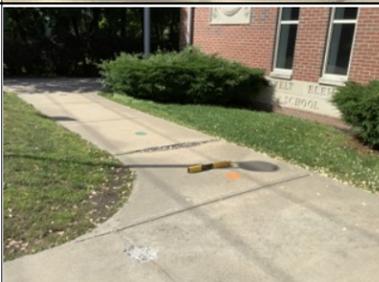
5	Walkway to Secondary Entrance, Egress Door 5	Ext.		Exterior Access Route	Walkway

Route not maintained in operable working condition	-	Repair crack in walkway to ensure the accessible route is maintained in operable working condition.	1	-	\$0

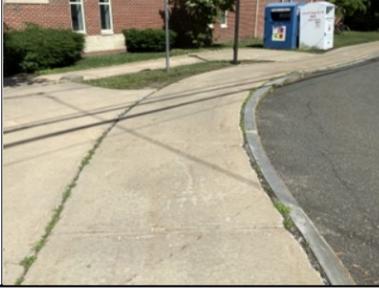
ID	Location	Floor	Room	Element	Type	Photo	Issues	Current Measure	Recommendations	Quantity	Price	Cost Estimation
6	Vinton Street Drop-Off Area	Ext.		Exterior Access Route	Walkway

Route not maintained in operable working condition	-	To ensure the accessible route is maintained in operable working condition, remove the grass in the sidewalk to create a flush and smooth walkway.	1	-	\$0
<b>Curb Ramp</b>												
7	Walkway to Secondary Entrance, Egress Door 5	Ext.		Curb Ramp	N/A

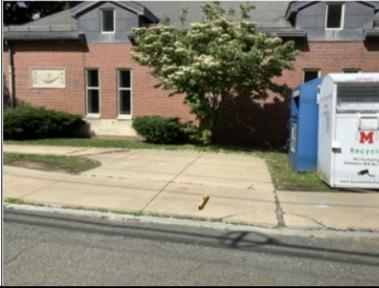
Transition from curb ramp to street not flush	-	Ensure transition from curb ramp to street is flush or free of changes in level.	1	-	\$0
<b>Exterior Stair</b>												
8	Stair to Secondary Entrance, Egress Door 5	Ext.		Exterior Stair	N/A

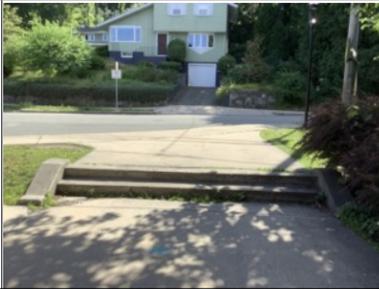
Handrails not provided	-	Provide handrail on one side of the staircase.	1	-	\$0
<b>Emergency Exit</b>												
9	Cafeteria, Egress Door 13	1		Emergency Exit	N/A

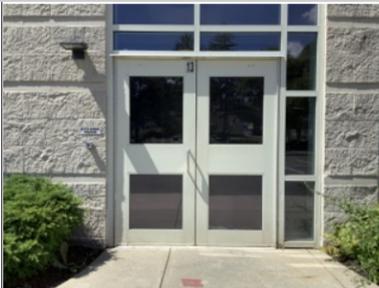
Illuminated Int. Symbol of Acc. not provided (MAAB 2006)	-	Provide an illuminated sign with the International Symbol of Accessibility (ISA).	1	-	\$0

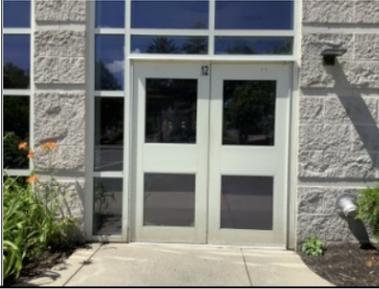
10	Cafeteria, Egress Door 12	1		Emergency Exit	N/A

Illuminated Int. Symbol of Acc. not provided (MAAB 2006)	-	Provide an illuminated sign with the International Symbol of Accessibility (ISA).	1	-	\$0

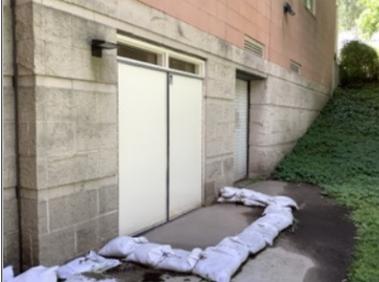
ID	Location	Floor	Room	Element	Type	Photo	Issues	Current Measure	Recommendations	Quantity	Price	Cost Estimation
11	Egress Door 7	Ext.		Emergency Exit	N/A

Provide an accessible sign at the interior of this door directing users to the nearest accessible egress when sandbags or other elements temporarily make this egress inaccessible.	1	-	\$0
12	Egress Door 4	Ext.		Emergency Exit	N/A

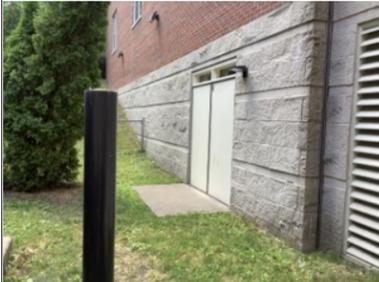
Directional sign to accessible emergency exit not provided	-	Provide a directional sign indicating the location of the nearest accessible emergency exit.	1	-	\$0
<b>Access to Goods and Services</b>												
<b>Means of Egress</b>												
13	Cafeteria, Egress Door 13	1		Means of Egress	N/A

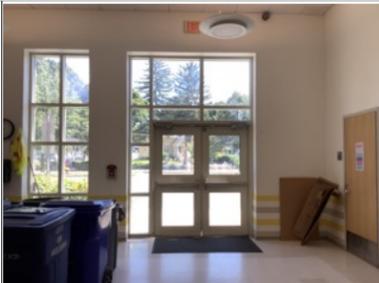
Tactile exit sign not provided Illuminated ISA symbol not provided (MAAB)	- -	Ensure tactile exit signs with raised characters and braille are provided at exit doors. Mount signs between 48"- 60" above the finished floor located on the latch side of the door. Provide an illuminated sign with the International Symbol of Accessibility (ISA).	1	432	\$432

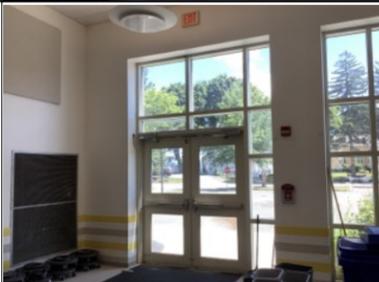
14	Cafeteria, Egress Door 12	1		Means of Egress	N/A

Tactile exit sign not provided Illuminated ISA symbol not provided (MAAB)	- -	Ensure tactile exit signs with raised characters and braille are provided at exit doors. Mount signs between 48"- 60" above the finished floor located on the latch side of the door. Provide an illuminated sign with the International Symbol of Accessibility (ISA).	1	432	\$432
15	Egress Door 9, Stair 1	1		Means of Egress	N/A

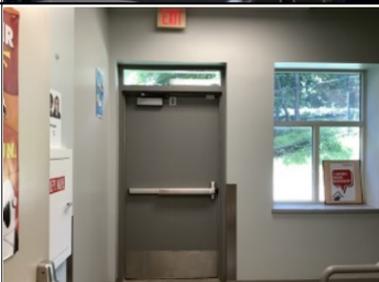
Tactile exit sign not provided Illuminated ISA symbol not provided (MAAB)	- -	Ensure tactile exit signs with raised characters and braille are provided at exit doors. Mount signs between 48"- 60" above the finished floor located on the latch side of the door. Provide an illuminated sign with the International Symbol of Accessibility (ISA).	1	432	\$432

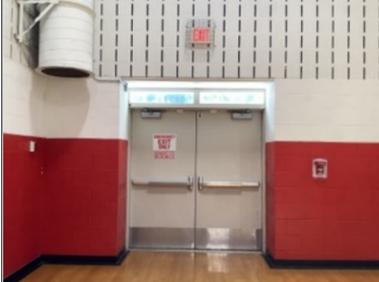
ID	Location	Floor	Room	Element	Type	Photo	Issues	Current Measure	Recommendations	Quantity	Price	Cost Estimation
16	Egress Door 4, Gymnasium	1		Means of Egress	N/A

Tactile exit sign not provided Illuminated ISA symbol not provided (MAAB)	- -	Ensure tactile exit signs with raised characters and braille are provided at exit doors. Mount signs between 48"- 60" above the finished floor located on the latch side of the door. Provide an illuminated sign with the International Symbol of Accessibility (ISA).	1	432	\$432
17	Egress Door 2, Stair 2	1		Means of Egress	N/A

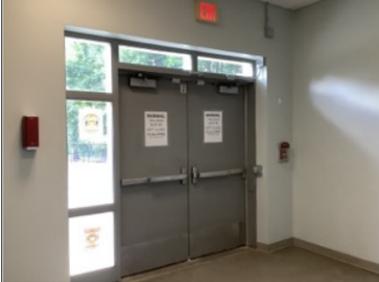
Tactile exit sign not provided Illuminated ISA symbol not provided (MAAB)	- -	Ensure tactile exit signs with raised characters and braille are provided at exit doors. Mount signs between 48"- 60" above the finished floor located on the latch side of the door. Provide an illuminated sign with the International Symbol of Accessibility (ISA).	1	432	\$432

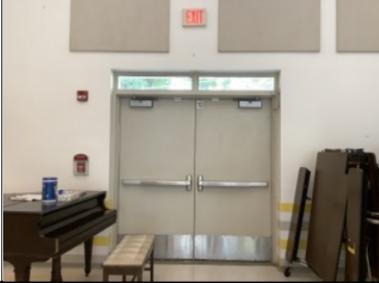
18	Cafeteria, Egress Door 10	1		Means of Egress	N/A

Illuminated ISA symbol not provided (MAAB)	-	Provide an illuminated sign with the International Symbol of Accessibility (ISA).	1	200	\$200
19	Egress Door 8	1		Means of Egress	N/A

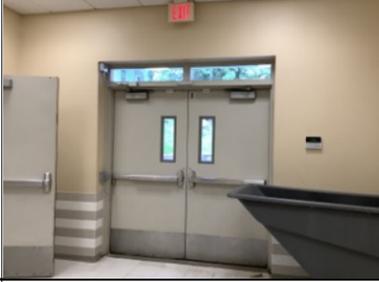
Illuminated ISA symbol not provided (MAAB)	-	Provide an illuminated sign with the International Symbol of Accessibility (ISA).	1	200	\$200
20	Egress Door 7	1		Means of Egress	N/A

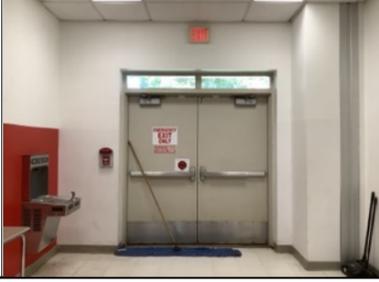
Illuminated ISA symbol not provided (MAAB)	-	Provide an illuminated sign with the International Symbol of Accessibility (ISA).	1	200	\$200

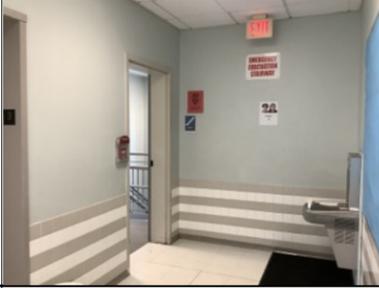
ID	Location	Floor	Room	Element	Type	Photo	Issues	Current Measure	Recommendations	Quantity	Price	Cost Estimation
21	Stair 1	3		Means of Egress	N/A

Directional sign to accessible emergency exit not provided		Provide a directional sign indicating the location of the nearest accessible emergency exit.	1	232	\$232
22	Secondary Entrance, Egress Door 5	Ext.		Means of Egress	N/A

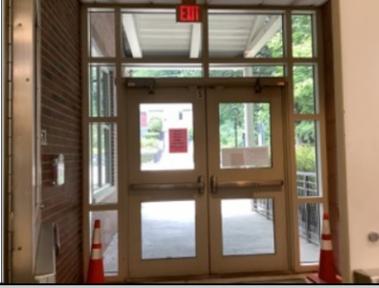
Tactile exit sign not provided Illuminated ISA symbol not provided (MAAB)	- -	Ensure tactile exit signs with raised characters and braille are provided at exit doors. Mount signs between 48"- 60" above the finished floor located on the latch side of the door. Provide an illuminated sign with the International Symbol of Accessibility (ISA).	1	432	\$432
<b>Interior Access Route</b>												
23	Health Office	1		Interior Access Route	N/A

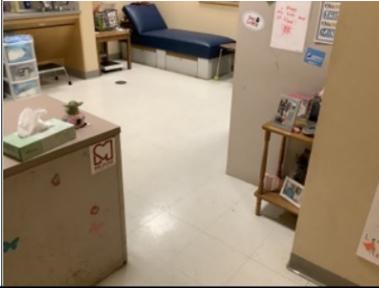
Route < 36" wide	32"	Relocate the wooden table to ensure that a clear width of 36" min. is maintained at the accessible route.	1	Labor	\$0

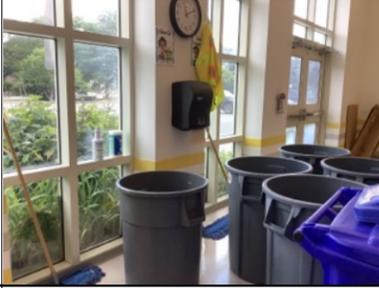
24	Cafeteria	1		Interior Access Route	N/A

Obstructed by protruding objects	9.3"	Relocate paper towel dispenser or provide a cane-detectable barrier 27" max. above the ground under the dispenser.	1	306	\$306
25	Library and Media Center	2		Interior Access Route	N/A

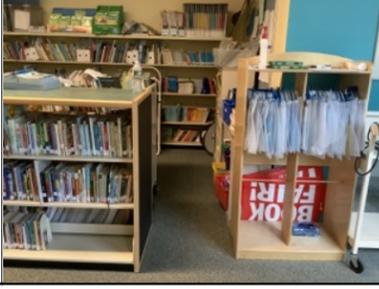
Route < 36" wide	24.6"	Ensure that a clear width of 36" min. is maintained at the accessible route.	1	Labor	\$0

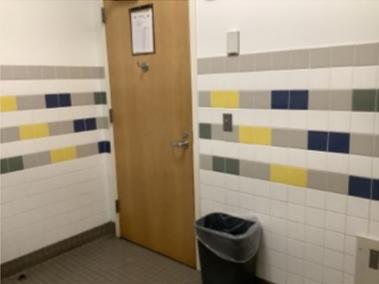
Maneuvering clearance(s) not provided	- 59.6"	Relocate the trash can to provide 18" min. maneuvering clearance on the latch side of the door.	1	Labor	\$0
27	Health Office	1		Doors, Doorways, & Gates	Office

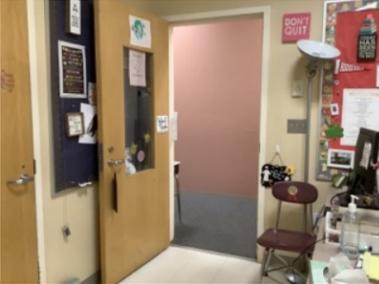
Maneuvering clearance(s) not provided	-	Remove the chair to provide 18" min. maneuvering clearance on the latch side of the door.	1	Labor	\$0
28	Conference Room	1		Doors, Doorways, & Gates	Circulation

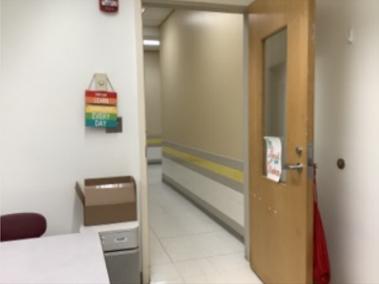
Maneuvering clearance(s) not provided	-	Relocate the heater to provide 18" min. maneuvering clearance at the latch side of the door.	1	Labor	\$0
29	Kindergarten Classroom Passage to Single-User Toilet Room	1		Doors, Doorways, & Gates	Circulation

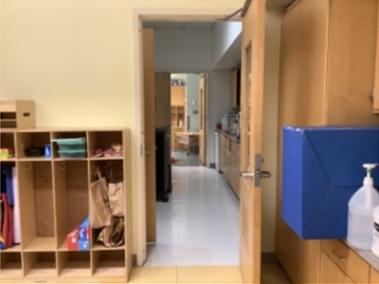
Maneuvering clearance(s) not provided	-	Relocate the shelf to provide 18" min. maneuvering clearance on the latch side of the door.	1	Labor	\$0

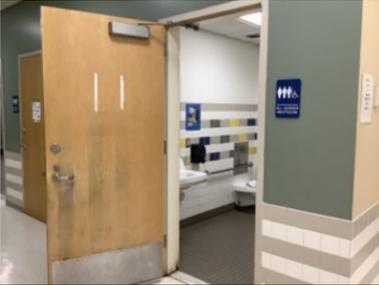
30	Single-User Toilet by Egress Door 8	1		Doors, Doorways, & Gates	Toilet Room

Door requires > 5 lbs. of force to open	10 lbs	Adjust closers so doors do not require more than 5 pounds of force to open.	1	Labor	\$0

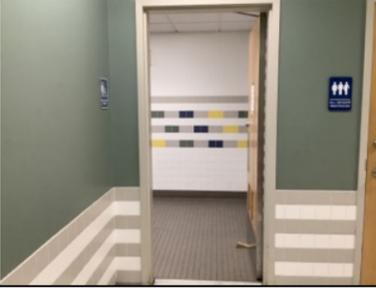
Door requires > 5 lbs. of force to open	10 lbs	Adjust closers so doors do not require more than 5 pounds of force to open.	1	Labor	\$0
32	Men's Multi-User Toilet Room	1		Doors, Doorways, & Gates	Toilet Room

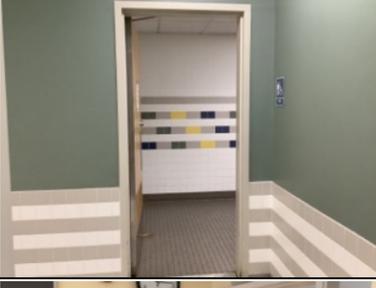
Door requires > 5 lbs. of force to open	10 lbs	Adjust closers so doors do not require more than 5 pounds of force to open.	1	Labor	\$0
33	Third Grade Classroom	2	205	Doors, Doorways, & Gates	Classroom

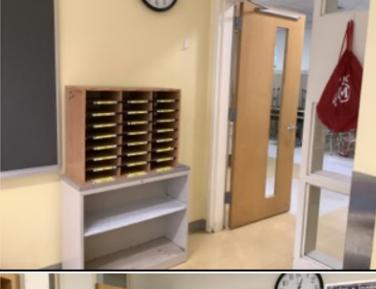
Maneuvering clearance(s) not provided	18.7"	Relocate the cabinet to provide 48" clear depth in front of the door.	1	Labor	\$0
34	Occupational Therapy/Physical Therapy	2	210	Doors, Doorways, & Gates	Classroom

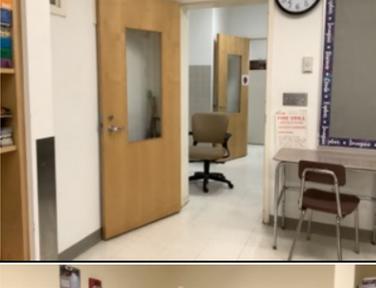
Maneuvering clearance(s) not provided	5"	Relocate the desk and chair to provide 18" min. maneuvering clearance on the latch side of the door.	1	Labor	\$0

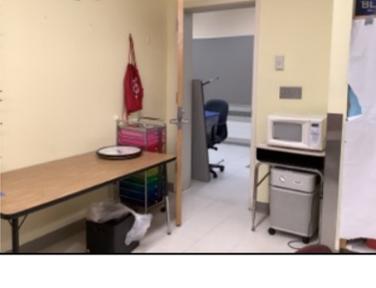
35	Guidance Counselors Office	2	212	Doors, Doorways, & Gates	Classroom

Maneuvering clearance(s) not provided	-	Relocate the table to provide 60" min. deep door maneuvering clearance. Relocate the desk and microwave to provide 18" min. maneuvering clearance on the latch side of the door.	1	Labor	\$0

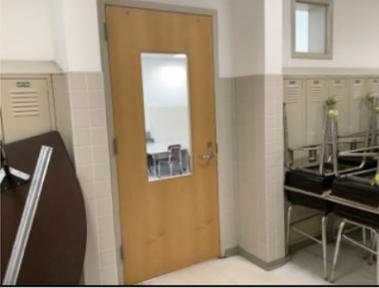
Maneuvering clearance not provided at recess > 6"	-	Install an automatic door opener.	1	3060	\$3060
37	Boys' Multi-User Toilet Room	2		Doors, Doorways, & Gates	Toilet Room

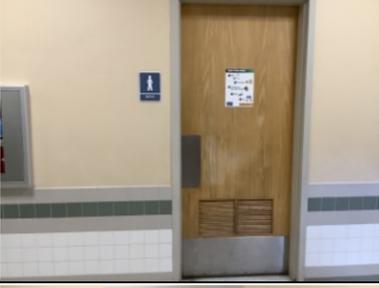
Door requires > 5 lbs. of force to open	10 lbs	Adjust closers so doors do not require more than 5 pounds of force to open.	1	Labor	\$0
38	Girls' Multi-User Toilet Room	2		Doors, Doorways, & Gates	Toilet Room
