# ADA Self-Evaluation and Transition Plan for the City of Melrose

Part 2 of 2

## Part 2: Reports:

January, 2023

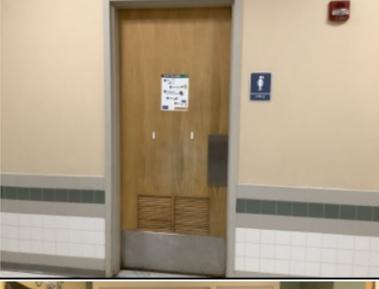
Door requires > 5 lbs. of force to open	10 lbs	Adjust closers so doors do not require more than 5 pounds of force to open.	1	Labor	\$0
39	Fifth Grade Classroom	3	305	Doors, Doorways, & Gates	Classroom

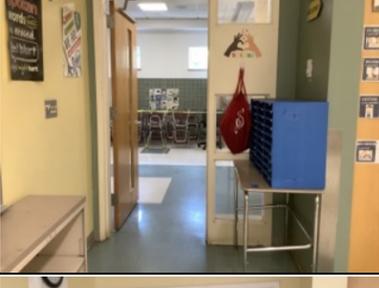
Maneuvering clearance(s) not provided	6"	Relocate the desk to provide 18" min. maneuvering clearance on the latch side of the door.	1	Labor	\$0

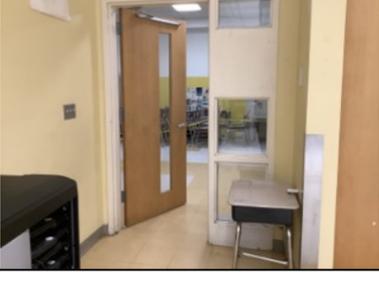
40	Fourth Grade Classroom	3	309	Doors, Doorways, & Gates	Classroom

Maneuvering clearance(s) not provided	6"	Relocate the desk to provide 18" min. maneuvering clearance on the latch side of the door.	1	Labor	\$0

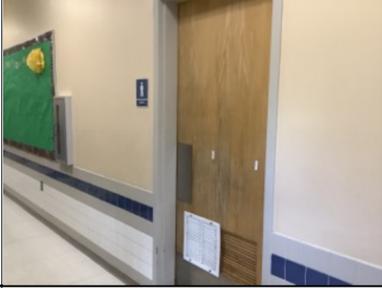
Door requires > 5 lbs. of force to open	10 lbs	Adjust closers so doors do not require more than 5 pounds of force to open.	1	Labor	\$0
42	Girls' Multi-User Toilet Room	3		Doors, Doorways, & Gates	Toilet Room

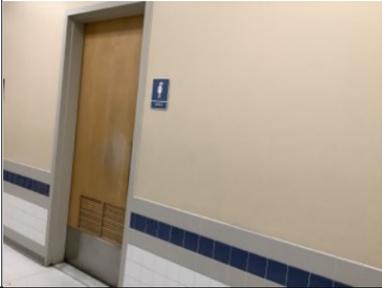
Door requires > 5 lbs. of force to open	10 lbs	Adjust closers so doors do not require more than 5 pounds of force to open.	1	Labor	\$0
<b>Ramps</b>												
43	Cafetorium, Ramp to Stage	1		Ramps	Interior

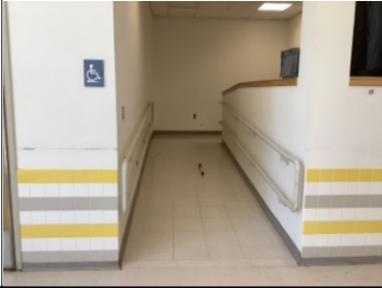
Handrails do not extend 12" past top & bottom	-	Alter handrails to extend horizontally above the landing for 12" min. beyond the top and bottom of ramp runs.	1	-	\$0
<b>Signage</b>												
44	Vestibule to Music Room	1	113	Signage	Designation

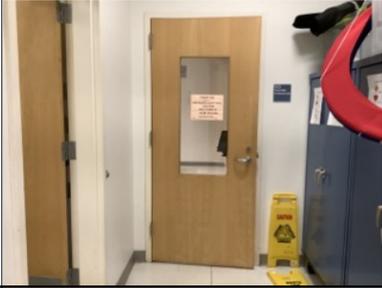
Compliant room designation on signage is not provided	-	Replace sign so field contents read "Music Room" instead of "Work Room".	1	232	\$232

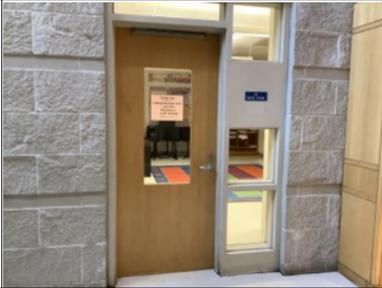
45	Music Room	1	113	Signage	Designation

Braille not provided on sign	-	Provide braille on the sign.	1	232	\$232

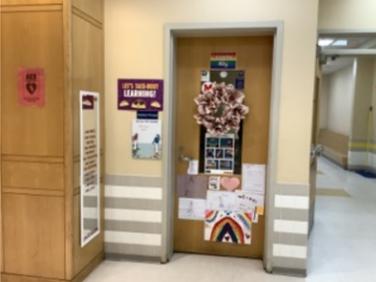
Braille not provided on sign	-	Provide braille on the sign.	1	232	\$232
47	Health Office Single-User Toilet Room	1		Signage	Designation

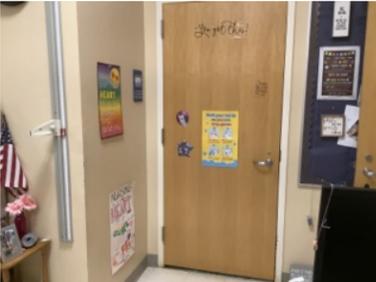
Sign not located on the latch side of the door	-	Locate the sign at permanent rooms alongside the door on the latch side.	1	Labor	\$0
48	Kindergarten Classroom, Single-User Toilet Room	1		Signage	Designation

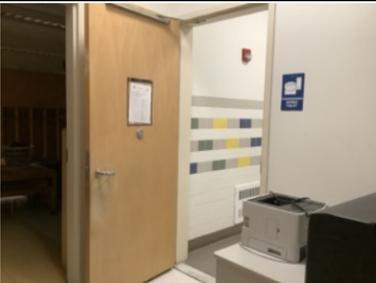
Signage lacks 18" by 18" clear floor space	-	Relocate the cabinet to provide a clear floor space of 18" min. by 18" min.	1	Labor	\$0
49	Occupational Therapy/Physical Therapy	2	208	Signage	Designation

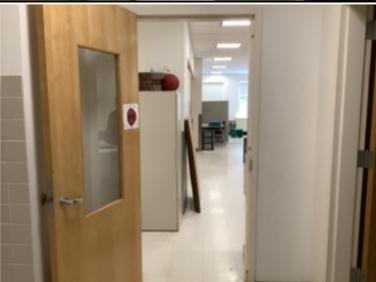
Signage is not provided	-	Locate compliant signage alongside the door on the latch side.	1	232	\$232
50	Occupational Therapy/Physical Therapy	2	210	Signage	Designation

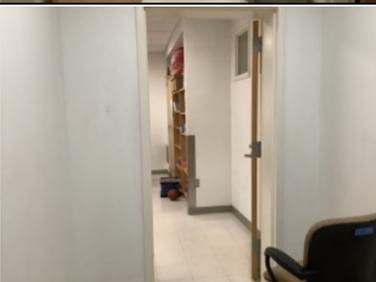
Signage is not provided	-	Locate compliant signage alongside the door on the latch side.	1	232	\$232

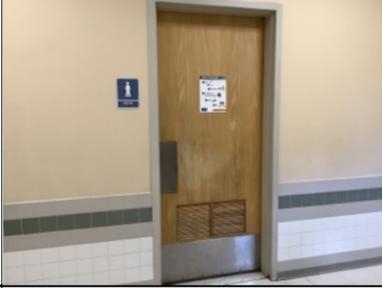
International Symbol of Acc. not provided	-	Replace the sign with a sign containing the International Symbol of Accessibility (ISA).	1	232	\$232
52	OT/PT Former Music Room	3	317	Signage	Designation

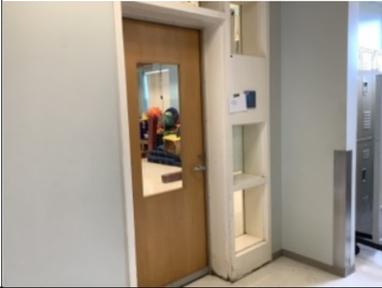
Designation signage has wrong room name		Update designation signage to reflect change in room use from music room to OP/PT.	1		\$0
<b>Dining or Work Surfaces</b>												
53	Library and Media Center	2		Dining or Work Surfaces	Work Surface

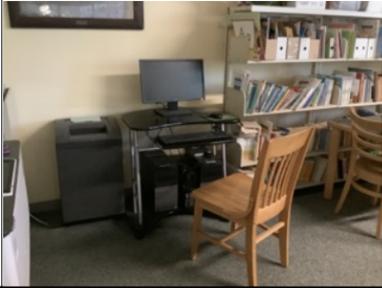
Knee or toe clearance not provided	26"	Provide at least one computer work surface with 27" min. knee and toe clearance.	1	700	\$700
<b>Exterior Benches</b>												
54	Brunswick Park Road	Ext.		Exterior Benches	N/A

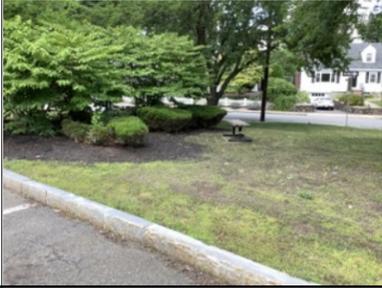
No accessible route to one bench in area	-	Relocate one bench to an accessible route or provide an accessible route to at least one bench in this area.	1	-	\$0

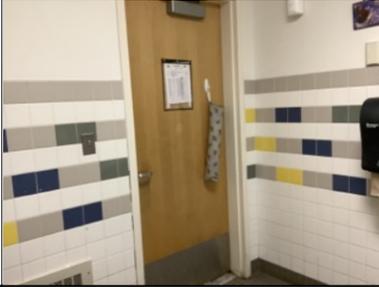
Hook located > 54" high	59.4"	Locate the coat hook no higher than 48" above the finished floor.	1	150	\$150
56	Main Office, Single-User Toilet Room	1		Single-User Toilet	N/A

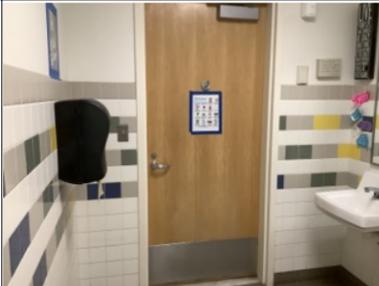
Hook located > 54" high	61.5"	Locate the coat hook no higher than 48" above the finished floor.	1	150	\$150
<b>Toilet Compartment</b>												
57	Women's Multi-User Toilet Room	1		Toilet Compartment	Accessible Compartment

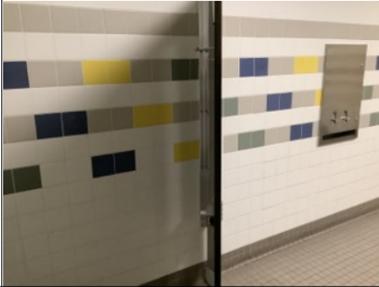
Door has non-compliant hardware Door has malfunctioning self-closing hinge Door pull not provided	- - -	Provide hardware that can be operable with one hand and not require tight grasping, pinching, or twisting of the wrist. Repair hinge. Provide a door pull on each side of the door between 34" to 48" above the finished floor that does not require tight grasping, pinching or twisting of the wrist.	1	140	\$140

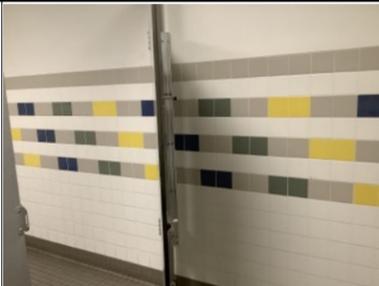
58	Men's Multi-User Toilet Room	1		Toilet Compartment	Accessible Compartment

Door has non-compliant hardware Door has malfunctioning self-closing hinge Door pull not provided	- - -	Provide hardware that can be operable with one hand and not require tight grasping, pinching, or twisting of the wrist. Repair hinge. Provide a door pull on each side of the door between 34" to 48" above the finished floor that does not require tight grasping, pinching or twisting of the wrist.	1	140	\$140
59	Girls' Multi-User Toilet Room	2		Toilet Compartment	Accessible Compartment

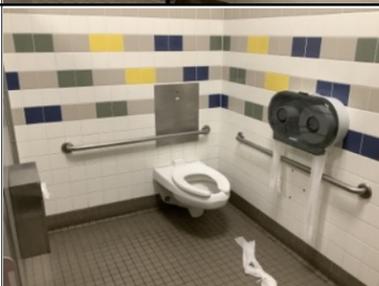
Non-compliant toilet paper dispenser Non-compliant toilet cover dispenser	- -	Relocate toilet paper so that it is 24" min high, located under the grab bar, and between 7" and 9" from the front of the toilet. Relocate toilet cover dispenser so the operable parts are no higher than 42" on the side of the toilet.	1	706	\$706

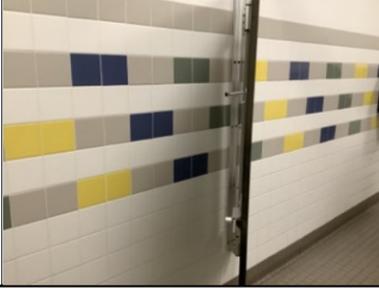
Door pull not provided	-	Provide a door pull on each side of the door between 34" to 48" above the finished floor that does not require tight grasping, pinching or twisting of the wrist.	1	70	\$70
<b>Urinal</b>												
61	Men's Multi-User Toilet Room	1		Urinal	N/A

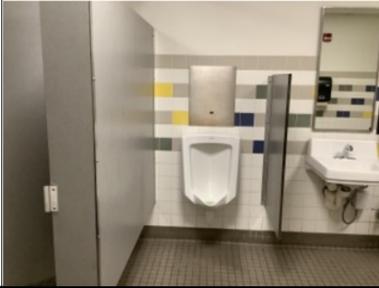
Rim > 17" high	18.7"	Provide at least one urinal with the rim no higher than 17" above the finished floor.	1	3248	\$3248
<b>Dispensers</b>												
62	Women's Multi-User Toilet Room	1		Dispensers	Paper Towel Dispenser

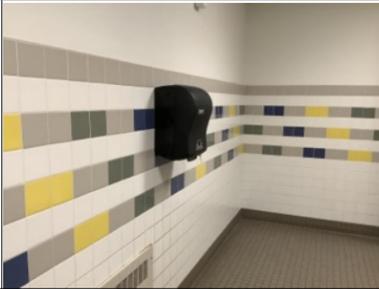
Dispenser acts as a protruding object	9.7"	Relocate paper towel dispenser out of the circulation path or provide a cane-detectible barrier 27" max. above the finished floor below the dispenser.	1	306	\$306

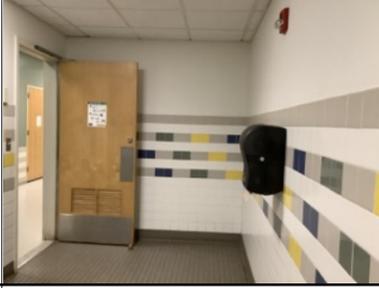
63	Men's Multi-User Toilet Room	1		Dispensers	Paper Towel Dispenser

Dispenser acts as a protruding object	9.4"	Relocate paper towel dispenser out of the circulation path or provide a cane-detectible barrier 27" max. above the finished floor below the dispenser.	1	306	\$306
64	Single-User Toilet Room by Music Room	1		Dispensers	Paper Towel Dispenser

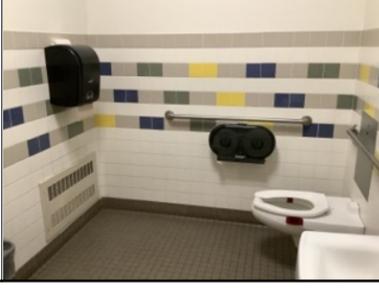
Paper towel dispenser acts as a protruding object	9.6"	Relocate paper towel dispenser out of the circulation path or provide a cane-detectible barrier 27" max. above the finished floor below the dispenser.	1	306	\$306

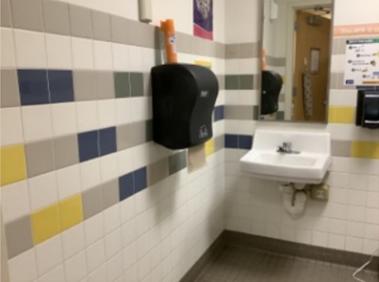
Paper towel dispenser acts as a protruding object	9.6"	Relocate paper towel dispenser out of the circulation path or provide a cane-detectible barrier 27" max. above the finished floor below the dispenser.	1	306	\$306
66	Main Office Single-User Toilet Room	1		Dispensers	Paper Towel Dispenser

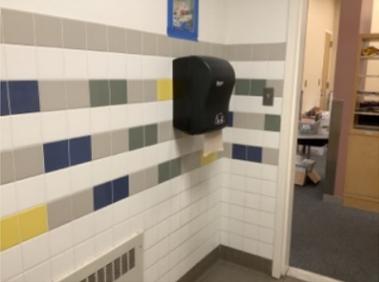
Paper towel dispenser acts as a protruding object	9.6"	Relocate paper towel dispenser out of the circulation path or provide a cane-detectible barrier 27" max. above the finished floor below the dispenser.	1	306	\$306
67	Single-User Toilet by Egress Door 8	1		Dispensers	Paper Towel Dispenser

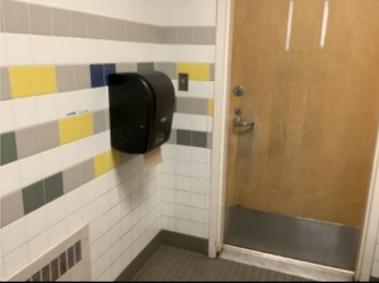
Paper towel dispenser acts as a protruding object	10.2"	Relocate paper towel dispenser out of the circulation path or provide a cane-detectible barrier 27" max. above the finished floor below the dispenser.	1	306	\$306

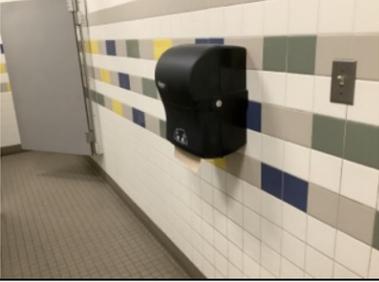
68	Girls' Multi-User Toilet Room	2		Dispensers	Paper Towel Dispenser

Paper towel dispenser acts as a protruding object	9.7"	Relocate paper towel dispenser out of the circulation path or provide a cane-detectible barrier 27" max. above the finished floor below the dispenser.	1	306	\$306
<b>Toilet Rooms for Children</b>												
<b>Single-User Toilet (Children)</b>												
69	Single-User Toilet by Egress Door 8	1		Single-User Toilet (Children)	444

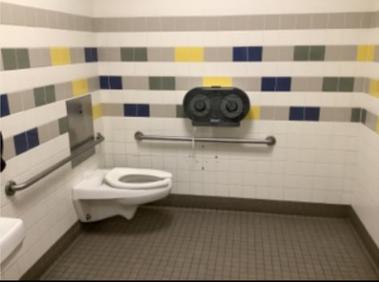
Non-compliant toilet paper dispenser	-	Relocate toilet paper dispenser so that it is between 14"- 19" above the floor and between 7"- 9" in front of the toilet. Ensure dispensers and other devices are not mounted above grab bars./Replace dispenser as it does not allow continuous paper flow.	1	353	\$353

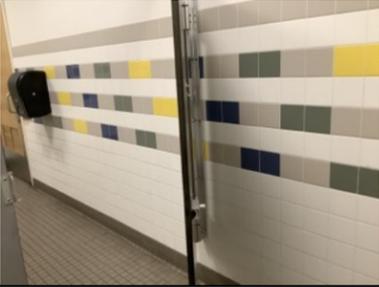
Door with malfunctioning self-closing hinge Door pull not provided	- -	Repair self-closing hinge. Provide a door pull on each side of the door between 34" to 48" above the finished floor that does not require tight grasping, pinching or twisting of the wrist.	1	70	\$70
71	Boys' Multi-User Toilet Room	2		Toilet Compartment (Children)	Accessible Compartment

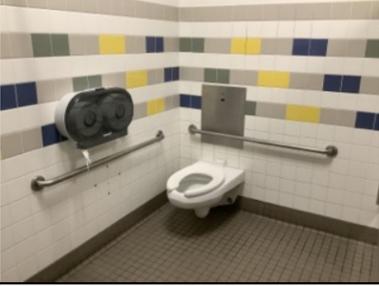
Non-compliant toilet paper dispenser	-	Relocate toilet paper so that it is 24" min. high, located under the grab bar, and between 7" and 9" from the front of the toilet.	1	353	\$353
72	Girls' Multi-User Toilet Room	3		Toilet Compartment (Children)	Accessible Compartment

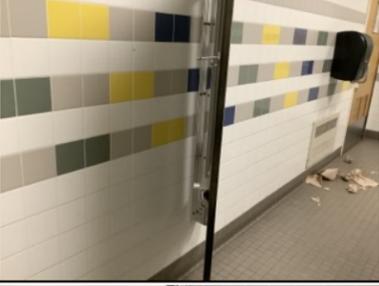
Door with malfunctioning self-closing hinge Door pull not provided	- -	Repair self-closing hinge. Provide a door pull on each side of the door between 34" to 48" above the finished floor that does not require tight grasping, pinching or twisting of the wrist.	1	70	\$70

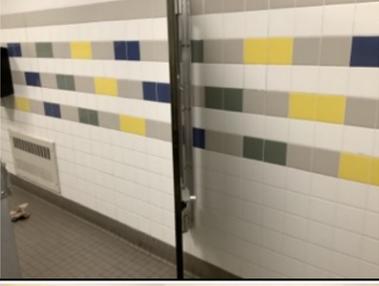
73	Boys' Multi-User Toilet Room	3		Toilet Compartment (Children)	Accessible Compartment

Door pull not provided Coat hook not within reach range	- 47.2"	Provide a door pull on each side of the door between 34" to 48" above the finished floor that does not require tight grasping, pinching or twisting of the wrist. Lower hook so that it is no higher than 36" high for children ages 3-4/40" for children ages 5-8/44" for children ages 9-12.	1	220	\$220
74	Boys' Multi-User Toilet Room	3		Toilet Compartment (Children)	Accessible Compartment

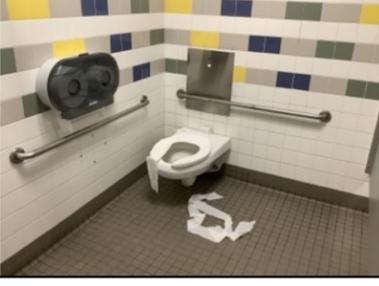
Non-compliant toilet paper dispenser	-	Relocate toilet paper dispenser so that it is between 14"- 19" above the finished floor and between 7"- 9" in front of the toilet. Ensure dispensers and other devices are not mounted above grab bars./Replace dispenser as it does not allow continuous paper flow.	1	353	\$353

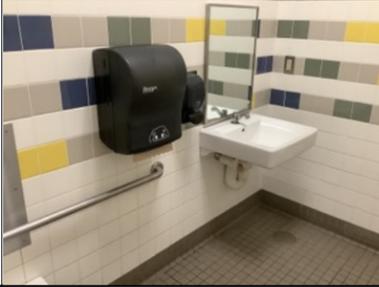
Dispenser is a protruding object	9.6"	Relocate dispenser out of the circulation path.	1	256 / 353	\$256353
76	Boys' Multi-User Toilet Room	2		Dispensers (Children)	Paper Towel Dispenser

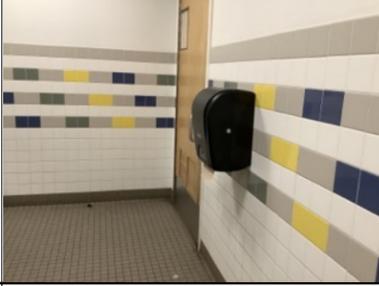
Paper towel dispenser is a protruding object	9.9"	Relocate paper towel dispenser out of the circulation path.	1	353	\$353
77	Girl's Multi-User Toilet Room	3		Dispensers (Children)	Paper Towel Dispenser

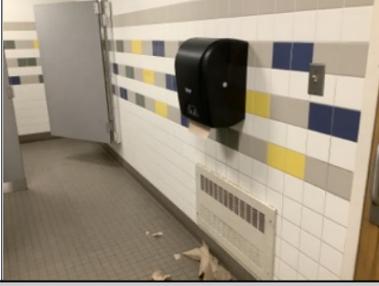
Dispenser is a protruding object	9.7"	Relocate dispenser out of the circulation path.	1	353	\$353
<b>Urinal (Children)</b>												
78	Boys' Multi-User Toilet Room	2		Urinal (Children)	N/A

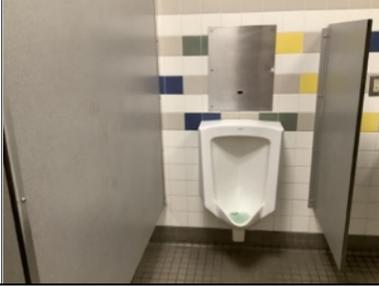
Rim > 15" high (MAAB)	16.7"	Provide at least one urinal with the rim no higher than 15" above the finished floor.	1	3248	\$3248

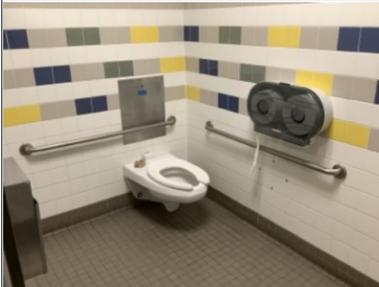
Dispenser located above grab bar	-	Relocate the toilet paper dispenser 1.5" min. underneath the grab bar.	1	353	\$353

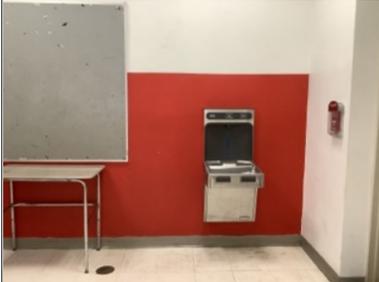
No drinking fountain provided for standing users	-	Provide an additional drinking fountain for standing users or install a Hi-Lo drinking fountain.	1	4028	\$4028
81	By Main Office	1		Drinking Fountains	Low

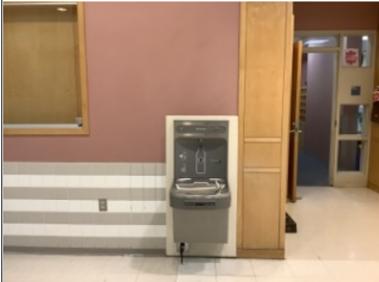
No drinking fountain provided for standing users Knee or toe clearance not provided	- 22.5"	Provide an additional drinking fountain for standing users. Provide knee and toe clearance, 27" min. high at drinking fountain for seated users.	1	6056	\$6056
82	By Library and Media Center	2		Drinking Fountains	Low

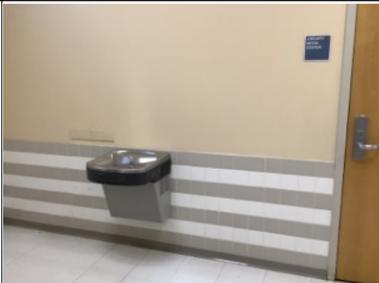
No drinking fountain provided for standing users	-	Provide an additional drinking fountain for standing users or install a Hi-Lo drinking fountain.	1	4028	\$4028

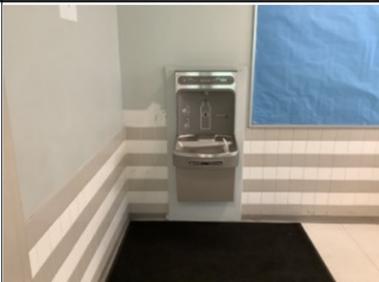
83	By Elevator	3		Drinking Fountains	Low

No drinking fountain provided for standing users Knee or toe clearance not provided	- 24"	Provide an additional drinking fountain for standing users or install a Hi-Lo drinking fountain. Provide knee and toe clearance, 27" min. high at drinking fountain for seated users.	1	6056	\$6056
<b>Sink</b>												
84	Health Office	1		Sink	Other

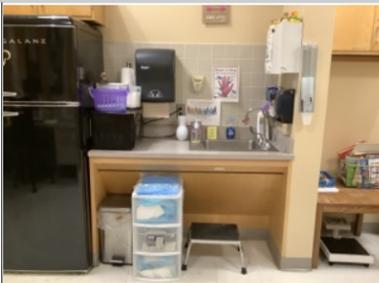
Clear floor space not provided at sink	-	Relocate cabinet and stool underneath the sink to provide a 30" by 48" clear floor space positioned for a forward approach.	1	Labor	\$0

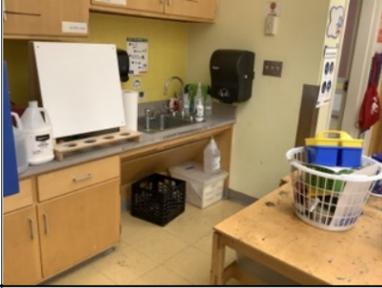
Clear floor space not provided at sink	-	Relocate objects underneath the sink to provide a 30" by 48" clear floor space positioned for a forward approach.	1	Labor	\$0
86	Third Grade Classroom	2	205	Sink	Classroom

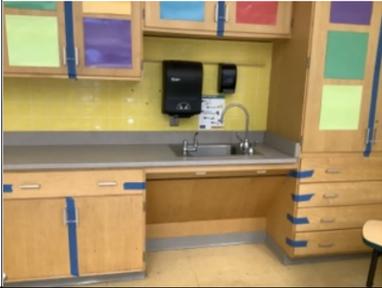
Dispenser not within reach range	51"	Relocate dispenser 48" max. above the finished floor or ground.	1	Labor	\$0
<b>Bike Rack</b>												
87	Walkway to Secondary Entrance, Egress Door 5	Ext.		Bike Rack	N/A

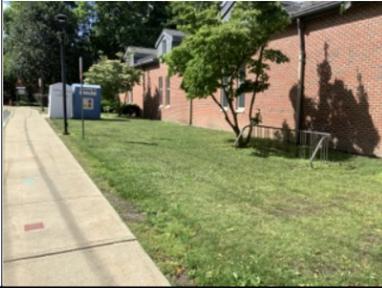
Provide an accessible route to the bike rack or relocate the bike rack to an accessible location.	1		\$0
<b>Best Practice</b>												
<b>Bench</b>												
88	Brunswick Park Road	Ext.		Bench	N/A

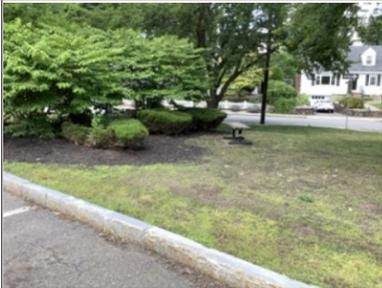
Recommend providing a 36" min. by 48" min. stable, firm and slip-resistant surface adjacent to at least one bench in each area where benches are provided positioned to allow a person in a wheeled mobility device and a person sitting on the bench to have their shoulders aligned.	1		\$0

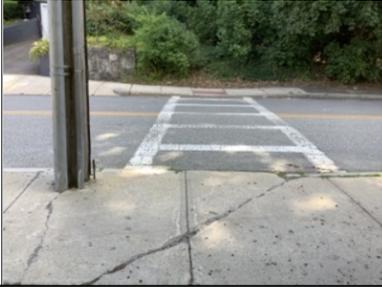
Recommend providing a detectible warning at the cross walk curb ramp that lacks a detectible warning.	1		\$0
<b>Dispenser</b>												
90	Women's Multi-User Toilet Room	1		Dispenser	N/A

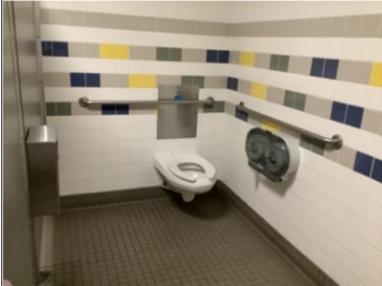
Recommend relocating sanitary napkin disposal bin to a location closer to the toilet on the side wall by but not above the grab bar. Note: Dispensers are not permitted to be located above the grab bar per 521 CMR., the regulations of the Massachusetts Architectural Access Board (MAAB).	1	-	\$0
91	Girls' Multi-User Toilet Room	2		Dispenser	N/A

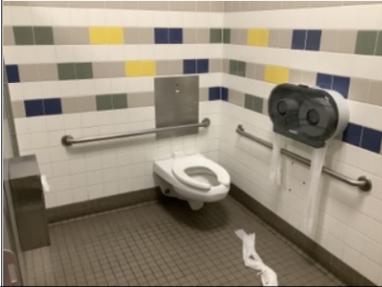
Recommend relocating sanitary napkin disposal bin to a location closer to the toilet on the side wall by but not above the grab bar. Note: Dispensers are not permitted to be located above the grab bar per 521 CMR., the regulations of the Massachusetts Architectural Access Board (MAAB).	1	-	\$0

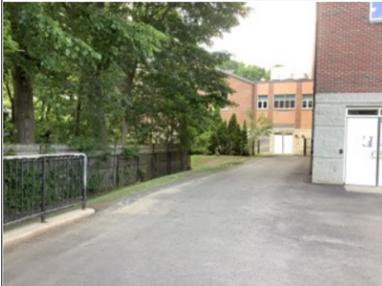
<b>Fence</b>												
92	Blacktop	Ext.		Fence	N/A

Recommend continuing fencing along where steep drop-off occurs.	1	-	\$0

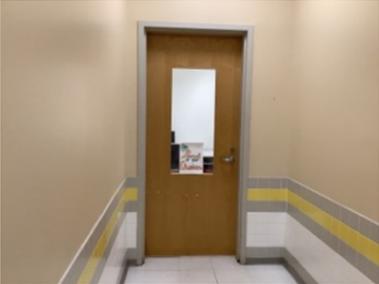
Recommend providing signage with raised characters and braille on the latch side of the door to all permanent rooms that lack designation signage.	1	-	\$0

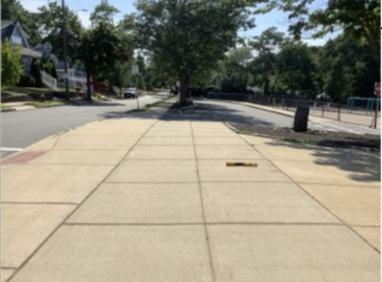
Cross slope > 1:50 (2.00%)	3%	Reduce cross slope to be no steeper than 1:50 (2.00%).	1	-	\$0
2	Egress Door 1, Main Entrance to Playground	Ext.		Exterior Access Route	Sidewalk

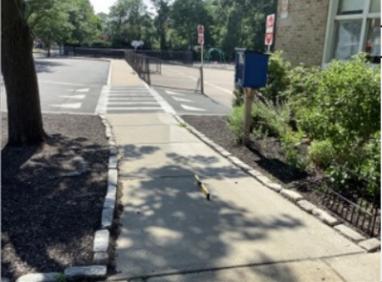
Cross slope > 1:50 (2.00%) Running slope > 1:20 (5.00%)	3% 8.3%	Reduce cross slope to be no steeper than 1:50 (2.00%). Reduce running slope to be no steeper than 1:20 (5.00%).	1	-	\$0
3	Egress Door 12 to 1st Street	Ext.		Exterior Access Route	Walkway

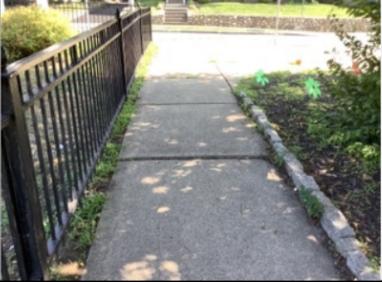
Level changes > 1/4"	2.5"	Repair the sidewalk so the change in level is at 1/4" height max.	1	-	\$0
<b>Curb Ramp</b>												
4	1st Street to Main Entrance, Egress Door 1	Ext.		Curb Ramp	Perpendicular

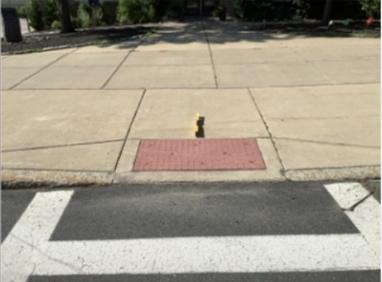
Transition from curb ramp to street not flush	-	Ensure transition from curb ramp to street is flush or free of changes in level.	1	-	\$0

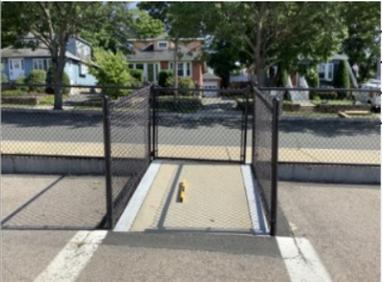
Running slope > 1:12 (8.33%) Cross slope of ramp > 1:50 (2.00%) Directional sign to accessible ramp not provided Handrails are not provided	16.2% 2.5%	Reduce running slope to be no steeper than 1:12 (8.33%). Reduce cross slope to be no steeper than 1:50 (2.00%). Provide a directional sign indicating the location of the nearest accessible ramp. Provide handrails with 1-1/4" to 1-1/2" circular cross sections.	1	-	\$0

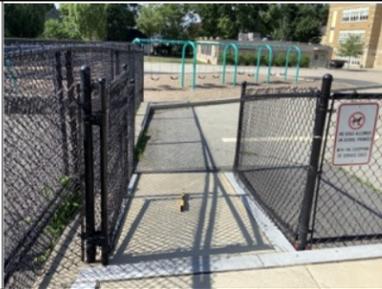
Running slope > 1:12 (8.33%) Cross slope of ramp > 1:50 (2.00%) Handrails are not provided	14% 2.5%	Reduce running slope to be no steeper than 1:12 (8.33%). Reduce cross slope to be no steeper than 1:50 (2.00%). Provide handrails with 1-1/4" to 1-1/2" circular cross sections.	1	-	\$0
<b>Exterior Stair</b>												
7	Entrance Door 7	Ext.		Exterior Stair	N/A

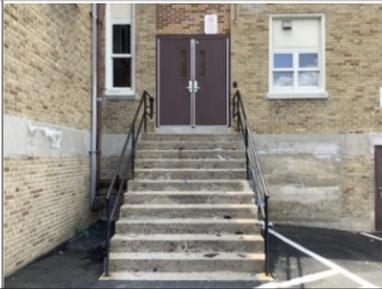
Handrails do not extend 12" from stair	-	Top: Ensure handrails extend horizontally above the landing for 12" min. beginning above the first riser nosing. Bottom: Ensure that the sloped bottom extension extends one tread depth min. beyond last riser nosing in same direction as stair flight.	1	-	\$0
8	Main Entrance, Egress Doors 8, 9, 10	Ext.		Exterior Stair	N/A

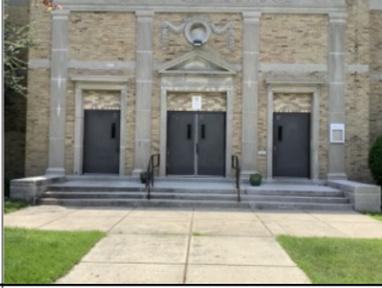
Handrails do not extend 12" from stair Cross section of handrail is not compliant	- -	Top: Ensure handrails extend horizontally above the landing for 12" min. beginning above the first riser nosing. Bottom: Ensure that the sloped bottom extension extends one tread depth min. beyond last riser nosing in same direction as stair flight. Provide handrails with 1 1/4" - 2" circular cross sections or 4"- 6 1/4" non-circular cross sections.	1	-	\$0

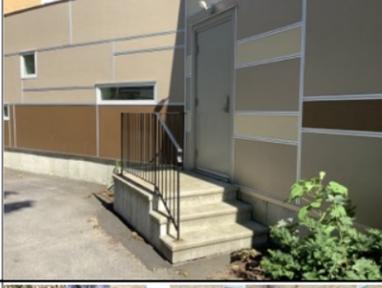
9	North Egress Door	Ext.		Exterior Stair	N/A

Handrails do not extend 12" from stair Cross section of handrail is not compliant Handrail not provided on both sides	- - -	Top: Ensure handrails extend horizontally above the landing for 12" min. beginning above the first riser nosing. Bottom: Ensure that the sloped bottom extension extends one tread depth min. beyond last riser nosing in same direction as stair flight. Provide handrails with 1 1/4" - 2" circular cross sections or 4"- 6 1/4" non-circular cross sections.	1	-	\$0
10	Stair to Egress Door 6	Ext.		Exterior Stair	N/A

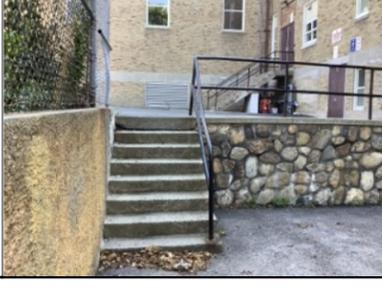
Handrails do not extend 12" from stair Handrail not provided on both sides	- -	Top: Ensure handrails extend horizontally above the landing for 12" min. beginning above the first riser nosing. Bottom: Ensure that the sloped bottom extension extends one tread depth min. beyond last riser nosing in same direction as stair flight. Provide a handrail on one side.	1	-	\$0

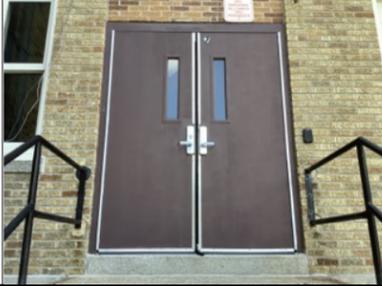
ID	Location	Floor	Room	Element	Type	Photo	Issues	Current Measure	Recommendations	Quantity	Price	Cost Estimation
<b>Entrance</b>												
11	Entrance Door 7	Ext.		Entrance	Secondary Entrance

Entrance not on an accessible route Directional sign to accessible entrance not provided	- -	Provide a directional sign indicating the location of the nearest accessible entrance.	1	-	\$0
12	Main Entrance, Egress Doors 8, 9, 10	Ext.		Entrance	Secondary Entrance

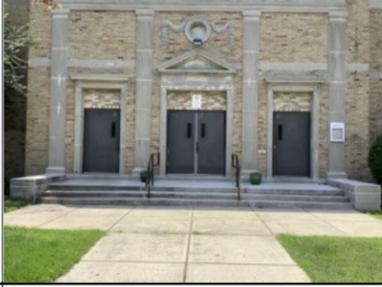
Entrance not on an accessible route Directional sign to accessible entrance not provided Threshold > 1/2" high	- - 3.5"	Provide a directional sign indicating the location of the nearest accessible entrance. Alter threshold to be 1/2" high max.	1	-	\$0
13	Northwest Entrance Door	Ext.		Entrance	Other

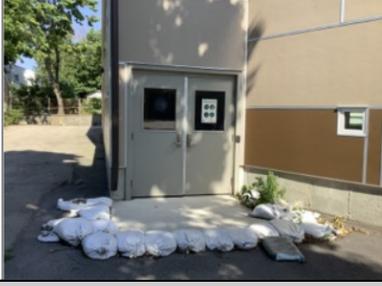
Directional sign to accessible entrance not provided	-	If this door is an entrance, provide a directional sign indicating the location of the nearest accessible entrance.	1	-	\$0

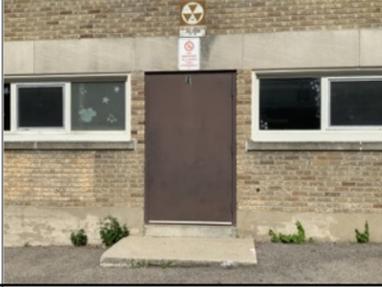
<b>Emergency Exit</b>												
14	Door 4	Ext.		Emergency Exit	N/A

Directional sign to accessible emergency exit not provided	-	Provide a directional sign indicating the location of the nearest accessible emergency exit.	1	-	\$0
15	North Egress Door	Ext.		Emergency Exit	N/A

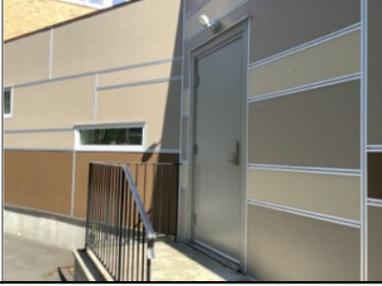
Directional sign to accessible emergency exit not provided	- -	Provide a directional sign indicating the location of the nearest accessible emergency exit.	1	-	\$0

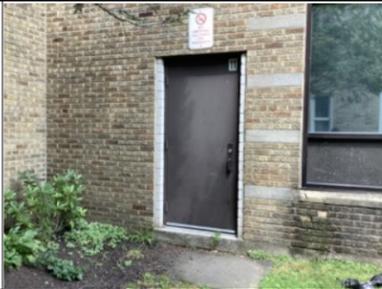
ID	Location	Floor	Room	Element	Type	Photo	Issues	Current Measure	Recommendations	Quantity	Price	Cost Estimation
16	Door 11, From Reading Room	Ext.		Emergency Exit	N/A

Directional sign to accessible emergency exit not provided	-	Provide a directional sign indicating the location of the nearest accessible emergency exit.	1	-	\$0
17	Entrance Door 12	Ext.		Emergency Exit	N/A

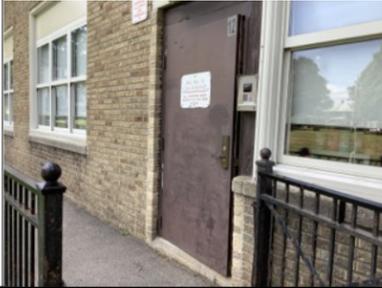
Directional sign to accessible emergency exit not provided Threshold > 1/2" high	- 4.5"	Provide a directional sign indicating the location of the nearest accessible emergency exit. Alter the threshold to be 1/2" high max.	1	-	\$0
<b>Access to Goods and Services</b>												
<b>Means of Egress</b>												
18	Northwest Egress	1		Means of Egress	N/A

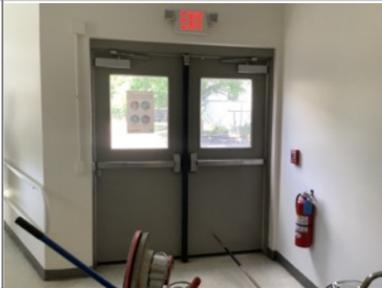
Tactile exit sign not provided Illuminated ISA symbol not provided (MAAB)	- -	Ensure tactile exit signs with raised characters and braille are provided at exit doors. Mount signs between 48"- 60" above the finished floor located on the latch side of the door. Provide an illuminated sign with the International Symbol of Accessibility (ISA).	1	432	\$432

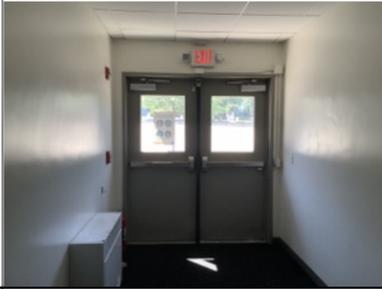
19	South Egress Door	1		Means of Egress	N/A

Tactile exit sign not provided Illuminated ISA symbol not provided (MAAB)	- -	Ensure tactile exit signs with raised characters and braille are provided at exit doors. Mount signs between 48"- 60" above the finished floor located on the latch side of the door. Provide an illuminated sign with the International Symbol of Accessibility (ISA).	1	432	\$432
20	Main Entrance - Egress Door 1	1		Means of Egress	N/A

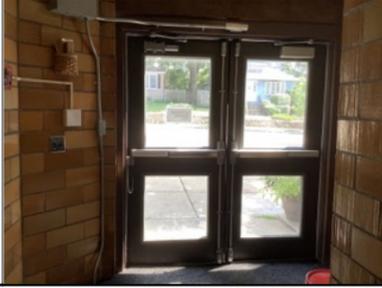
Tactile exit sign not provided Illuminated ISA symbol not provided (MAAB)	- -	Ensure tactile exit signs with raised characters and braille are provided at exit doors. Mount signs between 48"- 60" above the finished floor located on the latch side of the door. Provide an illuminated sign with the International Symbol of Accessibility (ISA).	1	432	\$432

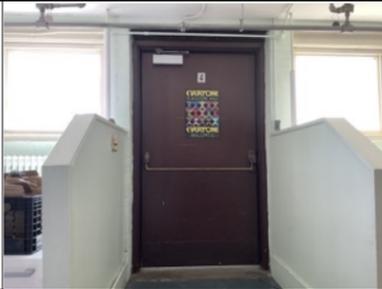
ID	Location	Floor	Room	Element	Type	Photo	Issues	Current Measure	Recommendations	Quantity	Price	Cost Estimation
21	Music Room - Egress Door 4	Basement		Means of Egress	N/A

Tactile exit sign not provided Directional sign to accessible emergency exit not provided	- -	Ensure tactile exit signs with raised characters and braille are provided at exit doors. Mount signs between 48"- 60" above the finished floor located on the latch side of the door. Provide a directional sign indicating the location of the nearest accessible emergency exit.	1	464	\$464
22	North Egress Door	1		Means of Egress	N/A

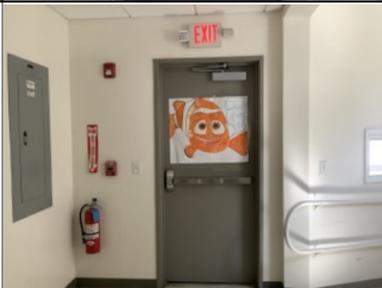
Tactile exit sign not provided Directional sign to accessible emergency exit not provided	- -	Ensure tactile exit signs with raised characters and braille are provided at exit doors. Mount signs between 48"- 60" above the finished floor located on the latch side of the door. Provide a directional sign indicating the location of the nearest accessible emergency exit.	1	464	\$464

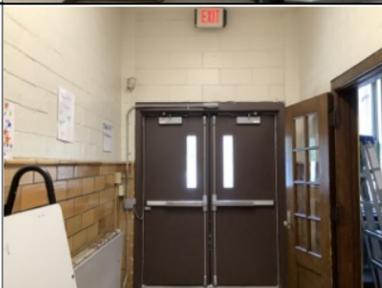
23	Egress Door 7	1		Means of Egress	N/A

Tactile exit sign not provided Directional sign to accessible emergency exit not provided	- -	Ensure tactile exit signs with raised characters and braille are provided at exit doors. Mount signs between 48"- 60" above the finished floor located on the latch side of the door. Provide a directional sign indicating the location of the nearest accessible emergency exit.	1	464	\$464
24	Egress Door 12	1		Means of Egress	N/A

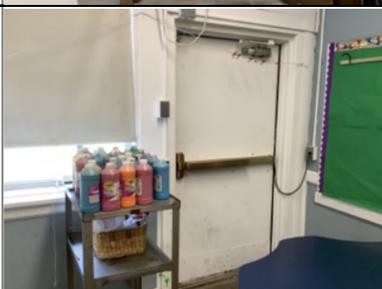
Tactile exit sign not provided Directional sign to accessible emergency exit not provided	- -	Ensure tactile exit signs with raised characters and braille are provided at exit doors. Mount signs between 48"- 60" above the finished floor located on the latch side of the door. Provide a directional sign indicating the location of the nearest accessible emergency exit.	1	464	\$464
25	Reading Room - Door 11	1		Means of Egress	N/A

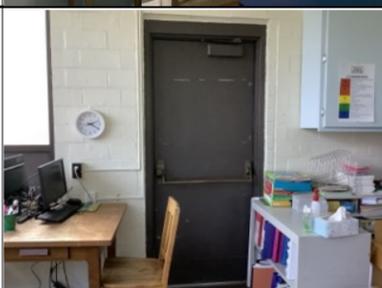
Tactile exit sign not provided Directional sign to accessible emergency exit not provided	- -	Ensure tactile exit signs with raised characters and braille are provided at exit doors. Mount signs between 48"- 60" above the finished floor located on the latch side of the door. Provide a directional sign indicating the location of the nearest accessible emergency exit.	1	464	\$464

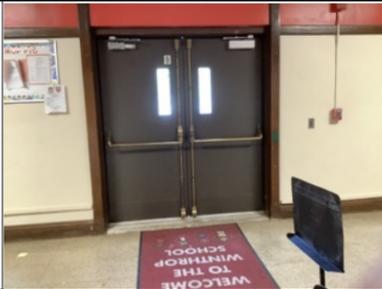
ID	Location	Floor	Room	Element	Type	Photo	Issues	Current Measure	Recommendations	Quantity	Price	Cost Estimation
26	Main Entrance, Egress Doors 8, 9, 10	1		Means of Egress	N/A

Tactile exit sign not provided Directional sign to accessible emergency exit not provided Mat not securely attached	- -	Ensure tactile exit signs with raised characters and braille are provided at exit doors. Mount signs between 48"- 60" above the finished floor located on the latch side of the door. Provide a directional sign indicating the location of the nearest accessible emergency exit. Secure the mat.	3	464	\$1392
<b>Interior Access Route</b>												
27	Art Room	1		Interior Access Route	N/A

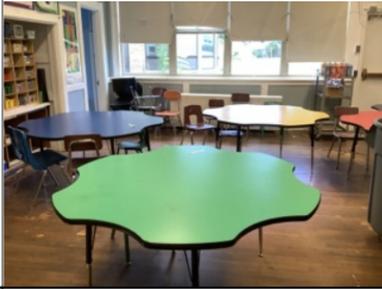
Route < 36" wide	25"	Ensure that a clear width of 36" min. is maintained at the accessible route by relocating the tables.	1	Labor	\$0
28	Egress Door 12	1		Interior Access Route	N/A

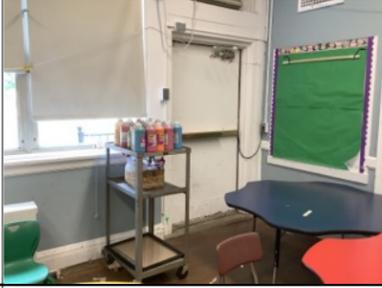
Accessible route not provided	- -	Relocate furniture to not block path to egress door.	1	Labor	\$0

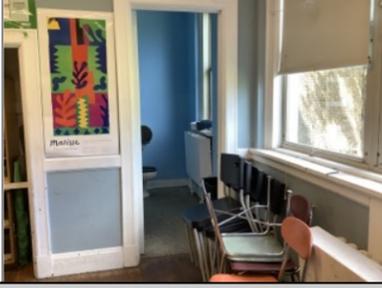
29	Single-User Toilet Room - Art Room	1		Interior Access Route	N/A

Accessible route not provided	-	Relocate chairs to ensure an accessible route to the toilet room.	1	Labor	\$0
<b>Doors, Doorways, &amp; Gates</b>												
30	Egress Door 7	1		Doors, Doorways, & Gates	Emergency Egress

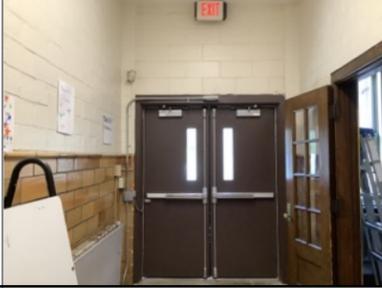
Clear width at door < 32"	30"	Provide signage directing users to an accessible exit.	1	232	\$232

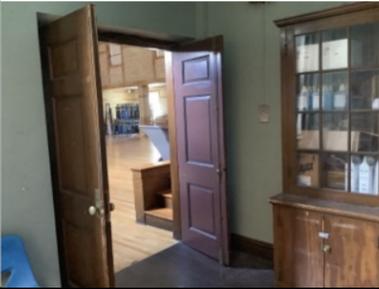
ID	Location	Floor	Room	Element	Type	Photo	Issues	Current Measure	Recommendations	Quantity	Price	Cost Estimation
31	To Gymnasium/ Cafeteria	1		Doors, Doorways, & Gates	Assembly Space

If double-leaf door, neither compliant Maneuvering clearance(s) not provided Threshold > 1/2" high Hardware not operable with a closed fist	- - 1.5" -	Ensure that both door leaves are kept opened during school business hours to provide 32" min. clear width. Relocate the cabinet to provide 60" min. maneuvering clearance at the double doors. Alter the threshold to be 1/2" high max. Provide hardware that can be operable with one hand and not require tight grasping, pinching, or twisting of the wrist.	1	634	\$634
32	Gymnasium/ Cafeteria Egress to Hallway	1		Doors, Doorways, & Gates	Circulation

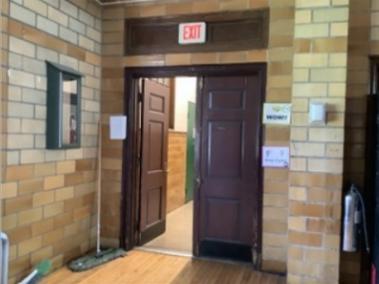
If double-leaf door, neither compliant Hardware not operable with a closed fist	- -	Ensure that both door leaves are kept opened during school business hours to provide 32" min. clear width. Provide hardware that can be operable with one hand and not require tight grasping, pinching, or twisting of the wrist.	1	484	\$484

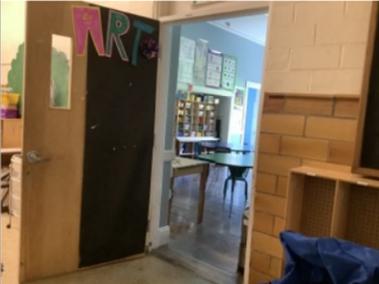
33	Art Room	1		Doors, Doorways, & Gates	Classroom

Maneuvering clearance(s) not provided	13"	Relocate the shelf to provide at least 18" min. maneuvering clearance on the pull side of the door.	1	Labor	\$0
34	Main Office	1		Doors, Doorways, & Gates	Circulation

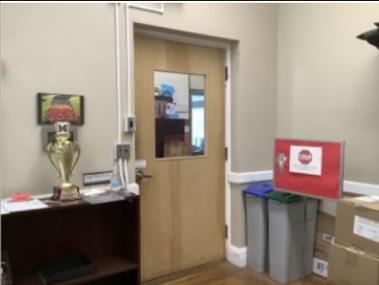
Maneuvering clearance(s) not provided	6"	Relocate the desk to provide at least 18" min. maneuvering clearance at the latch side of the door.	1	Labor	\$0
35	Fifth Grade Classroom	2	31	Doors, Doorways, & Gates	Classroom

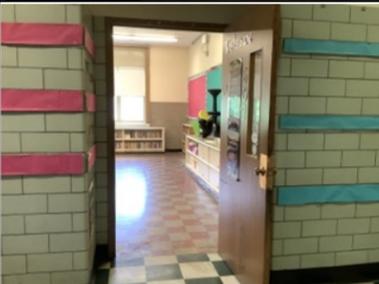
Maneuvering clearance(s) not provided Hardware not operable with a closed fist	6" -	Provide an automatic door opener. Provide hardware that can be operable with one hand and not require tight grasping, pinching, or twisting of the wrist.	1	3544	\$3544

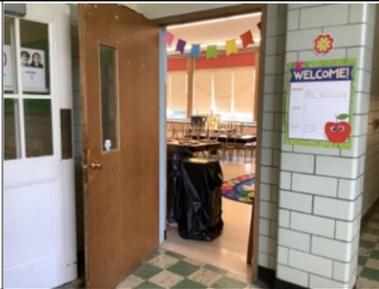
ID	Location	Floor	Room	Element	Type	Photo	Issues	Current Measure	Recommendations	Quantity	Price	Cost Estimation
36	First Grade Classroom	1	22	Doors, Doorways, & Gates	Classroom

Maneuvering clearance(s) not provided Hardware not operable with a closed fist	- -	Provide an automatic door opener. Provide hardware that can be operable with one hand and not require tight grasping, pinching, or twisting of the wrist.	1	3544	\$3544
37	Girls' Multi-User Toilet Room - Across From Side A Staircase	2		Doors, Doorways, & Gates	Toilet Room

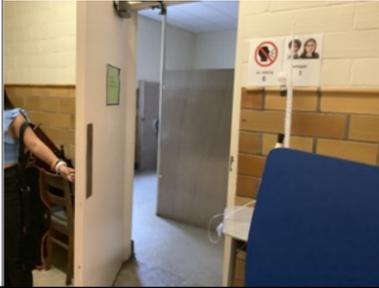
Maneuvering clearance(s) not provided Hardware not operable with a closed fist Door requires > 5 lbs. of force to open	- - 9 lbs	Relocating stored objects to provide at least 12" min maneuvering clearance at the latch side of the door. Provide hardware that can be operable with one hand and not require tight grasping, pinching, or twisting of the wrist. Adjust closers so doors do not require more than 5 pounds of force to open.	1	484	\$484

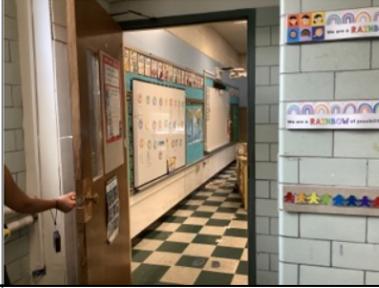
38	Second Grade Classroom	Basement		Doors, Doorways, & Gates	Classroom

Maneuvering clearance(s) not provided Hardware not operable with a closed fist Door requires > 5 lbs. of force to open	10" - 17 lbs	Provide an automatic door opener. Provide hardware that can be operable with one hand and not require tight grasping, pinching, or twisting of the wrist. Adjust closers so doors do not require more than 5 pounds of force to open.	1	3544	\$3544
39	Multi-User Toilet Room Near Music Room	Basement		Doors, Doorways, & Gates	Toilet Room

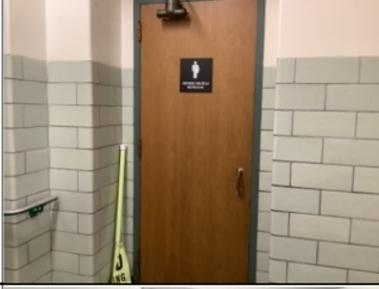
Maneuvering clearance(s) not provided Door requires > 5 lbs. of force to open	10" 13 lbs	Provide an automatic door opener. Adjust closers so doors do not require more than 5 pounds of force to open.	1	3060	\$3060
40	Single-User Toilet Room - Kindergarten Classroom	1		Doors, Doorways, & Gates	Toilet Room

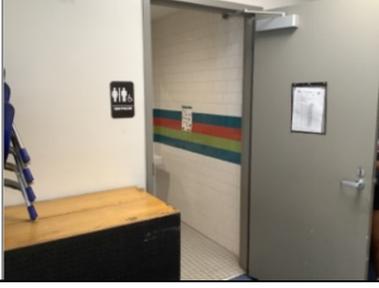
Maneuvering clearance(s) not provided Door requires > 5 lbs. of force to open	2" 14 lbs	Remove the cabinet to provide min. 18" maneuvering clearance at the latch side of the door. Adjust closers so doors do not require more than 5 pounds of force to open.	1	Labor	\$0

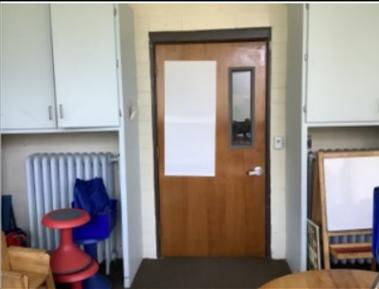
ID	Location	Floor	Room	Element	Type	Photo	Issues	Current Measure	Recommendations	Quantity	Price	Cost Estimation
41	Reading Room	1		Doors, Doorways, & Gates	Classroom

Maneuvering clearance not provided at recess > 6"	7.5"	Keep the door opened as needed.	1	Labor	\$0
42	First Grade Classroom	1	22	Doors, Doorways, & Gates	Classroom

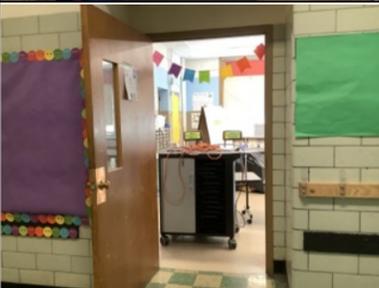
Maneuvering clearance not provided at recess > 6" Hardware not operable with a closed fist	6.5" -	Install an automatic door opener. Provide hardware that can be operable with one hand and not require tight grasping, pinching, or twisting of the wrist.	1	3544	\$3544
43	Counselor and Psychologist	1		Doors, Doorways, & Gates	Office

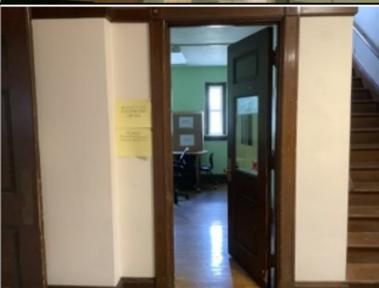
Hardware not operable with a closed fist	-	Provide hardware that can be operable with one hand and not require tight grasping, pinching, or twisting of the wrist.	1	484	\$484
44	Single-User Toilet Room - Art Room	1		Doors, Doorways, & Gates	Toilet Room

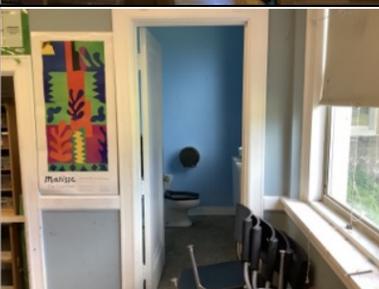
Hardware not operable with a closed fist	-	Provide hardware that can be operable with one hand and not require tight grasping, pinching, or twisting of the wrist.	1	484	\$484

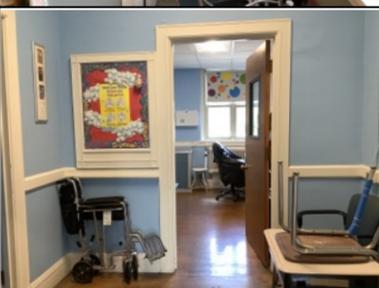
45	Nurse's Office	2		Doors, Doorways, & Gates	Office

Hardware not operable with a closed fist	-	Provide hardware that can be operable with one hand and not require tight grasping, pinching, or twisting of the wrist.	1	484	\$484

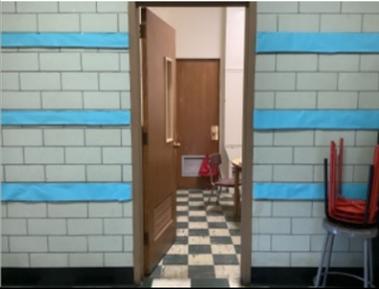
Hardware not operable with a closed fist	-	Provide hardware that can be operable with one hand and not require tight grasping, pinching, or twisting of the wrist.	1	484	\$484
47	Girls' Toilet Room Near Gymnasium/ Cafeteria	1		Doors, Doorways, & Gates	Toilet Room

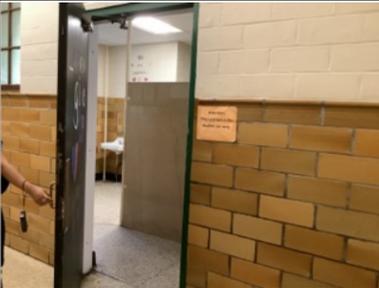
Hardware not operable with a closed fist Door requires > 5 lbs. of force to open	- 18 lbs	Provide hardware that can be operable with one hand and not require tight grasping, pinching, or twisting of the wrist. Adjust closers so doors do not require more than 5 pounds of force to open.	1	484	\$484
48	Single-User Toilet Room by Music Room	Basement		Doors, Doorways, & Gates	Toilet Room

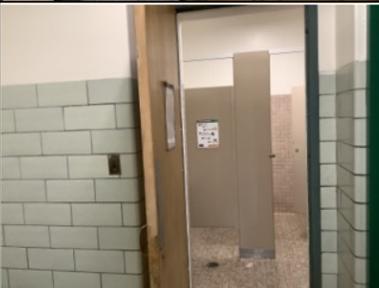
Door requires > 5 lbs. of force to open	24 lbs	Adjust closers so doors do not require more than 5 pounds of force to open.	1	Labor	\$0

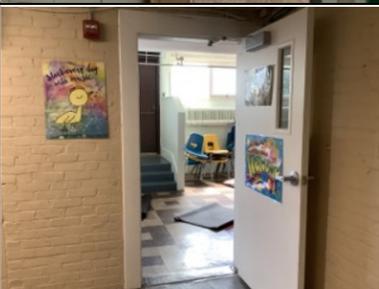
49	Music Room	Basement		Doors, Doorways, & Gates	Classroom

Door requires > 5 lbs. of force to open	12 lbs	Adjust closers so doors do not require more than 5 pounds of force to open.	1	Labor	\$0
50	Girls' Single-User Toilet Room - Near Side A Staircase	1		Doors, Doorways, & Gates	Toilet Room

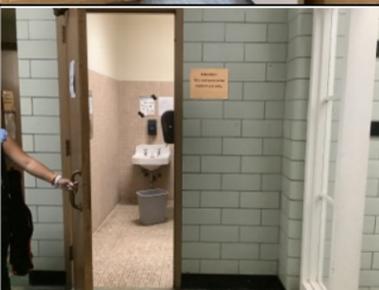
Door requires > 5 lbs. of force to open	21 lbs	Adjust closers so doors do not require more than 5 pounds of force to open.	1	Labor	\$0

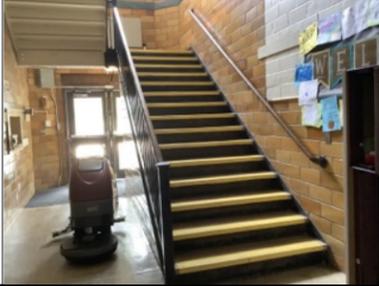
Handrail height < 34" or > 38" Handrails do not extend 12" from stairs	30" -	Alter so the handrails are 34"- 38" high above the floor. Top: Ensure handrails extend horizontally above the landing for 12" min. beginning above the first riser nosing. Bottom: Ensure handrails extend to one tread depth beyond the last riser.	1	-	\$0
52	Music Room - Egress Door 4	Basement		Stairways	Egress

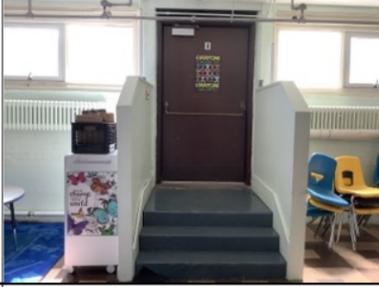
Handrail not provided on both sides	-	Provide handrail on both sides of the stair.	1	-	\$0
53	Side C Staircase	2		Stairways	Egress

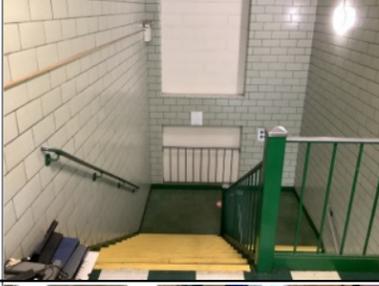
Handrails do not extend 12" from stairs Handrails not continuous where required	- -	Top: Ensure handrails extend horizontally above the landing for 12" min. beginning above the first riser nosing. Bottom: Ensure handrails extend to one tread depth beyond the last riser. Provide continuous handrails.	1	-	\$0

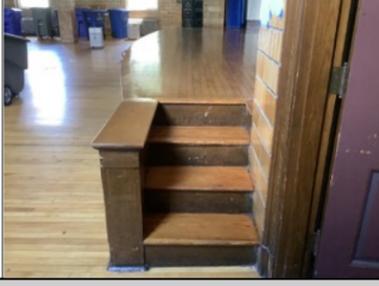
54	Gymnasium/ Cafeteria - Stage	1		Stairways	Other

Handrails not provided	-	Provide handrails on both sides.	1	-	\$0
<b>Signage</b>												
55	Counselor and Psychologist	1		Signage	Designation

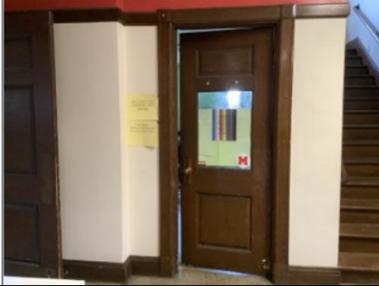
Signage is not provided	-	Locate compliant signage alongside the door on the latch side.	1	232	\$232

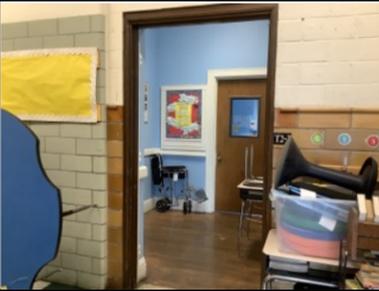
Signage is not provided	-	Locate compliant signage alongside the door on the latch side.	1	232	\$232
57	Single-User Toilet Room by Kindergarten Classrooms	1		Signage	Informational

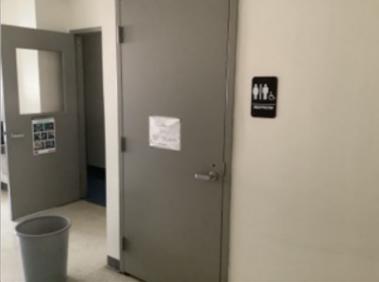
Raised characters not provided on sign Braille not provided on sign	- -	Provide text with raised characters duplicated in braille on sign.	2	464	\$928
58	Girls' Toilet Room Near Gymnasium/ Cafeteria	1		Signage	Designation

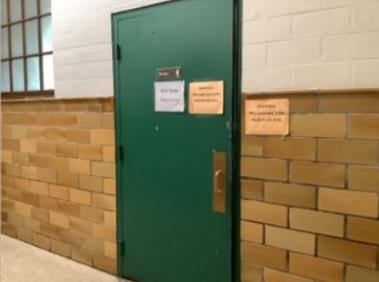
Raised characters not provided on sign Braille not provided on sign Sign not located on the latch side of the door	- - -	Provide text with raised characters duplicated in braille on sign. Locate the sign at permanent rooms alongside the door on the latch side.	1	232	\$232
59	Art Room	1		Signage	Designation

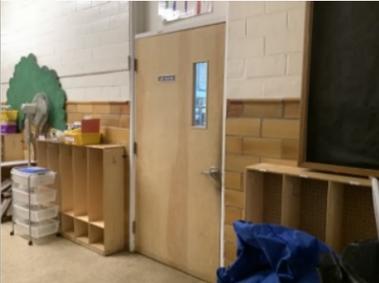
Raised characters not provided on sign Braille not provided on sign Sign not located on the latch side of the door	- - - -	Provide text with raised characters duplicated in braille on sign. Mount signs so that the baseline of the lowest tactile character is 48" min. above finished floor and the baseline of the highest tactile character is 60" max. above the finished floor. Locate the sign at permanent rooms alongside the door on the latch side.	1	232	\$232

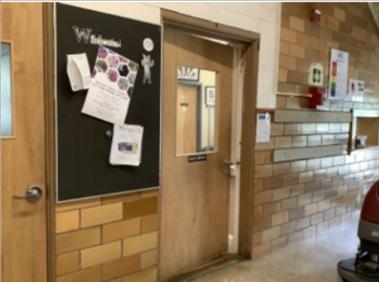
60	Main Office	1		Signage	Designation

Raised characters not provided on sign Braille not provided on sign Sign not located on the latch side of the door	- - -	Provide text with raised characters duplicated in braille on sign. Locate the sign at permanent rooms alongside the door on the latch side.	1	232	\$232

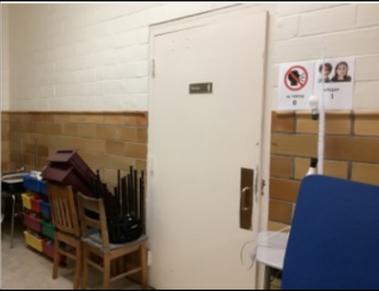
<ul style="list-style-type: none"> <li>Raised characters not provided on sign</li> <li>Braille not provided on sign</li> <li>Sign not located on the latch side of the door</li> </ul>	<ul style="list-style-type: none"> <li>-</li> <li>-</li> <li>-</li> </ul>	<ul style="list-style-type: none"> <li>Provide text with raised characters duplicated in braille on sign.</li> <li>Mount signs so that the baseline of the lowest tactile character is 48" min. above finished floor and the baseline of the highest tactile character is 60" max. above the finished floor.</li> <li>Locate the sign at permanent rooms alongside the door on the latch side.</li> </ul>	1	232	\$232
62	Fifth Grade Classroom	2	31	Signage	Designation
