# ADA Self-Evaluation and Transition Plan for the City of Melrose

Part 2 of 2

## Part 2: Reports:

January, 2023

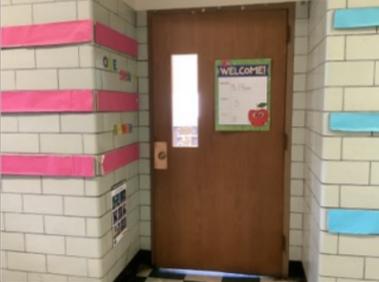
<ul style="list-style-type: none"> <li>Raised characters not provided on sign</li> <li>Braille not provided on sign</li> <li>Sign not located on the latch side of the door</li> </ul>	<ul style="list-style-type: none"> <li>-</li> <li>-</li> <li>-</li> </ul>	<ul style="list-style-type: none"> <li>Provide text with raised characters duplicated in braille on sign.</li> <li>Locate the sign at permanent rooms alongside the door on the latch side.</li> </ul>	1	232	\$232

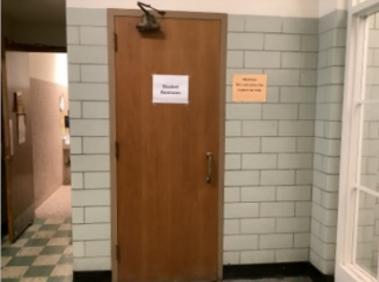
63	Girls' Single-User Toilet Room - Near Side A Staircase	1		Signage	Designation

<ul style="list-style-type: none"> <li>Raised characters not provided on sign</li> <li>Braille not provided on sign</li> <li>Sign not located on the latch side of the door</li> </ul>	<ul style="list-style-type: none"> <li>-</li> <li>-</li> <li>-</li> </ul>	<ul style="list-style-type: none"> <li>Provide text with raised characters duplicated in braille on sign.</li> <li>Locate the sign at permanent rooms alongside the door on the latch side.</li> </ul> <p>Until the toilet room is made accessible, provide a directional sign indicating the location of the nearest accessible toilet room.</p>	1	232	\$232
64	Boys' Single-User Toilet Room - Near Side A Staircase	1		Signage	Designation

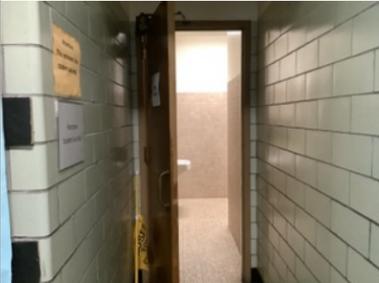
<ul style="list-style-type: none"> <li>Raised characters not provided on sign</li> <li>Braille not provided on sign</li> <li>Sign not located on the latch side of the door</li> </ul>	<ul style="list-style-type: none"> <li>-</li> <li>-</li> <li>-</li> </ul>	<ul style="list-style-type: none"> <li>Provide text with raised characters duplicated in braille on sign.</li> <li>Locate the sign at permanent rooms alongside the door on the latch side.</li> </ul>	1	232	\$232

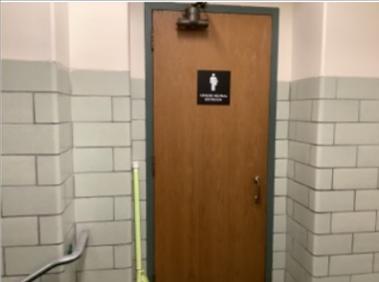
65	Multi-User Toilet Room Near Music Room	Basement		Signage	Designation

<ul style="list-style-type: none"> <li>Sign not located on the latch side of the door</li> <li>Directional sign to access. toilet not provided</li> </ul>	<ul style="list-style-type: none"> <li>-</li> <li>-</li> </ul>	<ul style="list-style-type: none"> <li>Locate the designation sign at permanent rooms alongside the door on the latch side.</li> </ul> <p>Until the toilet room is renovated, provide a directional sign indicating the location of the nearest accessible toilet room.</p>	2	232	\$464

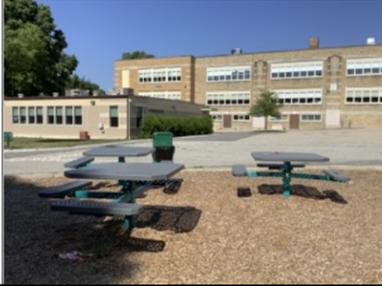
Picnic table not on an accessible route	-	Ensure that at least one picnic table is connected to an accessible route.	1	-	\$0
<b>Service Counter</b>												
67	Main Office, Sign-In	1		Service Counter	N/A

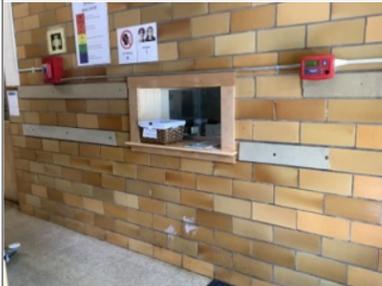
Counter > 36" high	40"	Provide an auxiliary table or fold-down counter that is 36" max. above the ground or finished floor.	1	-	\$0
<b>Bike Racks</b>												
68	Bike Rack Near Basketball Court	Ext.		Bike Racks	N/A

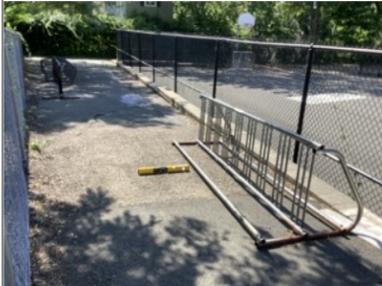
Bike rack is not connected to an accessible route	-	Ensure bike racks are connected to an accessible route.	1	-	\$0
<b>Assembly Area</b>												
69	Gymnasium/ Cafeteria - Stage	1		Assembly Area	N/A

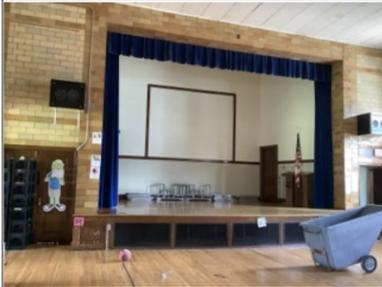
Accessible route to stage not provided Assistive listening devices not provided	- -	Provide an accessible route to the stage. If audible communication is integral to the use of the space, provide an assistive listening system.	1	1214	\$1214

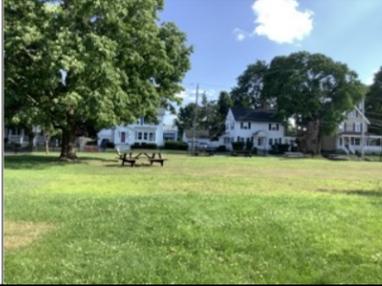
At least 5% accessible spaces not provided Picnic table not on an accessible route	- -	Ensure that at least 5% (minimum one) of picnic tables are accessible. Ensure that the picnic table is connected to an accessible route.	8	-	\$0
<b>Exterior Benches</b>												
71	Ashcroft Road and 1st Street	Ext.		Exterior Benches	N/A

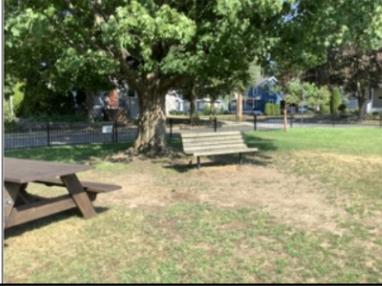
No accessible route to one bench in area	-	Provide an accessible route to one bench in this area.	1	-	\$0
72	Playground	Ext.		Exterior Benches	N/A

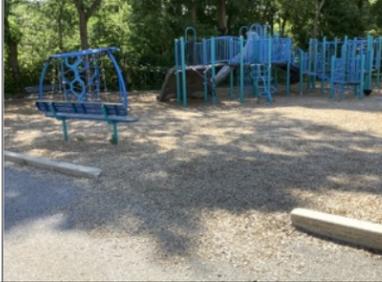
No accessible route to one bench in area Surface not stable, firm, and slip-resistant	-	Provide an accessible route to the bench in this area. Ensure that surface to and around the bench is firm, stable and slip-resistant.	1	-	\$0

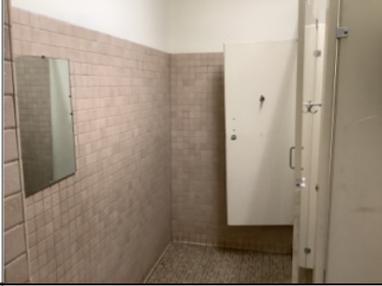
<b>Toilet &amp; Bathing Rooms</b>												
<b>Overall Access</b>												
73	Multi-User Toilet Room Near Music Room	Basement		Overall Access	Toilet Room

Turning space not provided Accessible plumbing fixtures or stalls not provided Audible and visible alarms not provided Sign to accessible toilet not provided	- - -	Until the toilet room is renovated, provide a directional sign indicating the location of the nearest accessible toilet room. When fire system is updated, ensure that a visible and audible fire alarm is installed.	1	232	\$232
74	Single-User Toilet Room by Music Room	Basement		Overall Access	Toilet Room

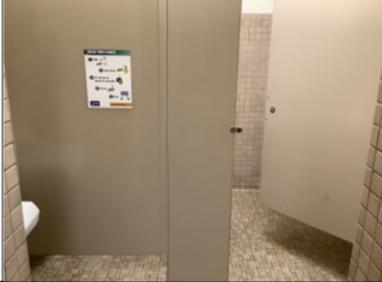
Turning space not provided Audible and visible alarms not provided	- -	Remove interior partition and obstacles as needed to provide turning space. When fire system is updated, ensure that a visible and audible fire alarm is installed.	1	-	\$0

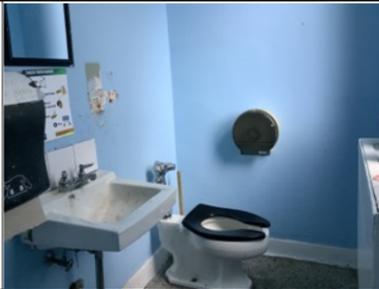
Turning space not provided Audible and visible alarms not provided	- -	Provide a directional sign to the accessible toilet. When fire system is updated, ensure that a visible and audible fire alarm is installed.	1	232	\$232
76	Girls' Toilet Room Near Gymnasium/ Cafeteria	1		Overall Access	Toilet Room

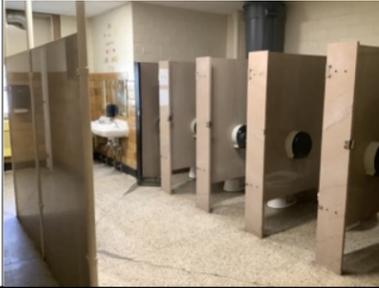
Accessible plumbing fixtures or stalls not provided Audible and visible alarms not provided	- -	Provide one accessible wheelchair compartment. When fire system is updated, ensure that a visible and audible fire alarm is installed.	1	6182	\$6182
77	Girls' Multi-User Toilet Room - Across Side A Staircase	2		Overall Access	Toilet Room

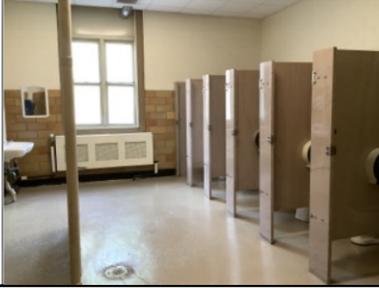
Accessible plumbing fixtures or stalls not provided Audible and visible alarms not provided	- -	Provide one accessible wheelchair compartment. When fire system is updated, ensure that a visible and audible fire alarm is installed.	1	6182	\$6182

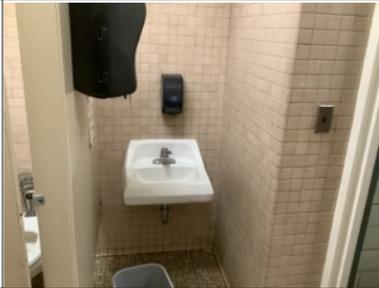
<b>Lavatory</b>												
78	Multi-User Toilet Room Near Music Room	Basement		Lavatory	N/A

Clear floor space not provided at lavatory Toe or knee clearances not provided Plumbing underneath is exposed	- 25" -	Remove partition to provide a 30" min. by 48" min. clear floor space positioned for a forward approach at the lavatory. Provide the lavatory with knee and toe clearance positioned for a forward approach. Insulate or otherwise configure pipes to prevent contact at the lavatory.	1	1778	\$1778
79	Single-User Toilet Room by Music Room	Basement		Lavatory	N/A

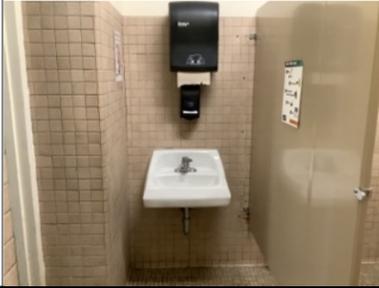
Plumbing underneath is exposed Dispensers not within reach range	- 54"	Insulate or otherwise configure pipes to prevent contact for at least one lavatory. Relocate dispenser to be located on the left-side wall and lowered to 48" max. above the finished floor.	1	348	\$348

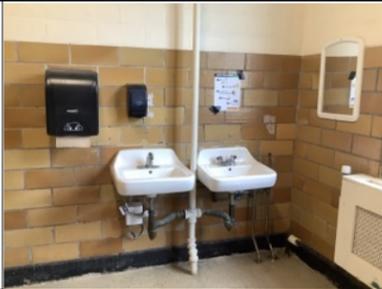
Plumbing underneath is exposed Mirror not above lavatory w/reflective surface > 35"	- 47"	Insulate or otherwise configure pipes to prevent contact for at least one lavatory. Lower mirror so that the bottom surface is at 35" max. above the finished floor.	1	348	\$348
81	Multi-User Toilet Room Near Music Room	Basement		Lavatory	N/A

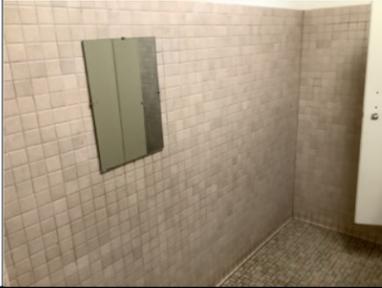
Mirror not above lavatory w/reflective surface > 35"	43"	Lower mirror so that the bottom surface is at 35" max. above the finished floor.	1	256	\$256
<b>Single-User Toilet</b>												
82	Single-User Toilet Room by Kindergarten Classrooms	1		Single-User Toilet	N/A

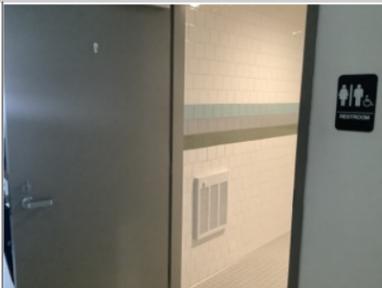
Hook located > 48" high (2010 ADA)	68"	Locate the coat hook no higher than 48" above the finished floor.	1	150	\$150

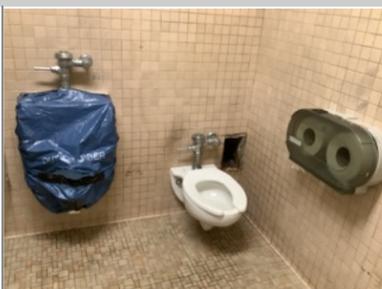
<b>Toilet Compartment</b>												
83	Single-User Toilet Room by Music Room	Basement		Toilet Compartment	Accessible Compartment

Grab bars not provided Non-compliant toilet paper dispenser Clearance at toilet < 60" clear width	- -	Provide one grab bar on the side wall of the water closet and one on the rear wall. Relocate toilet paper so that it is 24" min. high, located under the grab bar, and between 7" and 9" from the front of the toilet. Remove urinal to maintain the required 60" wide min. at the wheelchair accessible compartment.	1	7336	\$7336
<b>Dispensers</b>												
84	Multi-User Toilet Room Near Music Room	Basement		Dispensers	Paper Towel Dispenser

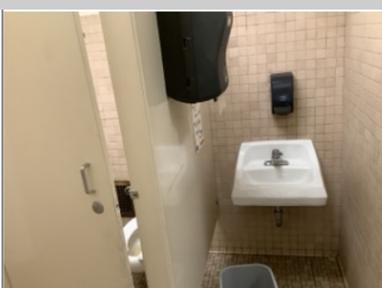
Controls > 48" high Dispenser acts as a protruding object	53" 9"	Relocate the paper towel dispenser so the operable part is 48" max. above the finished floor.  Relocate dispenser out of the circulation path.	1	Labor	\$0

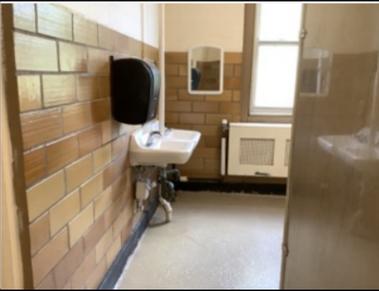
ID	Location	Floor	Room	Element	Type	Photo	Issues	Current Measure	Recommendations	Quantity	Price	Cost Estimation
85	Girls' Multi-User Toilet Room - Across Side A Staircase	2		Dispensers	Paper Towel Dispenser

Dispenser acts as a protruding object	10"	Relocate dispenser out of the circulation path.	1	Labor	\$0
<b>Toilet Rooms for Children</b>												
<b>Single-User Toilet (Children)</b>												
86	Single-User Toilet Room - Kindergarten Classroom	1		Single-User Toilet (Children)	N/A

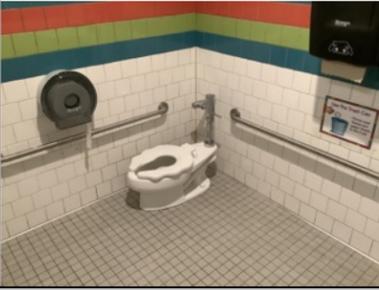
Non-compliant toilet paper dispenser	-	Relocate toilet paper dispenser so that it is between 14"- 19" above the floor and between 7"- 9" in front of the toilet. Ensure dispensers and other devices are not mounted above grab bars.	1	256	\$256
<b>Lavatory (Children)</b>												
87	Girls' Single-User Toilet Room - Near Side A Staircase	1		Lavatory (Children)	N/A

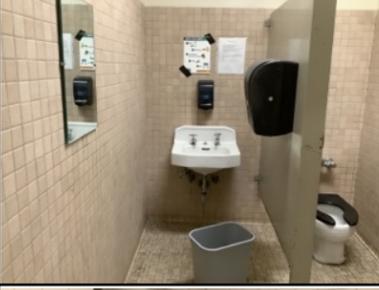
Toe or knee clearances not provided Faucet not operable with a closed fist Exposed plumbing underneath Mirror not above lavatory w/reflective surface > 35"	23" - 43"	Provide at least one lavatory with 25" min. knee clearance positioned for a forward approach. Ensure toe clearance is also provided. Provide a faucet that can be operable with one hand and not require tight grasping, pinching or twisting of the wrist for at the lavatory. Insulate or otherwise configure pipes to prevent contact at the lavatory. Lower mirror so that the bottom surface is at 35"	1	3020	\$3020

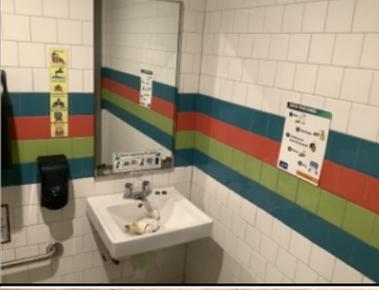
88	Single-User Toilet Room - Kindergarten Classroom	1		Lavatory (Children)	N/A

Toe or knee clearances not provided Mirror above lavatory w/reflective surface > 31"	26" 34"	Provide at least one lavatory with 25" min. knee clearance positioned for a forward approach. Ensure toe clearance is also provided.  Lower mirror so that the bottom surface is at 31" max. above the finished floor.	1	1942	\$1942
89	Boys' Single-User Toilet Room - Near Side A Staircase	1		Lavatory (Children)	N/A

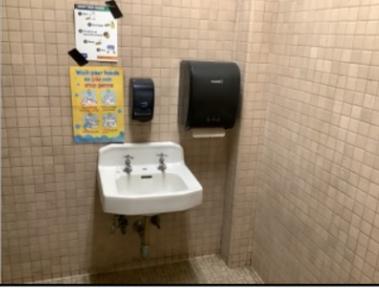
Faucet not operable with a closed fist Exposed plumbing underneath	- -	Provide a faucet that can be operable with one hand and not require tight grasping, pinching or twisting of the wrist for at least one lavatory.  Insulate or otherwise configure pipes to prevent contact at the lavatory.	1	1078	\$1078

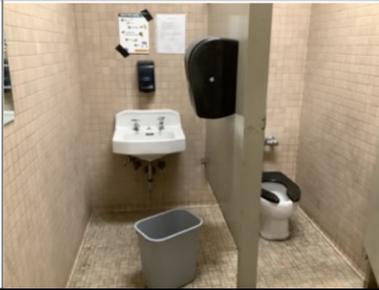
ID	Location	Floor	Room	Element	Type	Photo	Issues	Current Measure	Recommendations	Quantity	Price	Cost Estimation
<b>Dispensers (Children)</b>												
90	Girls' Single-User Toilet Room - Near Side A Staircase	1		Dispensers (Children)	Paper Towel Dispenser

Dispenser is a protruding object	9"	Relocate dispenser out of the circulation path.	1	256	\$256
91	Single-User Toilet Room - Kindergarten Classroom	1		Dispensers (Children)	Paper Towel Dispenser

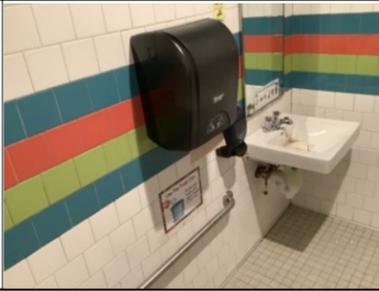
Dispenser is a protruding object	9"	Relocate dispenser out of the circulation path.	1	256	\$256
<b>Overall Access (Children)</b>												
92	Girls' Single-User Toilet Room Near Side A Staircase	1		Overall Access (Children)	Toilet Room

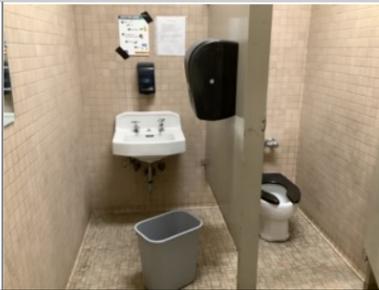
Turning space is not provided Audible and visible alarms are not provided	- -	Remove interior partition and obstacles as needed to provide turning space./Renovate toilet room to provide turning space./Provide a directional sign to the accessible toilet./Add an accessible single-user toilet room. When fire system is updated, ensure that a visible and audible fire alarm is installed.	1	9510	\$9510

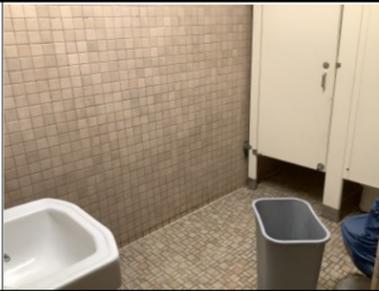
93	Boys' Single-User Toilet Room - Near Side A Staircase	1		Overall Access (Children)	Toilet Room

Turning space is not provided Audible and visible alarms are not provided	- -	Remove interior partition and obstacles as needed to provide turning space. When fire system is updated, ensure that a visible and audible fire alarm is installed.	1	9510	\$9510
<b>Additional Access</b>												
<b>Sinks for Children's Use</b>												
94	Kindergarten Classroom	1		Sinks for Children's Use	Classroom

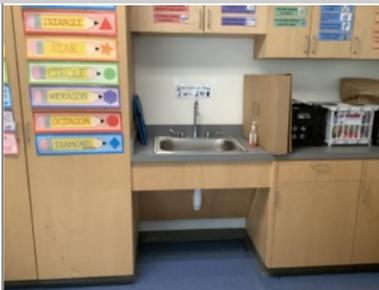
Rim or counter at sink > 34"	36"	Relocate sink with the front of the rim or counter no higher than 34" above the finished floor.	1	3094	\$3094

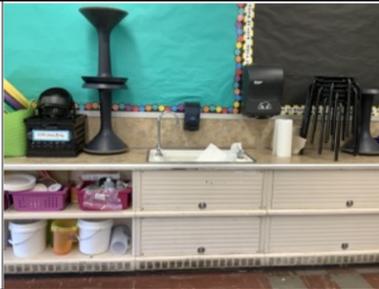
ID	Location	Floor	Room	Element	Type	Photo	Issues	Current Measure	Recommendations	Quantity	Price	Cost Estimation
95	Fifth Grade Classroom	2	31	Sinks for Children's Use	Classroom

Knee/toe clearance <27" at sink > 31" high	-	Provide at least one sink with 27" high knee and toe clearance positioned for a forward approach (per 521 CMR 12.2.2.c).	1	1686	\$1686
96	First Grade Classroom	1	22	Sinks for Children's Use	Classroom

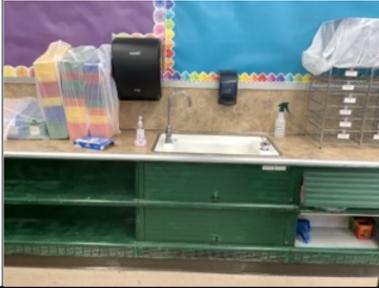
Knee/toe clearance <27" at sink > 31" high	-	Provide at least one sink with 27" high knee and toe clearance positioned for a forward approach (per 521 CMR 12.2.2.c).	1	1686	\$1686
97	Second Grade Classroom	Basement		Sinks for Children's Use	Classroom

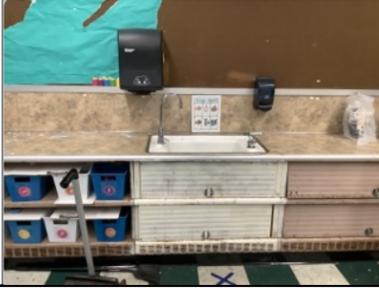
Knee/toe clearance <27" at sink > 31" high	-	Provide at least one sink with 27" high knee and toe clearance positioned for a forward approach (per 521 CMR 12.2.2.c).	1	1686	\$1686
<b>Play and Sport Areas</b>

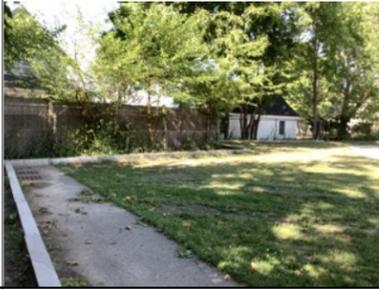
<b>Play Areas</b>												
98	Northwest Corner of School	Ext.		Play Areas	N/A

Accessible route not provided around playground	-	Install an accessible route around the playground.	1	-	\$0
99	Playground	Ext.		Play Areas	N/A

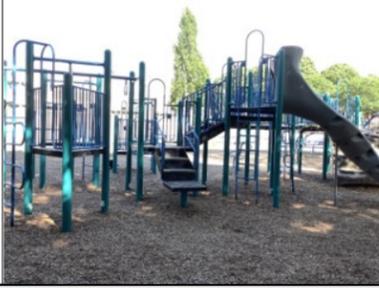
Accessible route not provided at play components Surface not stable, firm, and slip-resistant	- -	Provide a compliant impact-attenuating surface under and around the play components. Repair the surface and ensure that surface is firm, stable and slip-resistant (to areas under and around play components).	1	-	\$0
<b>Best Practice</b>

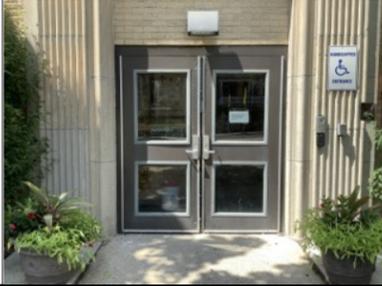
ID	Location	Floor	Room	Element	Type	Photo	Issues	Current Measure	Recommendations	Quantity	Price	Cost Estimation
<b>Signage</b>												
100	Entrance Door 1, Main Entrance	Ext.		Signage	Directional

Recommend replacing directional sign for the accessible entrance to read "Accessible Entrance" instead of "Handicapped Entrance".	1	-	\$0
101	Boys' Single-User Toilet Room - Near Side A Staircase	1		Signage	Designation

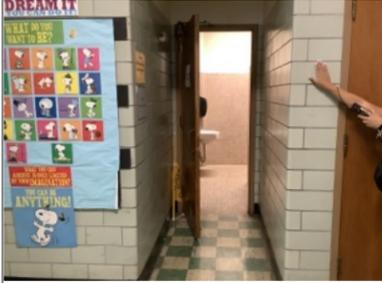
Recommend providing an additional directional sign along the right-hand side of the corridor to the boys' single-user toilet room.	1	-	\$0

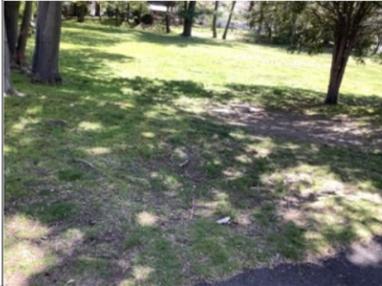
ID	Location	Floor	Room	Element	Type	Photo	Issues	Current Measure	Recommendations	Quantity	Price	Cost Estimation
<b>Approach and Entrance</b>												
<b>Exterior Access Route</b>												
1	Main Entrance	Ext.		Exterior Access Route	Exterior

Surface is not stable, firm, and slip-resistant Route not maintained in operable working condition Accessible route not provided	- - -	Ensure a stable, firm and slip-resistant accessible route with a running slope of 1:20 (5.00%) max. and a cross slope of 1:50 (2:00%) max. is provided from the sidewalk to the open field.	1	-	\$0
2	Route to Main Entrance	Ext.		Exterior Access Route	Walkway

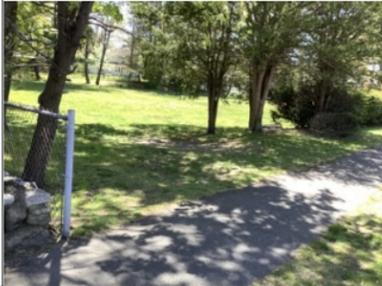
Route not maintained in operable working condition	-	Ensure that the accessible route to the field is maintained in operable working condition.	1	-	\$0
<b>Access to Goods and Services</b>												
<b>Stairways</b>												
3	Stepped Entrance	Ext.		Stairways	Exterior

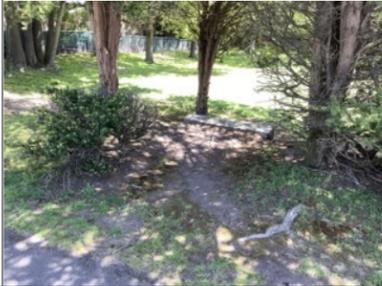
Surface not stable, firm, and slip-resistant Handrails not provided	- -	Repair surface leading to both sets of steps. Provide handrails at each sets of steps.	2	-	\$0

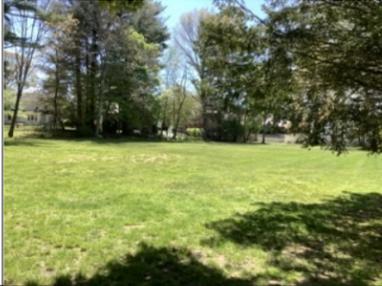
<b>Best Practice</b>												
<b>Bench</b>												
4	Field	Ext.		Bench	N/A

Recommend providing benches, some with backs and some with armrests, located on an accessible route in or near the open field.	1	-	\$0

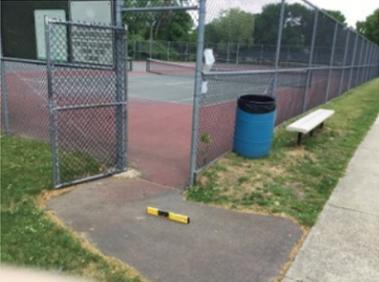
Running slope > 1:20 (5.00%)	15.6%	Reduce the running slope to be no steeper than 1:20 (5.00%).	1	-	\$0
2	Crystal Street Tennis Court Entrance at the North End of the Tennis Courts	Ext.		Exterior Access Route	Exterior

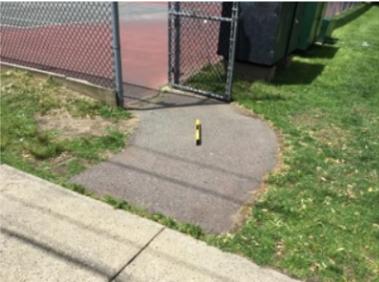
Running slope > 1:20 (5.00%) Route not maintained in operable working condition	6.2% -	Reduce the running slope to be no steeper than 1:20 (5.00%). Ensure that the accessible route is maintained in operable working condition.	1	-	\$0
3	Lynn Fells Parkway And Crystal Street	Ext.		Exterior Access Route	Sidewalk

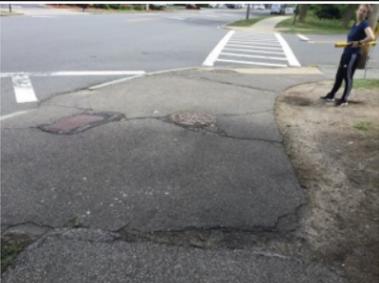
Level changes > 1/4" Route not maintained in operable working condition	2" -	Alter the change in level to be 1/4" high max. Ensure that the accessible route is maintained in operable working condition.	1	-	\$0

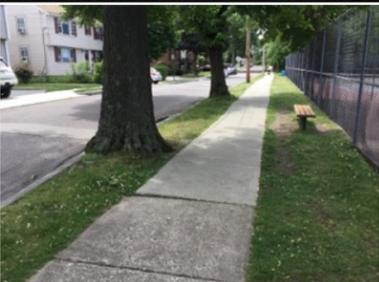
4	Crystal Street	Ext.		Exterior Access Route	Sidewalk

Route not maintained in operable working condition Level changes > 1/4"	1" -	Alter the change in level to be 1/4" high max. Ensure that the accessible route is maintained in operable working condition.	1	-	\$0
<b>Curb Ramp</b>												
5	Lynn Fells Parkway	Ext.		Curb Ramp	Diagonal

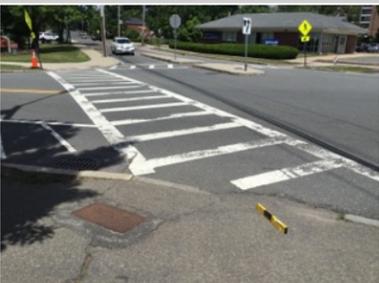
Running slope > 1:12 (8.33%) Transition from curb ramp to street not flush	10.2% -	Reduce the running slope to be no steeper than 1:12 (8.33%). Ensure transition from curb ramp to street is flush or free of changes in level.	1	-	\$0

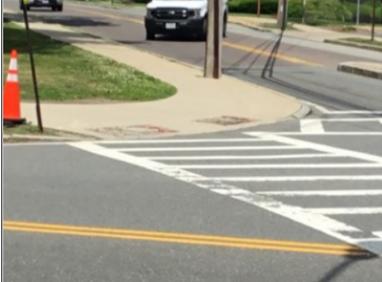
ID	Location	Floor	Room	Element	Type	Photo	Issues	Current Measure	Recommendations	Quantity	Price	Cost Estimation
6	Lynn Fells Parkway	Ext.		Curb Ramp	Parallel

Detectable warnings are deteriorated.	-	Provide new detectable warnings.	2	-	\$0
7	Crystal Street Near DesForges Park	Ext.		Curb Ramp	N/A

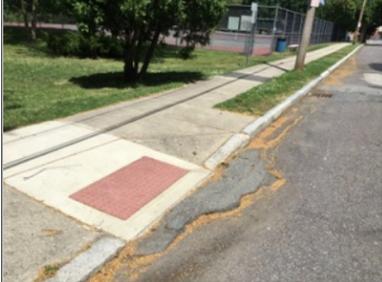
Transition from curb ramp to street not flush		Ensure transition from curb ramp to street is flush or free of changes in level.	1	-	\$0
<b>Access to Goods and Services</b>												
<b>Benches</b>												
8	Crystal Street	Ext.		Benches	N/A

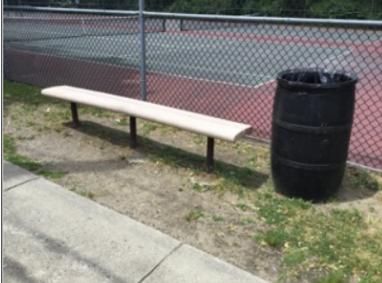
No accessible route to one bench in this area	-	Provide an accessible route to at least one bench in this area.	3	-	\$0
<b>Best Practice</b>												
<b>Bench</b>												
9	Crystal Street - Second Entrance Near DesForges Park	Ext.		Bench	N/A

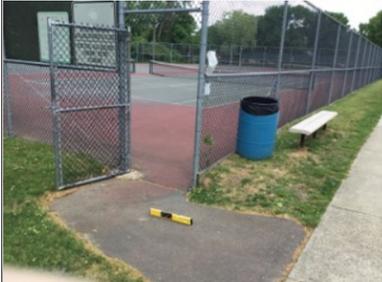
Recommend providing a 36" min. by 48" min. stable, firm and slip-resistant surface adjacent to at least one bench by the courts in each area where benches are provided.	1	-	\$0

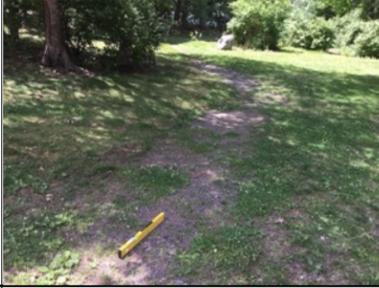
ID	Location	Floor	Room	Element	Type	Photo	Issues	Current Measure	Recommendations	Quantity	Price	Cost Estimation
1	Walkway From Crystal Street in DesForges Park			Exterior Access Route	Walkway

Running slope > 1:20 (5.00%) Surface is not stable, firm, and slip-resistant Route not maintained in operable working condition Accessible route not provided	7.7% - - -	Reduce the running slope to be no steeper than 1:20 (5.00%). Repair the surface. Ensure that the accessible route is maintained in operable working condition. Ensure an accessible route is provided.	1	-	\$0
2	Walkway Towards Benches			Exterior Access Route	Walkway

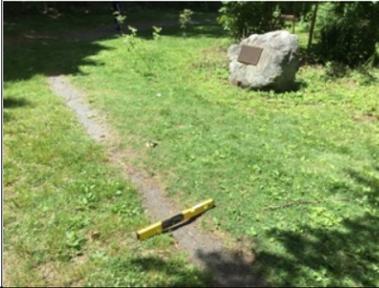
Exterior route < 36" wide Surface is not stable, firm, and slip-resistant Accessible route not provided	10" - -	Ensure that a clear width of 36" min. is maintained at the accessible route. Repair the surface. Ensure an accessible route is provided.	1	-	\$0
3	Benches			Benches	N/A

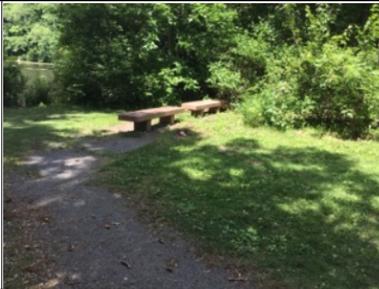
No accessible route to one bench in this area	-	Provide an accessible route to at least one bench in this area.	1	-	\$0

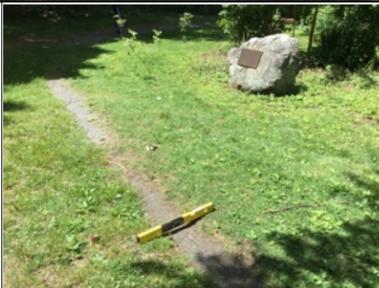
4	Plaque in Park			Exterior Access Route	Walkway

Accessible route not provided	-	Ensure an accessible route is provided to the plaque on a stone in the park.	1	-	\$0

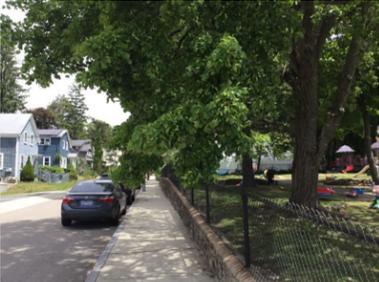
ID	Location	Floor	Room	Element	Type	Photo	Issues	Current Measure	Recommendations	Quantity	Price	Cost Estimation
<b>Approach and Entrance</b>												
<b>Exterior Access Route</b>												
1	Pratt Street	Ext.		Exterior Access Route	Sidewalk

Route obstructed by protruding objects	60"	Trim low hanging branches in trees.	1	-	\$0
2	Franklin Street Entrance	Ext.		Exterior Access Route	Walkway

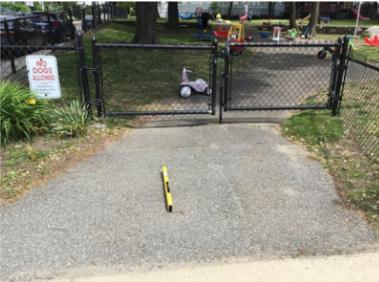
Running slope > 1:20 (5.00%)	13.6%	Reduce the running slope to be no steeper than 1:20 (5.00%).	1	-	\$0
3	Park	Ext.		Exterior Access Route	Walkway

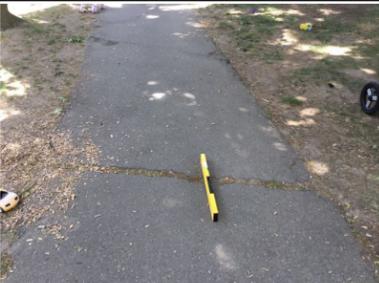
Running slope > 1:20 (5.00%) Surface openings > 1/2" Level changes > 1/4"	8.8% .75" -	Repair surface./Replace or reposition so that openings are 1/2" max. and the long opening dimension is perpendicular to the dominant direction of travel. Reduce the running slope to be no steeper than 1:20 (5.00%). Alter the change in level to be 1/4" high max.	1	-	\$0

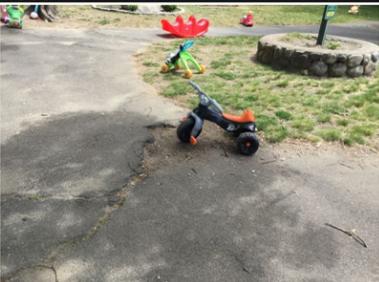
4	Park	Ext.		Exterior Access Route	Walkway

Level changes > 1/4" Route not maintained in operable working condition	1" -	Alter the change in level to be 1/4" high max. Ensure that the accessible route is maintained in operable working condition.	1	-	\$0
<b>Access to Goods and Services</b>

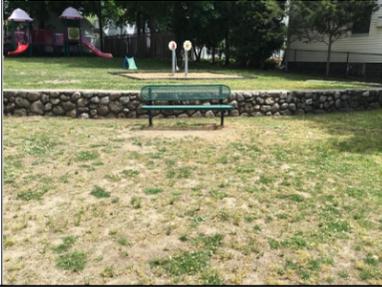
ID	Location	Floor	Room	Element	Type	Photo	Issues	Current Measure	Recommendations	Quantity	Price	Cost Estimation
<b>Benches</b>												
5	Park	Ext.		Benches	N/A

No accessible route to one bench in this area		Provide an accessible route to at least one bench in this area.	1	-	\$0
<b>Play and Sport Areas</b>												
<b>Play Areas</b>												
6	Park	Ext.		Play Areas	N/A

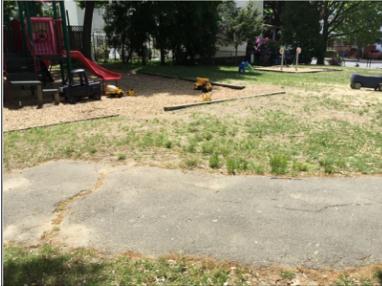
Accessible route not provided around playground Accessible route not provided at play components		Install an accessible route to and around the playground. Provide a compliant impact-attenuating surface under and around the play components.	1	-	\$0
7	Playground	Ext.		Play Areas	N/A

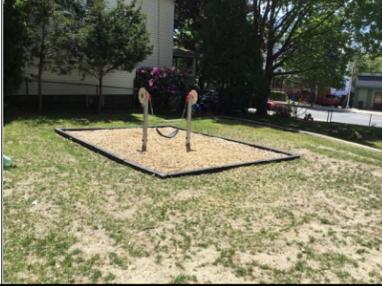
Accessible route not provided around playground Accessible route not provided at play components Not connected to an accessible route	- - -	Install an accessible route to and around the playground. Provide a compliant impact-attenuating surface under and around the play components. Provide an accessible route to play areas.	1	-	\$0

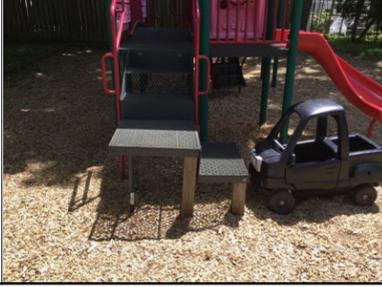
8	Playground	Ext.		Play Areas	N/A

No compliant transfer system Surface not stable, firm, and slip-resistant	- -	Alteration might be technically infeasible. Repair the surface and ensure that surface is firm, stable and slip-resistant (to areas under and around play components).	1	-	\$0

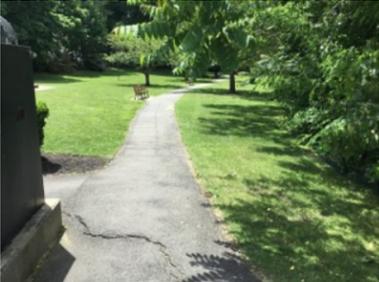
ID	Location	Floor	Room	Element	Type	Photo	Issues	Current Measure	Recommendations	Quantity	Price	Cost Estimation
<b>Approach and Entrance</b>												
<b>Exterior Access Route</b>												
1	Walkway			Exterior Access Route	Walkway

Route obstructed by protruding objects	57"	Trim low hanging branches in trees.	1	-	\$0
2	Main Street Walkway on Route From Livermore Municipal Parking Lot Towards Park			Exterior Access Route	Sidewalk

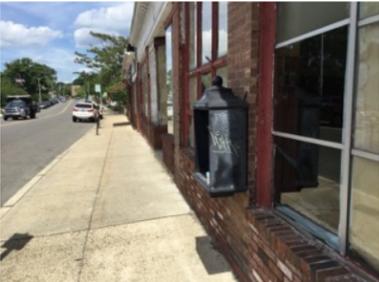
Route obstructed by protruding objects	28"	Relocate object or provide a cane-detectable barrier 27" max. above the ground below the object.	1	-	\$0
3	Walkway in Park			Exterior Access Route	Walkway

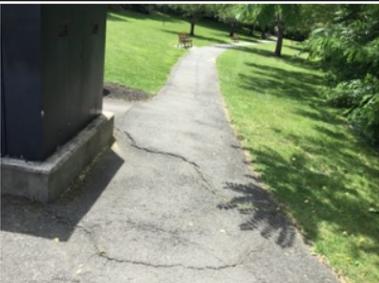
Route not maintained in operable working condition		Ensure that the accessible route is maintained in operable working condition.	1	-	\$0
4	Walkway in Park			Exterior Access Route	Walkway

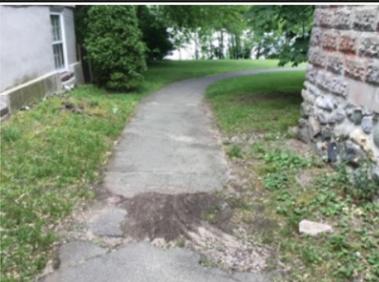
Route not maintained in operable working condition		Ensure that the accessible route is maintained in operable working condition.	1	-	\$0

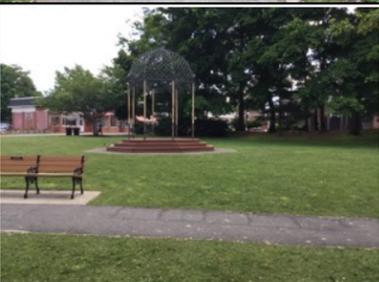
5	Gazebo			Exterior Access Route	Exterior

Accessible route not provided		Ensure an accessible route is provided to the gazebo.	1	-	\$0

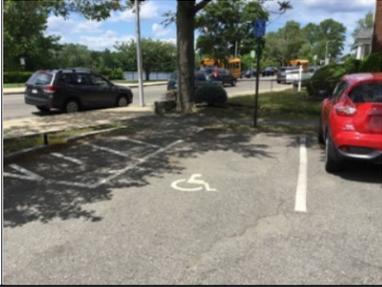
ID	Location	Floor	Room	Element	Type	Photo	Issues	Current Measure	Recommendations	Quantity	Price	Cost Estimation
<b>Off-Street Parking Lot or Garage</b>												
6	Livermore Municipal Parking Lot Across From Park			Off-Street Parking Lot or Garage	Visitor

Total # of parking Total # of designated accessible parking spaces Total # of designated van accessible spaces Access aisle < 96" wide at van space Sign does not have the designation "Van Accessible" Sign top > 96" above finished grade	18 - 1 84" - 116	Provide a marked access aisle that is at least 96" wide at the van parking space (re-stripe.) Add the designation "Van Accessible" to the sign located at the van accessible space. Locate sign with the bottom of the sign located 60" min. above the ground measured to the bottom of the sign and the top of the sign 96" max. above the ground measured to the top of the sign.	1	-	\$0
<b>Best Practice</b>

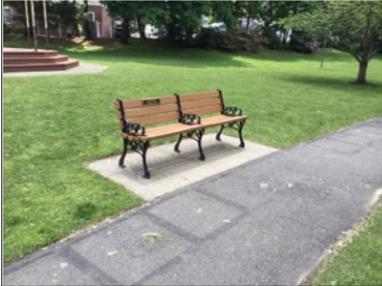
<b>Bench</b>												
7	Walkway			Bench	N/A

Recommend providing a 36" min. by 48" min. stable, firm and slip-resistant surface adjacent to at least one (1) bench in the park.	1	-	\$0

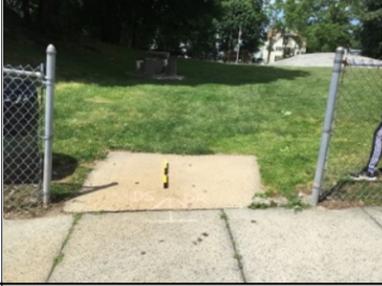
ID	Location	Floor	Room	Element	Type	Photo	Issues	Current Measure	Recommendations	Quantity	Price	Cost Estimation
<b>Approach and Entrance</b>												
<b>Exterior Access Route</b>												
1	Malvern Street Entry Southwest Corner of Park			Exterior Access Route	Exterior

Running slope > 1:20 (5.00%) Accessible route not provided	9.5%	Reduce the running slope to be no steeper than 1:20 (5.00%). Ensure an accessible route is provided to park amenities.	1	-	\$0
2	Lynde Street Entrance Towards Playground			Exterior Access Route	Exterior

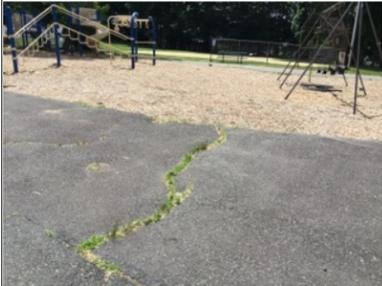
Route not maintained in operable working condition		Ensure that the accessible route is maintained in operable working condition.	1	-	\$0
3	Malvern Street Entrance Southeast Corner of Park			Exterior Access Route	Walkway

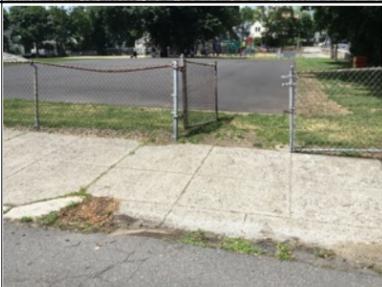
Accessible route not provided		Ensure an accessible route is provided.	1	-	\$0
4	Cement Gaming Table Near Entrance			Exterior Access Route	Exterior

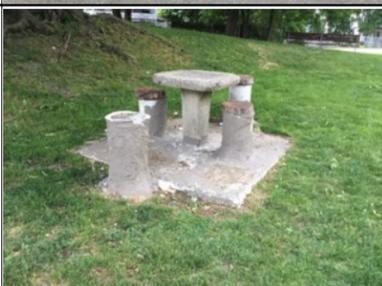
Accessible route not provided		Ensure an accessible route is provided. Ensure table is maintained in operable working condition.	1	-	\$0

- Recommend repairing the concrete table with two concrete seats that is presently not in operable working condition, maintaining two opposite sides of the table without seating and 27" min. knee and toe clearance so individuals in a wheeled mobility device could also use the table.

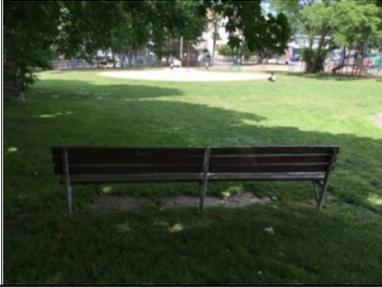
ID	Location	Floor	Room	Element	Type	Photo	Issues	Current Measure	Recommendations	Quantity	Price	Cost Estimation
<b>Benches</b>												
5	Inside Park			Benches	N/A

No accessible route to one bench in this area		Provide an accessible route to at least one bench in this area.	1	-	\$0
<b>Toilet &amp; Bathing Rooms</b>												
<b>Portable Toilet</b>												
6	By Playground			Portable Toilet	N/A

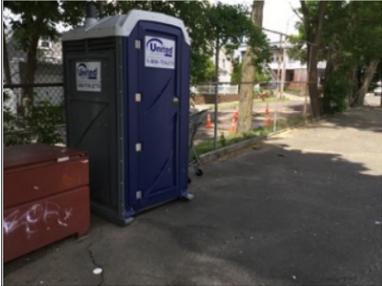
Not located on an accessible route Accessible portable toilets not provided	2" -	Locate portable toilet on an accessible route. Ensure change in level is not higher than 1/4". Ensure that at least 5% of portable toilets (with a minimum of one) are accessible. An accessible portable toilet must provide a clear floor space of at least 60" by 72".	1	-	\$0
<b>Play and Sport Areas</b>												
<b>Play Areas</b>												
7	Playground			Play Areas	N/A

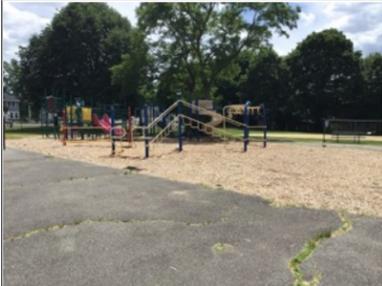
Accessible route not provided at play components Surface not stable, firm, and slip-resistant		Provide a compliant impact-attenuating surface under and around the play components. Repair the surface and ensure that surface is firm, stable and slip-resistant (to areas under and around play components).	1	-	\$0

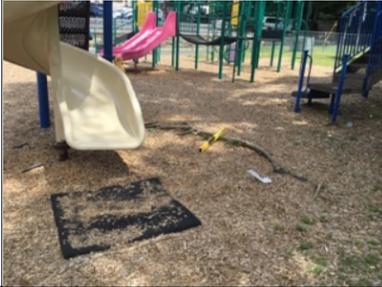
8	Playground			Play Areas	N/A

Surface not stable, firm, and slip-resistant		Repair the surface and ensure that surface is firm, stable and slip-resistant (to areas under and around play components).	1	-	\$0

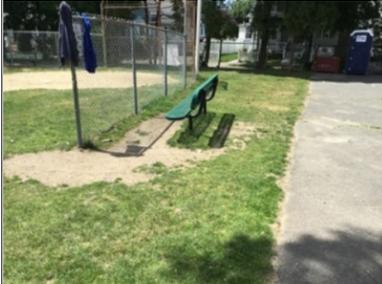
ID	Location	Floor	Room	Element	Type	Photo	Issues	Current Measure	Recommendations	Quantity	Price	Cost Estimation
Field												
9	Softball Field			Field	Softball

Not connected to an accessible-route	-	Provide an accessible route to the team seating.	1	-	\$0
10	Softball Field	Ext.		Field	Softball

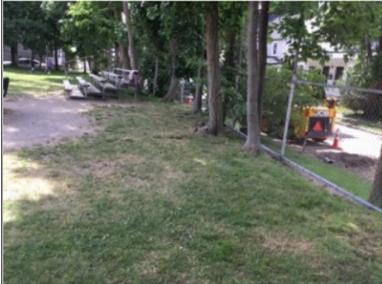
Not connected to an accessible-route	-	Provide an accessible route to the bleachers.	1	-	\$0

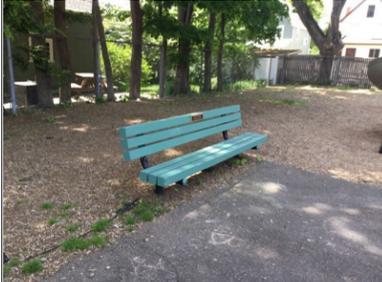
ID	Location	Floor	Room	Element	Type	Photo	Issues	Current Measure	Recommendations	Quantity	Price	Cost Estimation
<b>Access to Goods and Services</b>												
<b>Benches</b>												
1	Playground	Ext.		Benches	N/A

No accessible route to one bench in this area		Provide an accessible route to at least one bench in this area.	1	-	\$0
2	Open Field by Basketball	Ext.		Benches	N/A

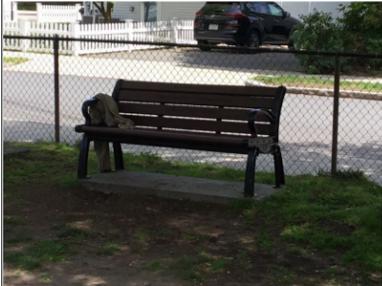
No accessible route to one bench in this area		Provide an accessible route to at least one bench in this area.	1	-	\$0
<b>Play and Sport Areas</b>												
<b>Play Areas</b>												
3	Playground	Ext.		Play Areas	N/A

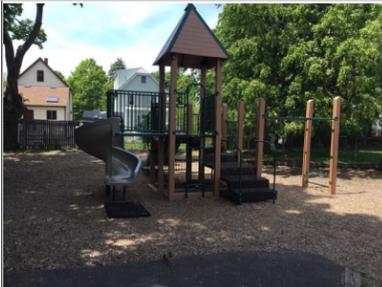
Accessible route not provided around playground Accessible route not provided at play components		Install an accessible route to and around the playground. Provide a compliant impact-attenuating surface under and around the play components.	1	-	\$0
4	Playground	Ext.		Play Areas	N/A

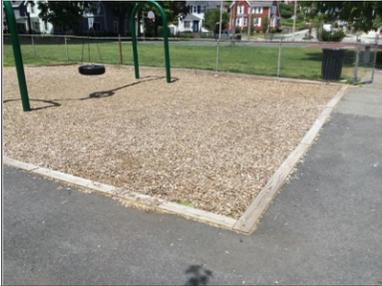
Accessible route not provided at play components	-	Provide a compliant impact-attenuating surface under and around the play components.	1	-	\$0

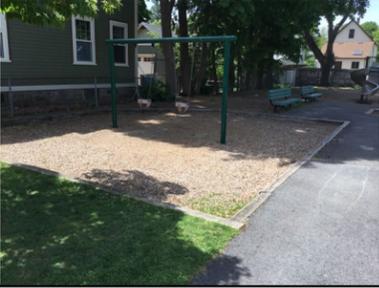
ID	Location	Floor	Room	Element	Type	Photo	Issues	Current Measure	Recommendations	Quantity	Price	Cost Estimation
5	Playground	Ext.		Play Areas	N/A

Accessible route not provided at play components Surface not stable, firm, and slip-resistant		Provide a compliant impact-attenuating surface under and around the play components. Repair the surface and ensure that surface is firm, stable and slip-resistant (to areas under and around play components).	1	-	\$0
<b>Court</b>												
6	Basketball Court	Ext.		Court	Basketball

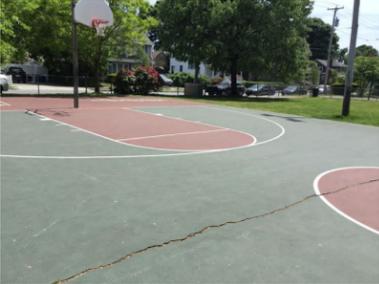
Court not maintained in operable working condition		Ensure court is maintained in operable working condition.	1	-	\$0

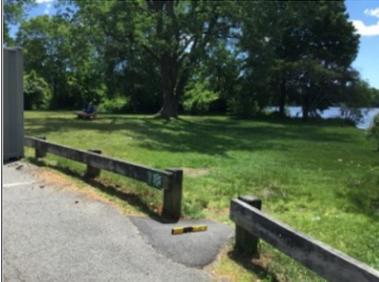
ID	Location	Floor	Room	Element	Type	Photo	Issues	Current Measure	Recommendations	Quantity	Price	Cost Estimation
<b>Approach and Entrance</b>												
<b>Exterior Access Route</b>												
1	Memorial Knoll Route to Bench by Pond	Ext.		Exterior Access Route

Running slope > 1:20 (5.00%) Surface is not stable, firm, and slip-resistant Accessible route not provided	18% - -	Provide an accessible route to at least one bench in this area.	1	-	\$0
2	Memorial Knoll Walkway Ascending Hill	Ext.		Exterior Access Route	Walkway

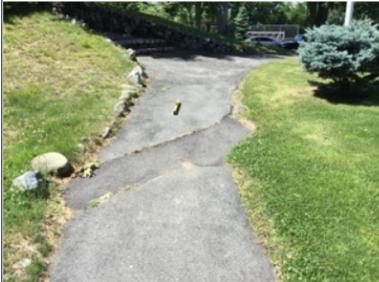
Running slope > 1:20 (5.00%) Route not maintained in operable working condition Accessible route not provided.	9% - -	Reduce the running slope to be no steeper than 1:20 (5.00%). Ensure that the accessible route is maintained in operable working condition. Note: Providing an accessible route may not be technically feasible. If an accessible route can not be provides to the top of the memorial, provide a display at an accessible route describing the top of the memorial hill.	1	-	\$0

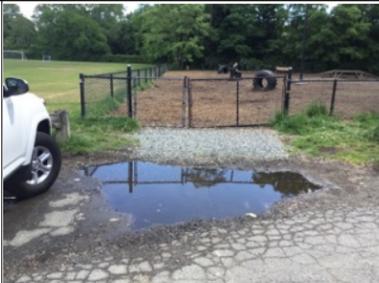
3	Knoll Complex Dog Park	Ext.		Exterior Access Route	Exterior

Does not prevent accumulation of water Accessible route not provided	- -	Repair the surface. Ensure an accessible route is provided.	1	-	\$0
4	Lynn Fells Parkway Walkway Along East Knoll Soccer Field	Ext.		Exterior Access Route

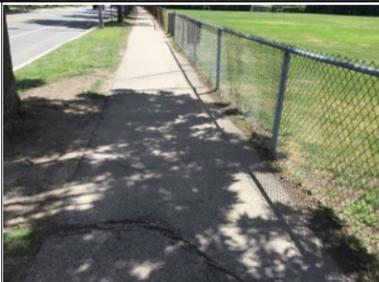
Route not maintained in operable working condition	-	Ensure that the accessible route is maintained in operable working condition.	1	-	\$0
<b>Off-Street Parking Lot or Garage</b>												
5	Memorial Knoll Parking	Ext.		Off-Street Parking Lot or Garage	Visitor

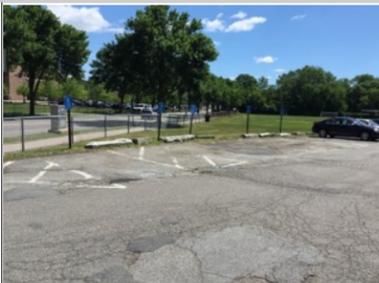
Total # of parking Total # of designated accessible parking spaces Total # of designated van accessible spaces Access aisle not provided Sign does not have the designation "Van Accessible" Sign bottom < 60" above finished grade Surface not stable, firm, and slip-resistant	125 4 1 - - 54" -	Provide a marked access aisle that is at least 60" wide at the car accessible spaces where the access aisle striping has been worn away. Repaint all faded parking space and access aisle striping. Add the designation "Van Accessible" to the sign located at the van accessible space. Locate all the accessible parking signs 60" min. and 96" max. above the ground. Repair deteriorated parking surface.	1	-	\$0

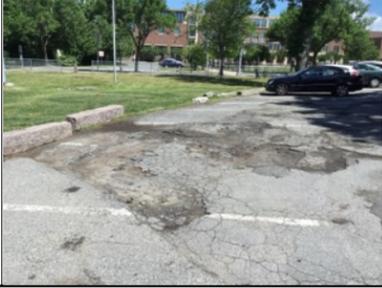
ID	Location	Floor	Room	Element	Type	Photo	Issues	Current Measure	Recommendations	Quantity	Price	Cost Estimation
6	Memorial Knoll Parking	Ext.		Off-Street Parking Lot or Garage	Visitor

Surface not stable, firm, and slip-resistant	-	Repair surface.	1	-	\$0
<b>Access to Goods and Services</b>												
<b>Stairways</b>												
7	West Knoll Soccer Field Near Memorial Knoll Parking	Ext.		Stairways	Exterior

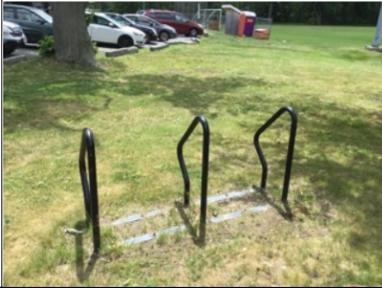
Handrails do not extend 12" from stairs Surface not stable, firm, and slip-resistant	- -	Top: Ensure handrails extend horizontally above the landing for 12" min. beginning above the first riser nosing. Bottom: Ensure that the sloped bottom extension extends one tread depth minimum beyond last riser nosing in same direction as stair flight. Provide a stable and firm accessible route to and from stairs.	1	-	\$0
8	Memorial Knoll Walkway Ascending Hill	Ext.		Stairways	Exterior

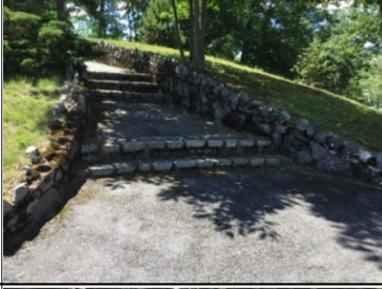
Handrails not provided	-	Provide handrails.	1	-	\$0

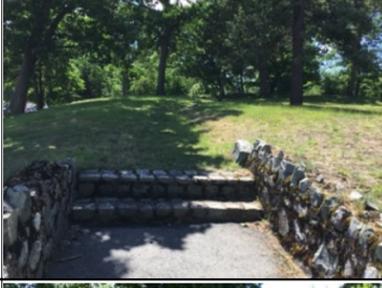
9	Memorial Knoll Walkway Ascending Hill	Ext.		Stairways	Exterior

Handrails not provided	-	Provide handrails.	1	-	\$0
10	Memorial Knoll Walkway Ascending Hill	Ext.		Stairways	Exterior

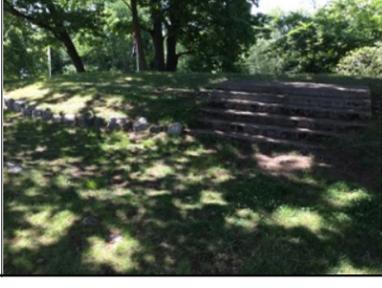
Handrails not provided	-	Provide handrails.	1	-	\$0

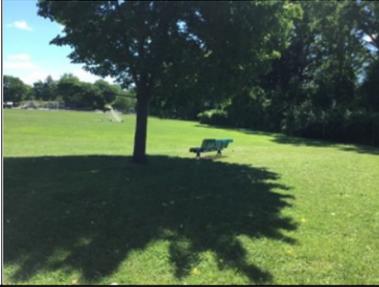
ID	Location	Floor	Room	Element	Type	Photo	Issues	Current Measure	Recommendations	Quantity	Price	Cost Estimation
<b>Benches</b>												
11	West Knoll Soccer Field by Lyons Tennis Courts	Ext.		Benches	N/A

No accessible route to one bench in this area	-	Provide an accessible route to at least one bench in this area.	1	-	\$0
12	Memorial Knoll	Ext.		Benches	N/A

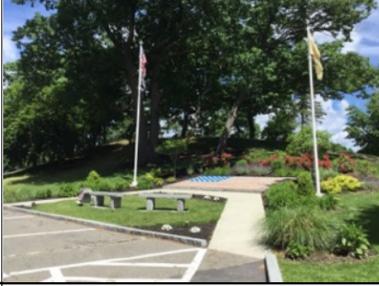
No accessible route to one bench in this area	-	Provide an accessible route to at least one bench in this area.	1	-	\$0
13	Korean War Memorial	Ext.		Benches	N/A

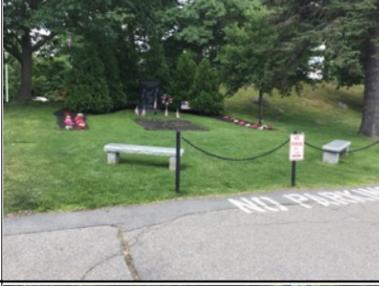
No accessible route to one bench in this area	-	Provide an accessible route to at least one bench in this area.	1	-	\$0
14	Memorial Knoll Atlantic and Pacific Campaigns Memorial	Ext.		Benches

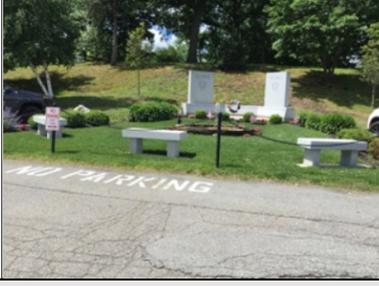
No accessible route to one bench in this area		Provide an accessible route to at least one bench in this area.	1	-	\$0
<b>Toilet &amp; Bathing Rooms</b>

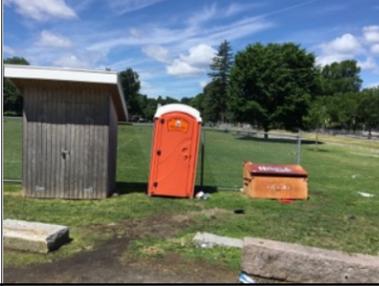
<b>Portable Toilet</b>												
15	West Knoll Soccer Field	Ext.		Portable Toilet	N/A

Not located on an accessible route Accessible portable toilets not provided	2" -	Locate portable toilet on an accessible route. Ensure that at least 5% of portable toilets (with a minimum of one) are accessible.	1	-	\$0

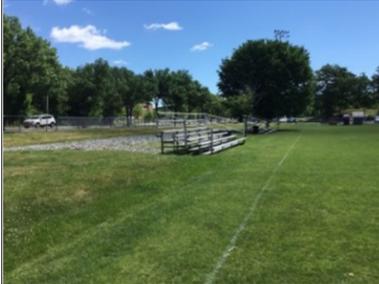
ID	Location	Floor	Room	Element	Type	Photo	Issues	Current Measure	Recommendations	Quantity	Price	Cost Estimation
<b>Play and Sport Areas</b>												
<b>Field</b>												
16	West Knoll Soccer Field	Ext.		Field	Soccer

Accessible spaces not provided at sidelines seating Not connected to an accessible-route	- -	Provide a 36" x 60" stable and firm clear floor space at both ends of the bottom row of the sidelines seating to create accessible seating spaces. Provide an accessible route to the sideline seating and to the boundary of sport activity at the soccer field.	1	-	\$0
17	West Knoll Soccer Field Lynn Fells Parkway Entry	Ext.		Field	Soccer

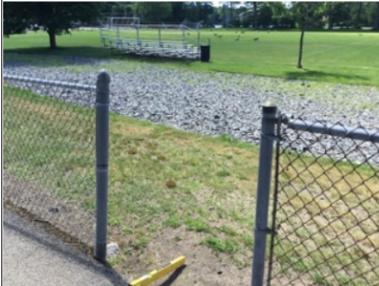
Not connected to an accessible-route	3"	Provide an accessible route to the boundary of sport activity at the soccer field.	1	-	\$0
18	East Knoll Soccer Field	Ext.		Field	Soccer

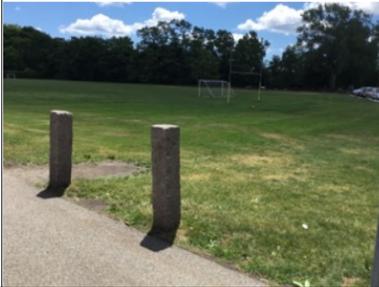
Not connected to an accessible-route		Provide an accessible route to the boundary of sport activity at the soccer field.	1	-	\$0

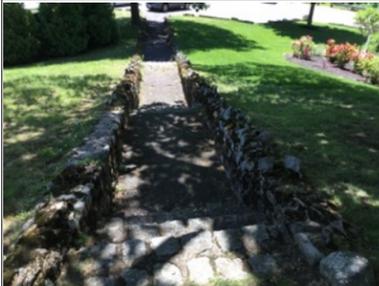
<b>Best Practice</b>												
<b>Exterior Stairs</b>												
19	Memorial Knoll Walkway Descending Hill	Ext.		Exterior Stairs	Exterior

Recommend providing contrasting color strips on all stairs.	1	-	\$0

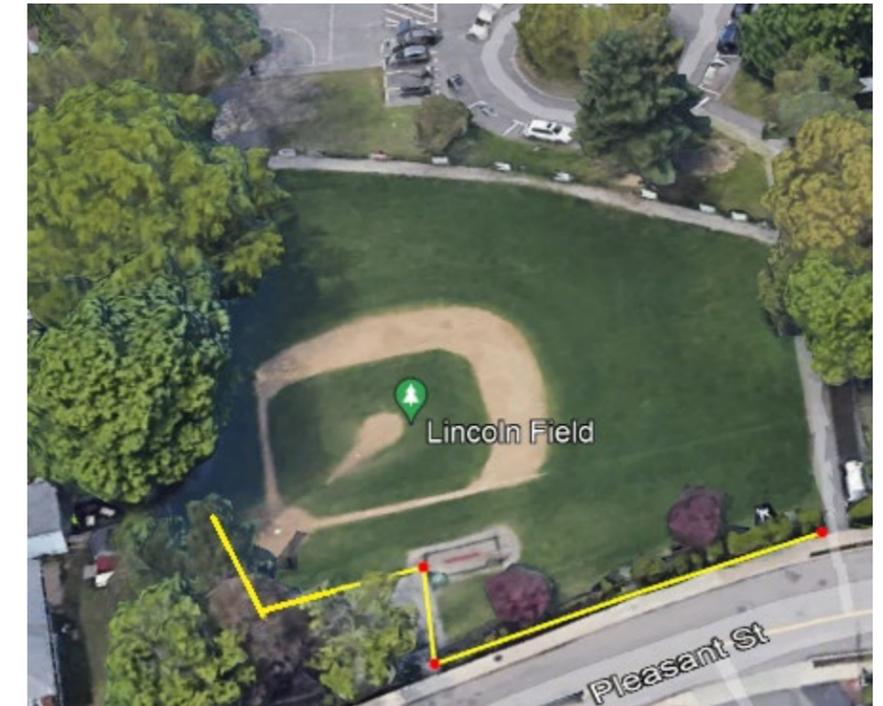
- Lack of an accessible route to the team seating area and to the boundary of sport activity on the third base side of the baseball field.
- A portion of the walkway extending from the parking lot at the Lincoln Elementary School towards the baseball field is not maintained in operable working condition.

Figure 1: The image below uses a yellow line to indicate the approximate suggested location for a 48" wide min. stable, firm and slip resistant accessible route connecting park entry points to the team seating areas and the boundary of sport activity on the first base and third base sides of the baseball field.

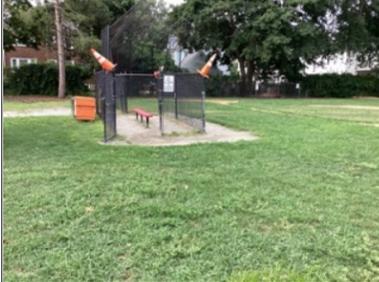
ID	Location	Floor	Room	Element	Type	Photo	Issues	Current Measure	Recommendations	Quantity	Price	Cost Estimation
Approach and Entrance												
Exterior Access Route												
1	Third Base Team Seating at the Baseball Field	Ext.		Exterior Access Route	Exterior

Surface is not stable, firm, and slip-resistant Accessible route not provided	- -	Provide a 48" wide min. accessible route extending from the Pleasant Street fence opening and first base team seating area to the third base team seating area so that both team seating areas and the boundary of sport activity are connected by an accessible route. <b>(Note:</b> See Figure 1 in the report narrative for a suggested location of the accessible route.)	1	-	\$0
2	Walkway From Lincoln Elementary School Parking Towards the Baseball Field	Ext.		Exterior Access Route
