# ADA Self-Evaluation and Transition Plan for the City of Melrose

Part 2 of 2

## Part 2: Reports:

January, 2023

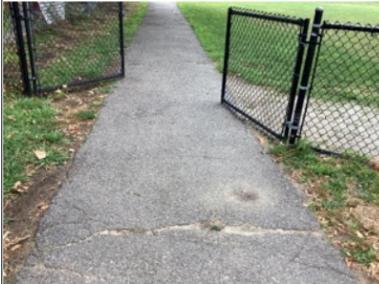
Route not maintained in operable working condition		Ensure the accessible route is maintained in operable working condition.	1	-	\$0

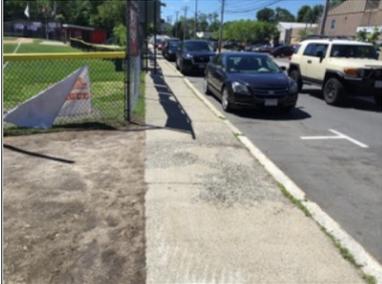
ID	Location	Floor	Room	Element	Type	Photo	Issues	Current Measure	Recommendations	Quantity	Price	Cost Estimation
<b>Approach and Entrance</b>												
<b>Exterior Access Route</b>												
1	Tremont Street	Ext.		Exterior Access Route	Sidewalk

Route not maintained in operable working condition		Ensure that the accessible route is maintained in operable working condition.	1	-	\$0
<b>Access to Goods and Services</b>												
<b>Benches</b>												
2	Tremont Street	Ext.		Benches	N/A

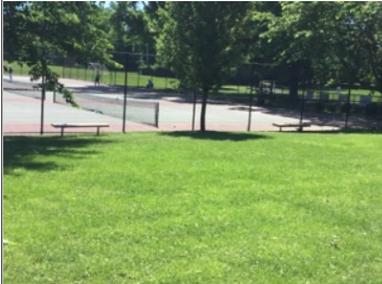
No accessible route to one bench in this area		Provide an accessible route to at least one bench in this area.	1	-	\$0
<b>Best Practice</b>												
<b>Curb Ramp And Accessible Street Parking Space</b>												
3	Tremont Street	Ext.		Curb Ramp And Accessible Street Parking Space	N/A

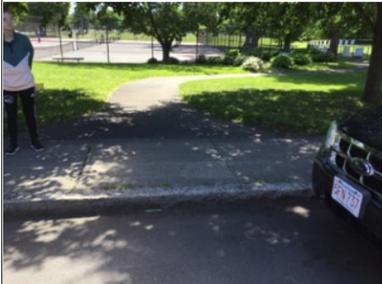
Recommend providing a curb ramp where the sidewalk meets the walkway to the accessible entry to the tennis courts. Recommend providing a sign with the International Symbol of Accessibility (ISA) on Tremont Street just before the recommended curb ramp. (This would result in an accessible street parking space on the shortest accessible route to the walkway.)	1		\$0

- Recommend providing a curb ramp at the Tremont Street sidewalk where the sidewalk meets the walkway to the accessible entry to the tennis courts.
- Recommend providing a sign with the International Symbol of Accessibility (ISA) on Tremont Street just before the recommended curb ramp where the sidewalk meets the walkway to the accessible entry to the tennis courts to create an accessible street parking space. (This would result in an accessible street parking space on the shortest accessible route to the walkway that leads to the tennis court entry.)

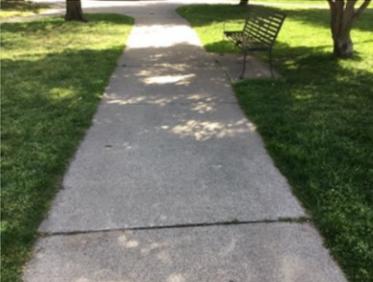
ID	Location	Floor	Room	Element	Type	Photo	Issues	Current Measure	Recommendations	Quantity	Price	Cost Estimation
<b>Approach and Entrance</b>												
<b>Exterior Access Route</b>												
1	Grove Street	Ext.		Exterior Access Route	Walkway

Level changes > 1/4"	.75"	Alter the change in level to be 1/4" high max.	1	-	\$0
2	Faulkner Street North Walkway	Ext.		Exterior Access Route	Walkway

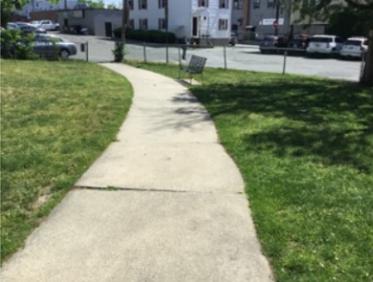
Level changes > 1/4"	1"	Alter the change in level to be 1/4" high max.	1	-	\$0
3	Faulkner Street North Walkway	Ext.		Exterior Access Route	Walkway

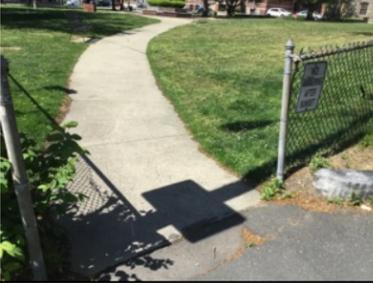
Level changes > 1/4"	1"	Alter the change in level to be 1/4" high max.	1	-	\$0
4	Mary Foley Monument	Ext.		Exterior Access Route	Walkway

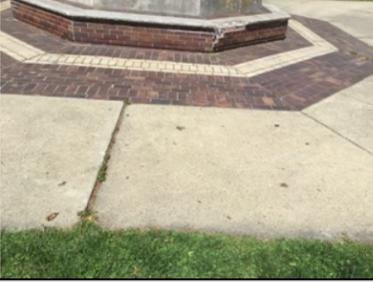
Level changes > 1/4"	1"	Alter the change in level to be 1/4" high max.	1	-	\$0
<b>Curb Ramp</b>												
5	Faulkner Street Entrance	Ext.		Curb Ramp	N/A

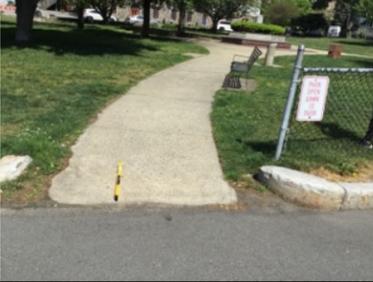
Running slope > 1:12 (8.33%) Transition from curb ramp to street not flush	13.3%	Reduce the running slope to be no steeper than 1:12 (8.33%). Ensure transition from curb ramp to street is flush or free of changes in level.	1	-	\$0

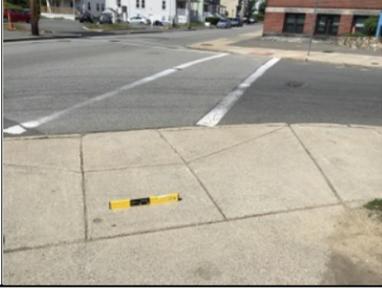
ID	Location	Floor	Room	Element	Type	Photo	Issues	Current Measure	Recommendations	Quantity	Price	Cost Estimation
6	Grove Street Curb Ramp	Ext.		Curb Ramp	N/A

Detectable warning not provided (PROWAG)		Provide a detectable warning on the curb ramp.	1	-	\$0
<b>Access to Goods and Services</b>												
<b>Benches</b>												
7	Mary Foley Monument	Ext.		Benches	N/A

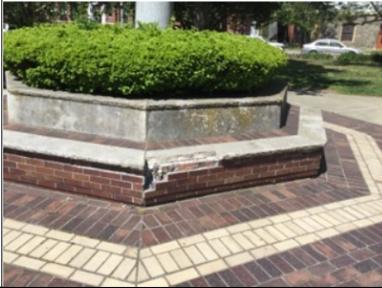
Ensure bench is maintained in operable working condition.	1	-	\$0
<b>Best Practice</b>												
<b>Bench</b>												
8	Park	Ext.		Bench	N/A

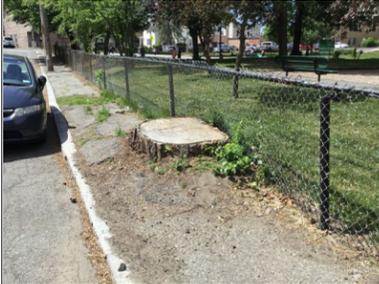
ID	Location	Floor	Room	Element	Type	Photo	Issues	Current Measure	Recommendations	Quantity	Price	Cost Estimation
<b>Approach and Entrance</b>												
<b>Exterior Access Route</b>												
1	Towards Felton Place Park Entrance	Ext.		Exterior Access Route	Sidewalk

Exterior route < 48" wide Cross slope > 1:50 (2.00%) Route not maintained in operable working condition	24" 33% -	Ensure that a clear width of 48" min. is maintained at the accessible route. Reduce the cross slope to be no steeper than 1:50 (2.00%). Ensure that the accessible route is maintained in operable working condition.	1	-	\$0
2	Playground Entrance Near Felton Place	Ext.		Exterior Access Route	Exterior

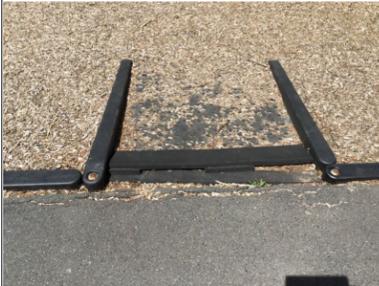
Level changes > 1/4" Accessible route not provided	2" -	Alter the change in level to be 1/4" high max. Ensure an accessible route is provided (Keep entry surface clear of Engineered Wood Fiber (EWF)).	1	-	\$0
<b>Access to Goods and Services</b>

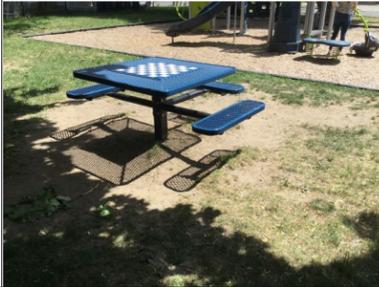
<b>Picnic Tables</b>												
3	Picnic Table Near Playground	Ext.		Picnic Tables	N/A

Picnic table not on an accessible route	-	Ensure that the picnic table is connected to an accessible route.	1	-	\$0
<b>Benches</b>												
4	By Basketball Court	Ext.		Benches

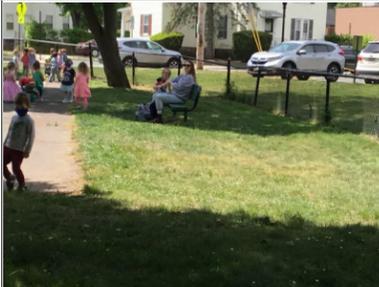
No accessible route to one bench in this area		Provide an accessible route to at least one bench in this area.	1	-	\$0
<b>Play and Sport Areas</b>

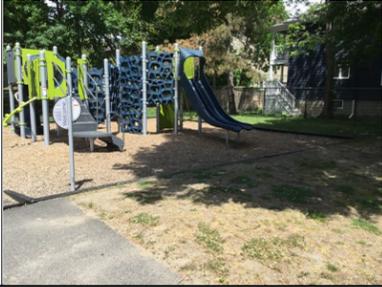
ID	Location	Floor	Room	Element	Type	Photo	Issues	Current Measure	Recommendations	Quantity	Price	Cost Estimation
<b>Play Areas</b>												
5	Playground	Ext.		Play Areas	N/A

Accessible route not provided around playground Accessible route not provided at play components		Install an accessible route to and around the playground. Provide a compliant impact-attenuating surface under and around the play components.	1	-	\$0
<b>Best Practice</b>												
<b>Bench</b>												
6	Inside Park	Ext.		Bench	N/A

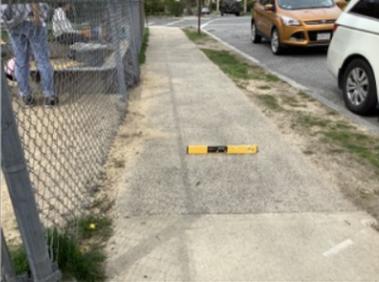
ID	Location	Floor	Room	Element	Type	Photo	Issues	Current Measure	Recommendations	Quantity	Price	Cost Estimation
<b>Approach and Entrance</b>												
<b>Exterior Access Route</b>												
1	East Foster & Larrabee Street Corner of Park	Ext.		Exterior Access Route	Sidewalk

Cross slope > 1:50 (2.00%)	5.6%	Reduce the cross slope to be no steeper than 1:50 (2.00%).	1	-	\$0
2	Laurel Street	Ext.		Exterior Access Route	Walkway

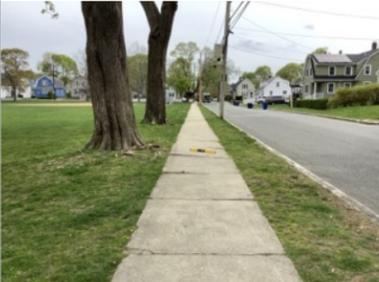
Cross slope > 1:50 (2.00%) Level changes > 1/4" Route not maintained in operable working condition	10% 2" -	Reduce the cross slope to be no steeper than 1:50 (2.00%). Alter the change in level to be 1/4" high max. Ensure that the accessible route is maintained in operable working condition.	1	-	\$0
3	Laurel Street & Larrabee Street Corner of Park	Ext.		Exterior Access Route	Sidewalk

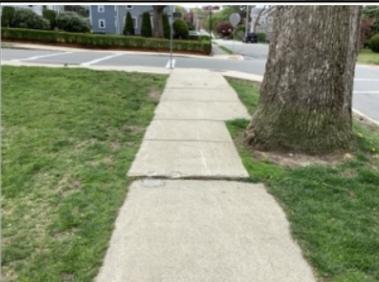
Level changes > 1/4"	2"	Alter the change in level to be 1/4" high max.	1	-	\$0

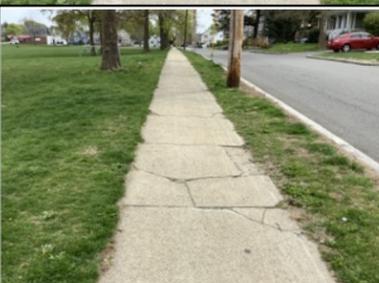
4	Laurel Street	Ext.		Exterior Access Route	Sidewalk

Route not maintained in operable working condition	-	Repair the cracks in the walkway to ensure that the accessible route is maintained in operable working condition.	1	-	\$0
5	Sandbox	Ext.		Exterior Access Route	Exterior

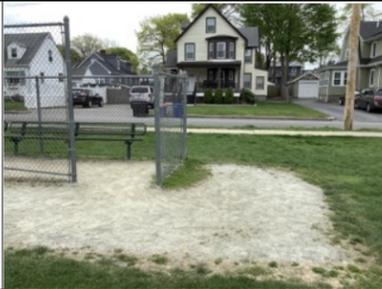
ID	Location	Floor	Room	Element	Type	Photo	Issues	Current Measure	Recommendations	Quantity	Price	Cost Estimation
6	Softball Field at 6th Street	Ext.		Exterior Access Route	Walkway

Accessible route not provided	-	Ensure an accessible route is provided to the team seating.	2	-	\$0
<b>Curb Ramp</b>												
7	Laurel Street & Larrabee Street Park	Ext.		Curb Ramp	N/A

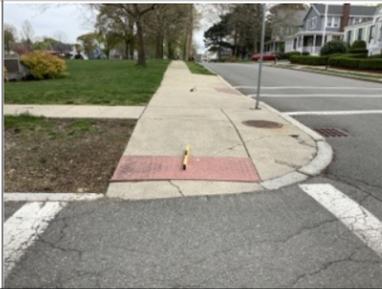
Running slope > 1:12 (8.33%)	14.3%	Reduce the running slope to be no steeper than 1:12 (8.33%).	1	-	\$0
8	East Foster & Larrabee Street Corner of Park	Ext.		Curb Ramp	Diagonal

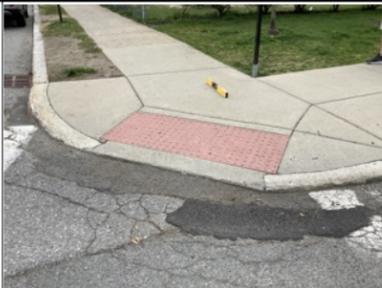
Transition from curb ramp to street not flush Cross slope > 1:50 (2.00%) (MAAB)	0.5" 3.8%	Ensure transition from curb ramp to street is flush or free of changes in level. Reduce cross slope at curb ramp to be no steeper than 1:50 (2.00%).	1	-	\$0
<b>Access to Goods and Services</b>												
<b>Picnic Tables</b>												
9	Picnic Tables by Sandbox	Ext.		Picnic Tables	N/A

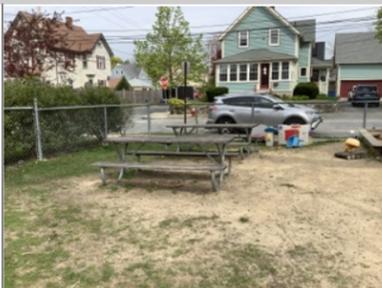
Picnic table not on an accessible route	-	Ensure that the picnic table is connected to an accessible route.	1	-	\$0

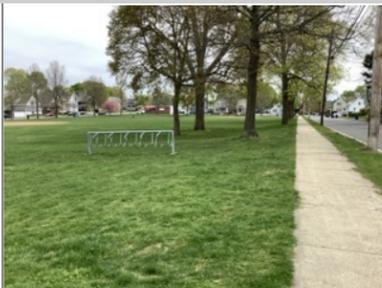
<b>Bike Racks</b>												
10	By Basketball Court Laurel Street	Ext.		Bike Racks	N/A

Bike rack is not connected to an accessible route	-	Ensure bike racks are connected to an accessible route.	1	-	\$0

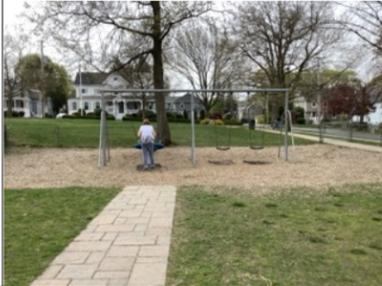
ID	Location	Floor	Room	Element	Type	Photo	Issues	Current Measure	Recommendations	Quantity	Price	Cost Estimation
<b>Play and Sport Areas</b>												
<b>Play Areas</b>												
11	Swing Set	Ext.		Play Areas	N/A

Surface not stable, firm, and slip-resistant	-	Repair the surface and ensure that surface is firm, stable and slip-resistant (to areas under and around play components).	1	-	\$0
12	Playground	Ext.		Play Areas	N/A

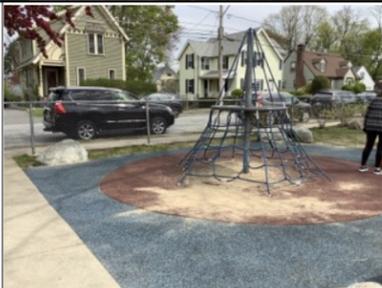
Surface not stable, firm, and slip-resistant	-	Remove the sand underneath the play surface to ensure that surface is firm, stable and slip-resistant (to areas under and around play components).	1	-	\$0
<b>Field</b>												
13	Softball Field at Playground	Ext.		Field	Softball

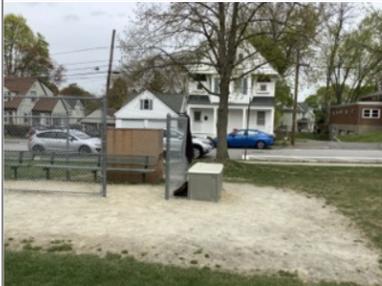
Not connected to an accessible-route	-	Provide an accessible route to the field or to the team seating.	2	-	\$0

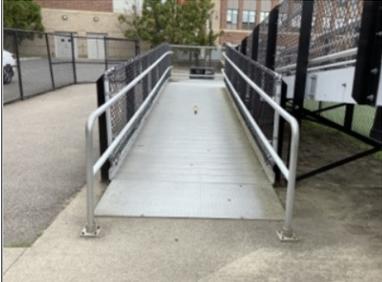
ID	Location	Floor	Room	Element	Type	Photo	Issues	Current Measure	Recommendations	Quantity	Price	Cost Estimation
<b>Approach and Entrance</b>												
<b>Exterior Ramp</b>												
1	Ramp at East End of Bleachers	Ext.		Exterior Ramp	N/A

Running slope > 1:12 (8.33%)	9%	Reduce running slope to be no steeper than 1:12 (8.33%).	1	-	\$0
<b>Access to Goods and Services</b>												
<b>Means of Egress</b>												
2	Press Box, Northwest Egress	1		Means of Egress	N/A

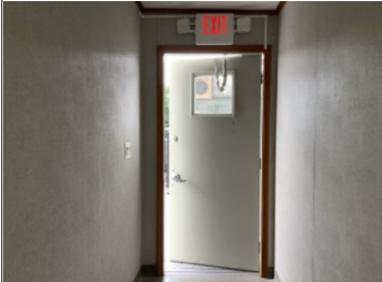
Tactile exit sign not provided	-	Ensure tactile exit signs with raised characters and braille are provided at exit doors. Mount signs between 48"- 60" above the finished floor located on the latch side of the door.	1	232	\$232
3	Press Box, Northeast Egress	1		Means of Egress	N/A

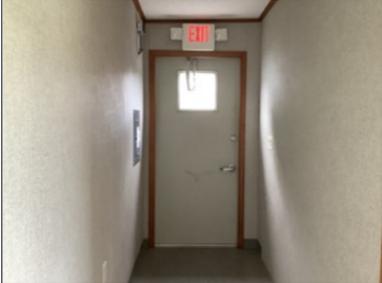
Tactile exit sign not provided Directional sign to accessible emergency exit not provided	- -	Ensure tactile exit signs with raised characters and braille are provided at exit doors. Mount signs between 48"- 60" above the finished floor located on the latch side of the door. Provide a directional sign indicating the location of the nearest accessible emergency exit.	1	464	\$464

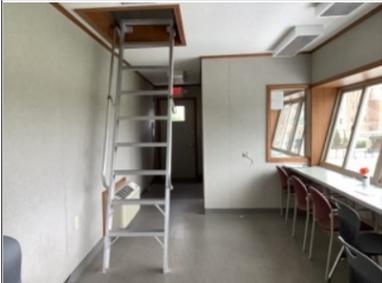
<b>Interior Access Route</b>												
4	Press Box Towards Southeast Egress	1		Interior Access Route	N/A

Obstructed by protruding objects	-	Provide a cane-detectable barrier.	1	878	\$878

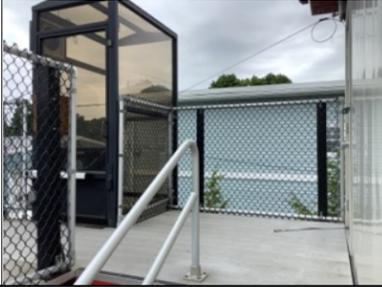
ID	Location	Floor	Room	Element	Type	Photo	Issues	Current Measure	Recommendations	Quantity	Price	Cost Estimation
<b>Platform Lift or LULA Elevator</b>												
5	Lift by Press Box, Northwest Egress	Ext.		Platform Lift or LULA Elevator	Exterior

Bleachers can be accessed via a ramp on the northeast side or a stairway on the northwest side. An additional ramp located near the toilet rooms provides an accessible route to the lift that goes to the press box. On the day of the survey the lift was not in operable working condition.

Not in operable working condition	-	Ensure lift is maintained in operable working condition.	1	-	\$0
<b>Signage</b>												
6	Women's Toilet Room	Ext.		Signage	Designation

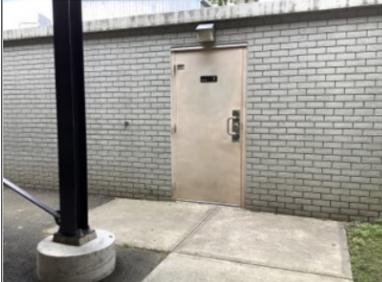
Raised characters not provided on sign Braille not provided on sign Sign not located on the latch side of the door	- - -	Provide text with raised characters duplicated in braille on sign. Locate the sign at permanent rooms alongside the door on the latch side.	1	-	\$0
7	Men's Toilet Room	Ext.		Signage	Designation

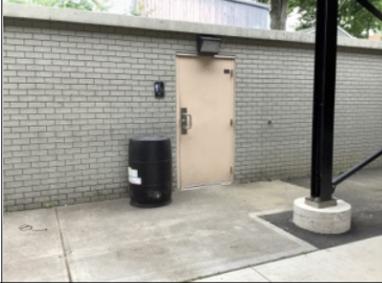
Signage lacks 18" by 18" clear floor space	-	Relocate trash can to maintain the required 18" min. by 18" min. at the sign.	1	-	\$0
<b>Picnic Tables</b>

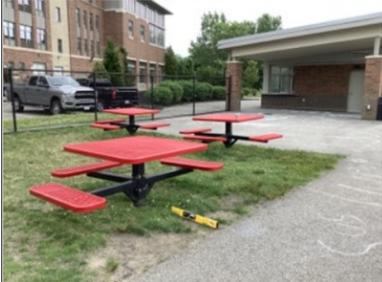
8	By Concession Stand	Ext.		Picnic Tables	N/A

Number of seating spaces at picnic tables Toe or knee clearance at tables not provided Picnic table not on an accessible route	4 24" -	Provide at least 1 picnic table (or ensure that 5% of picnic tables) have toe and knee clearance. Ensure that the picnic table is connected to an accessible route.	1	-	\$0
<b>Toilet &amp; Bathing Rooms</b>

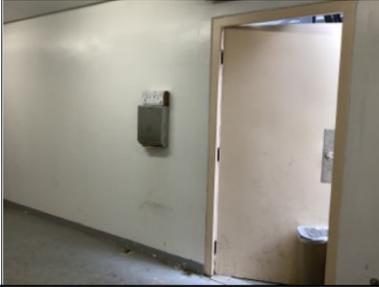
ID	Location	Floor	Room	Element	Type	Photo	Issues	Current Measure	Recommendations	Quantity	Price	Cost Estimation
<b>Overall Access</b>												
9	Men's Toilet Room	1		Overall Access	Toilet Room

Audible and visible alarms not provided	-	When the fire system is updated, ensure that a visible and audible fire alarm is installed.	1	-	\$0
10	Women's Toilet Room	1		Overall Access	Toilet Room

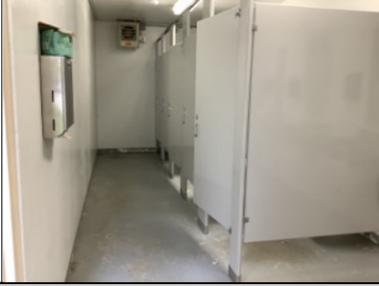
Audible and visible alarms not provided	-	When the fire system is updated, ensure that a visible and audible fire alarm is installed.	1	-	\$0
<b>Lavatory</b>												
11	Men's Toilet Room	1		Lavatory	N/A

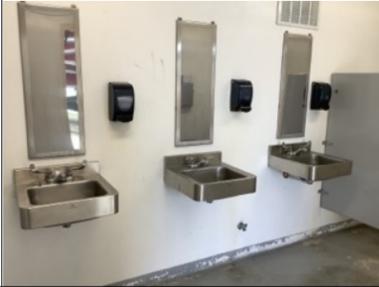
Plumbing underneath is exposed	-	Insulate or otherwise configure pipes to prevent contact for at least one lavatory.	1	92	\$92
12	Women's Toilet Room	1		Lavatory	N/A

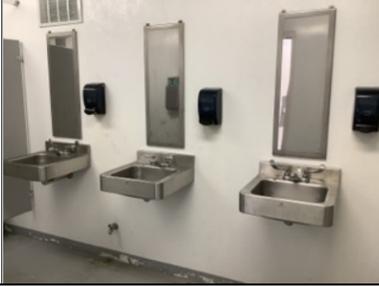
Plumbing underneath is exposed	-	Insulate or otherwise configure pipes to prevent contact for at least one lavatory.	1	92	\$92

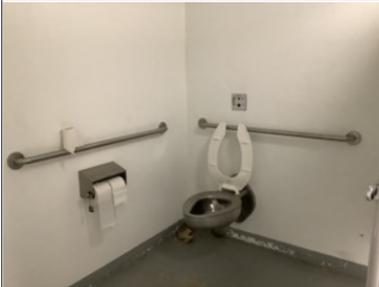
<b>Toilet Compartment</b>												
13	Men's Toilet Room	1		Toilet Compartment	Accessible Compartment

Centerline < or > 18" (MAAB)	18.6"	Relocate toilet so the centerline is 18" from the side wall.	1	2828	\$2828

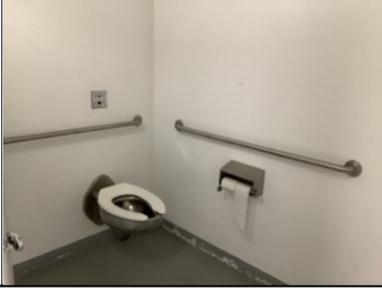
ID	Location	Floor	Room	Element	Type	Photo	Issues	Current Measure	Recommendations	Quantity	Price	Cost Estimation
14	Women's Toilet Room	1		Toilet Compartment	Accessible Compartment

Centerline < or > 18" (MAAB)	18.9"	Relocate toilet so the centerline is 18" from the side wall.	1	2828	\$2828
<b>Best Practice</b>												
<b>Signage</b>												
15	From Toilet Rooms to Ramp at East End of Bleachers	Ext.		Signage	N/A

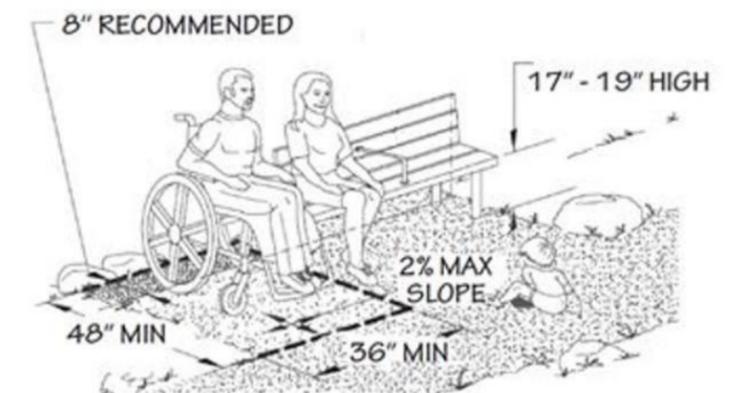
**Figure 1:** Shows a 36" min. by 48" min. stable, firm and slip-resistant surface adjacent to a bench positioned to allow a person using a wheeled mobility device and a person sitting on the bench to have their shoulders aligned.

- Recommend providing a 36" min. by 48" min. stable, firm and slip-resistant surface adjacent to at least one (1) bench in the playground at each location where benches are provided in a manner that is substantially similar to what is shown in Figure 1.

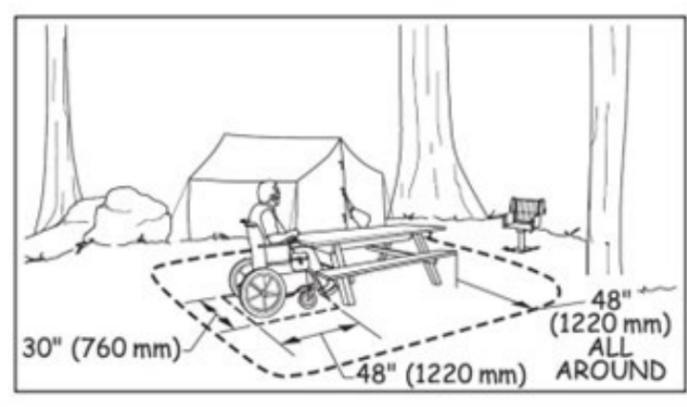
**Figure 2:** Shows a stable, firm and slip-resistant surface around a picnic table to allow a person in a wheeled mobility device to maneuver around the picnic table.

- Recommend providing a 48" min. stable, firm, and slip-resistant surface around at least one (1) accessible picnic table in the park at each location where picnic tables are provided in a manner that is substantially similar to what is shown in Figure 1.

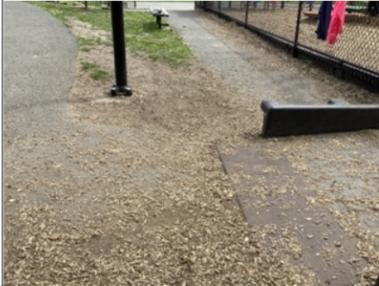
ID	Location	Floor	Room	Element	Type	Photo	Issues	Current Measure	Recommendations	Quantity	Price	Cost Estimation
<b>Approach and Entrance</b>												
<b>Exterior Access Route</b>												
1	Ramp Route to Basketball and Playground	Ext.		Exterior Access Route	Exterior

Exterior route < 36" wide Route not maintained in operable working condition	21" -	Ensure that a clear width of 36" min. is maintained at the accessible route. Ensure that the accessible route is maintained in operable working condition (keep route clear of Engineered Wood Fiber).	1	-	\$0
2	Parking to Basketball	Ext.		Exterior Access Route	Walkway

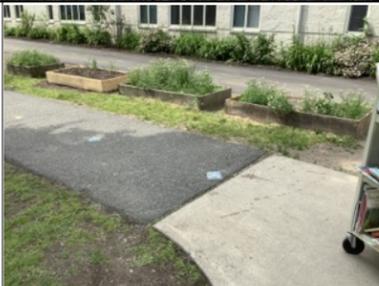
Surface openings > 1/2"	1.5"	Repair surface between concrete and asphalt so that openings are 1/2" max. and the long opening dimension is perpendicular to the dominant direction of travel.	1	-	\$0
3	Route to Basketball	Ext.		Exterior Access Route	Walkway

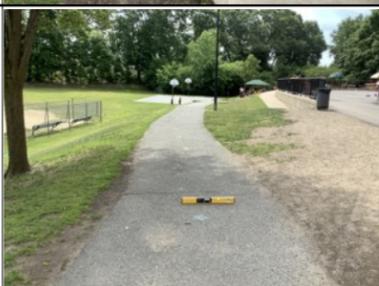
Cross slope > 1:50 (2.00%)	3%	Reduce the cross slope to be no steeper than 1:50 (2.00%).	1	-	\$0

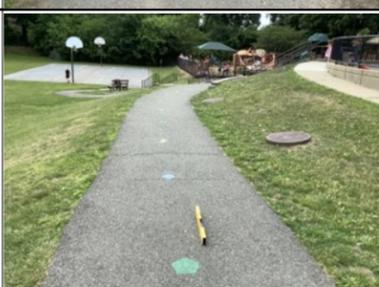
4	Route to Basketball	Ext.		Exterior Access Route	Walkway

Cross slope > 1:50 (2.00%) Running slope > 1:20 (5.00%)	3.2% 7.3%	Reduce the cross slope to be no steeper than 1:50 (2.00%). Reduce the running slope to be no steeper than 1:20 (5.00%).	1	-	\$0
5	Route to Basketball	Ext.		Exterior Access Route	Walkway

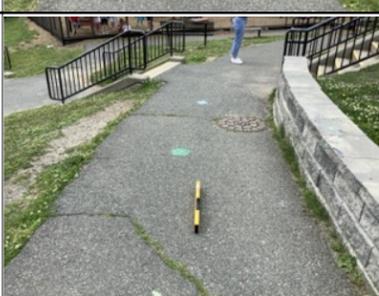
Running slope > 1:20 (5.00%)	8.1%	Reduce the running slope to be no steeper than 1:20 (5.00%). Note: Reducing slope may not be technically feasible.	1	-	\$0

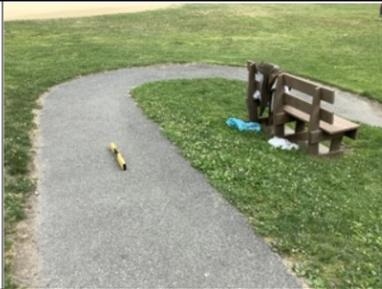
ID	Location	Floor	Room	Element	Type	Photo	Issues	Current Measure	Recommendations	Quantity	Price	Cost Estimation
6	Route to Basketball	Ext.		Exterior Access Route	Exterior

Running slope > 1:20 (5.00%)	8.3%	Reduce the running slope to be no steeper than 1:20 (5.00%). Note: Reducing slope may not be technically feasible.	1	-	\$0
7	Route to Basketball	Ext.		Exterior Access Route	Walkway

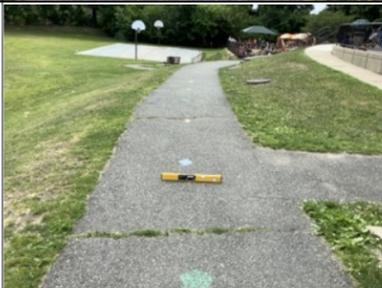
Route not maintained in operable working condition	-	Ensure that the accessible route is maintained in operable working condition.	1	-	\$0
8	Route to Basketball	Ext.		Exterior Access Route	Walkway

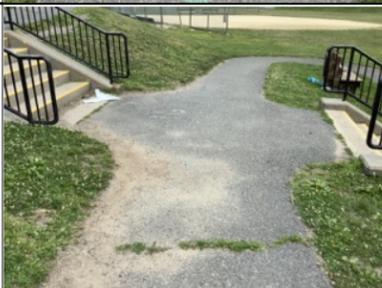
Route not maintained in operable working condition	-	Ensure that the accessible route is maintained in operable working condition.	1	-	\$0
9	Route to Blacktop	Ext.		Exterior Access Route	Walkway

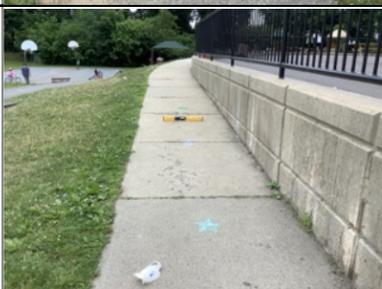
Route not maintained in operable working condition	-	Ensure that the accessible route is maintained in operable working condition. (Patch cement as necessary, remove vegetation.)	1	-	\$0

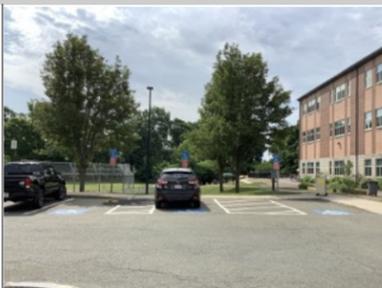
<b>Off-Street Parking Lot or Garage</b>												
10	Parking	Ext.		Off-Street Parking Lot or Garage	Visitor

Running or cross slope at space > 1:50 (2.00%)	52 3 1 3.3%	Reduce running or cross slope to be no steeper than 1:50 (2.00%) in all directions at the accessible parking spaces.	1	-	\$0

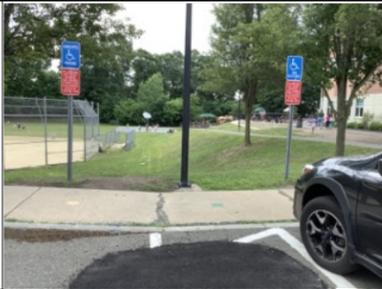
ID	Location	Floor	Room	Element	Type	Photo	Issues	Current Measure	Recommendations	Quantity	Price	Cost Estimation
11	Parking	Ext.		Off-Street Parking Lot or Garage	Visitor

Access aisle does not adjoin an accessible route	0.5"	Ensure the access aisle adjoins an accessible route. (Repair concrete, level surface at access aisle and re-stripe access aisle.)	1	-	\$0
<b>Access to Goods and Services</b>												
<b>Stairways</b>												
12	Stairs to Blacktop	Ext.		Stairways	Exterior

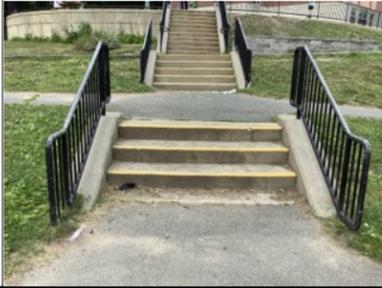
Handrail height < 34" or > 38"	32.8"	Alter so the handrails are 34"- 38" high above ground.	1	-	\$0
13	Stairs to Basketball Court	Ext.		Stairways	Exterior

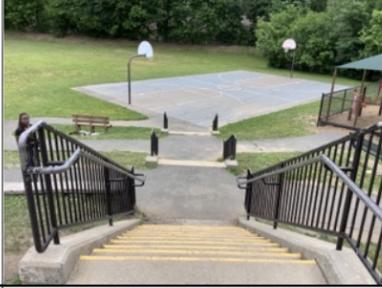
Handrail height < 34" or > 38"	32.9"	Alter so the handrails are 34"- 38" high above the ground.	1	-	\$0
14	Stairs to Basketball Court	Ext.		Stairways	Exterior

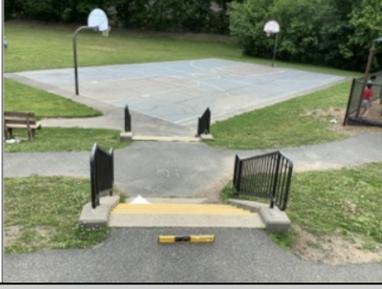
Handrail height < 34" or > 38" Handrails do not extend 12" from stairs	30.6" -	Alter so the handrails are 34"- 38" high above the ground. Top: Ensure handrails extend horizontally above the landing for 12" min. beginning above the first riser nosing. Bottom: Ensure that the sloped bottom extension extends one tread depth minimum beyond last riser nosing in same direction as stair flight.	1	-	\$0

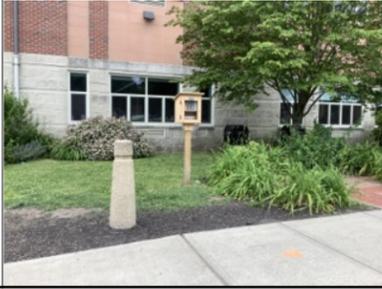
<b>Operable Parts</b>												
15	Book Exchange Receptacle School Entrance	Ext.		Operable Parts	N/A

Element not on an accessible route Reach < 15" or > 48"(forward/side approach) Not operable with a closed fist	- 52.2" -	Ensure book exchange receptacle is located on an accessible route. Relocate book exchange so that controls are between 15"- 48" above the ground. Provide hardware that can be operable with one hand and does not require tight grasping, pinching, or twisting of the wrist.	1	-	\$0

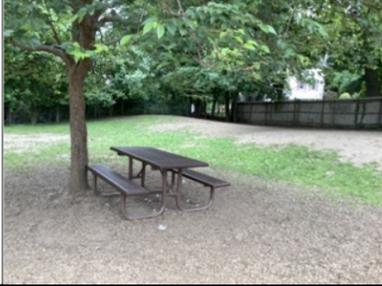
ID	Location	Floor	Room	Element	Type	Photo	Issues	Current Measure	Recommendations	Quantity	Price	Cost Estimation
<b>Picnic Tables</b>												
16	Playground	Ext.		Picnic Tables	N/A

Toe or knee clearance at table not provided Picnic table not on an accessible route	- - -	Provide at least one picnic table with top between 28"- 34" above the ground and 27" clear height underneath. Ensure that the picnic table is connected to an accessible route.	1	-	\$0
<b>Benches</b>												
17	By Stair to Basketball	Ext.		Benches	N/A

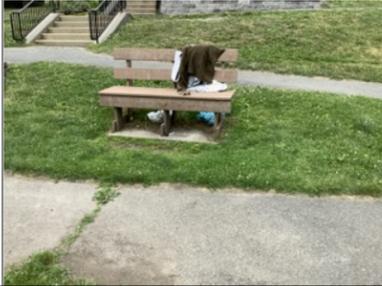
No accessible route to one bench in this area	-	Provide an accessible route to at least one bench in this area or relocate bench on an accessible route.	1	-	\$0
18	Playground	Ext.		Benches	N/A

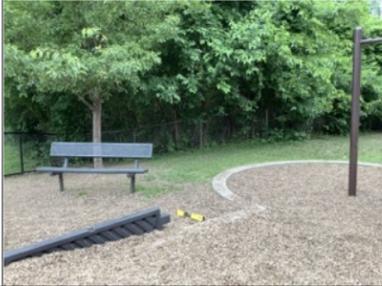
No accessible route to one bench in this area	12%	Provide an accessible route to at least one bench in this area or relocate bench on an accessible route. (Recommend poured-in-place rubber for accessible route.)	1	-	\$0

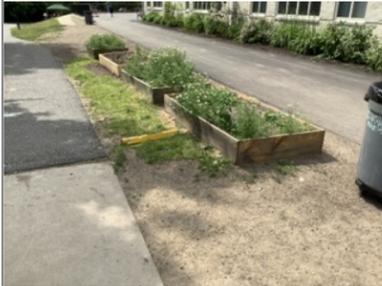
<b>Community Gardens Beds</b>												
19	Garden by Parking	Ext.		Community Gardens Beds	N/A

Not connected to an accessible route	8%	Ensure that the garden beds are connected to an accessible route.	1	-	\$0
<b>Play and Sport Areas</b>

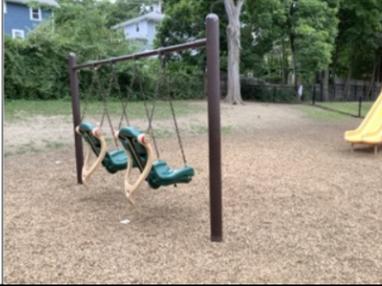
ID	Location	Floor	Room	Element	Type	Photo	Issues	Current Measure	Recommendations	Quantity	Price	Cost Estimation
<b>Play Areas</b>												
20	Playground	Ext.		Play Areas	N/A

Accessible route not provided at play components Surface not stable, firm, and slip-resistant	- -	Provide a compliant impact-attenuating surface under and around the play components.	1	-	\$0
21	Playground	Ext.		Play Areas	N/A

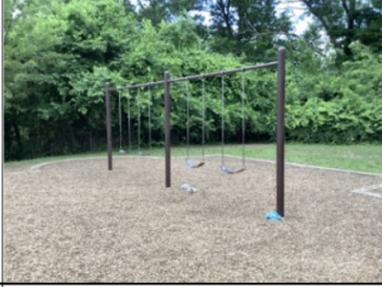
Accessible route not provided at play components Surface not stable, firm, and slip-resistant	- -	Provide a compliant impact-attenuating surface under and around the play components.	1	-	\$0
22	Playground	Ext.		Play Areas	N/A

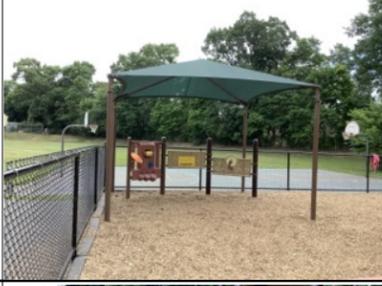
Accessible route not provided at play components Surface not stable, firm, and slip-resistant	- -	Provide a compliant impact-attenuating surface under and around the play components.	1	-	\$0
23	Playground	Ext.		Play Areas	N/A

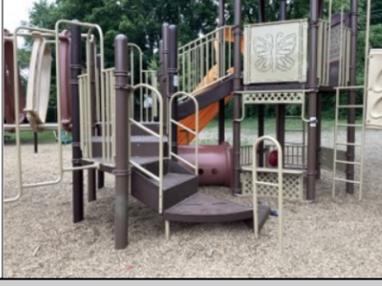
Surface not stable, firm, and slip-resistant Accessible route not provided at play components	- -	Provide a compliant impact-attenuating surface under and around the play components.	1	-	\$0

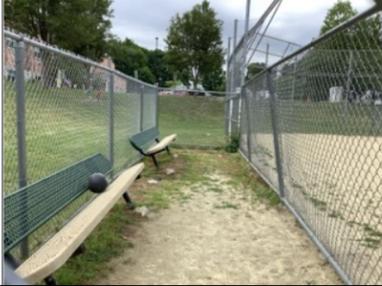
<b>Field</b>												
24	First Base Seating	Ext.		Field	Baseball

Accessible spaces are not provided at team seating Not connected to an accessible-route	- -	Provide a 36" x 48" stable, firm and slip resistant clear floor space at team seating. Provide an accessible route to team seating, and repair benches.	1	-	\$0

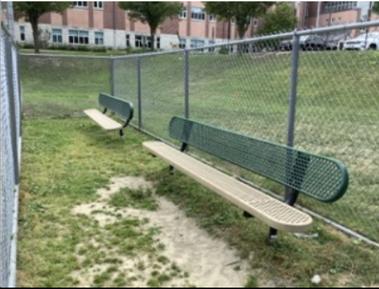
ID	Location	Floor	Room	Element	Type	Photo	Issues	Current Measure	Recommendations	Quantity	Price	Cost Estimation
25	Third Base Seating	Ext.		Field	Baseball

Accessible spaces are not provided at team seating Not connected to an accessible-route	- -	Provide a 36" x 48" stable, firm and slip resistant clear floor space at team seating. Provide an accessible route to team seating, and repair benches.	1	-	\$0
26	Baseball Field	Ext.		Field	Baseball

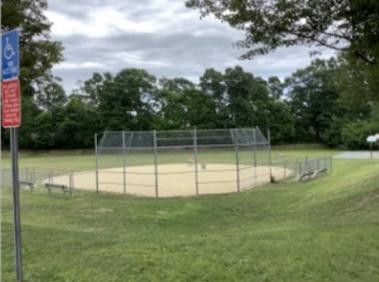
Not connected to an accessible-route	-	Provide an accessible route to the boundary of sport activity at the field.	1	-	\$0
<b>Court</b>												
27	Basketball	Ext.		Court	Basketball

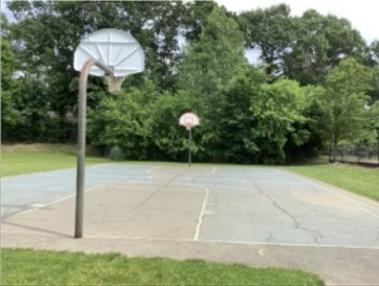
Court not maintained in operable working condition	-	Ensure court is maintained in operable working condition.	1	-	\$0
<b>Best Practice</b>												
<b>Benches</b>												
28	Route to Basketball	Ext.		Benches	N/A

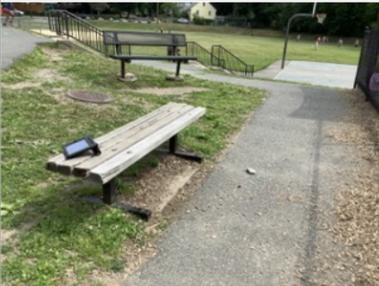
Recommend a 36"x48" min. clear floor space located beside each bench and ensure both benches are connect to an accessible route.	1		\$0

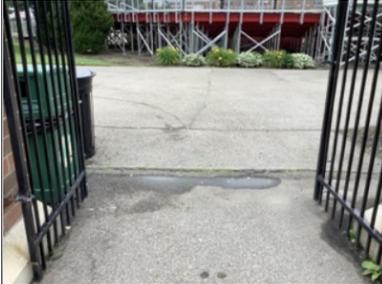
ID	Location	Floor	Room	Element	Type	Photo	Issues	Current Measure	Recommendations	Quantity	Price	Cost Estimation
<b>Approach and Entrance</b>												
<b>Exterior Access Route</b>												
1	Baseball Field Entrance - Corner of Tremont Street and Lynn Fells Parkway,	Ext.		Exterior Access Route	4

Route not maintained in operable working condition	-	Ensure that the accessible route is maintained in operable working condition.	1	-	\$0
<b>Access to Goods and Services</b>												
<b>Means of Egress</b>												
2	Press Box, East Bleacher Seating Egress	Ext.		Means of Egress	N/A

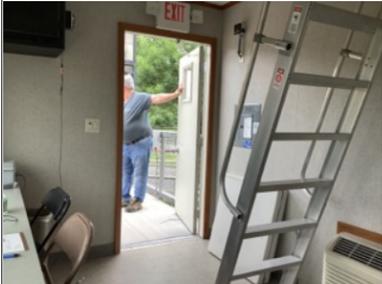
Tactile exit sign not provided	-	Ensure tactile exit signs with raised characters and braille are provided at exit doors. Mount signs between 48"- 60" above the finished floor located on the latch side of the door.	1	232	\$232
<b>Interior Access Route</b>												
3	Press Box	1		Interior Access Route	N/A

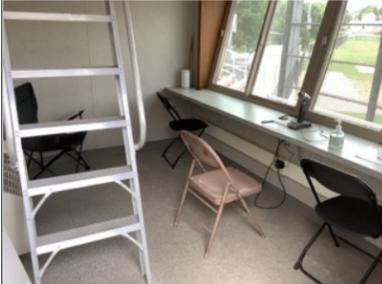
Obstructed by protruding objects	-	Relocate object./Provide a cane-detectable barrier.	1	878	\$878

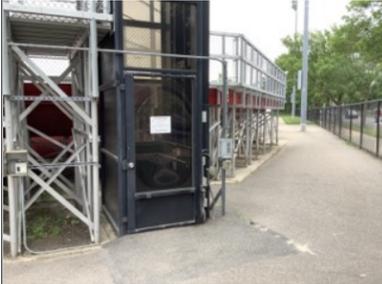
<b>Platform Lift or LULA Elevator</b>												
4	Lift Behind Bleachers, NE From Entrance	Ext.		Platform Lift or LULA Elevator	Exterior

Bleachers can be accessed via a ramp on the north side or a stairway on the southeast side. A lift provides an accessible route to the press box (south side). On the day of the survey the lift was not in operable working condition.

Not in operable working condition	-	Ensure lift is maintained in operable working condition.	1	Labor	\$0
<b>Toilet &amp; Bathing Rooms</b>

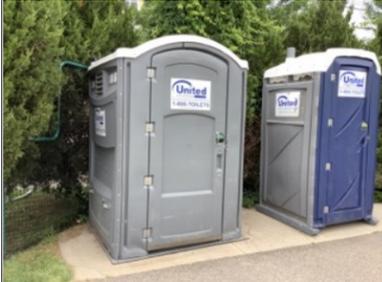
ID	Location	Floor	Room	Element	Type	Photo	Issues	Current Measure	Recommendations	Quantity	Price	Cost Estimation
<b>Portable Toilet</b>												
5	Portable Toilets Along North Route to Fred Green Memorial Field	Ext.		Portable Toilet	N/A

Accessible portable toilets not provided	-	Ensure that at least 5% of portable toilets is accessible.  See ID #7 for additional information.	1	-	\$0
6	Portable Toilet	Ext.		Portable Toilet	N/A

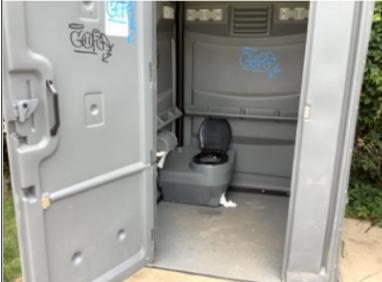
60" by 72" clear space not provided	-	Provide an accessible portable toilet that has 60" wide and 72" deep at the toilet.	1	-	\$0
<b>Play and Sport Areas</b>												
<b>Field</b>												
7	Team Seating, Third Base	Ext.		Field	Baseball

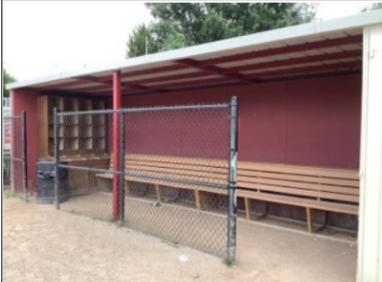
Accessible spaces not provided at team seating	-	Provide a 36" x 48" clear floor space at team seating.	1	-	\$0
8	Team Seating, First Base	Ext.		Field	Baseball

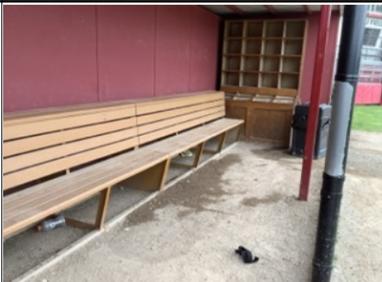
Accessible spaces not provided at team seating	-	Provide a 36" x 48" clear floor space at team seating.	1	-	\$0

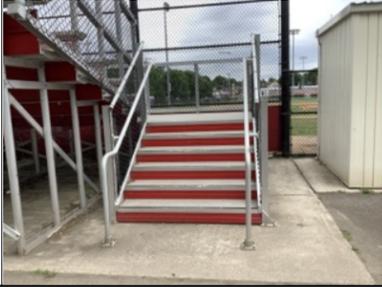
ID	Location	Floor	Room	Element	Type	Photo	Issues	Current Measure	Recommendations	Quantity	Price	Cost Estimation
9	East Bleachers Stairs	Ext.			205

If the extension is a protruding object for people approaching the stairs from the right (east side) recommend providing a cane-detectable barrier.	1		\$0
<b>Gate</b>												
10	Entrance to Third Base Team Seating	Ext.		Gate	N/A
